February 11, 2022

**Re: Tantalus Resort Lodge – 4200 Whistler Way, Whistler  
Garage, Roof, and Siding Evaluation - DRAFT**

Sense's Project No. 22vR006A

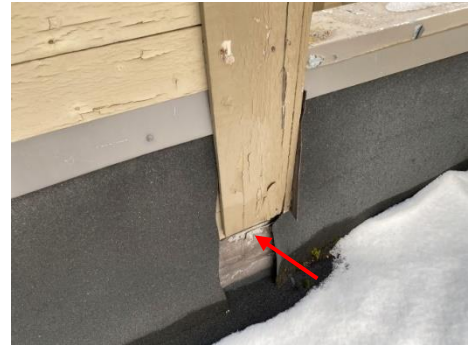
*Photo 5: Gap in loose laid wall waterproofing has left the improper lapped roofing exposed.*

There are many gaps in the loose laid roof sheets on the walls, allowing moisture to get behind the roofing. There are also improper roof laps with siding (roofing is lapped over siding rather than under) creating multiple additional paths for water or snow to get behind the newer modified bitumen roofing.

Over-roofing is not a long-term repair strategy for roofs that have leaked previously as it can trap moisture and cause framing deterioration in the system and premature failure (i.e. blistering) of the newer roofing. Additionally, the original, hardened and inflexible modified bitumen roofing system restricts movement of both the new and old roofing, which can lead to ridging and blistering. It was difficult to review all of the horizontal roof areas of the roof due to snow accumulation and we will review these areas more in the Spring. Prior to replacement, any of the loose laid wall modified bitumen should be sealed and areas of gaps covered so that water can not get behind the roofing over the short term.

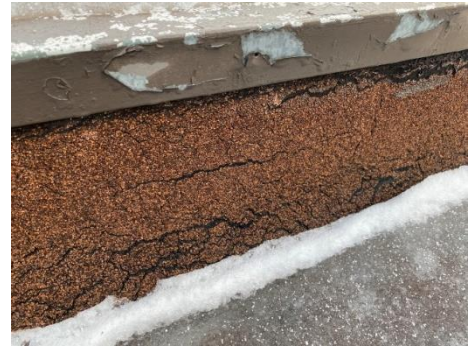
Where reviewed at the visible roof areas at the fourth floor roofs and roof decks, the exposed modified bitumen roofing has cracks and crazing consistent with it being 25 years old. The cracking and crazing are signs that the membrane is losing its elasticity and flexibility and is becoming more susceptible to damage or blistering. As the membrane continues to harden, it is less able to move with thermal expansion of the building and is more prone to mechanical damage. We noted most upturns had cracking and crazing.

*Photo 6: Cracking and crazing modified bitumen waterproofing.*

The Strata should plan to replace the 4<sup>th</sup> floor roofs in the next three to four years.

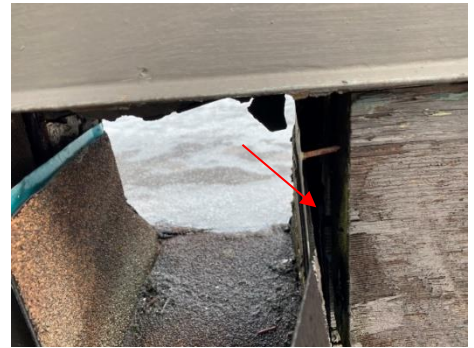
The scuppers at the roofs are generally not well sealed and have open joints into the siding and parapet framing, creating opportunities for water ingress. Some of the membrane terminations on the edges of the scupper did not appear to be fully welded and had exposed modified bitumen base sheet, which is not UV stable, and is starting to degrade. At some of the fifth floor roof areas, the scuppers have been blocked off by new waterproofing leaving only a single internal roof drain as a means of drainage. If the primary drain were to get blocked, water could back up under siding or behind the roofing membrane. Providing a secondary means of drainage in case of primary drain blockage is good industry practice.

*Photo 7: Open joint behind siding at scupper.*

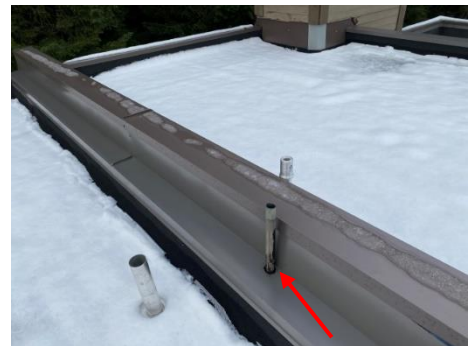
There are also plumbing vents that are not installed correctly. At one of the replaced roofs, the plumbing stack was not installed with the roofing and loosely installed over the vent and leaves the vent penetration susceptible to leakage. At other areas, the existing vent flashings are not properly sized for the vent pipe and have been crudely formed to fit the pipe, and installed without caps in some locations. Any unprotected gaps between the vent pipe and flashing can allow for water to leak into the roofing assembly or framing.

*Photo 8: Plumbing vent flashing not secured or lapped with waterproofing.*

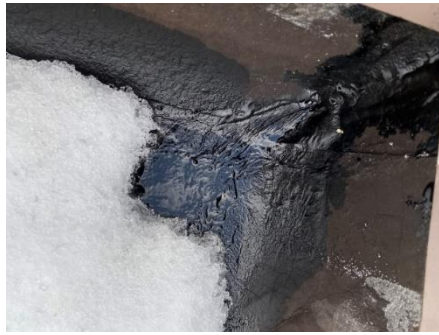
The small chimney roofs have exposed modified bitumen base sheet installed as the waterproofing. The base sheet waterproofing is not UV stable and has cracked, crazed, and hardened where reviewed. The cap flashings are starting to rust and sealants at the chimney storm collars are also hardened, crazed, and cracked. These roofs and flashings should be replaced during the upcoming roof replacement project.

Photo 9: Exposed base sheet waterproofing at chimney.

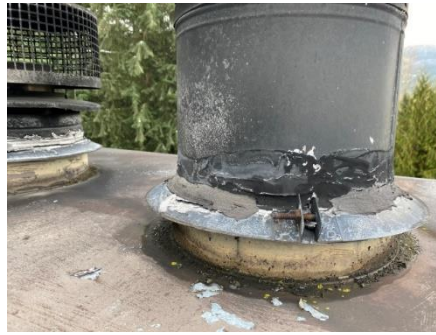
Photo 10: Failing chimney vent sealant.

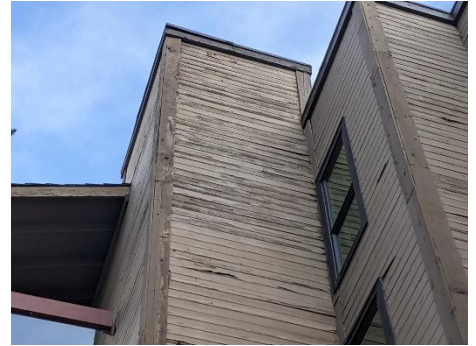
The cedar siding is installed in a concealed barrier fashion, with no provision for drainage behind the siding. The walls rely on the caulking and a continuous cedar siding barrier to keep bulk water from penetrating the face of the cladding and accessing the moisture-sensitive materials behind. This type of wall system does provide the same level of protection as drained wall systems that are now the industry standard and a building code requirement. Water that leaks past the face of the siding can damage plywood sheathing, wooden framing, and supporting fasteners.

*Photo 11: Weathered siding on the south elevation.*

Given its' condition, we recommend that the siding be replaced at all building areas with a drained cavity system, since the sheltered wall areas are small in relation to unsheltered walls. Should the Strata not replace all of the siding, all trim and corner joints should be sealed to better protect against moisture getting into the walls.

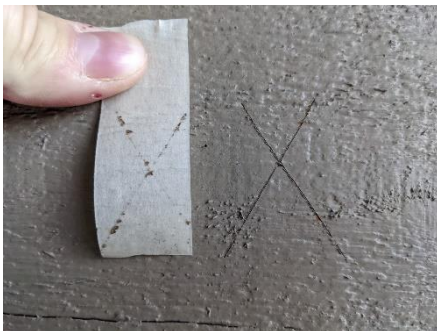
*Photo 12: Paint adhesion test showing good paint adhesion, taken at a protected wall area on the balcony at Suite 202.*

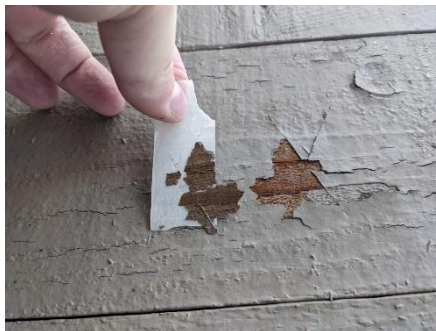
*Photo 13: Paint adhesion test showing poor paint adhesion, taken at an exposed wall area from the balcony at Suite 202.*

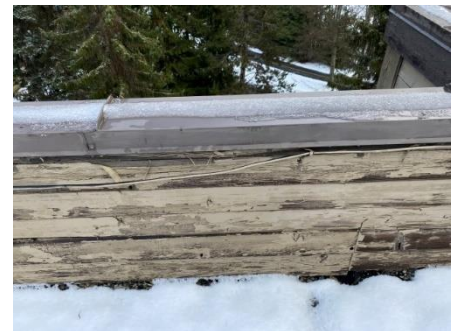
*Photo 14: Damaged paint and weathered siding at exposed rooftop areas.*

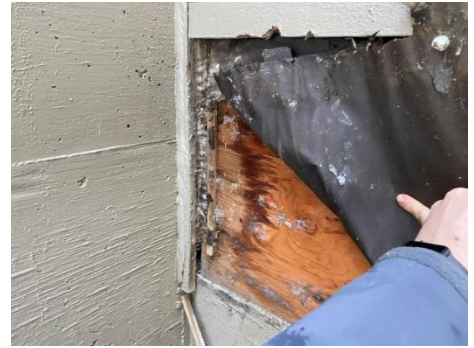
The siding was generally sealed to the wall and window trims throughout; however, the sealant at trim joints and wall corners was crazed, cracked, hardened, and failed, allowing some water to bypass the wood siding to the building paper and wood sheathing. At 6 of 17 wall openings, we found water staining, typically concentrated at the inside or outside corner.

Moisture levels of the wall sheathing closer to the trim and wall corners was generally elevated compared to the moisture readings taken at the field of the wall sheathing away from the joints. Although there is water staining on the building paper and wall sheathing behind the siding to trim joints at the wall opening locations, we did not note any areas where wood framing or sheathing rot had occurred. The elevated moisture content found at most of the areas reviewed and signs of water staining can lead to damaged interior finishes and promote mould growth, particularly on interior drywall.

*Photo 15: Moisture staining at inside corner.*

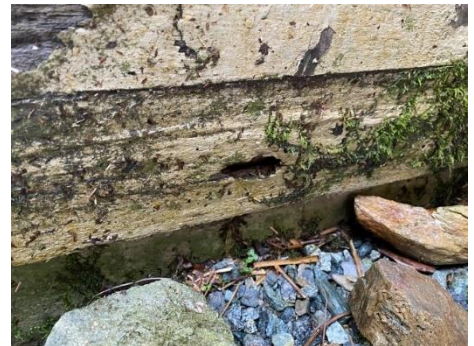
At some locations, the cedar siding extends close to grade level or close to the roof level. The siding at these areas was typically wet, paint was peeling off boards and boards were rotten. This is from snow build up against the walls over prolonged periods of time or rain splashing onto the walls, keeping the siding wet for longer periods of time. When siding is replaced in these areas, the bottom of the siding should be raised to allow a minimum of 12" (300mm) clearance between the bottom of the siding and grade or the roof. Alternative siding material could be considered in these areas, such as metal panels, that would be more durable than wood or fibre cement siding.

*Photo 16: Deteriorated siding just above grade.*

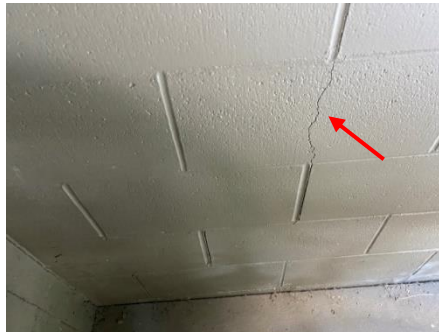
Generally, the concrete masonry walls appear to be in good condition, with some areas of cracked mortar or masonry units, and blistered paint at exposed areas. Although cracking is minor, water can penetrate these cracks and potentially cause further damage to paint and the masonry. During upcoming siding repairs, concrete masonry should be repaired where cracked and blistered paint should be stripped, and new paint applied at these areas. The tops of the concrete masonry walls should also be better protected to direct water away from the masonry units to prevent future paint blistering.

Photo 17: Cracked masonry unit.

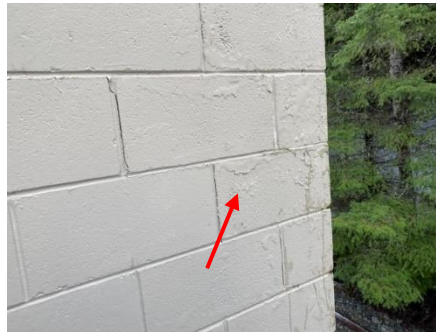
Photo 18: Cracked mortar, and blistered paint at a masonry wall.

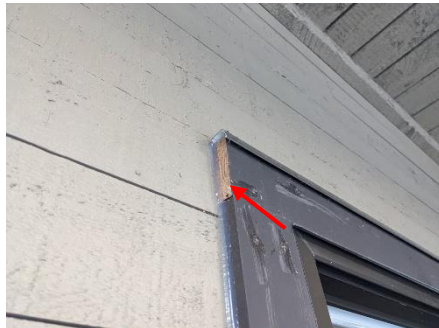
We understand that the windows and sliding doors were recently replaced. The trim and sealant around the windows and doors is generally in good condition; however there are some areas where the trim was left bare at cut edges or paint on boards were applied thin and there are bare, unprotected areas of wood. Trim boards should be repainted where required to improve durability.

Photo 19: Unpainted cut end of trim board.

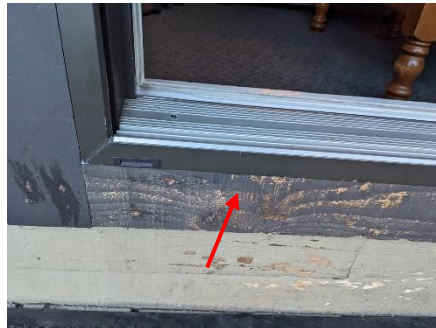
Photo 20: Damaged trim paint.

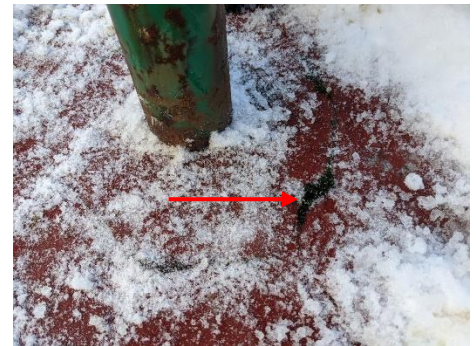
The tennis court area has had a layer of modified bitumen waterproofing installed at the perimeter, likely in an effort to reduce leakage into the parking garage. The waterproofing appears to be installed over the concrete perimeter curb and lapped onto the asphalt walking surface; however, it does not lap with the original garage roof slab waterproofing. While this repair may reduce the amount of water that can get into the garage from the perimeter curbs, it does not stop prevent water from travelling underneath the asphalt surface. Water can get underneath the asphalt through penetrations or defects in its surface or at unrepaired perimeters. Once under the asphalt, water can travel horizontally until it finds a defect in waterproofing and leak into the garage. Where reviewed at one tennis net post, the asphalt has cracked and is allowing water into the roof assembly below. Depending on when garage roof slab repairs will be completed, local repairs may be needed to help protect the concrete below and prevent leaks into the garage.

Photo 21: Cracked asphalt surface at a tennis net post.

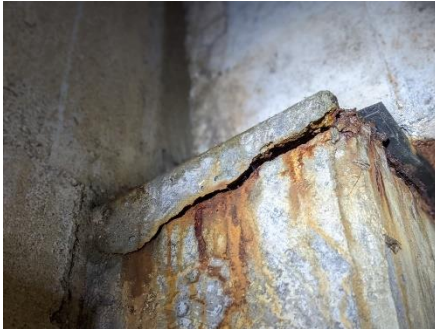
- Corbels (concrete projections extending out of walls that support the precast double tee beams) are spalled, cracked, or have exposed rebar.

Structural damage is mainly concentrated at corbels; however, there are a few isolated areas where concentrated water flow has caused moderate-to-severe concrete damage throughout P1 and P2.

*Photo 23: Corbels are spalled, and delaminating.*

Structural repairs to the corbels in the garage will require pre-cast sections to be temporarily shored until the concrete cures enough to support the pre-cast sections. Once these repairs are completed, the roof slab should be re-waterproofed to provide a reasonably dry environment for subsequent interior garage repairs (i.e., concrete topping, electrical, and drainage repairs, suspended slab waterproofing). Painting and sealant work should be completed at the same time to restore the water-tightness of the garage exterior.

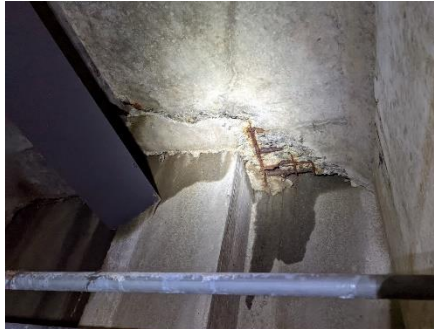
*Photo 24: Exposed rebar in the roof slab soffit.*

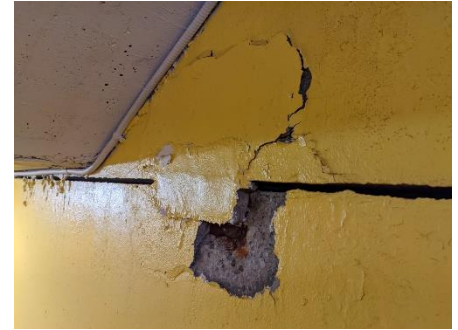
*Photo 25: Large delamination in the staircase wall.*

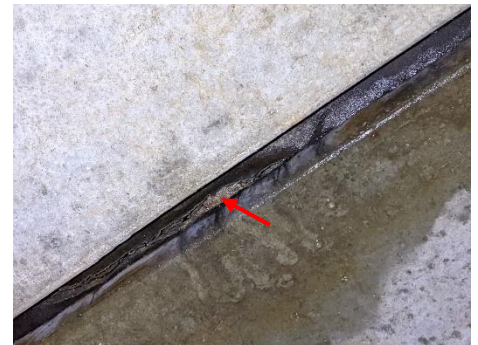
The majority of the water that is causing damage to the parking garage structure is entering through the pre-cast double tee beam joints in the garage roof slab. It appears that the panel joints were pre-stripped with an asphaltic sheet waterproofing before the field garage roof slab waterproofing was applied overtop. Movement at the panel joints has likely created breaches in the waterproofing as it ages and becomes less flexible.

Of our three inspection pit openings we found two locations where the waterproofing was poorly bonded, although no water was observed under the waterproofing at these locations. These inspection pit areas were not over joints between panels, where there was moisture observed under the waterproofing. There are also areas of the roof slab perimeter waterproofing that has de-bonded and defects that would allow water behind the waterproofing.

*Photo 26: Roof slab membrane has split at a double tee joint.*

Based on the widespread roof slab leaks, it appears that the garage roof slab waterproofing has generally failed. We recommend that the garage roof slab waterproofing be replaced to prevent further damage to the structure and property inside the garage.

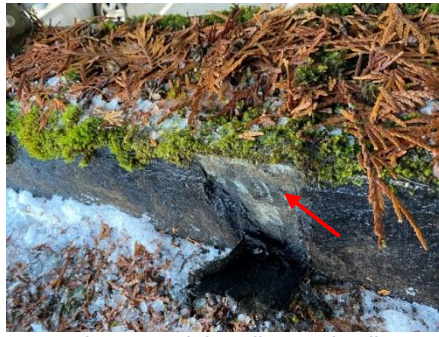
*Photo 27: debonding and split waterproofing at curb.*

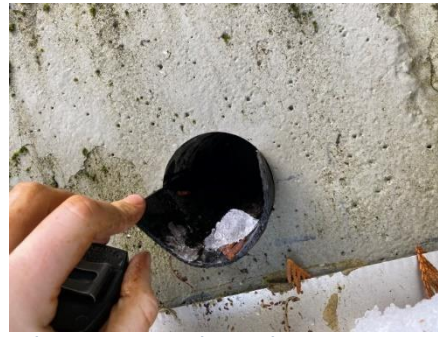
The roof slab leaks have been addressed by installing drip trays at most of the panel joints inside the garage, which direct water to the wall panel joints, resulting in steel wall clips are rusting. Scupper drains have also been installed at the roof slab waterproofing wall upturns, likely to reduce the amount of water leaking into the garage. These scupper repairs were poorly installed with exposed UV sensitive modified bitumen that is not watertight around the opening.

*Photo 28: Loose base sheet at scupper.*

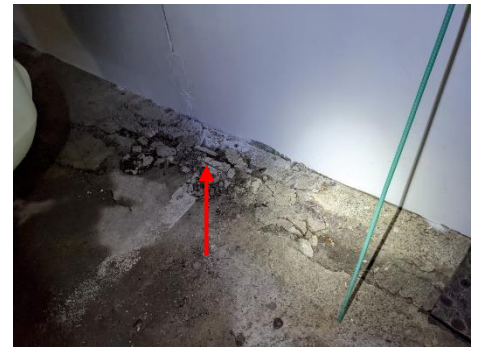
The suspended intermediate slab is not waterproofed to help prevent leaking into garage areas below and reduce concrete damage. Current building code requires that suspended slabs in parking garages be protected from deterioration mechanisms like corrosion of reinforcing steel resulting from exposure to water and salts. Specifically, water entering cracks and joints in the garage structures can cause reinforcing steel in the concrete to corrode. When steel corrodes, it causes concrete to delaminate (i.e. cause pieces of concrete to break off). The additional water ingress concentrated below roof slab drip trays has accelerated the damage to the suspended slab. Even though the intermediate slab topping is not significantly damaged away from walls, waterproofing the top surface of the intermediate slab will reduce future wetting and structural deterioration at these locations.

*Photo 29: The unprotected suspended slab topping has delaminated.*

The parking garage repair project should include waterproofing suspended floors after concrete repairs and roof slab repairs are completed.

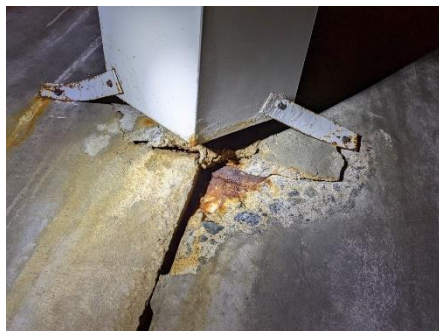
In addition to the damage at the suspended slab perimeters, the concentrated water from the drip trays has resulted in spalling of the concrete at the steel wall panel ties at a number of locations.

*Photo 30: Drip tray directing water to a wall joint, resulting in spalling of the concrete around a steel tie.*

Where concrete has spalled, ties should be cleaned of rust and epoxy coated, concrete repaired, and drip trays removed. If drip trays are reinstalled at a later date, they should be directed away from wall joints, ideally into area drains.

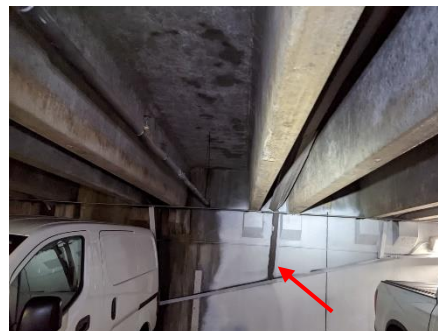
*Photo 31: Network of connected drip trays directing water to an area drain.*

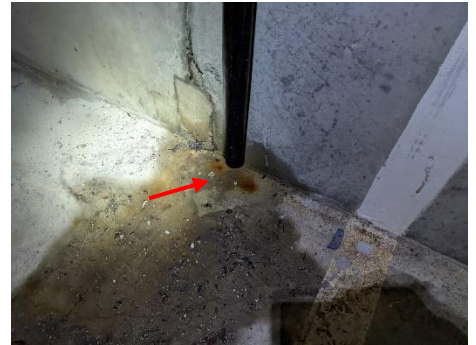
Area drains on the intermediate suspended slab are not tied into the plumbing system, and discharge water onto the slab-on-grade. While it does not appear that this has caused significant concrete damage yet, these drains should be properly integrated into the garage's plumbing system as part of the garage repair project.

Photo 32: Area drain discharging onto the slab-on-grade.

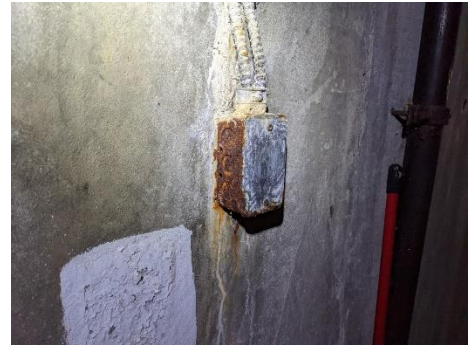
There are several electrical receptacles, junction boxes, and electrical conduits inside the garage that are water damaged. Water around electrical services could disrupt power to the complex and may be a safety hazard. These fixtures should be replaced as part of the garage repair project.

Photo 33: Water damaged electrical box.

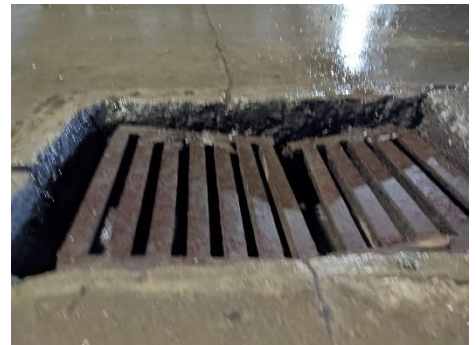
One drain grate has broken and is sitting approx. 2" (50mm) below the surrounding slab height. This drain is a tripping hazard and the drain grate should be replaced.

Photo 34: Cracked drain grate.

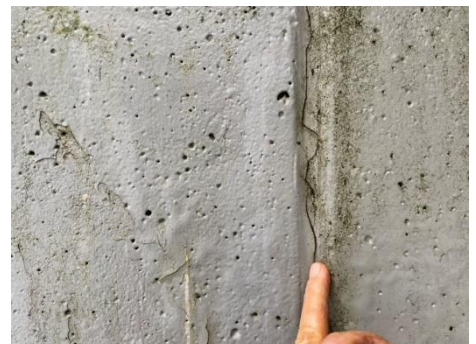
Where reviewed at the exterior pre-cast wall joints, existing sealant is generally stiff and cracked, potentially allowing water into the joint cavity. All wall sealant should be removed and replaced as part of the garage repair project.

Photo 35: Sealant at panel joints is split.

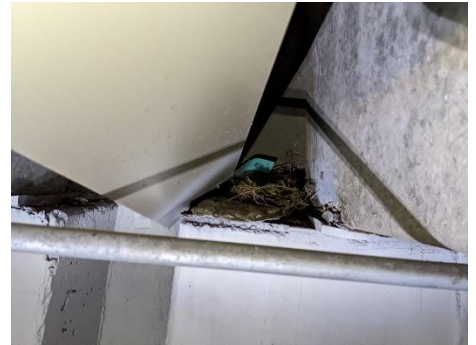
Where reviewed at a few locations on the lower level of the parking garage, there are bird nests on the corbels. The Strata should contact the local animal control authority to coordinate their removal and develop a plan to deter birds from nesting in the garage.

*Photo 36: Birds nest at a corbel.*

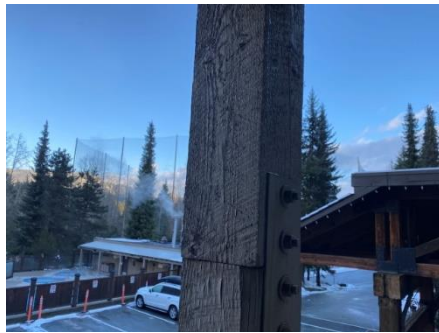
The balconies are a drain-through design supported with pressure treated exterior posts and beams that are tied back to the structure with a ledger board and steel angles. Some of the balcony posts are spliced at various points mid height between floors and connected on two sides with steel plates and through bolts. This type of splice is not typical and creates a weak point in the post.

*Photo 37: Balcony post splice mid-height.*

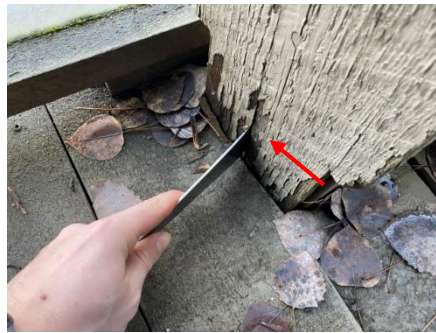
*Photo 38: Framing starting to deteriorate at base of posts.*

The drain-through balcony design does not protect moisture sensitive components of the balconies from related deterioration. Our review did not include the balconies but we did observe rust staining on the hardware and weathering of structural components where exposed to wetting. The Strata should consider a balcony evaluation to check that balcony posts are installed to meet load requirements and review for deterioration of framing members.

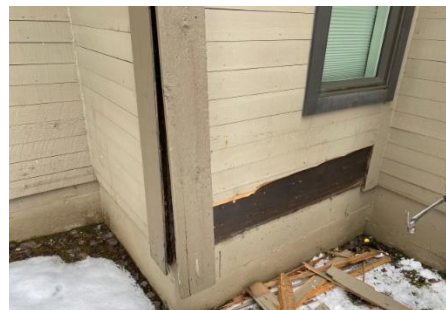
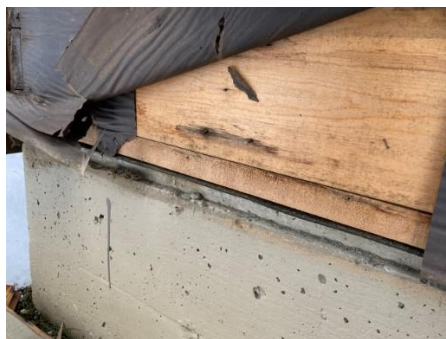
| Opening No. | Opening Type | Date of Opening | Weather |
|---|---|---|---|
| <ul style="list-style-type: none"> <li>• No evidence of moisture or leakage</li> <li>• No damage on sheathing or framing</li> <li>• Wood moisture content: 15.6%</li> </ul> | | | |

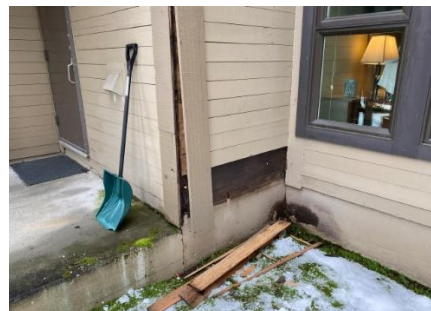
| Opening No. | Opening Type | Date of Opening | Weather |
|---|---|---|---|
| <ul style="list-style-type: none"> <li>• Minor staining on sheathing</li> <li>• Wood moisture content: 24.9%</li> </ul> | | | |

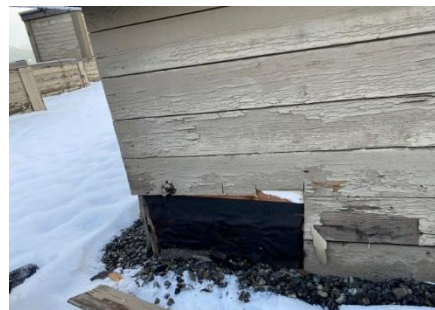
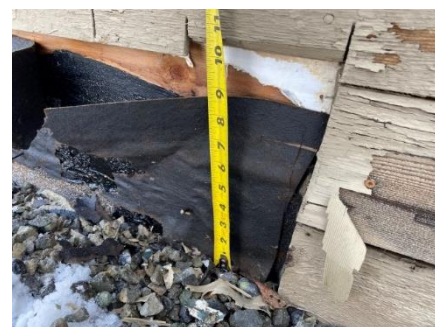
| Opening No. | Opening Type | Date of Opening | Weather |
|---|---|---|---|
| <ul style="list-style-type: none"> <li>• No evidence of moisture or leakage</li> <li>• No damage on sheathing or framing</li> </ul> | | | |

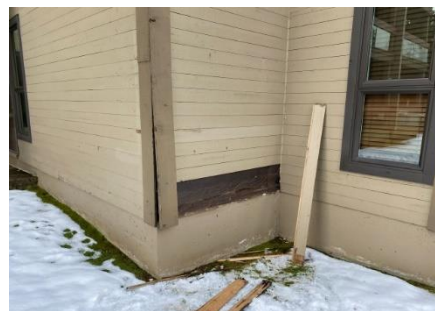
| Opening No. | Opening Type | Date of Opening | Weather |
|---|---|---|---|
| <ul style="list-style-type: none"> <li>• Minor staining on sheathing in corner</li> <li>• Wood moisture content: 18.8%</li> </ul> | | | |

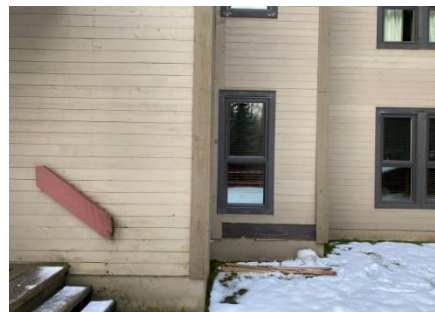
| Opening No. | Opening Type | Date of Opening | Weather | |
|---|---|---|---|--|
| <ul style="list-style-type: none"> <li>• No evidence of moisture or leakage</li> <li>• No damage on sheathing or framing</li> <li>• Wood moisture content: 20.1%</li> </ul> | | | | |

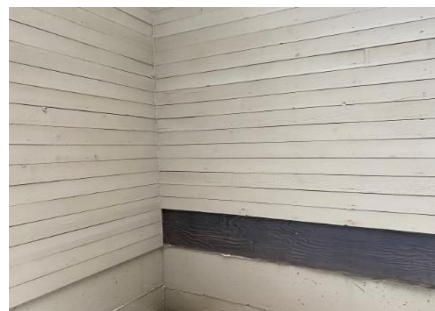
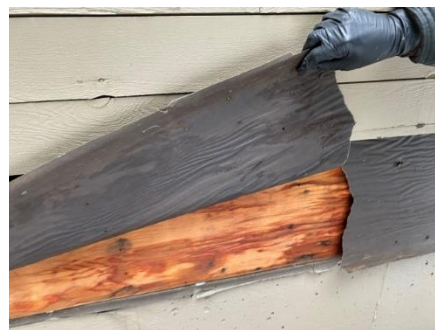
| Opening No. | Opening Type | Date of Opening | Weather | |
|---|---|---|---|--|
| <ul style="list-style-type: none"> <li>• Moisture on sheathing and paper</li> <li>• No damage on sheathing or framing</li> <li>• Wood moisture content: 33.6%</li> </ul> | | | | |

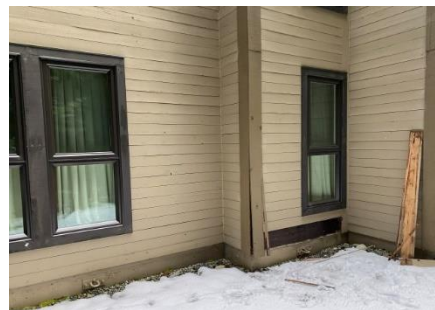
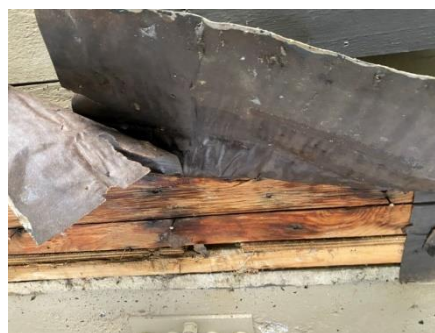
| Opening No. | Opening Type | Date of Opening | Weather | |
|---|---|---|---|--|
| <ul style="list-style-type: none"> <li>• Moisture on sheathing and paper</li> <li>• Wood moisture content: 29.2%</li> </ul> | | | | |

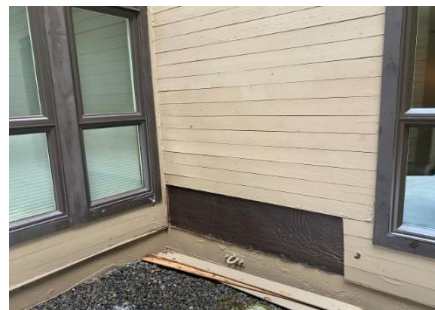
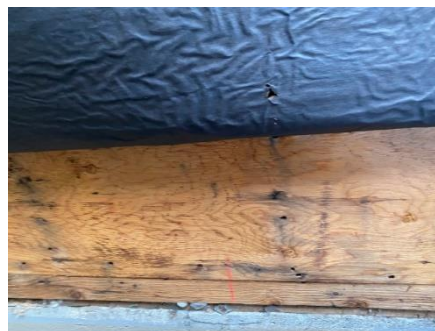
| Opening No. | Opening Type | Date of Opening | Weather | |
|---|---|---|---|--|
| <ul style="list-style-type: none"> <li>• No evidence of moisture or leakage</li> <li>• No damage on sheathing or framing</li> <li>• Wood moisture content: 17.5%</li> </ul> | | | | |

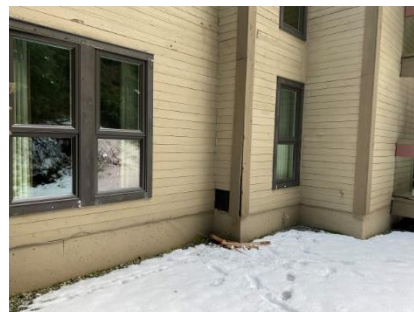
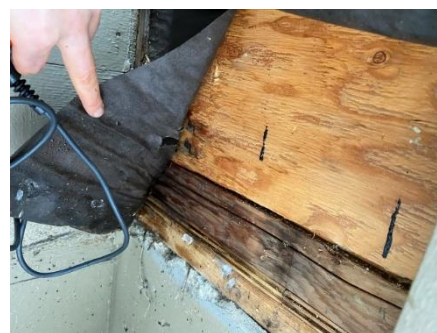
| Opening No. | Opening Type | Date of Opening | Weather |
|---|---|---|---|
| <ul style="list-style-type: none"> <li>• Moisture staining on framing and paper</li> <li>• Wood moisture content: 20.0%</li> </ul> | | | |

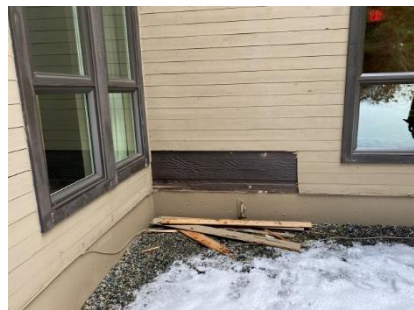
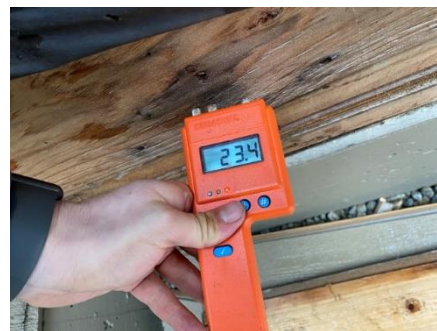
| Opening No. | Opening Type | Date of Opening | Weather |
|---|---|---|---|
| <ul style="list-style-type: none"> <li>• Moisture staining on framing and paper</li> <li>• Wood moisture content: 28.9%</li> </ul> | | | |

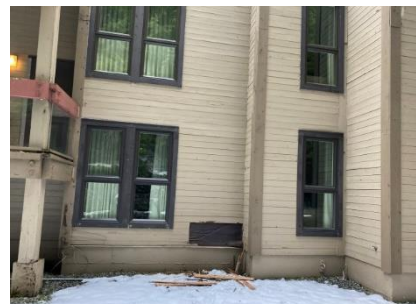
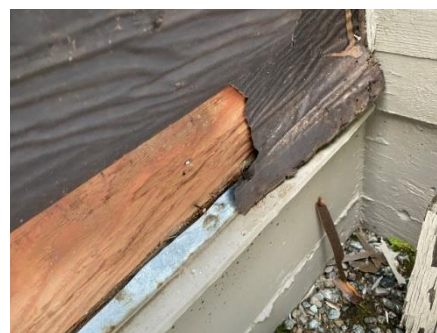
| Opening No. | Opening Type | Date of Opening | Weather |
|---|---|---|---|
| <ul style="list-style-type: none"> <li>• No evidence of moisture or leakage</li> <li>• No damage on sheathing or framing</li> <li>• Wood moisture content: 23.3%</li> </ul> | | | |

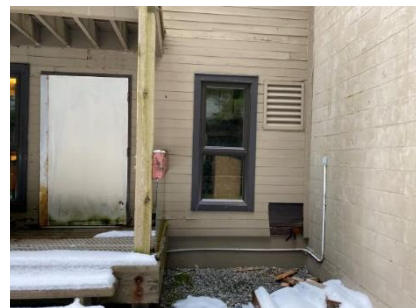
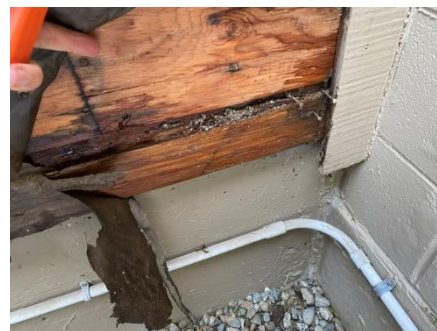
| Opening No. | Opening Type | Date of Opening | Weather |
|---|---|---|---|
| <ul style="list-style-type: none"> <li>• Moisture staining on paper and sheathing</li> <li>• Wood moisture content: 31.9%</li> </ul> | | | |

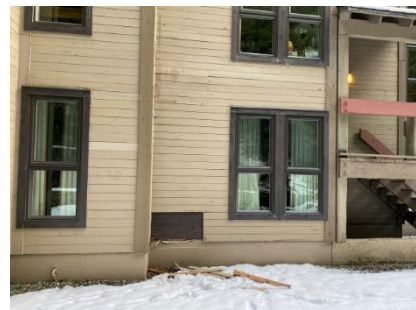
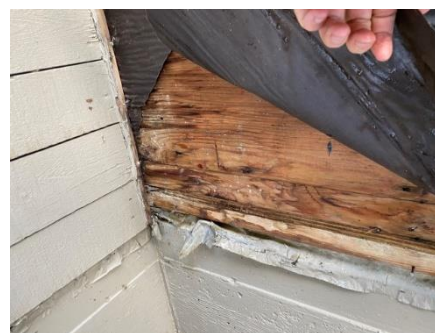
| Opening No. | Opening Type | Date of Opening | Weather |
|---|---|---|---|
| <ul style="list-style-type: none"> <li>• Moisture staining on paper and sheathing</li> <li>• Wood moisture content: 23.4%</li> </ul> | | | |

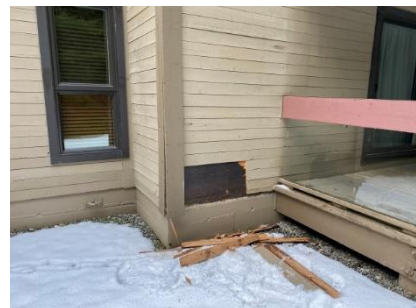
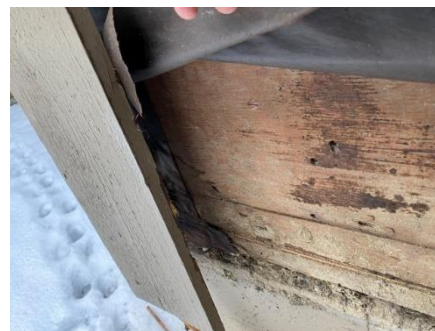
| Opening No. | Opening Type | Date of Opening | Weather |
|---|---|---|---|
| <ul style="list-style-type: none"> <li>• No evidence of moisture or leakage</li> <li>• No damage on sheathing or framing</li> <li>• Wood moisture content: 20.1%</li> </ul> | | | |

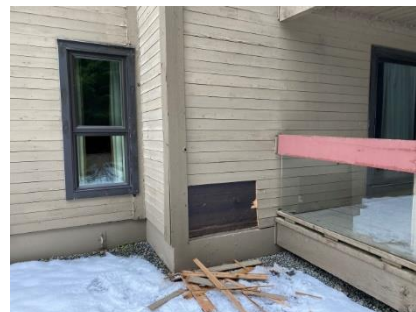
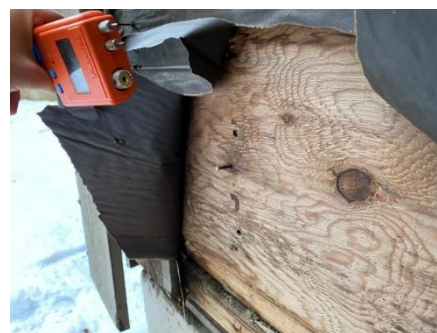
| Opening No. | Opening Type | Date of Opening | Weather | |
|---|---|---|---|--|
| <ul style="list-style-type: none"> <li>• No evidence of moisture or leakage</li> <li>• No damage on sheathing or framing</li> <li>• Wood moisture content: 17.4%</li> </ul> | | | | |

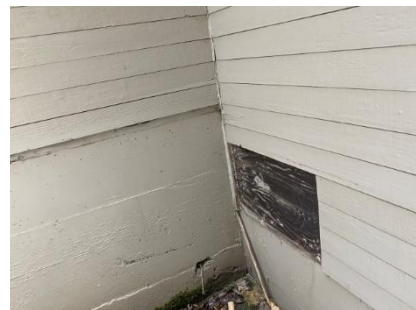
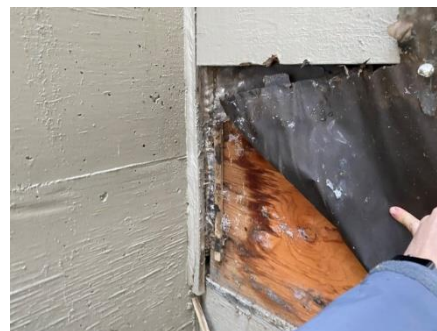
| Opening No. | Opening Type | Date of Opening | Weather | |
|---|---|---|---|--|
| <ul style="list-style-type: none"> <li>• Staining on sheathing and paper</li> <li>• Wood moisture content: 29.1%</li> </ul> | | | | |

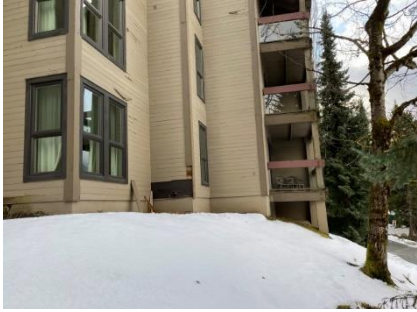
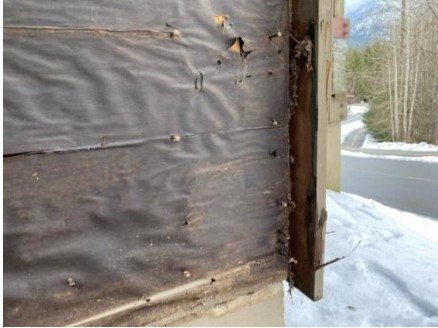
| Opening No. | Opening Type | Date of Opening | Weather | |
|---|---|---|---|---|
| <ul style="list-style-type: none"><li>• No evidence of moisture or leakage</li><li>• No damage on sheathing or framing</li><li>• Wood moisture content: 23.4%</li></ul> | | | | |
