INSPECTION REPORT

For the Property at:
454 WELLER STREET
PETERBOROUGH, ON K9H 2N6

Prepared for: TOM SANGSTER
Inspection Date: Monday, June 2, 2025
Prepared by: David Sharman

RE: Report No. 5306, v.2
454 Weller Street
Peterborough, ON
K9H 2N6

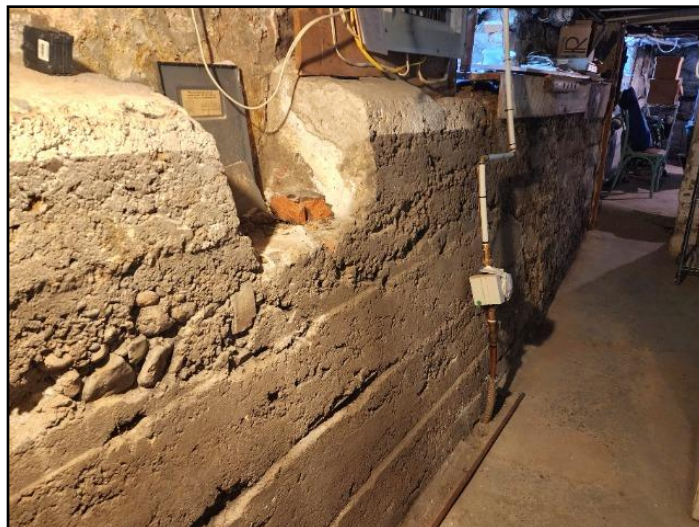
3. Condition: • Basement lowered

Implication(s): Chance of structural movement

5. Basement lowered

Task: Monitor

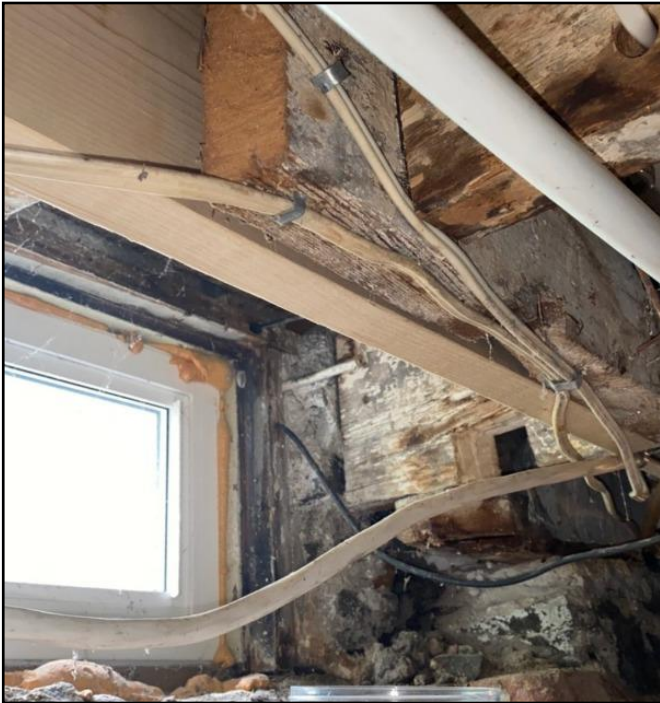
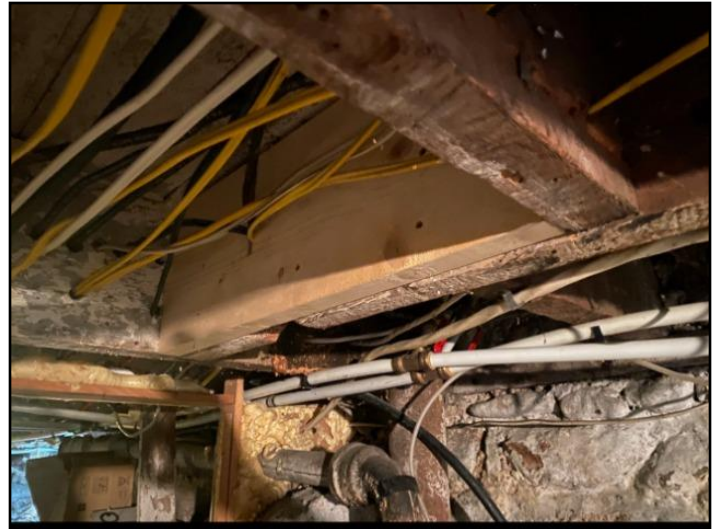
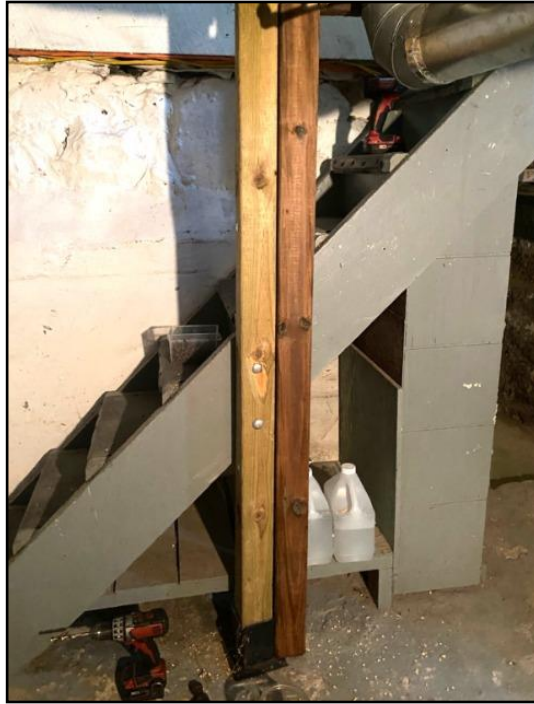
5. Condition: • Prior repair/replacement

Implication(s): Possible weakend structure, Chane of structural movement

6. Prior repair/replacement

Task: Monitor

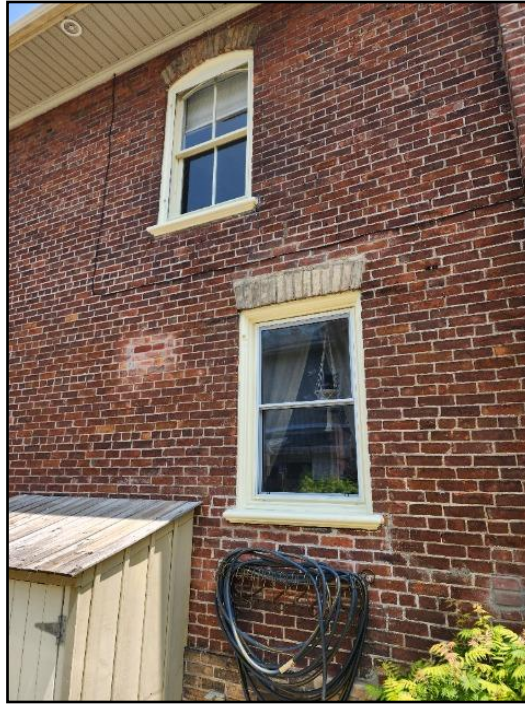
6. Condition: • Prior repairs

Location: Left elevation

9. Prior repairs

Task: Monitor

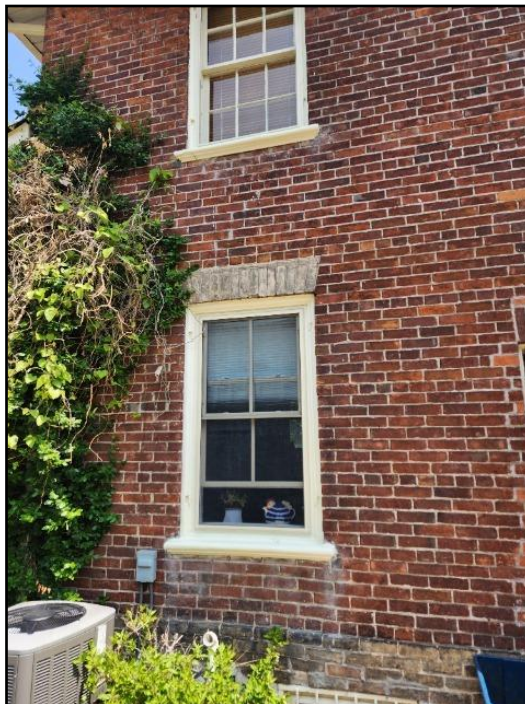
7. Condition: • Typical minor cracking

Implication(s): Material deterioration

Location: Left elevation

10. Typical minor cracking

Task: Repair

Time: Discretionary

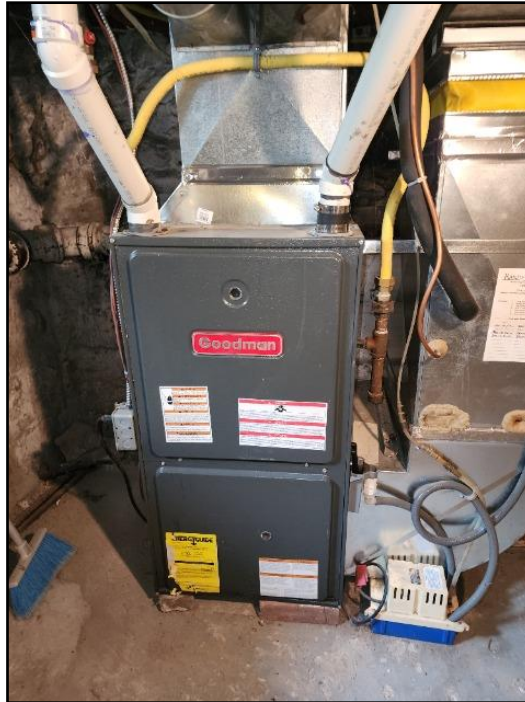
16. Goodman

9. Condition: • Near end of life expectancy

Implication(s): Equipment failure | No heat for building

Task: Monitor

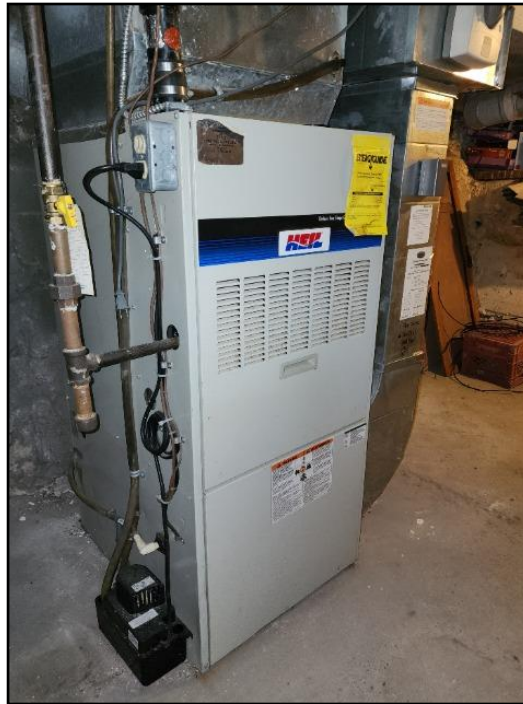
17. Heil

10. Condition: • Past life expectancy

Implication(s): Equipment failure | No heat for building

Task: Monitor

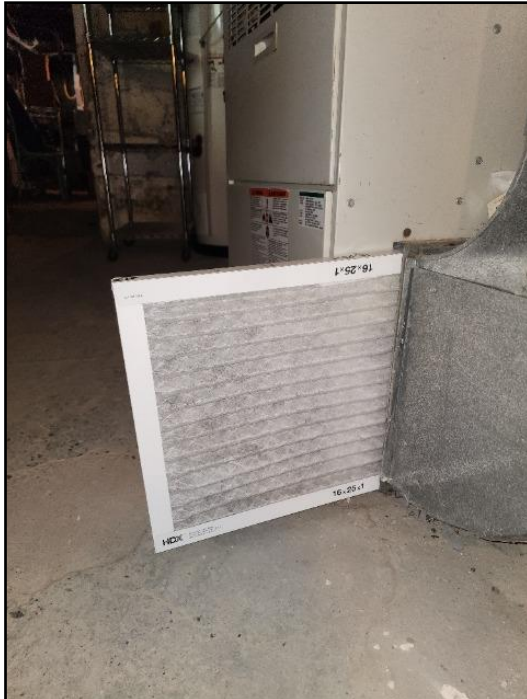
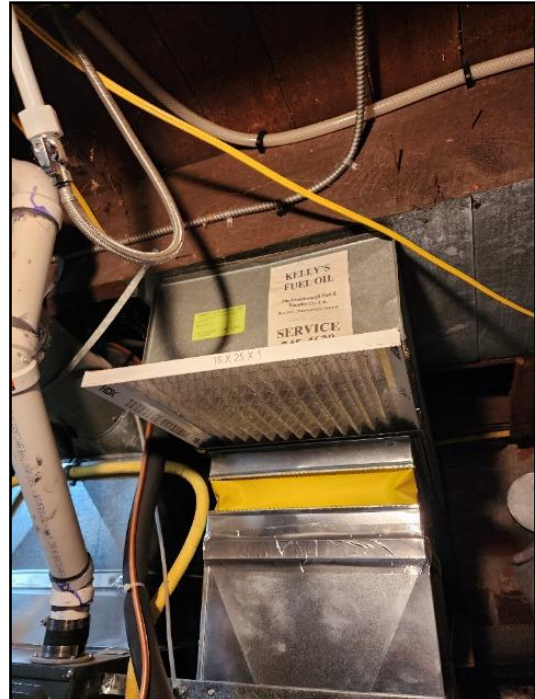
11. Condition: • Replace - regular maintenance

Implication(s): Increased heating & maintenance costs, Reduced comfort

29. Replace - regular maintenance

Task: Replace - regular maintenance

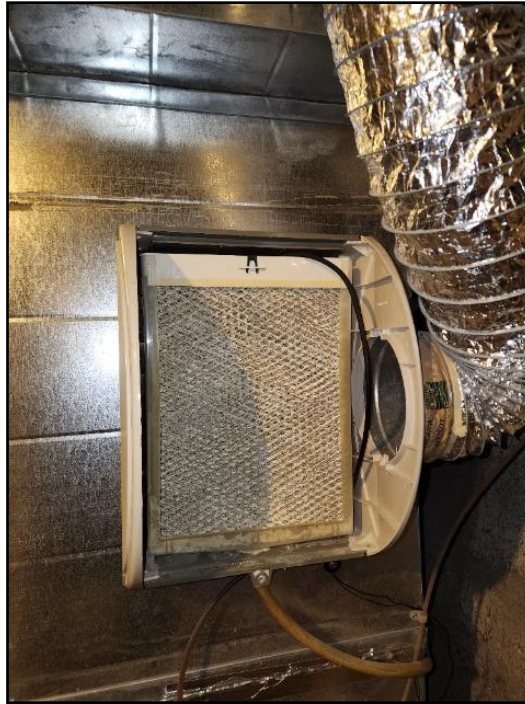
12. Condition: • Clean pad/mesh - regular maintenance

Implication(s): Equipment not operating properly

31. Clean pad/mesh - regular maintenance

Task: Clean - regular maintenance

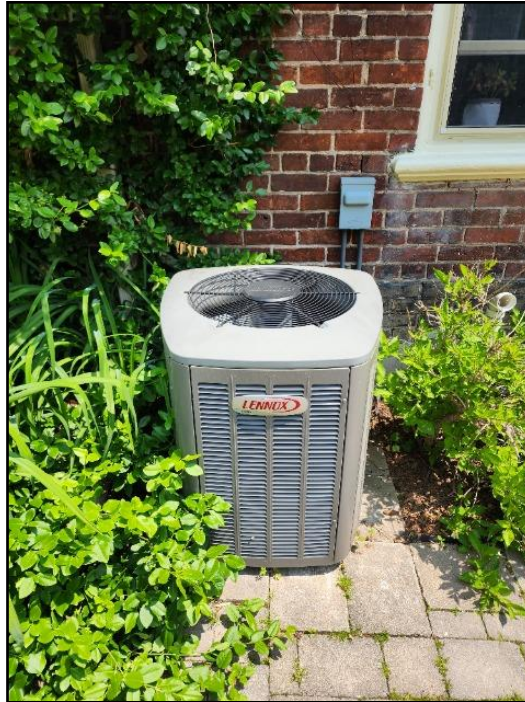
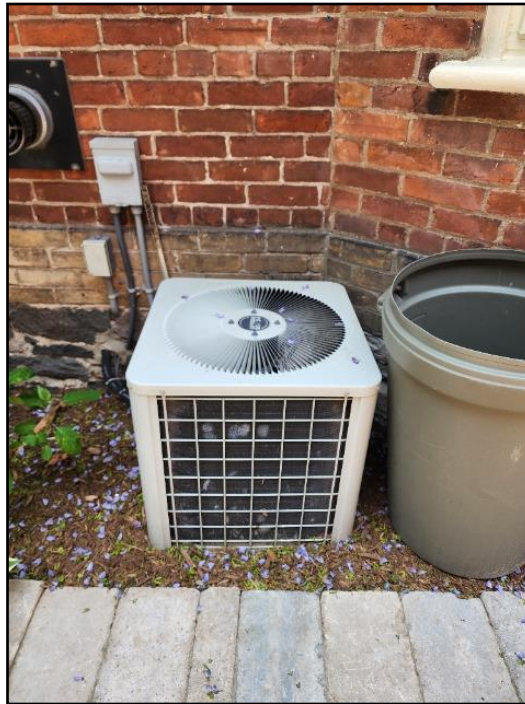
32. Lennox

14. Condition: • Past life expectancy

Implication(s): Equipment failure | Reduced comfort

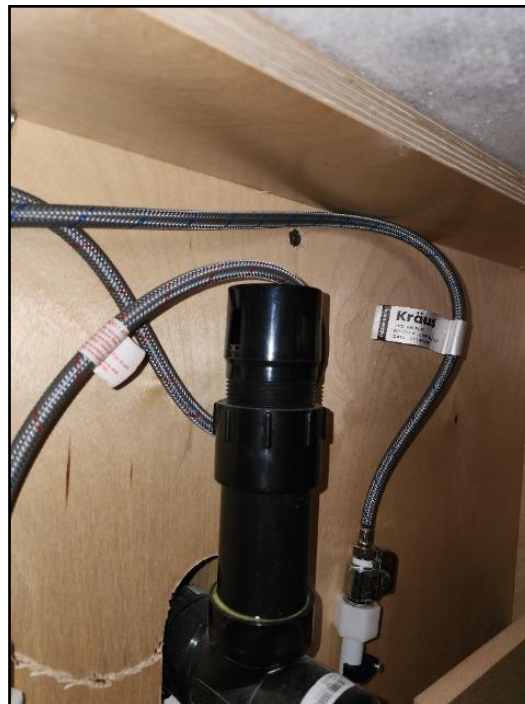
16. Condition: • Automatic air vents

Implication(s): Failure may allow sewer gasses to enter building

38. Automatic air vents

Task: Monitor
