# INSPECTION REPORT

For the Property at:  
**848 GILBERT STREET**  
PETERBOROUGH, ON

Prepared for: CARLEY STENSON  
Inspection Date: Friday, May 13, 2022  
Prepared by: David Sharman

RE: Report No. 3840  
848 Gilbert Street  
Peterborough, ON

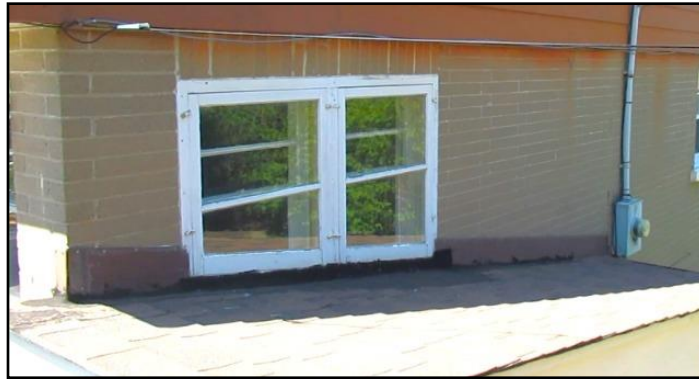
3.

1. Condition: • Patched

Implication(s): Chance of water damage to structure, finishes and contents

Location: Rear elevation

Task: Monitor

Time: Ongoing

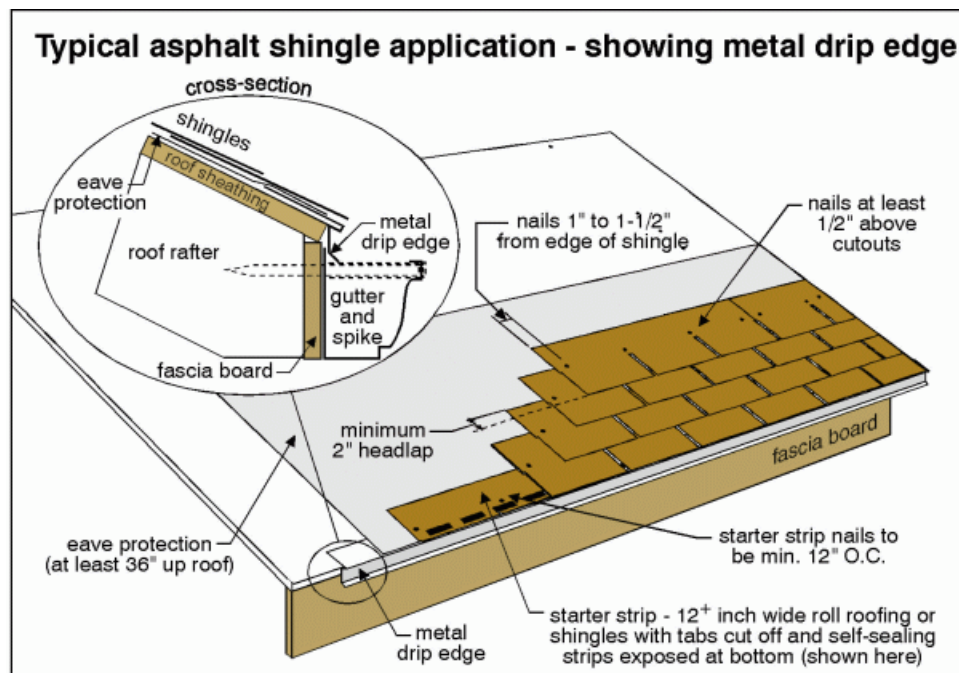
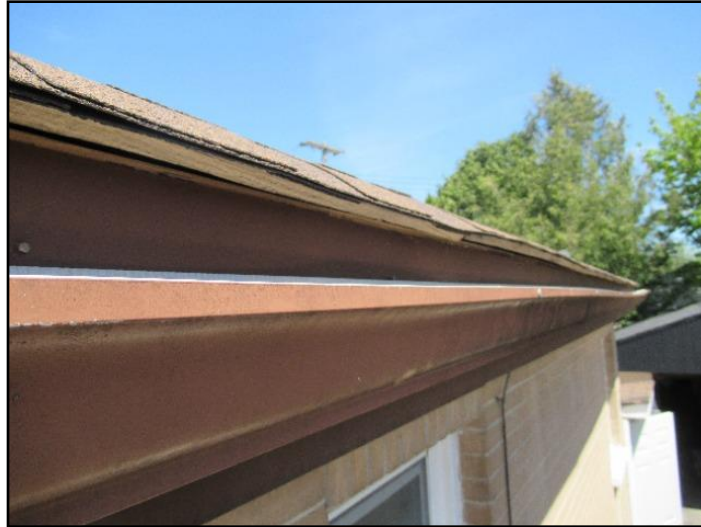
**2. Condition:** • Missing

**Implication(s):** Chance of water damage to structure, finishes and contents

**Location:** Throughout

4. Missing

**Task:** Provide

**Time:** Discretionary

**Cost:** Minor

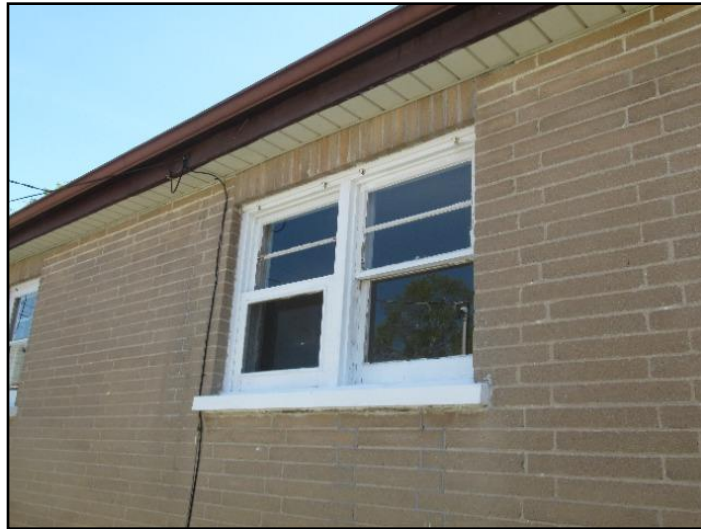
**3. Condition:** • Missing and/or damaged

**Implication(s):** Increased heating and cooling costs | Reduced comfort

**Location:** Left elevation

5. Missing and/or damaged

**Task:** Replace

**Time:** Discretionary

**Cost:** Minor

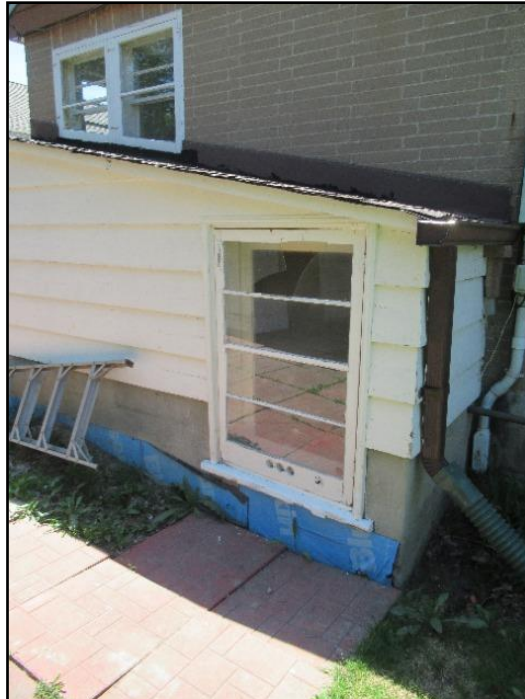
**4. Condition:** • Glass broken, cracked or missing

**Implication(s):** Increased heating and cooling costs | Reduced comfort

**Location:** Rear elevation

6. Glass broken, cracked or missing

**Task:** Replace

**Time:** As soon as is practicable

**Cost:** Minor

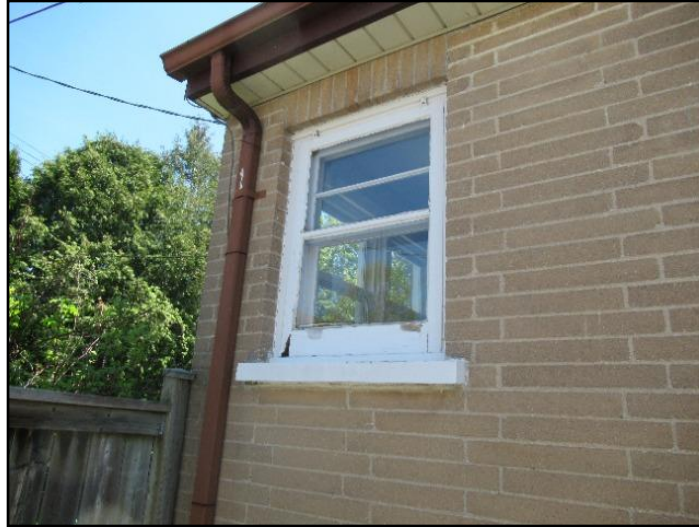
**5. Condition:** • Rot

**Implication(s):** Further material deterioration, chance of water entering building

**Location:** Rear left corner

7. Rot

**Task:** Repair

**Time:** Discretionary

**Cost:** Minor

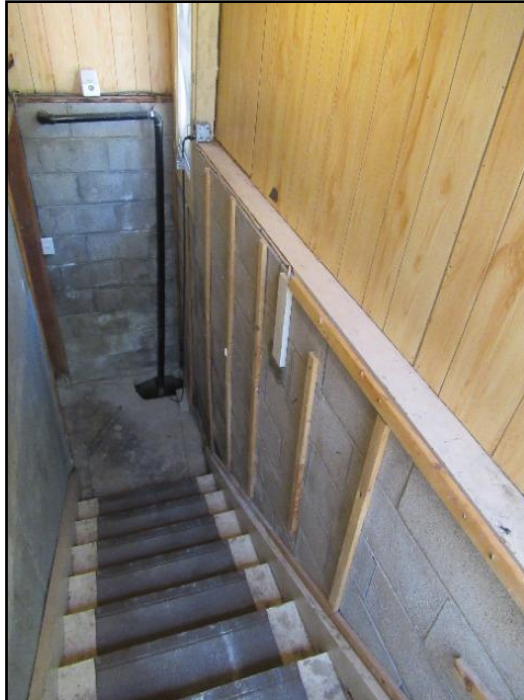
**6. Condition:** • Leaning

**Implication(s):** Weakened structure | Chance of movement

**Location:** Basement entry

8. Leaning

**Task:** Further evaluation

**Time:** Discretionary

**Cost:** Depends on work needed

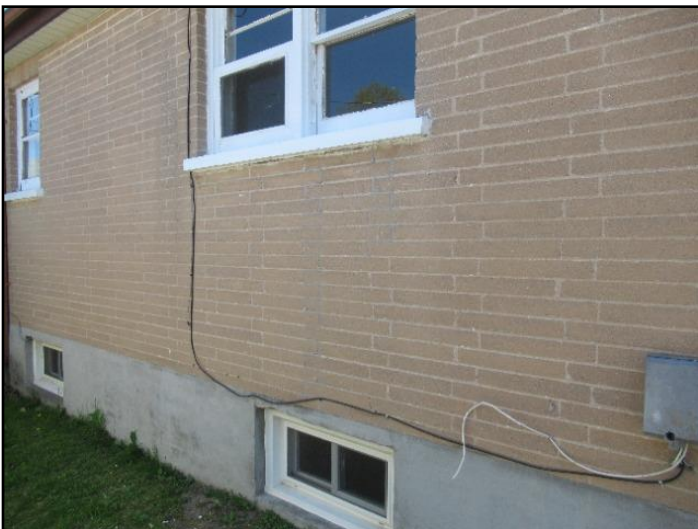
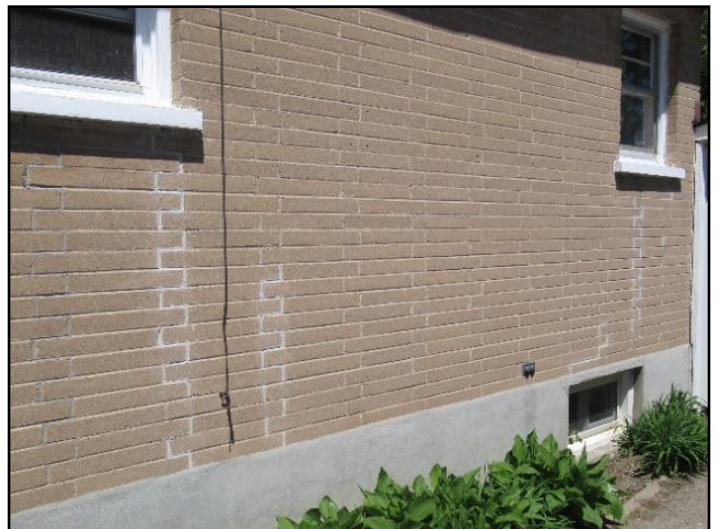
**8. Condition:** • Prior repairs

**Implication(s):** No implications exist for this condition

9. Prior repairs

**Task:** Monitor

**Time:** Ongoing

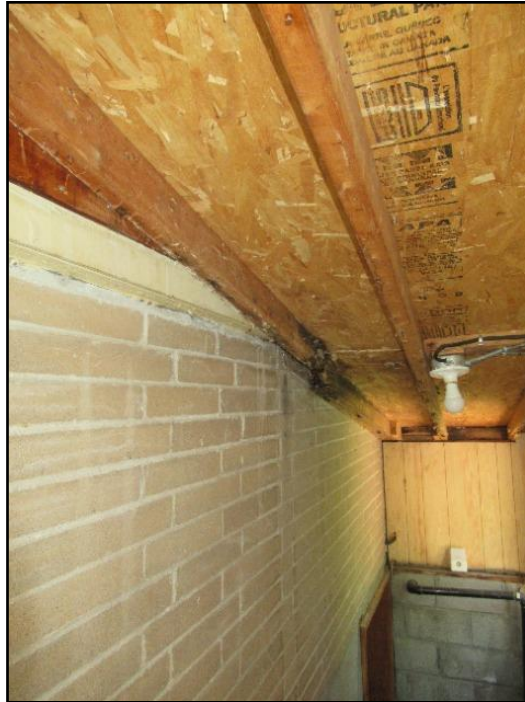
**9. Condition:** • Rot

Rot may be indicative of the patched roof/wall flashing above

11. Rot

**Task:** Repair or replace

**Time:** Discretionary

**Cost:** Minor

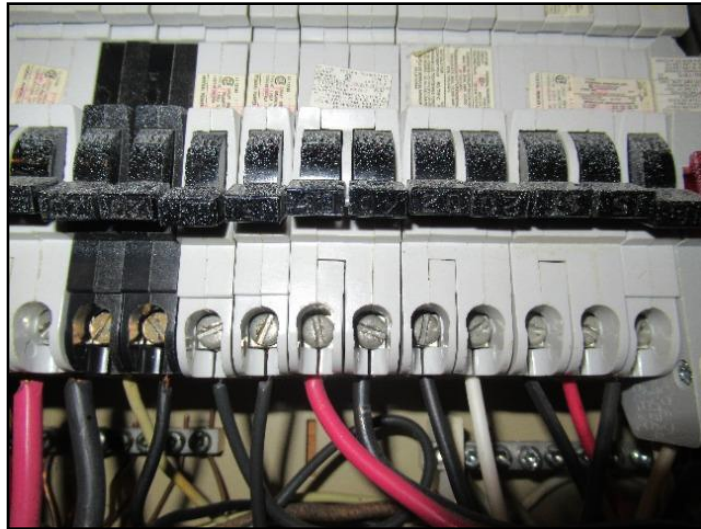
**10. Condition:** • Breakers too big

**Implication(s):** Equipment overheating | Fire hazard

14. Breakers too big

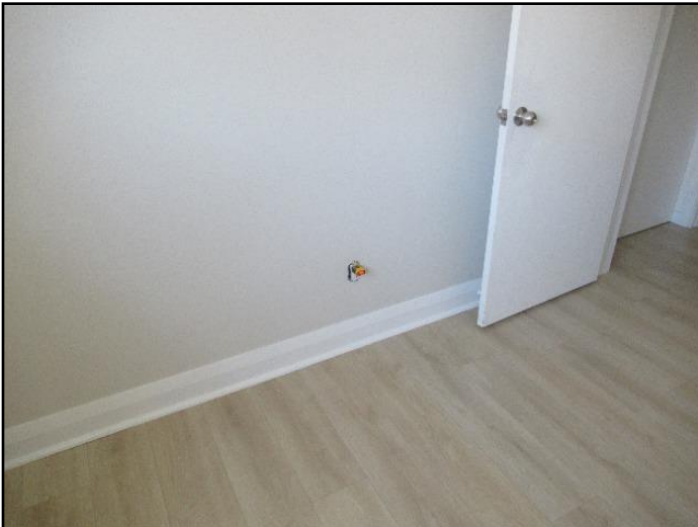
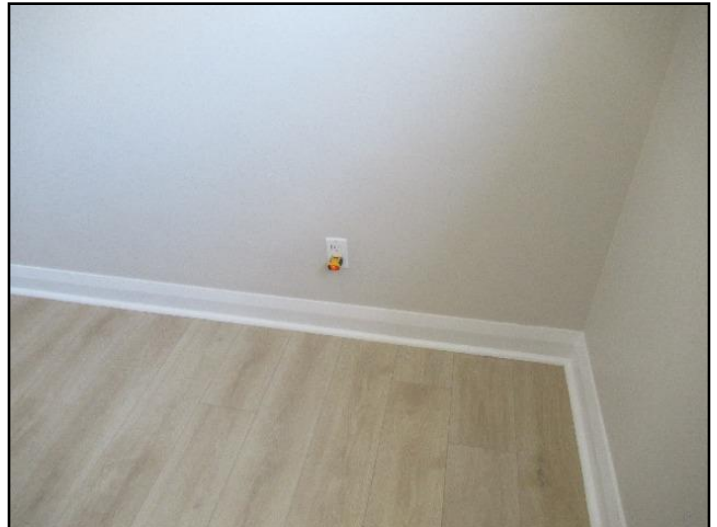
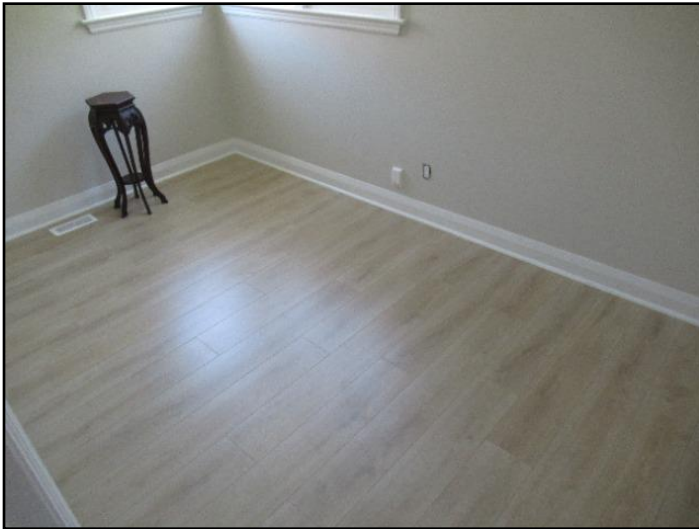
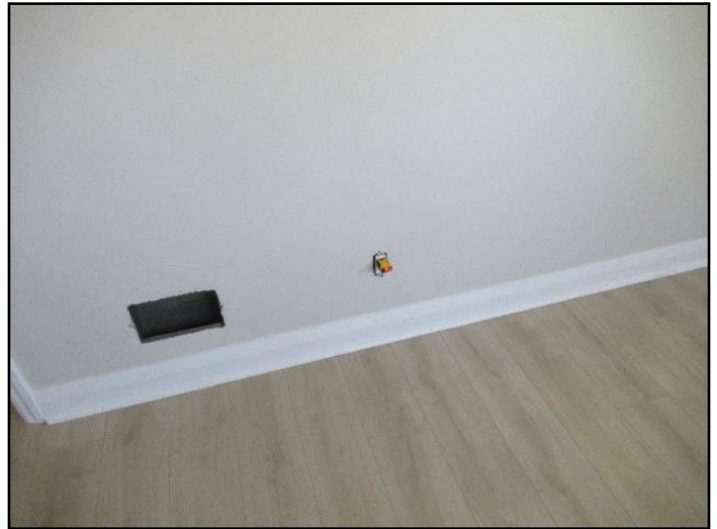
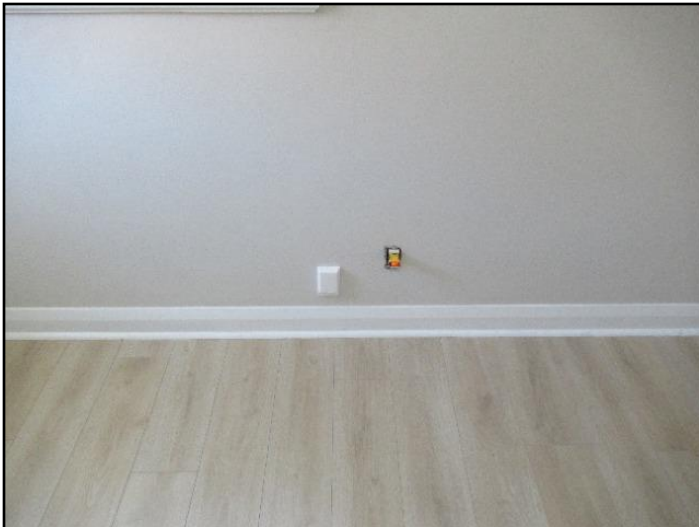
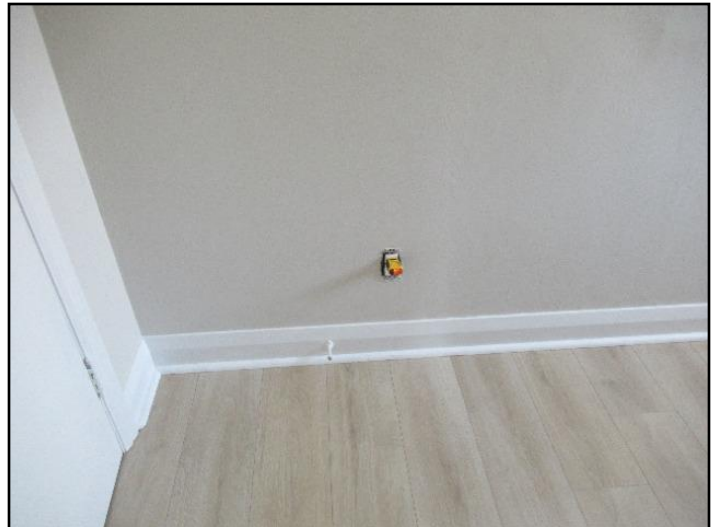
**11. Condition:** • Ungrounded

15. Ungrounded

**Time:** Discretionary

**Cost:** Minor

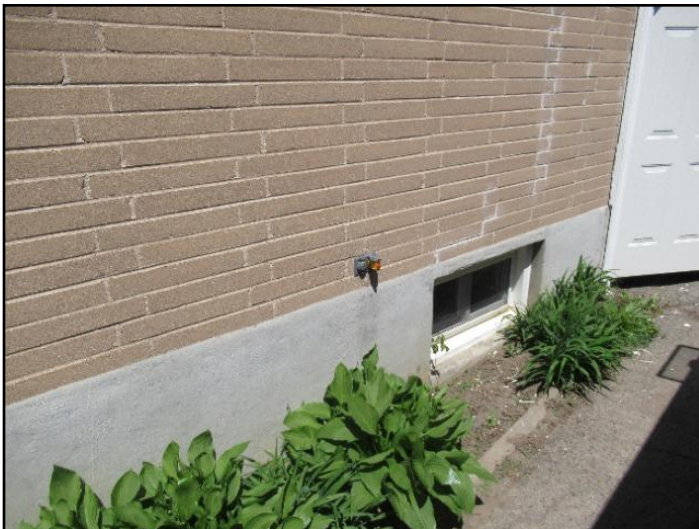
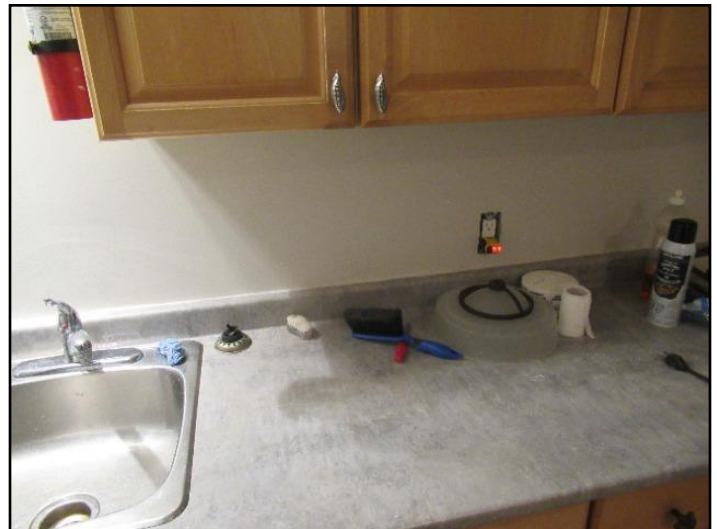
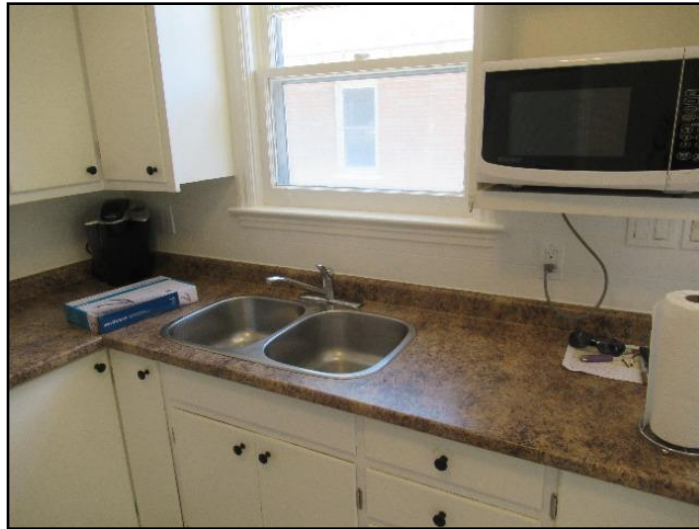
**12. Condition:** • No GFCI/GFI (Ground Fault Circuit Interrupter)

Although not a deficiency in a home of this age, safety may be improved by upgrading these receptacles

26. No GFCI/GFI (Ground Fault Circuit...

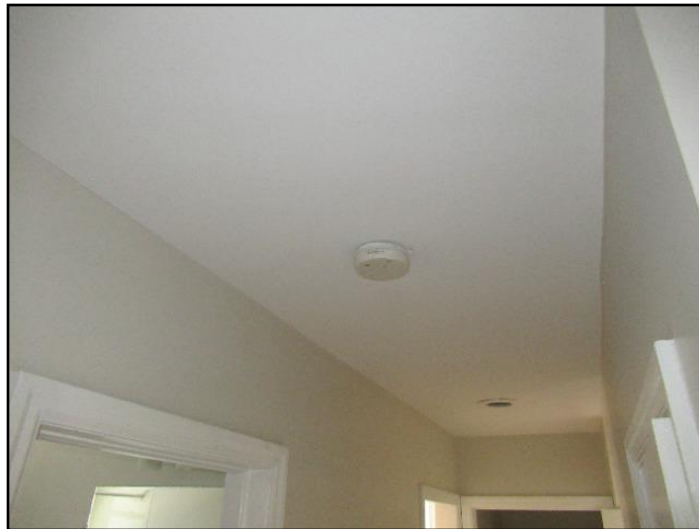
**13. Condition:** • More than 10 years old

**Implication(s):** Life safety hazard

29. More than 10 years old

**Task:** Replace

**Time:** Immediate

**Cost:** Minor

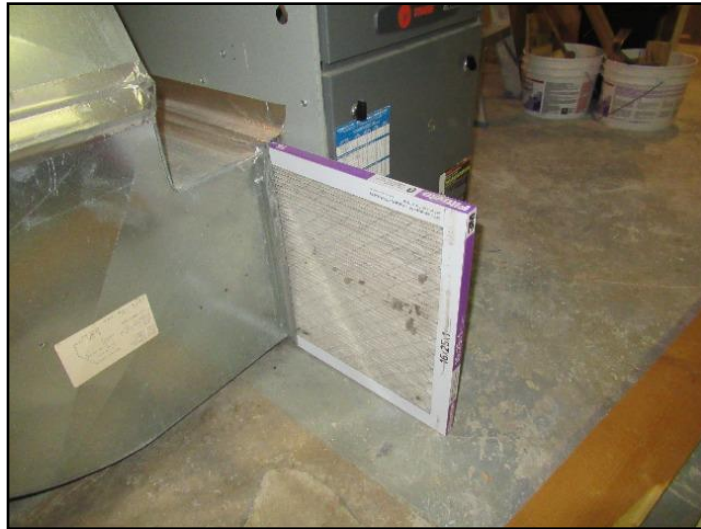
**16. Condition:** • Replace - regular maintenance

35. Replace - regular maintenance

**Task:** Replace

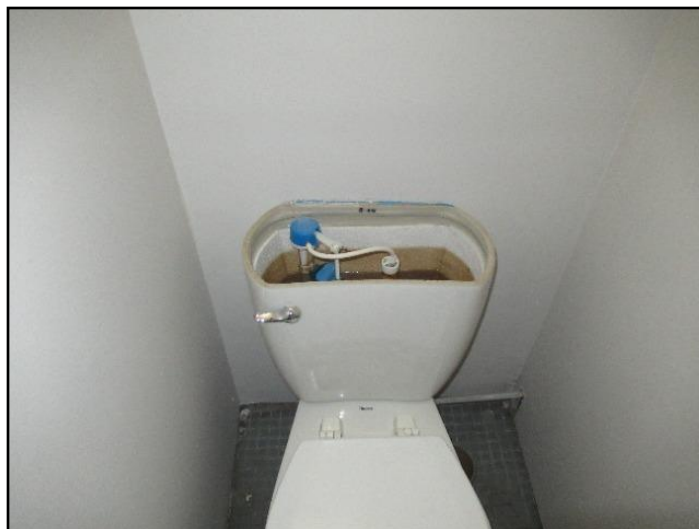
**19. Condition:** • Broken or cracked tank lids, bowls or seats

**Implication(s):** Chance of water damage to structure, finishes and contents | Physical injury

**43.** Broken or cracked tank lids, bowls or seats

**Task:** Replace

**Time:** As soon as is practicable

**Cost:** Minor

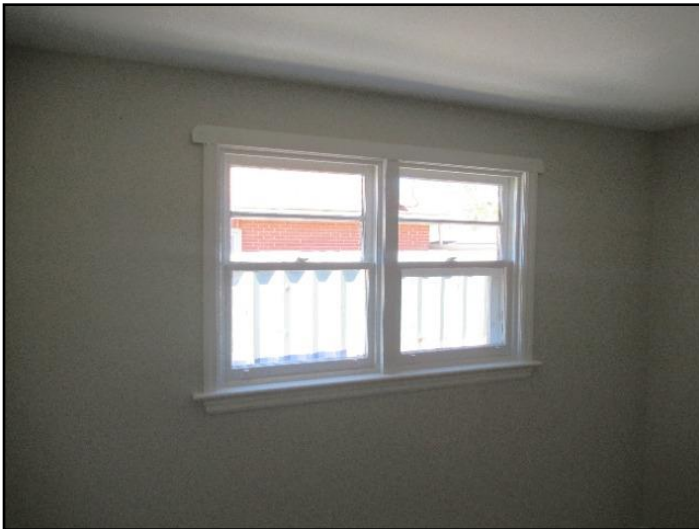
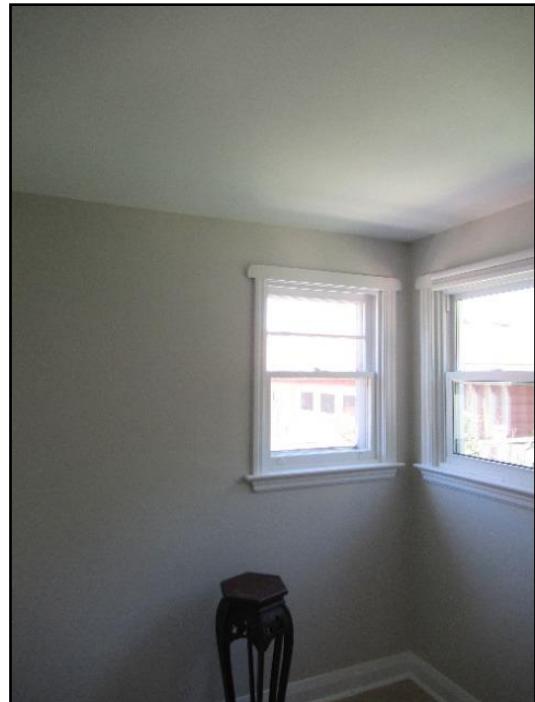
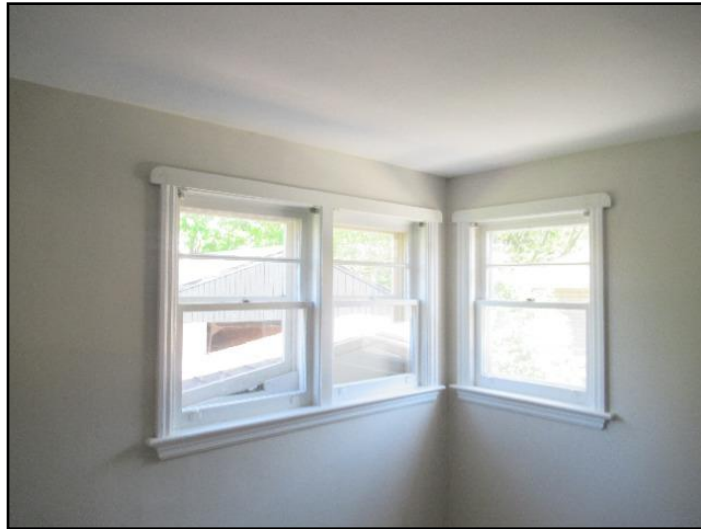
**21. Condition:** • Painted shut

44. Painted shut

**Time:** Discretionary

**Cost:** Minor

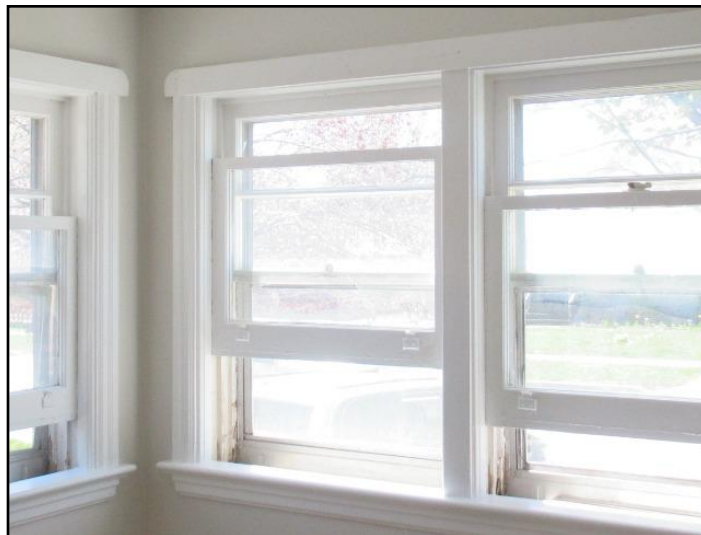
**22. Condition:** • Broken

47. Broken

**Task:** Replace

**Time:** As soon as is practicable

**Cost:** Minor

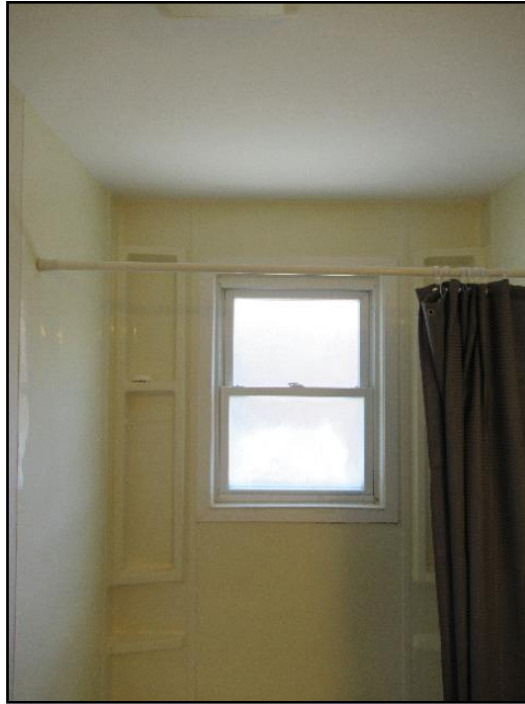
**23. Condition:** • Lost seal on double glazing

**48.** *Lost seal on double glazing*

**Task:** Repair or replace

**Time:** Discretionary

**Cost:** Minor
