# Your Inspection Report

60 Clendenan Ave  
Toronto, ON M6P 2W5

RE: Report No. 99254, v.2  
60 Clendenan Ave  
Toronto, ON  
M6P 2W5

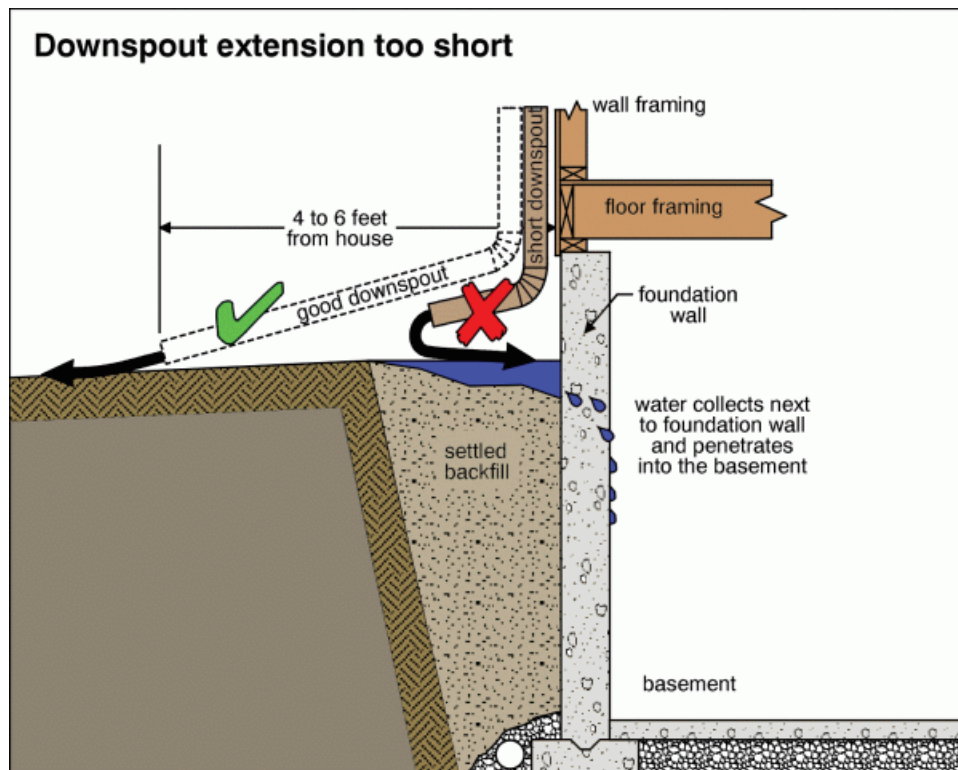
### ROOF DRAINAGE \ Downspouts

Condition: • [Discharge too close to building](#)

Always transfer water as far away from the house as practical. However attention to erosion, tripping hazard, or creating a slippery ice surface should also be considered.

Task: Improve

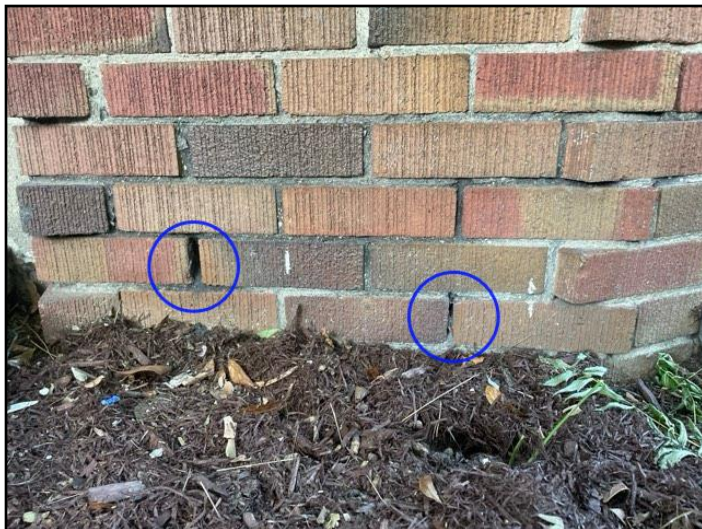
Condition: • [Mortar deterioration](#)

Minor mortar deterioration was observed, which is consistent with the age and normal weathering of the home. Periodic maintenance is expected with any masonry structure and typically includes repointing deteriorated mortar joints as needed to help prevent water penetration and further deterioration. Monitoring and routine repairs are recommended to maintain the integrity of the masonry.

*Minor mortar deterioration*

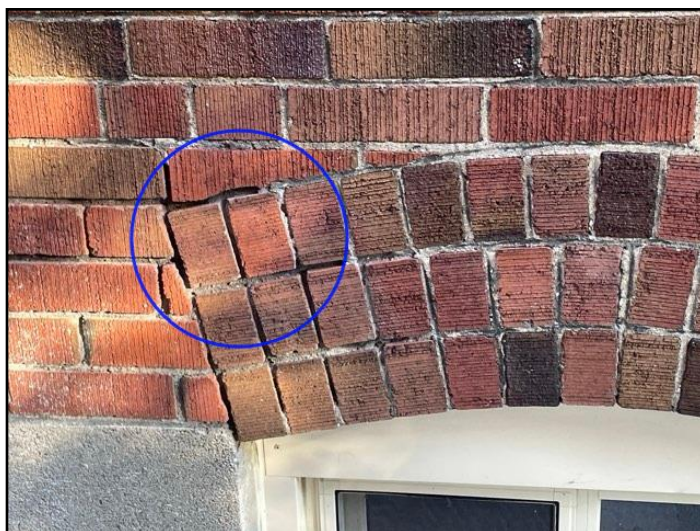
*Mortar deterioration*

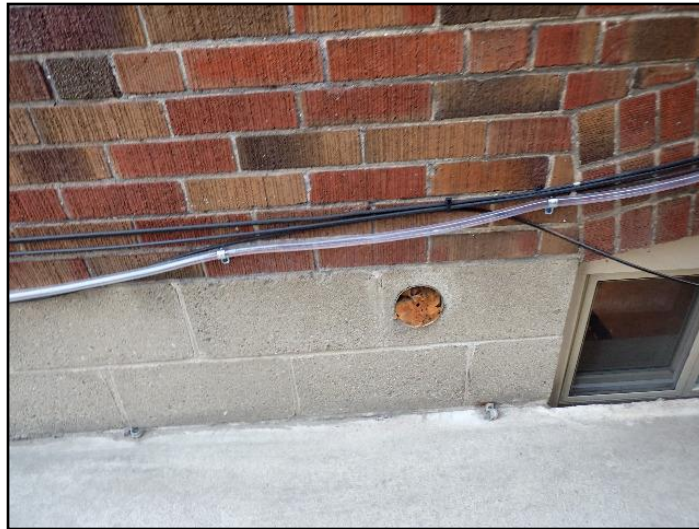
**Condition:** • Cover damaged  
Abandoned duct missing cover.

*Cover damaged*

**Task:** Patch with masonry

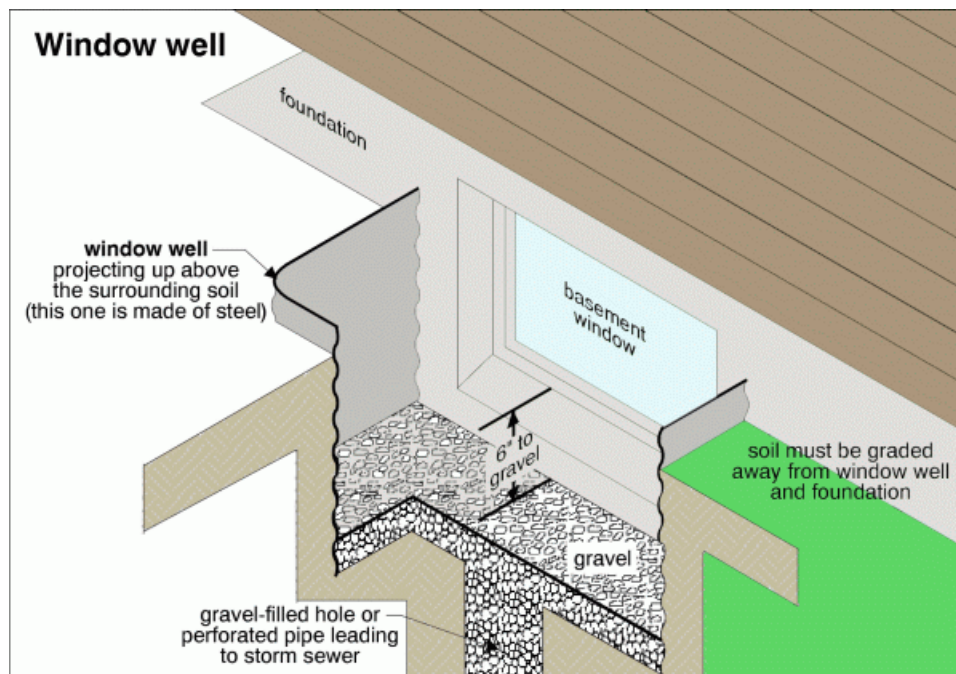
## EXTERIOR \ Window wells

**Condition:** • Missing

windows below grade, no drain observed. Moisture detected in this location in the basement.

**Task:** Improve

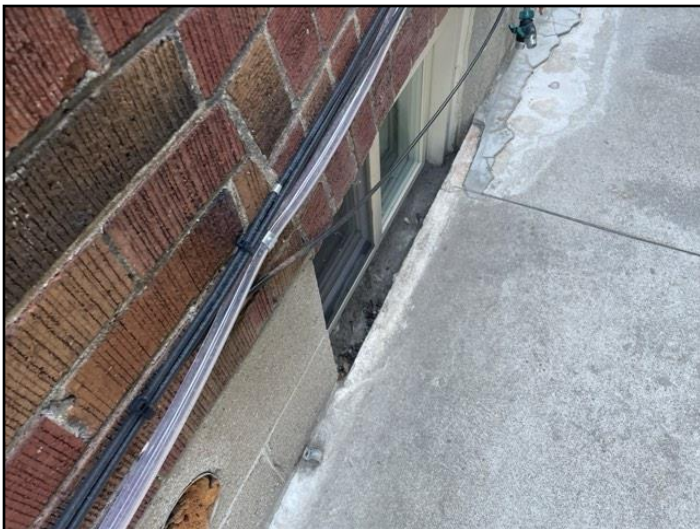
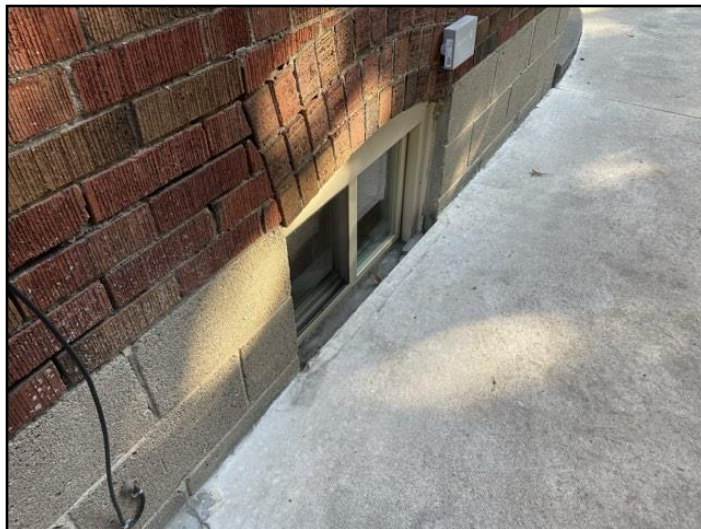
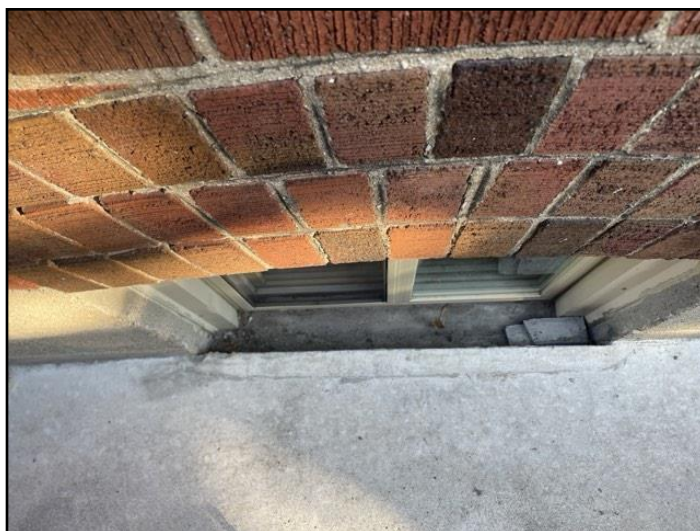
Missing

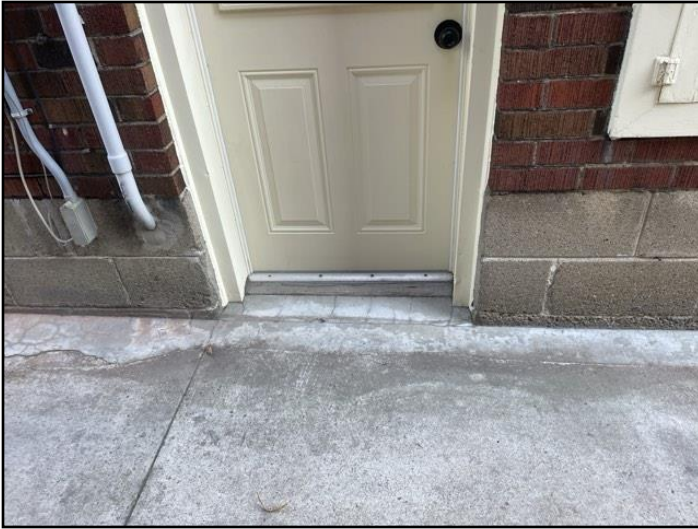
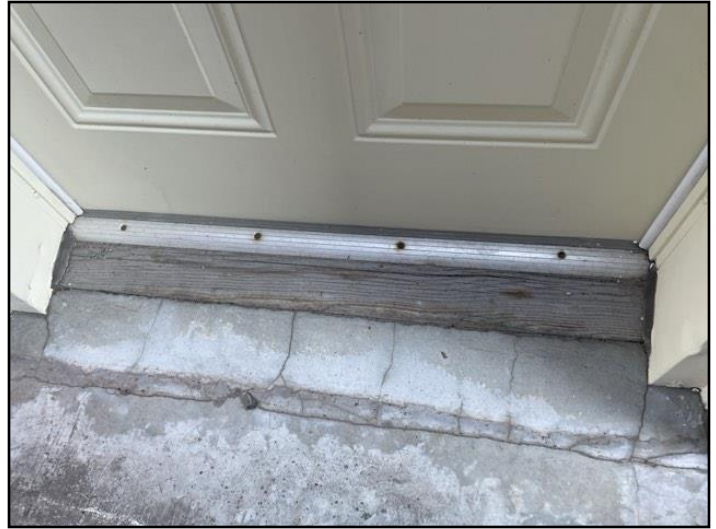
**Condition:** • Threshold - ineffective

The threshold is too low, and the sill is wood, wood embedded in concrete is prone to premature deterioration. Consider removing the wood sill and replacing with an elevated masonry sill, the door would have to be cut to fit in the new opening.

Threshold - ineffective

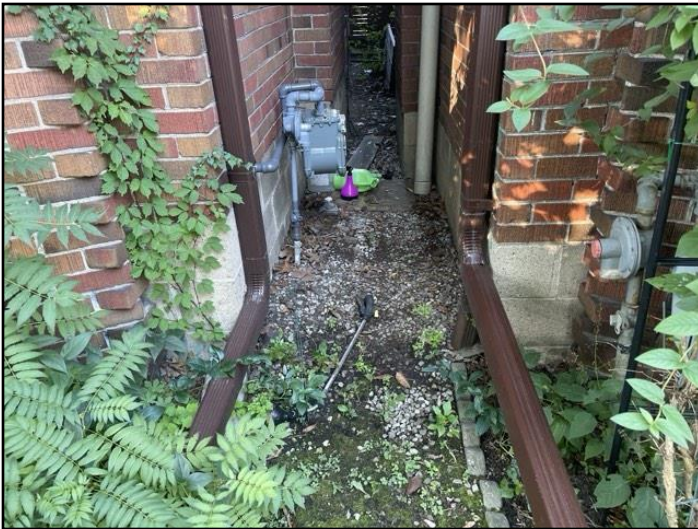
Left sidee

**Condition:** • The ground around some parts of the home does not slope to drain water away from the foundation.

Low spot on right side between houses and the front garden create areas where water may collect against the foundation

**Task:** Improve grading so the ground slopes down at least 1 inch per foot for the first 6 feet away from the home. Note: Less slope is needed on hard surfaces like driveways

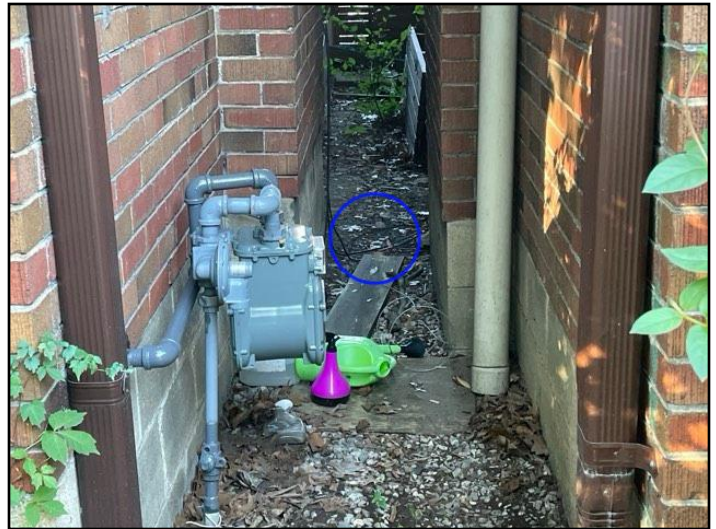
Elevated moisture Left side basement bedroom

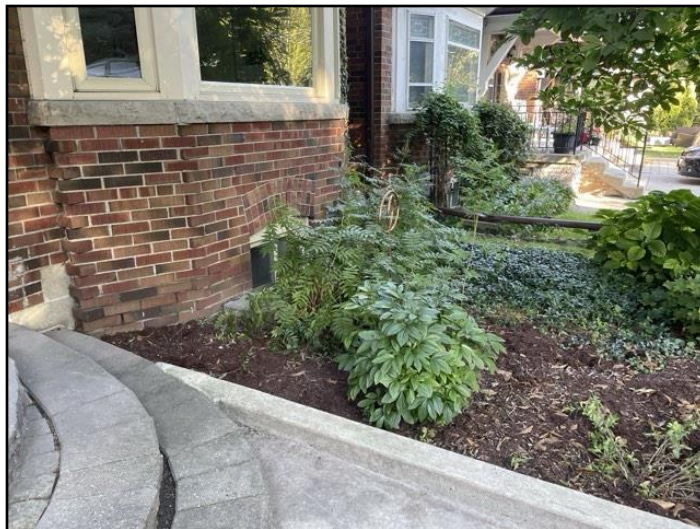
*The Garden is a soft low spot*

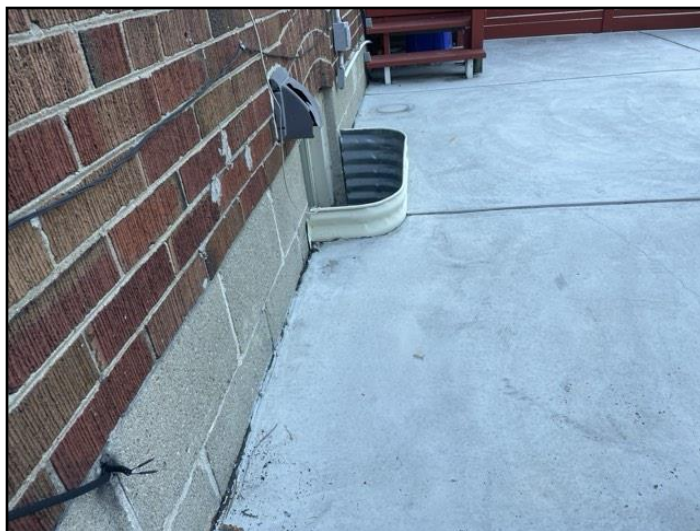
**Condition:** • [Unsealed gap at building](#)

*Unsealed gap at building*

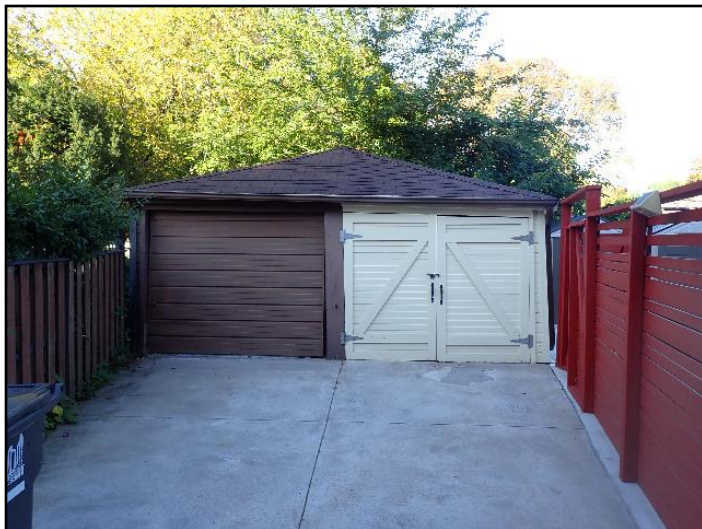
**Condition:** • Older Garage

The garage looked generally solid, despite the slight lean. the wood in contact with the ground is prone to premature rot/deterioration. replace as needed

*Older Garage - Appears to lean*

**Task:** Monitor / Replace as needed

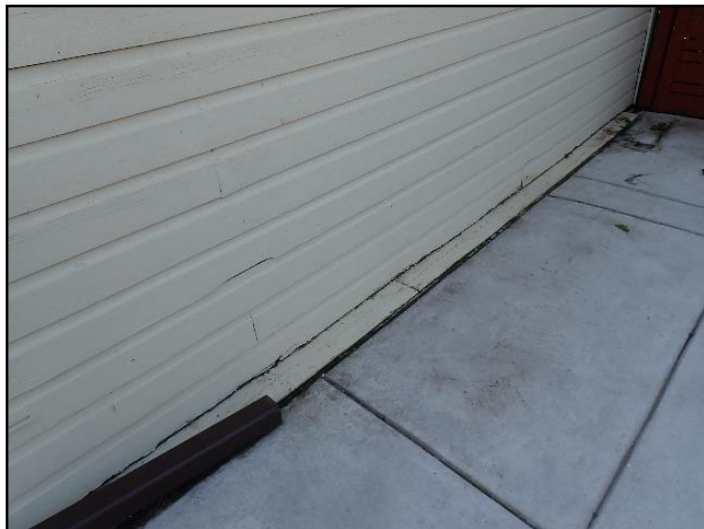
*Wood ground contact*

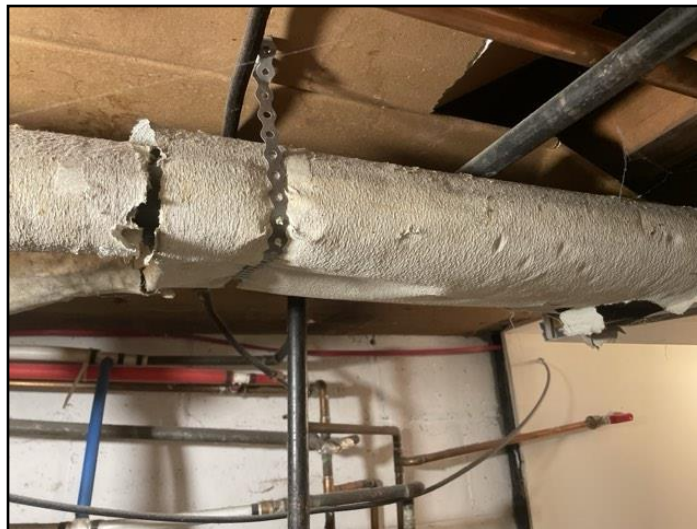
**Condition:** • The insulation on boiler piping may contain asbestos. Health Canada recommends the insulation be left in place undisturbed. If the insulation is damaged or is to be disturbed, and if it contains asbestos (confirm with laboratory test), precautions should be taken that asbestos fibers are not released into the house air during the work.

*The insulation on boiler piping may contain...*

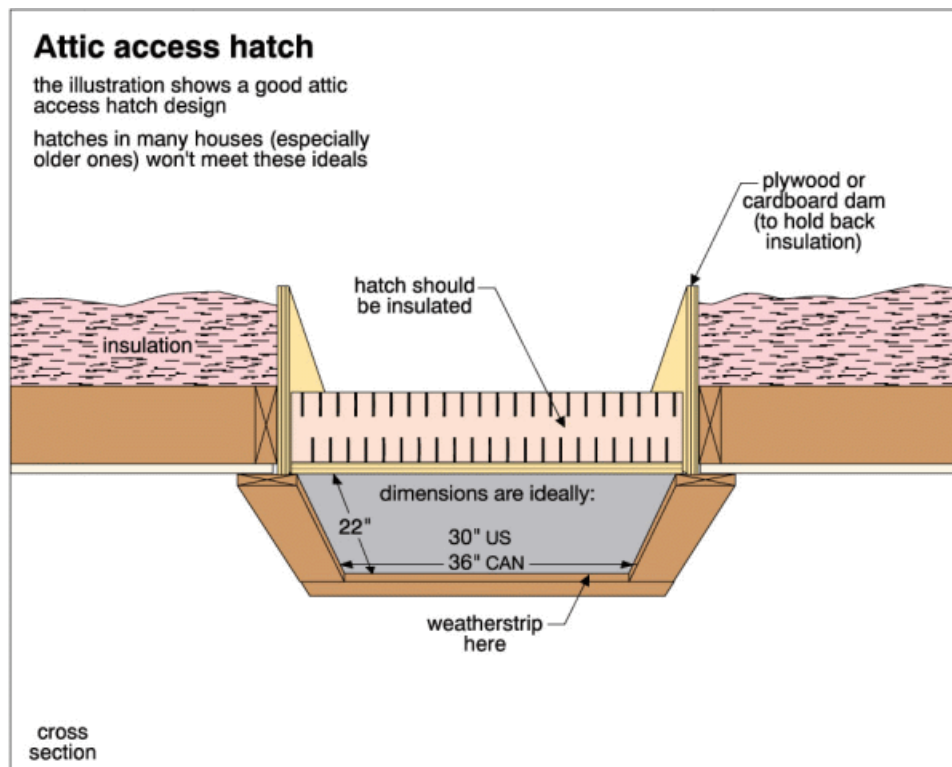
Condition: • [Not insulated and not weatherstripped](#)

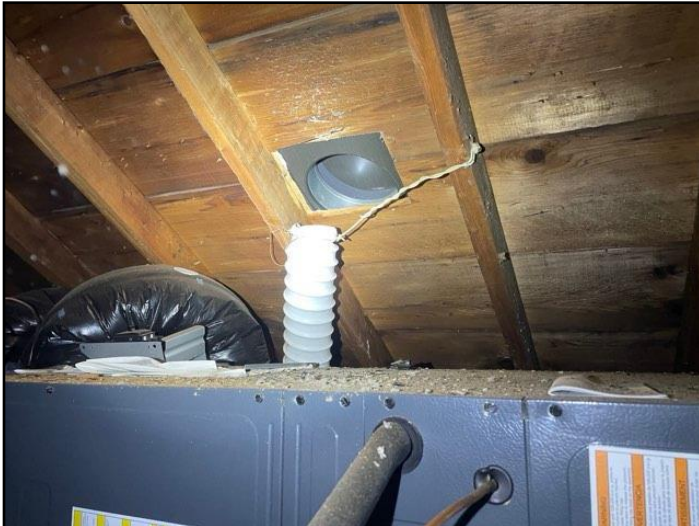
**Condition:** • [Not insulated in unconditioned space](#)

*Uninsulated vent discharges in attic*

**Task:** Improve/Replace

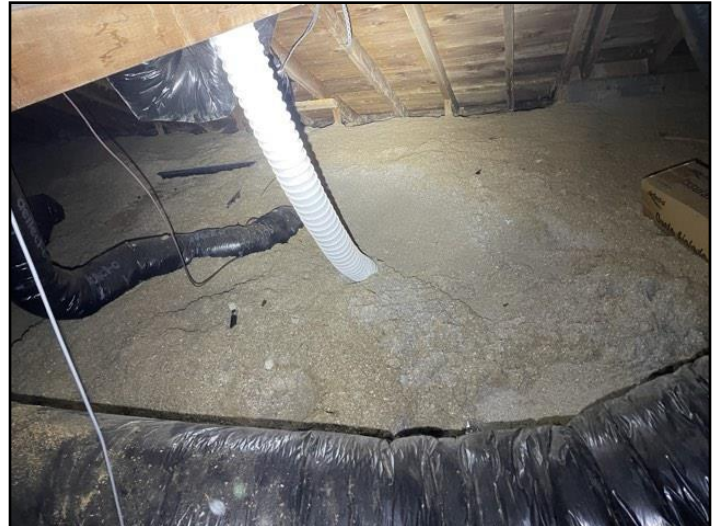
*Uninsulated duct*

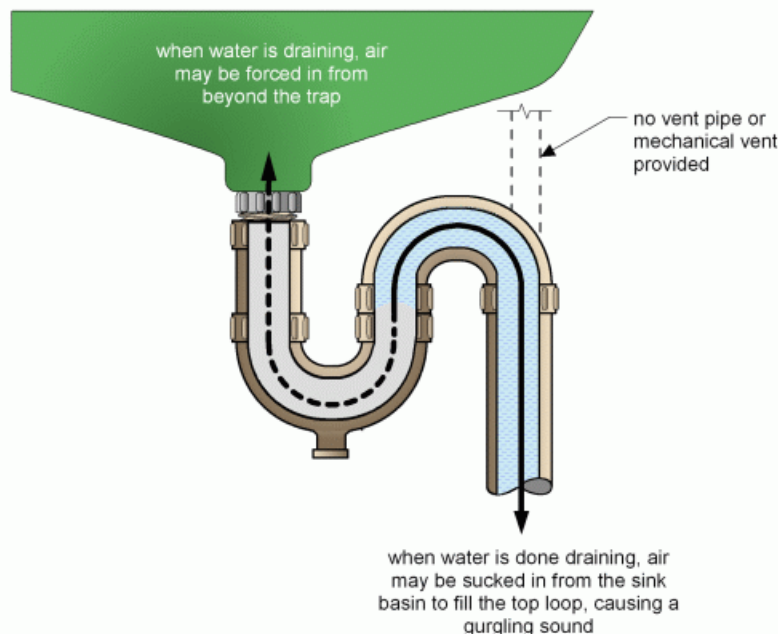
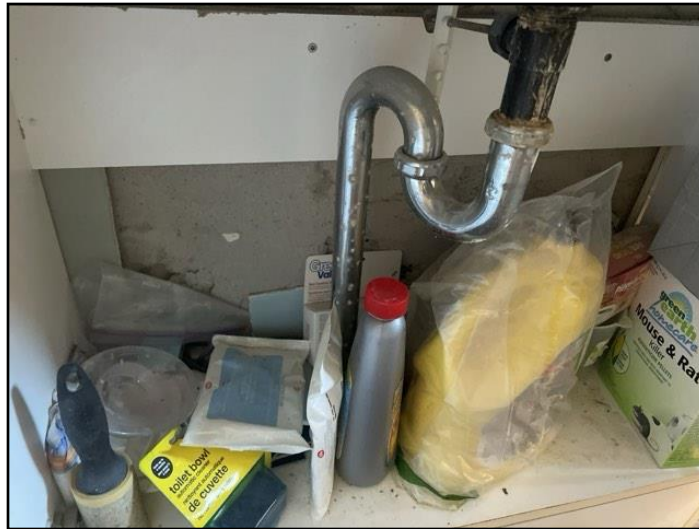
**Condition:** • S-trap

### **S-traps can lead to siphoning**

S-trap

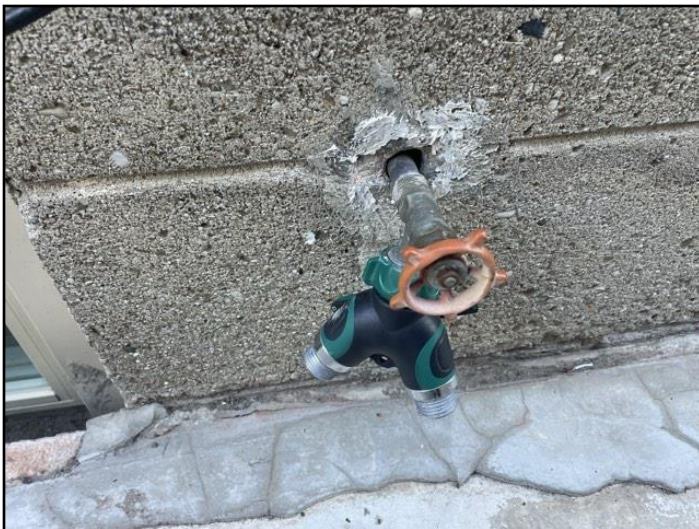
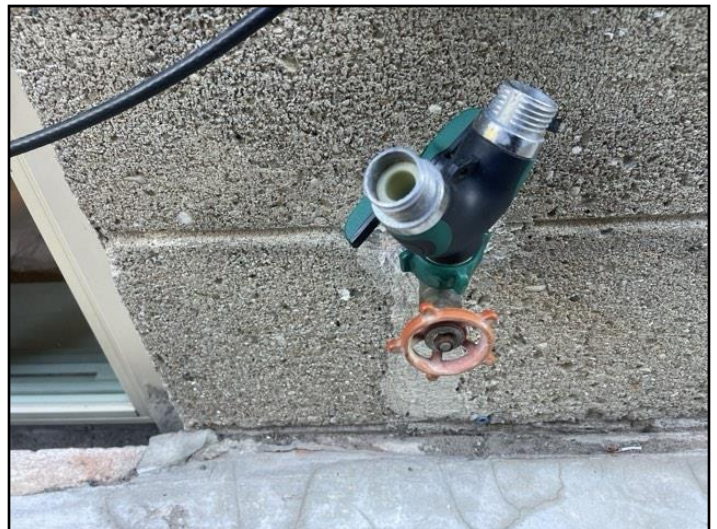
**Condition:** • Pipe spins in place hole is un sealed

**Task:** Improve (remove or repair, and seal)

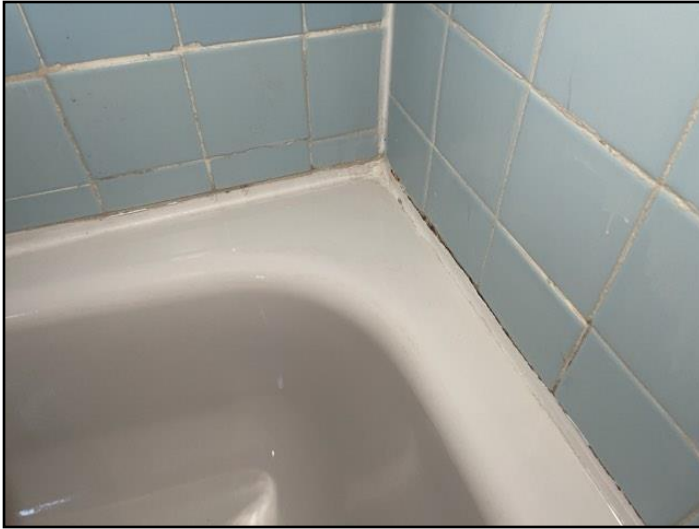
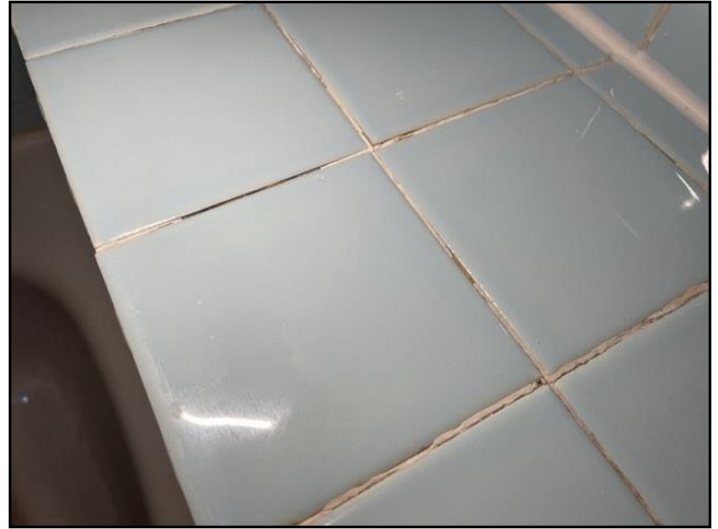
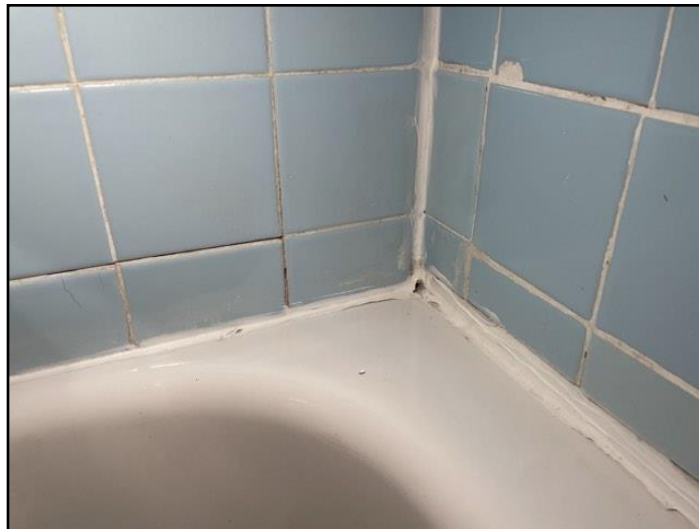
**Condition:** • [Caulking loose, missing or deteriorated](#)

*Caulking loose, missing or deteriorated*

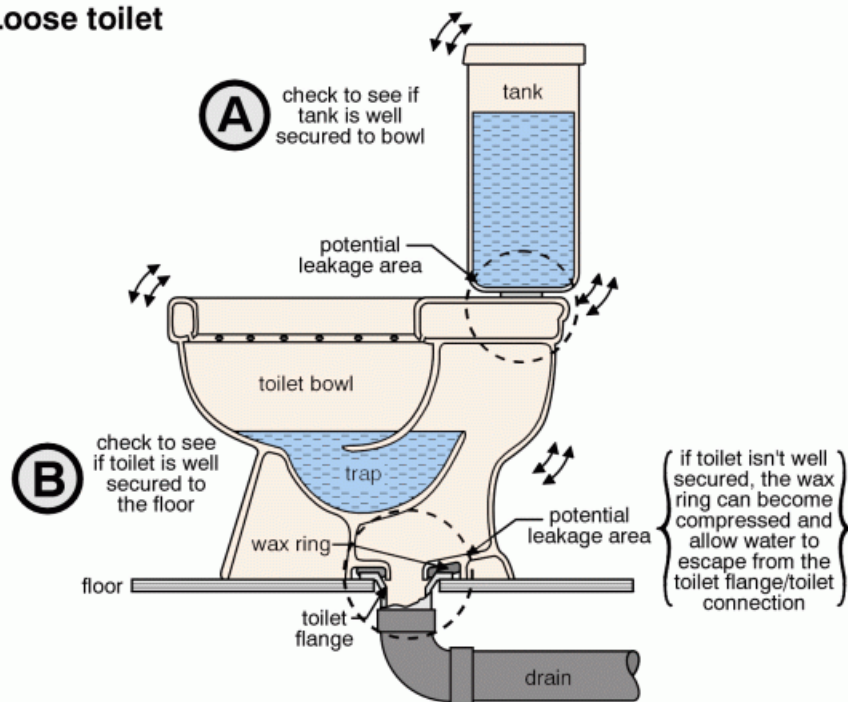
**Condition:** • Loose

## Loose toilet

**Task:** Secure

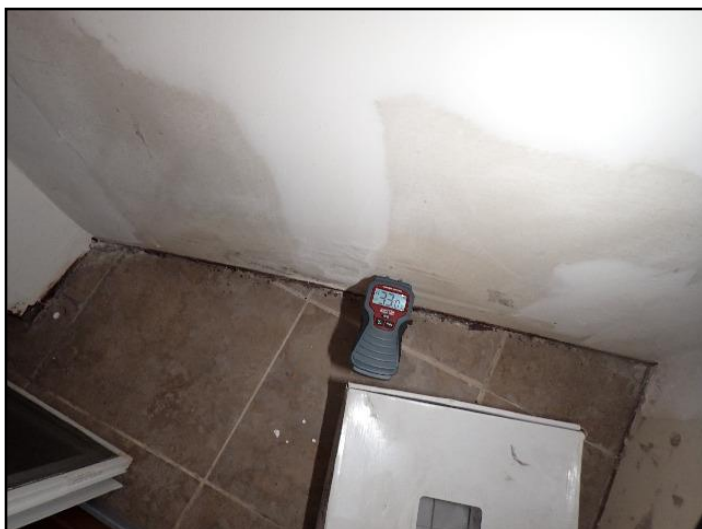
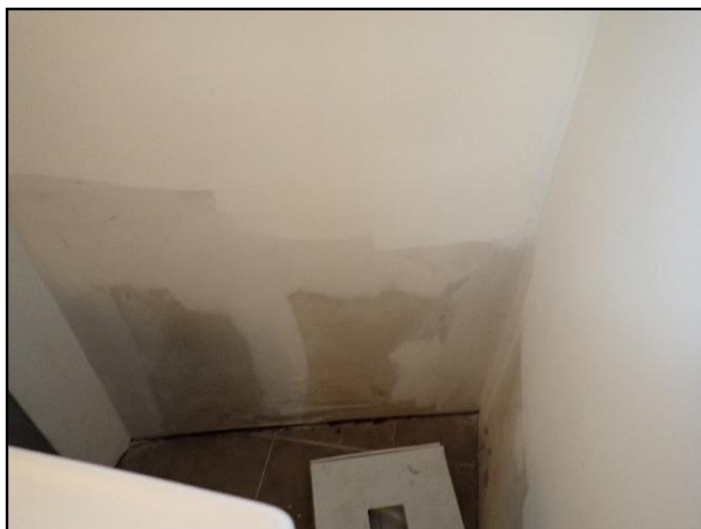
**Condition:** • Evidence of moisture noted

Low spot / garden against the house, and missing window wells/windows below grade are suspected to be contributing. Remove affected finishes and complete exterior recommendations.

*Elevated moisture lear laundry area*

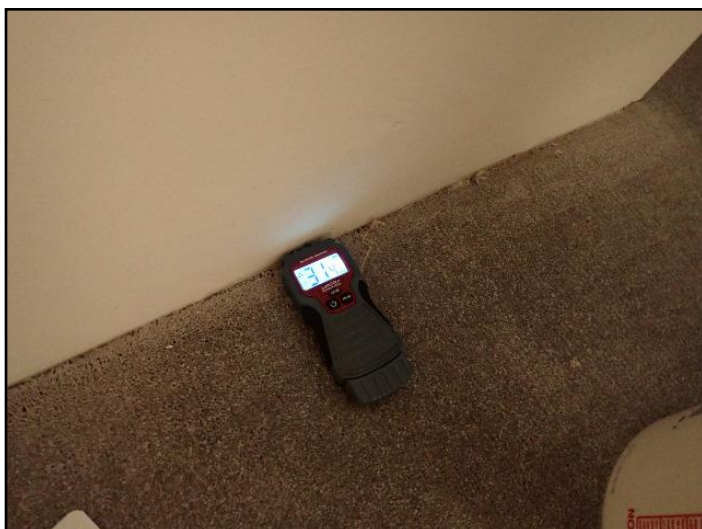
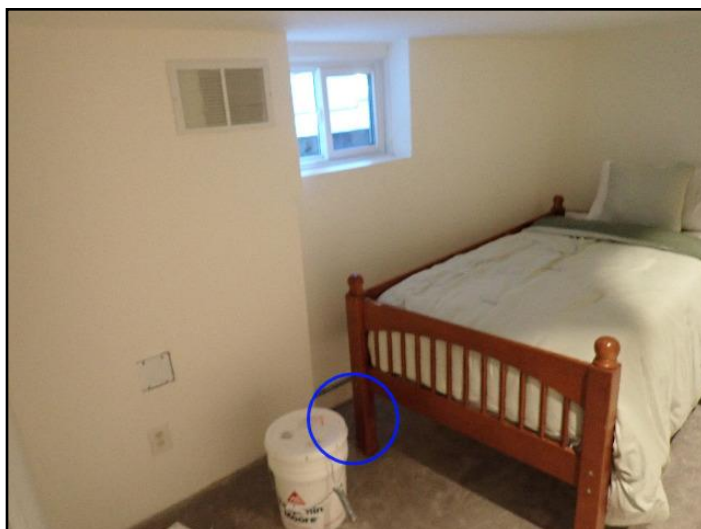
*Elevated moisture Left side basement bedroom*
