# Your Inspection Report

403 Durie St  
Toronto, ON M6S 3G5

**INSPECTION DATE:**  
Monday, August 24, 2026

RE: Report No. 98938, v.2  
403 Durie St  
Toronto, ON  
M6S 3G5

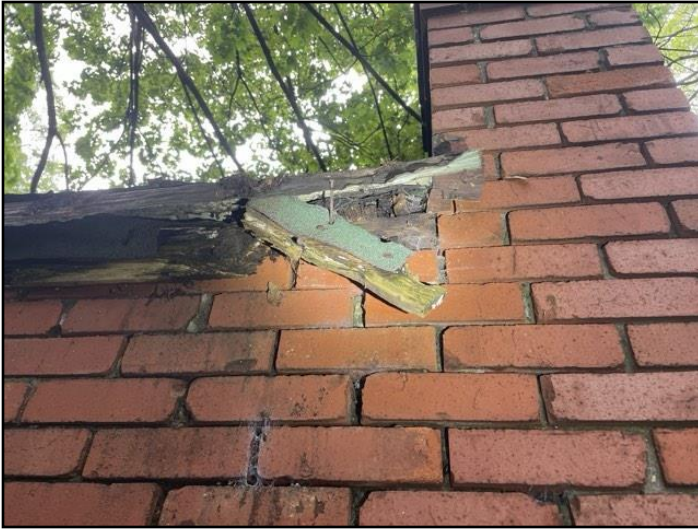
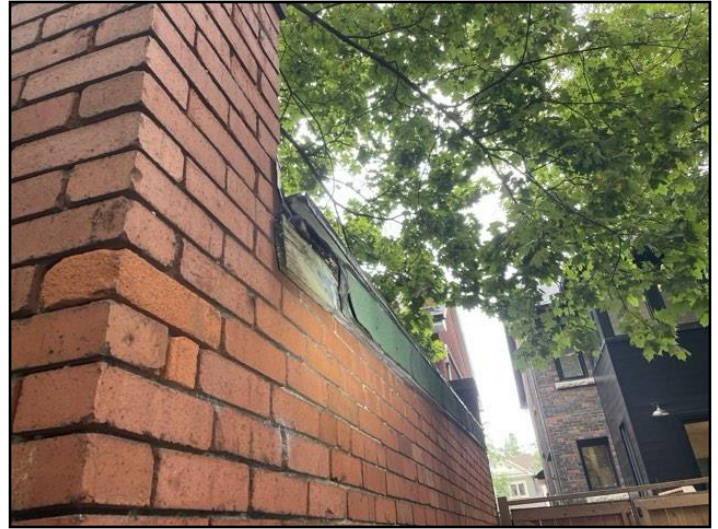
**Condition:** • Damage

Damage

**Task:** Repair / replace

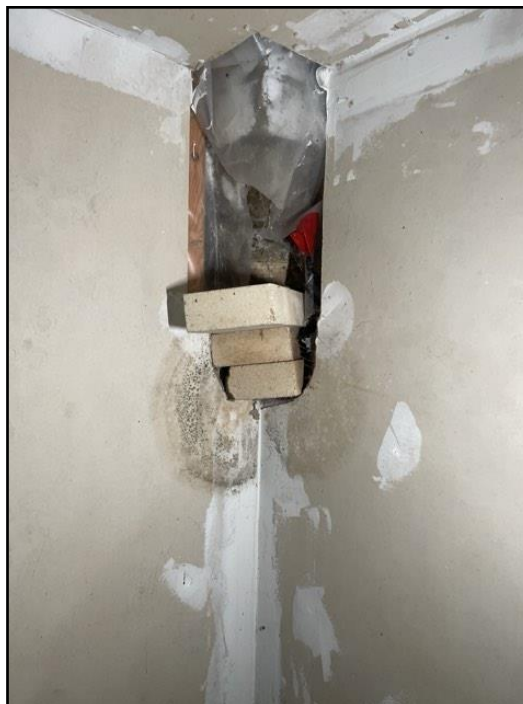
Moisture/Mould detected in this area

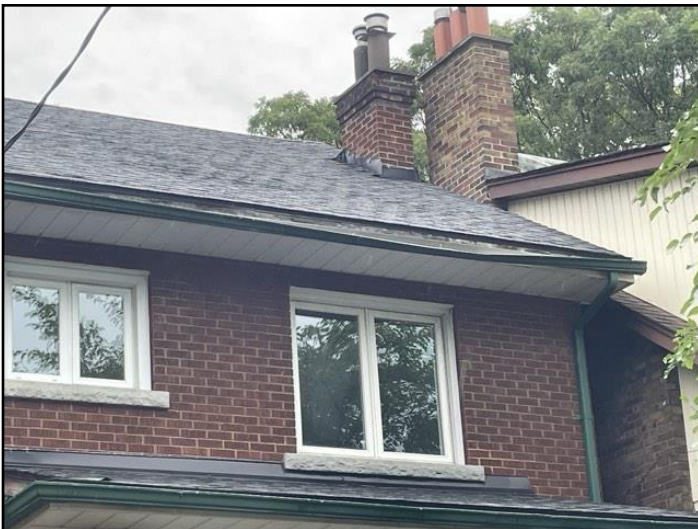
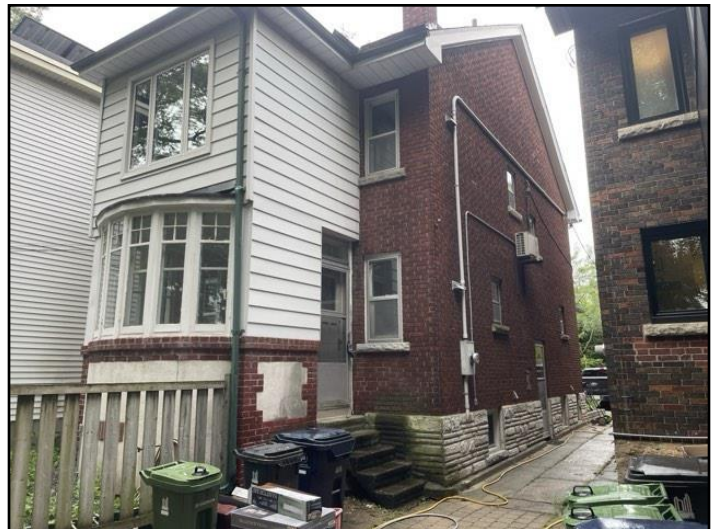
**Condition:** • [Loose or damaged](#)

Most of the gutters and downspouts are loose, damaged, or improperly configured. Elevated moisture levels were detected in the basement, and deficiencies in the roof drainage system may be contributing to moisture around the foundation.

*Loose or damaged front*

*Clogged / loose / Water overflowing gutter*

Given the overall condition of the system, replacement and reconfiguration may provide better value than piecemeal repairs. Upgrading to wider gutters is recommended due to the size of the roof, along with improving downspout locations to promote more effective drainage away from the foundation.

**Task:** Repair/Replace/Upgrade

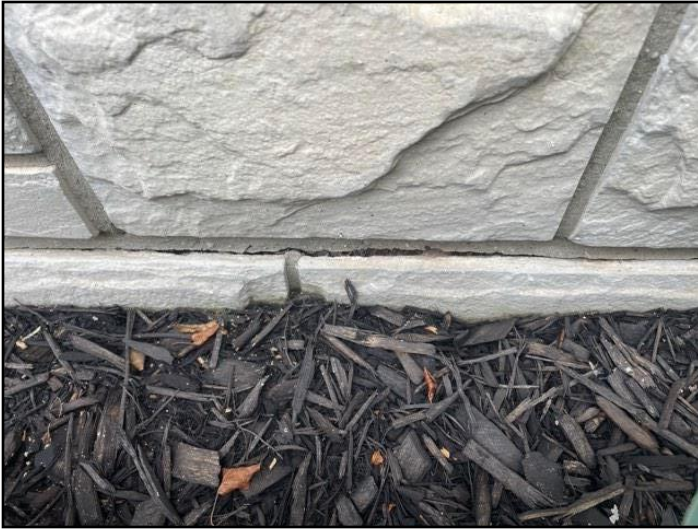
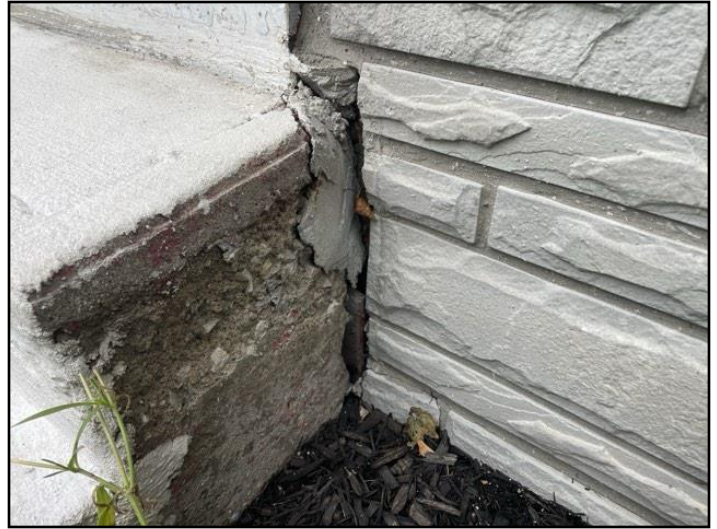
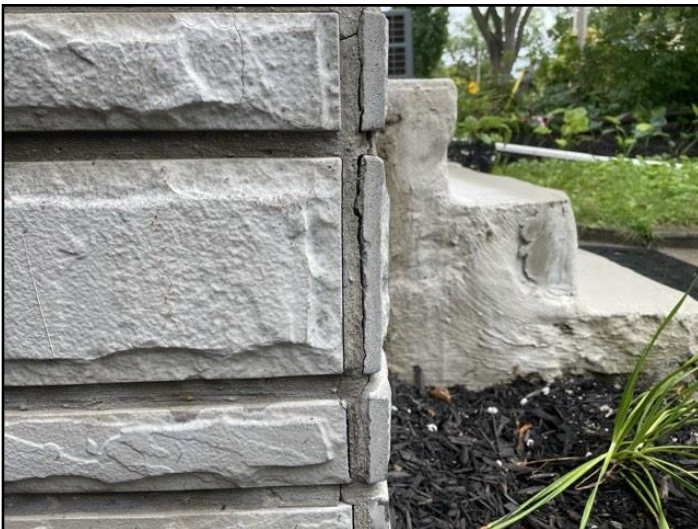
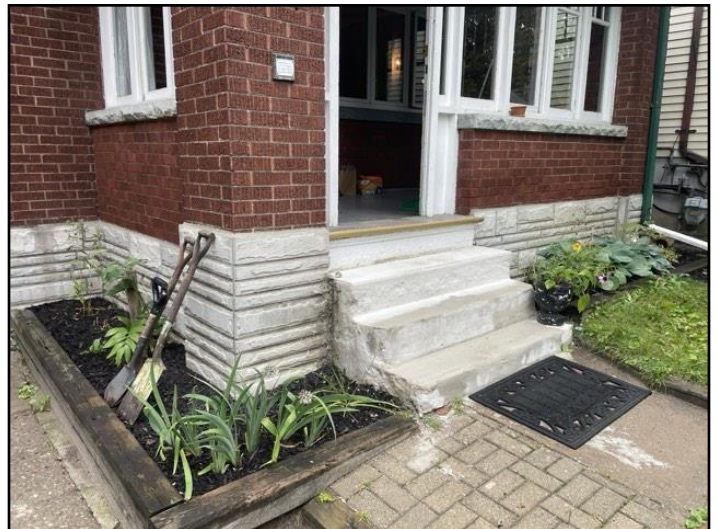
**Condition:** • [Cracked](#)

Masonry veneer mortar is cracked in several areas.

*Cracked*

*Gap*

**Task:** Repair

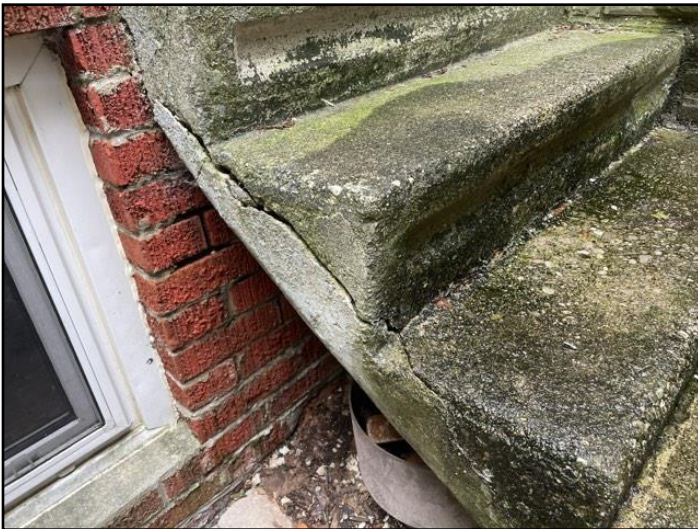
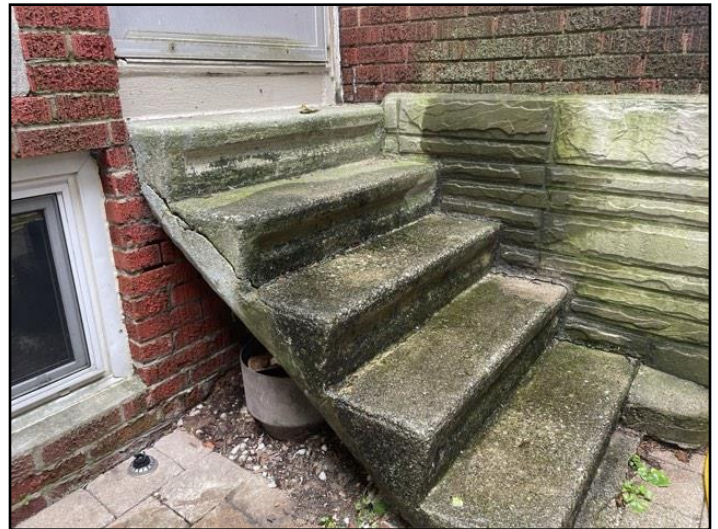
**Condition:** • [Masonry or concrete cracking](#)

The gutters are clogged and leaking in this area and may be contributing to masonry erosion, Elevated moisture was detected in thi part of the basement (under the stairs) (see Exterior-Gutters and Interior for more details)

Masonry or concrete cracking

Gutter is leaking in this area

**Task:** Repair/replace stairs

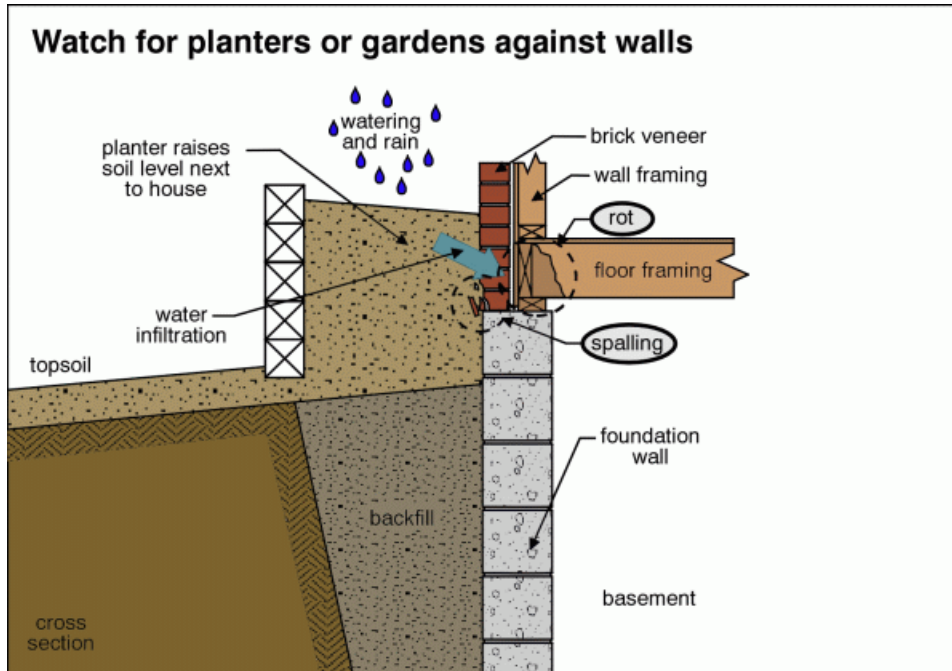
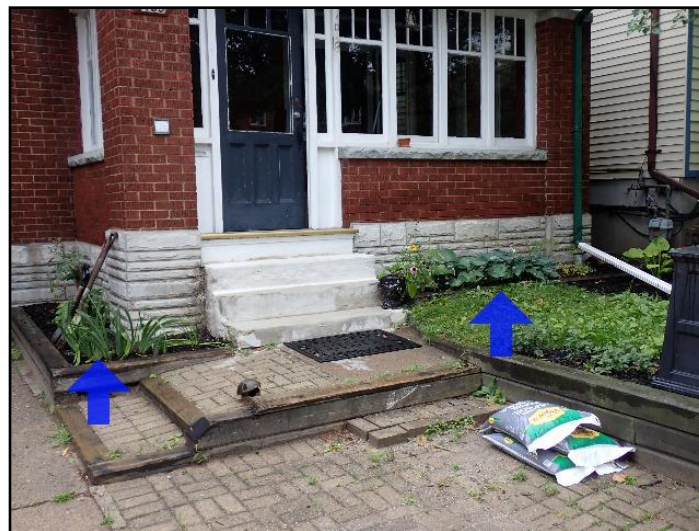
**Condition:** • Raised gardens against the house

*Raised gardens against the house*

**Task:** Monitor and re-arrange if necessary.

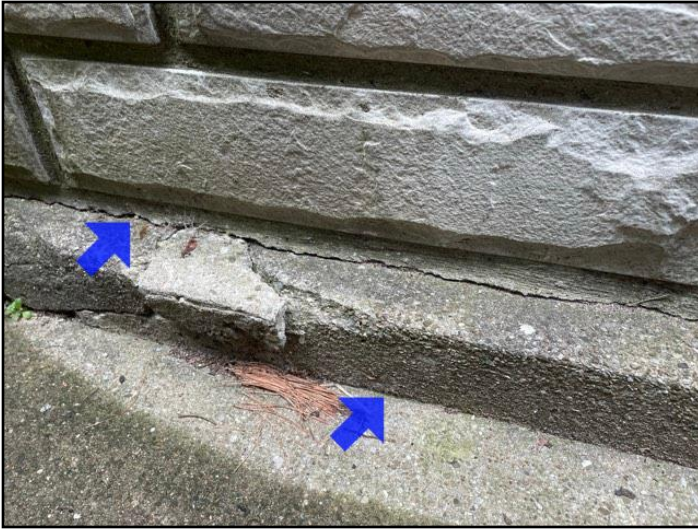
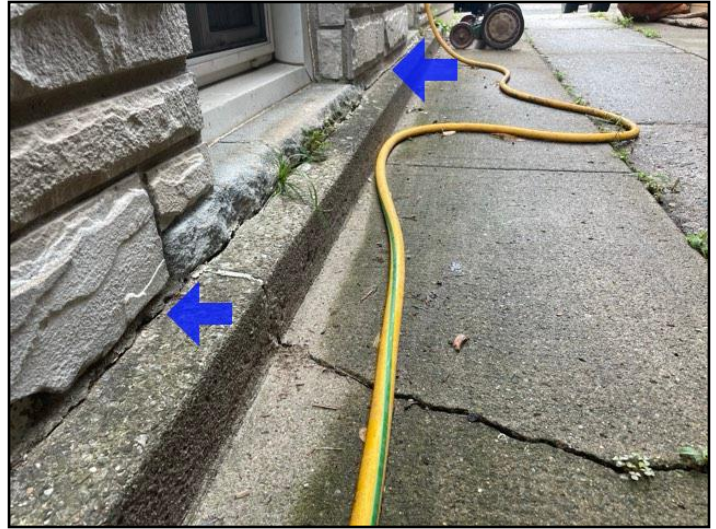
**Condition:** • [Unsealed gap at building](#)

Unsealed gap at building

Unsealed gap - Left side

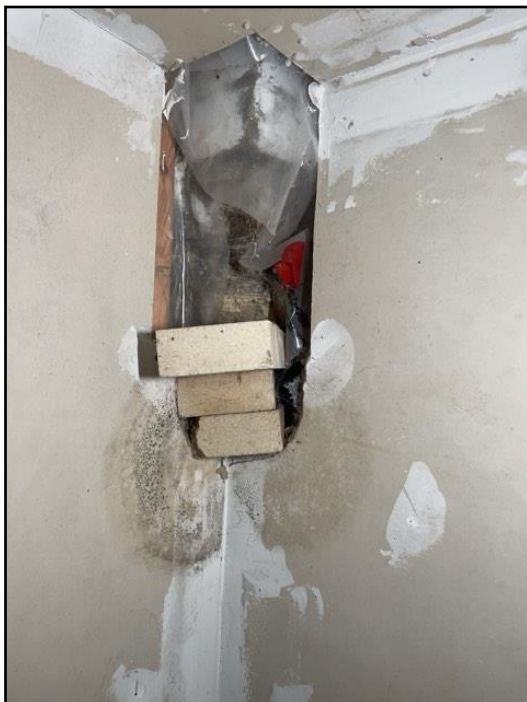
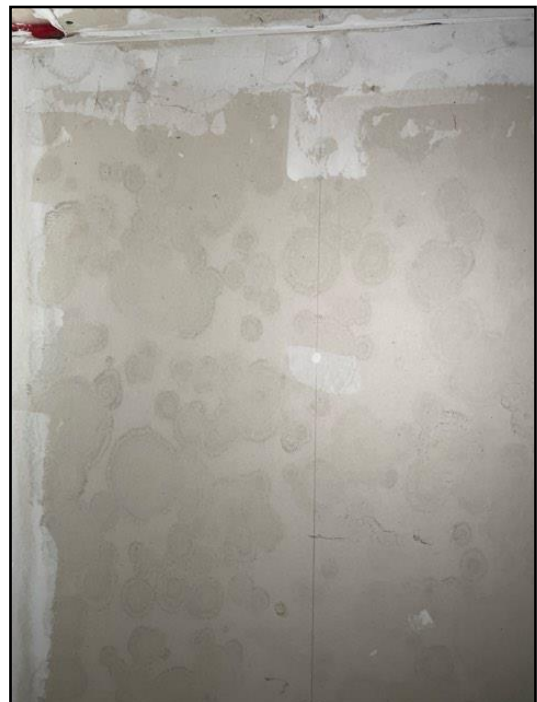
**Condition:** • Damage

Garage walls are clad with unfinished drywall, which is vulnerable to mould, and without proper ventilation or climate control mould has started to develop on the surface. Additionally, wet drywall was observed in the corner, damage to the roof flashing may be a contributing factor.

Damage/Mould

Mould

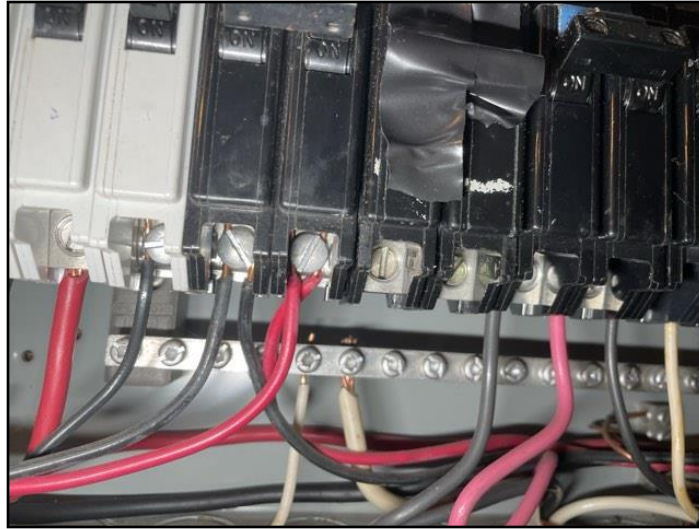
**Condition:** • [Double taps](#)

*Double taps*

**Task:** Further evaluation/improve

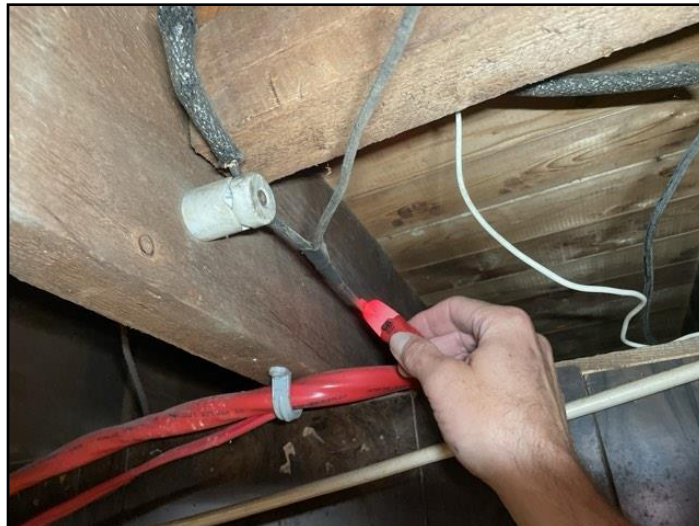
**Condition:** • [Active knob and tube was noted in the home. The extent of the knob and tube could not be determined at the inspection.](#) Click here to see the Ontario Electrical Safety Authority's position on this wiring system.

*Knob and tube - Active*

**Task:** Replace when remodeling. In the short term, ground fault circuit interrupters (GFCIs) are an inexpensive way to help protect against electric shocks. Further evaluation.

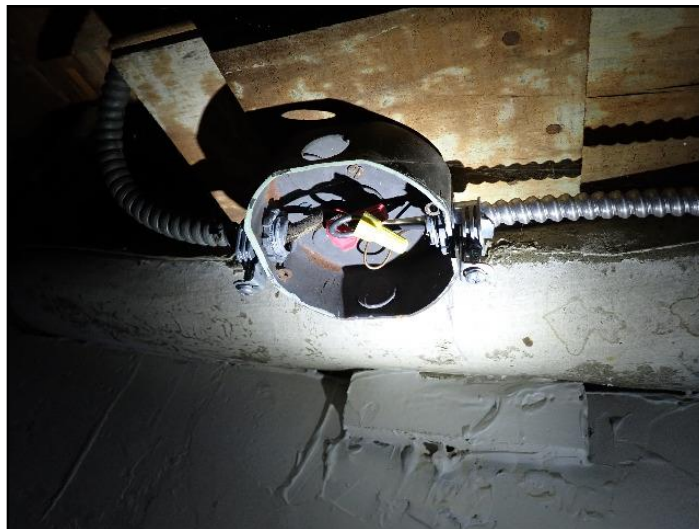
**Condition:** • [Cover loose or missing](#)

*Cover loose or missing*

**Task:** Provide

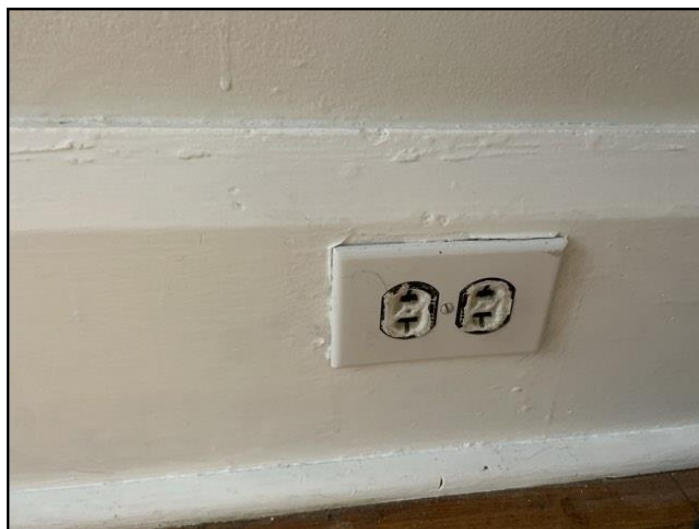
**Condition:** • [Ungrounded](#)

Ungrounded 2-prong receptacles were noted. These outlets are common in older homes and are not necessarily considered a defect; however, upgrading affected circuits should be considered during future renovations or electrical improvements.

*Ungrounded*

**Task:** Replace

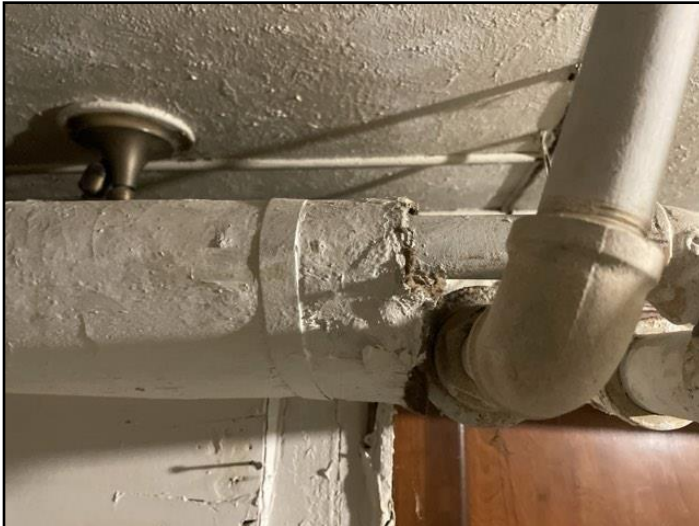
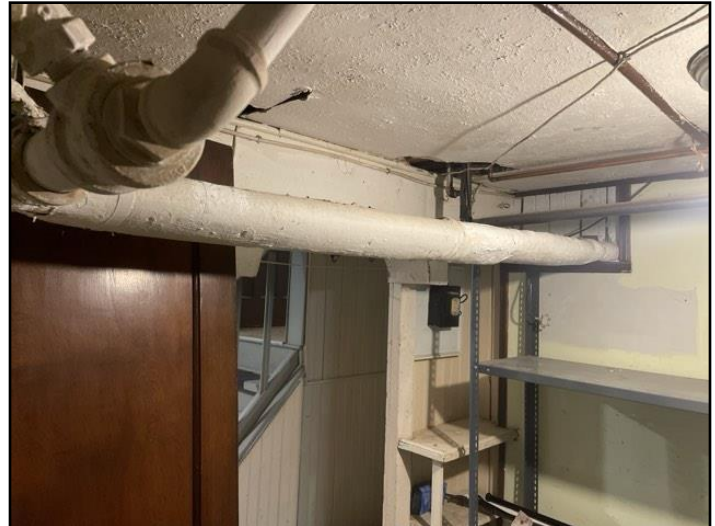
**Condition:** • The insulation on boiler piping may contain asbestos. Health Canada recommends the insulation be left in

place undisturbed. If the insulation is damaged or is to be disturbed, and if it contains asbestos (confirm with laboratory test), precautions should be taken that asbestos fibers are not released into the house air during the work.

*Insulation on boiler piping*

**Task:** Do not disturb / Further evaluation from a professional, if removing

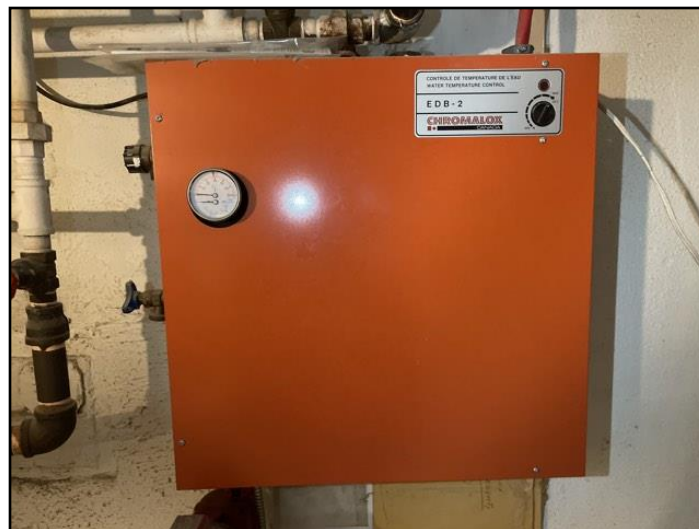
**Condition:** • Old heating equipment, Remove as desired.

*old equipment no longer connected.*

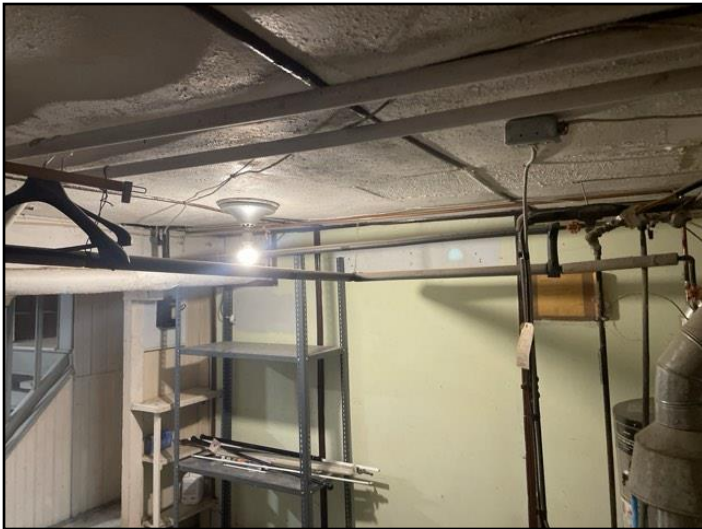
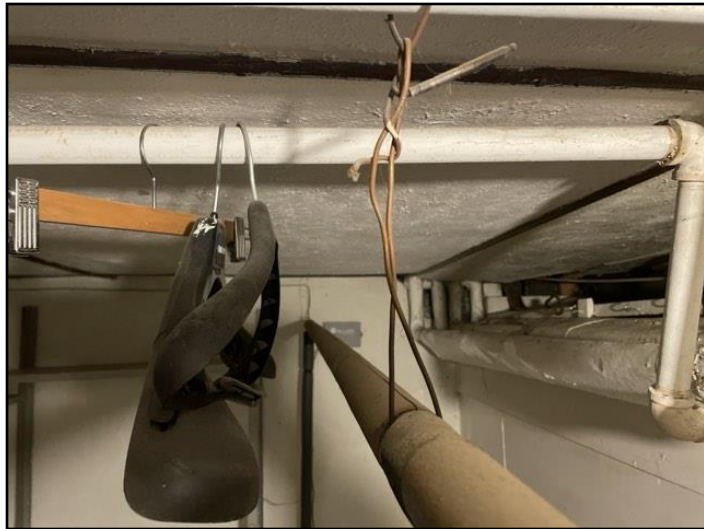
**Condition:** • [Poor support](#)

Poor support

**Task:** Improve

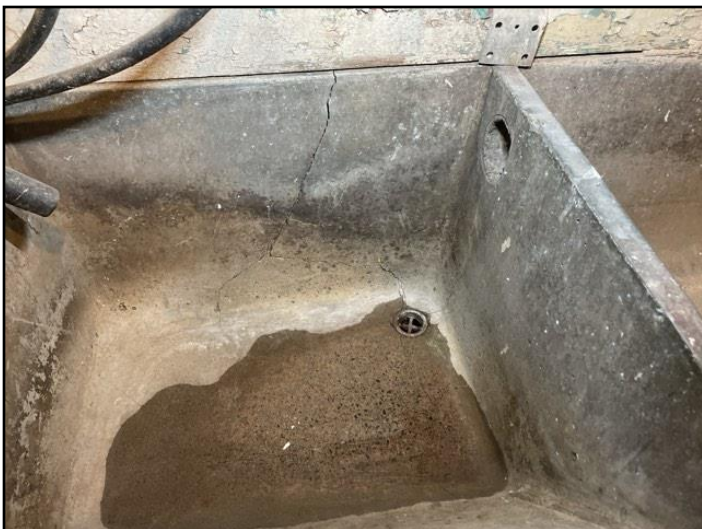
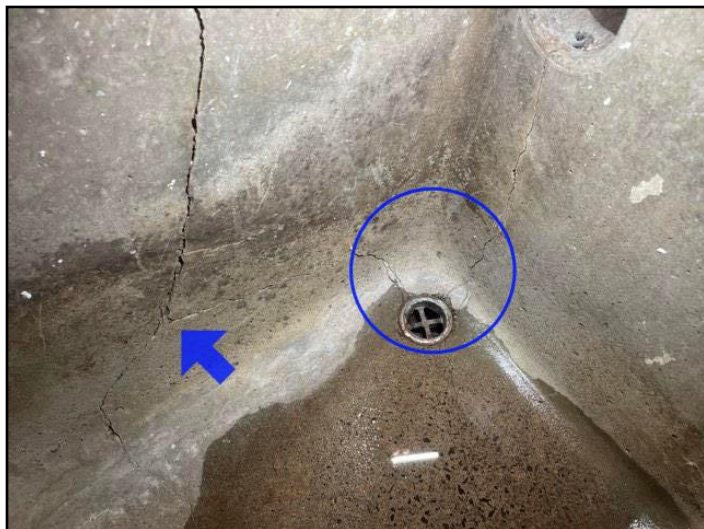
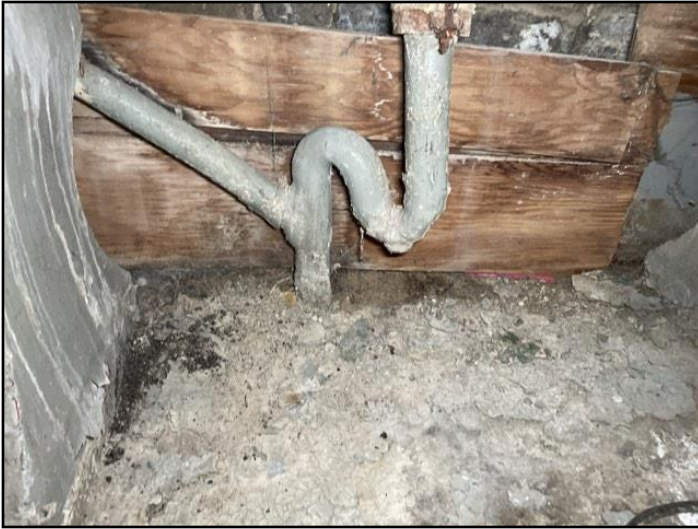
**Condition:** • Concrete laundry tub is cracked, and has its original lead drain.

Laundry tub

Cracked

Hand formed lead drain

**Task:** Replace the basin and drain piping

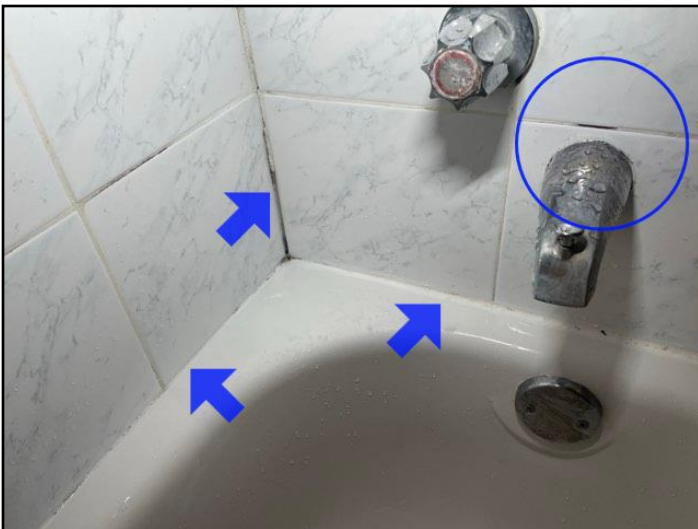
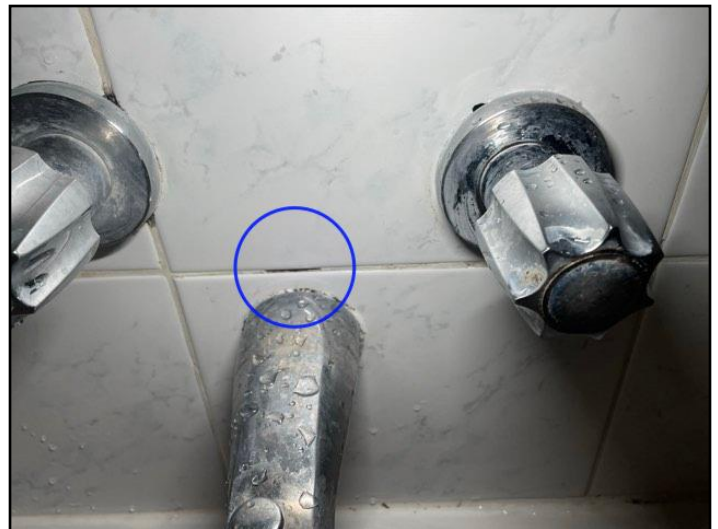
**Condition:** • [Caulking loose, missing or deteriorated](#)

Caulking loose, missing or deteriorated

Grout missing

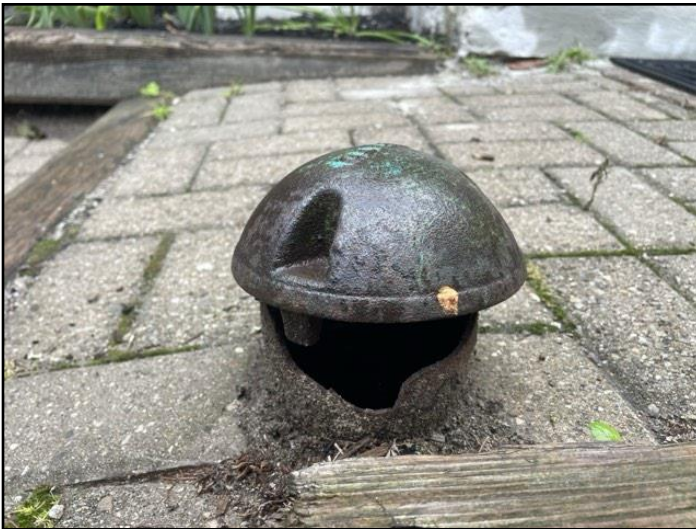
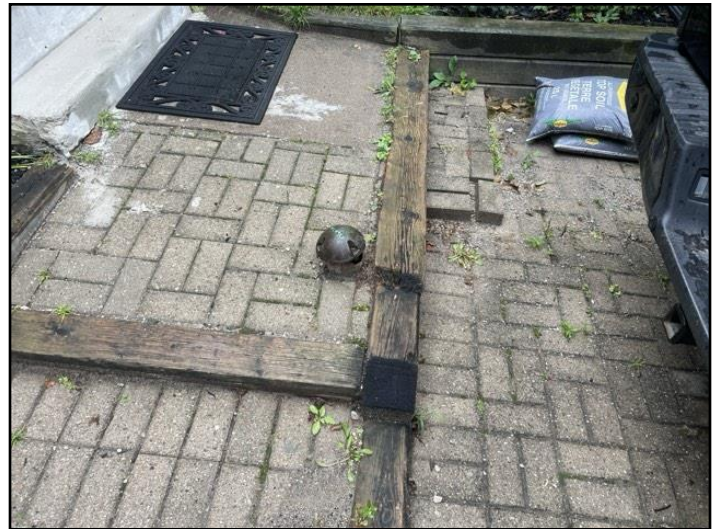
**Condition:** • Plumbing clean-out pipe is damaged

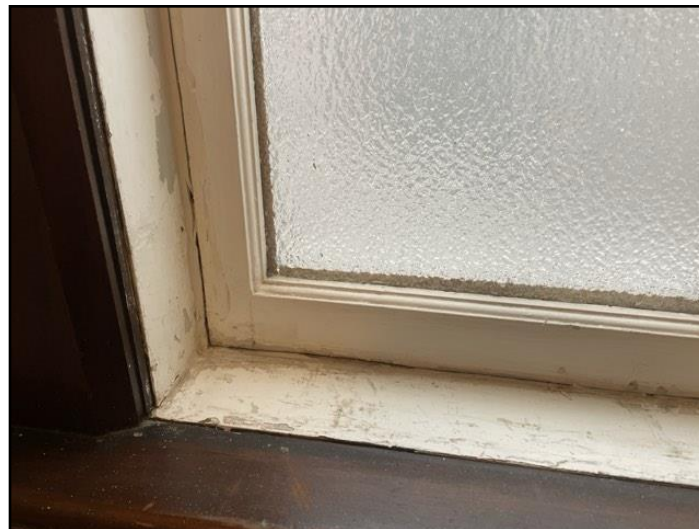
**Condition:** • Painted shut

*Painted shut*

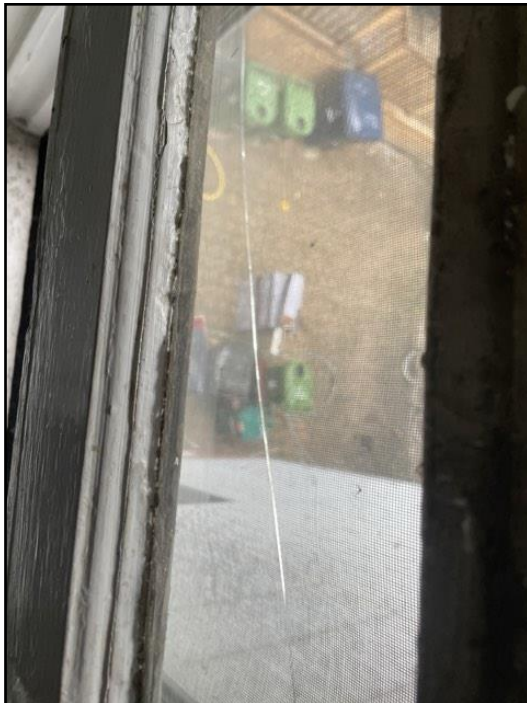
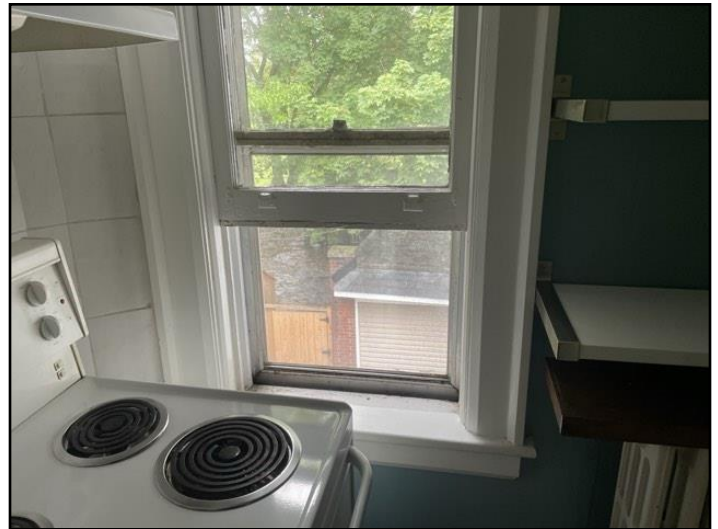
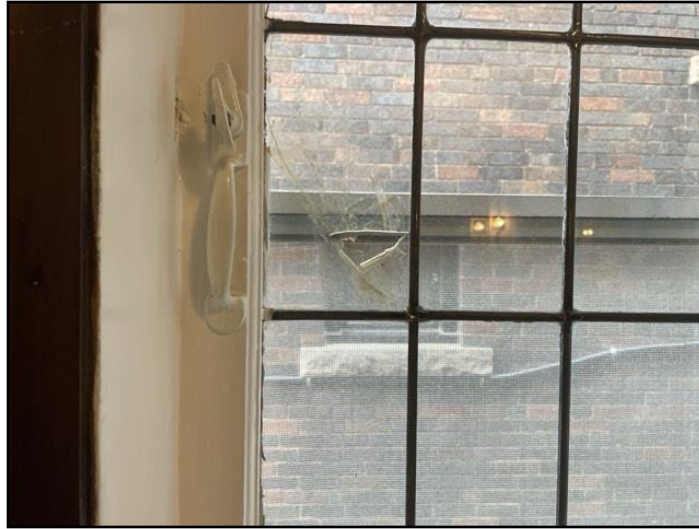
**Condition:** • [Cracked](#)

This is an older wood frame, sash window and aluminum storm window. both are single pane glass which simplifies repair

*Cracked-Second floor kitchen*

*Cracked- Second floor kitchen*

*Cracked-Stairwell window*

**Task:** Replace glass

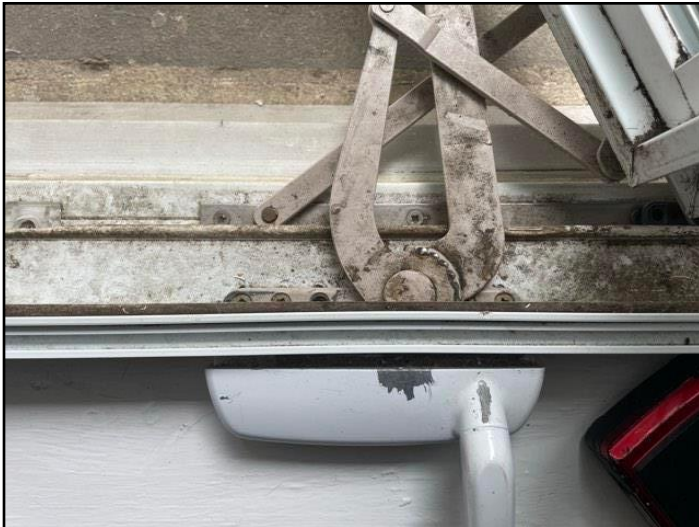
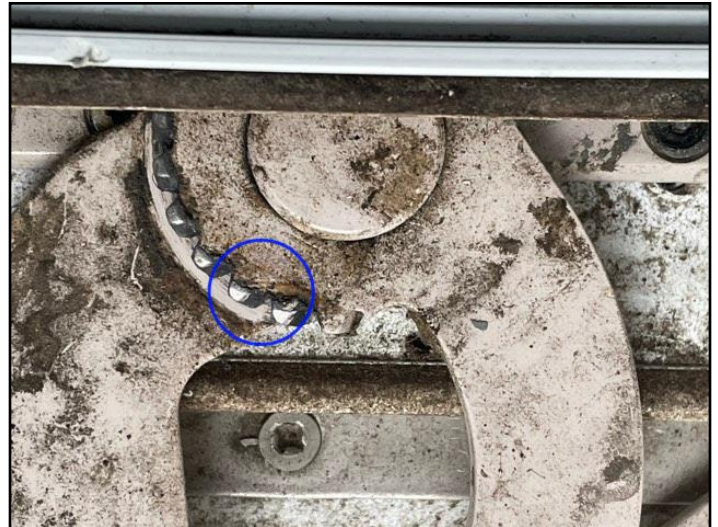
**Condition:** • [Inoperative](#)

*Inoperative*

*Inoperative - Worn drive gear*

**Task:** Replace window crank mechanism

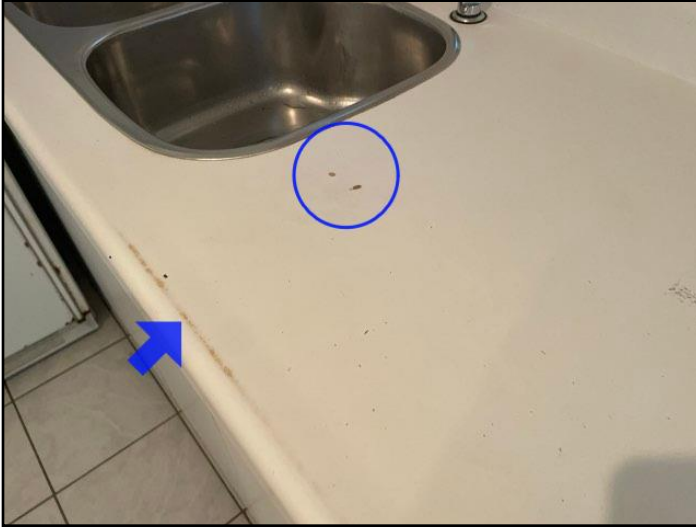
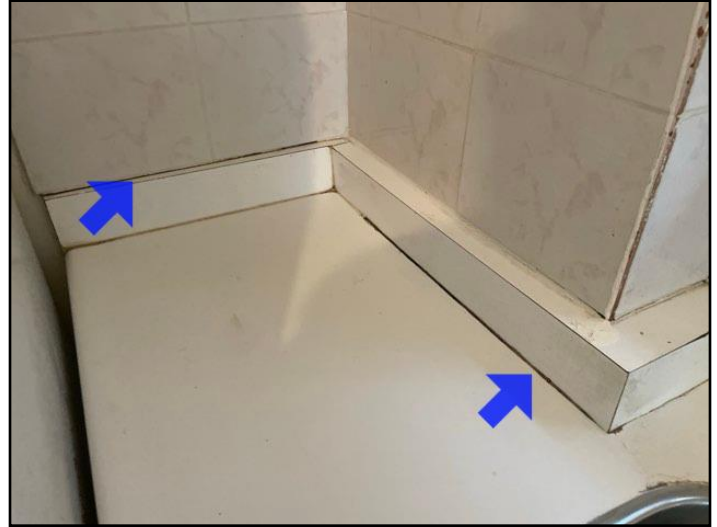
**Condition:** • Worn

*Missing Caulking*

**Task:** Replace

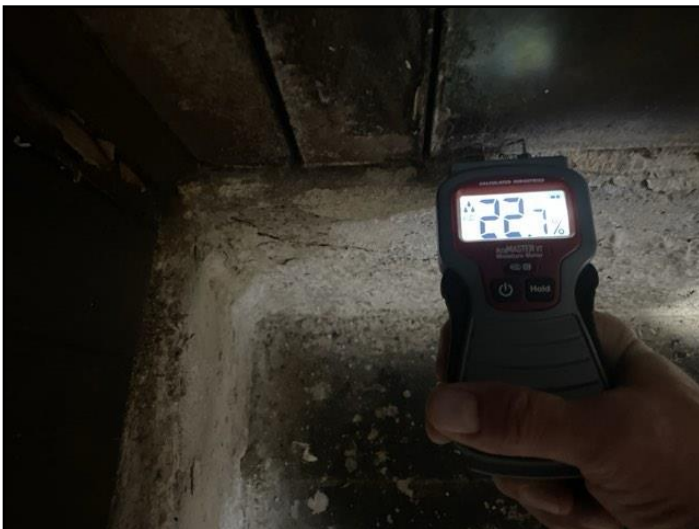
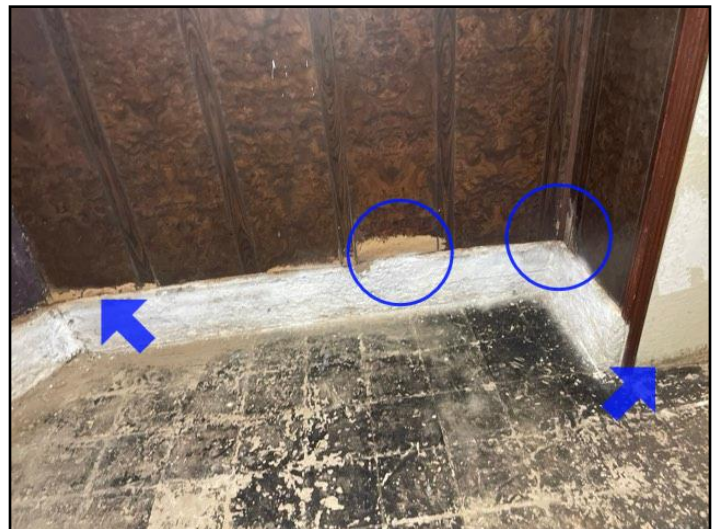
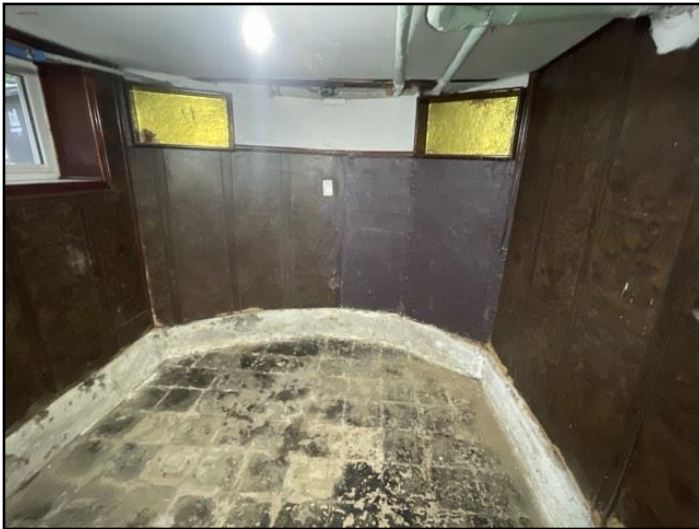
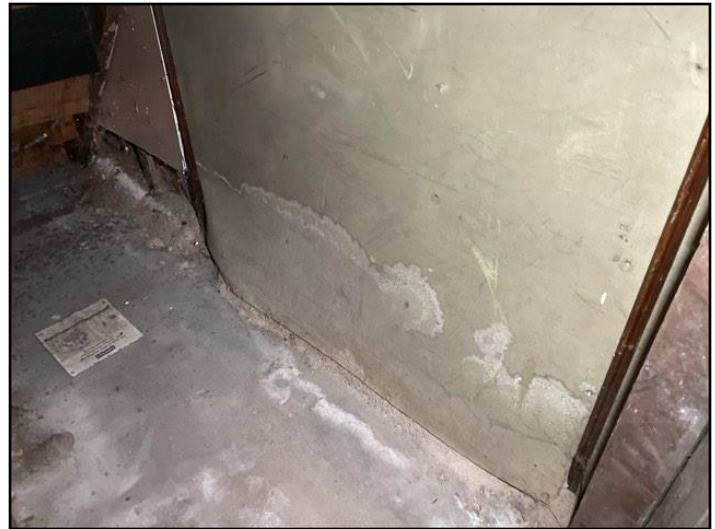
**Condition:** • Evidence of moisture noted

Elevated moisture and related damage was observed in the wall paneling in the rear room and the drywall under the stairs is installed too close to the foundation wall, which may be wicking moisture from the wall and accumulated efflorescence and debris behind the paneling. Overflowing gutters and unsealed gap on the left side between the

walkway and house may be contributing to the condition by increasing moisture levels at the foundation.

Elevated moisture readings (High)

Evidence of moisture lower wall

Rear addition basement

Below basement stairs - Left side

Recommend removing the affected paneling to permit cleaning and further evaluation of the foundation wall. Where basement walls are refinished, moisture-tolerant materials should be considered, as masonry foundation walls are generally more resistant to minor moisture infiltration than conventional wall finishes such as particle board or drywall. Correction of the gutter overflow and improvement of the seal between the building and the adjacent walkway or driveway are also recommended to help reduce moisture intrusion at the foundation.
