# Your Inspection Report

220 Medland St  
Toronto, ON M6P 2N7

**INSPECTION DATE:**  
Thursday, August 20, 2026

RE: Report No. 98891, v.2  
220 Medland St  
Toronto, ON  
M6P 2N7

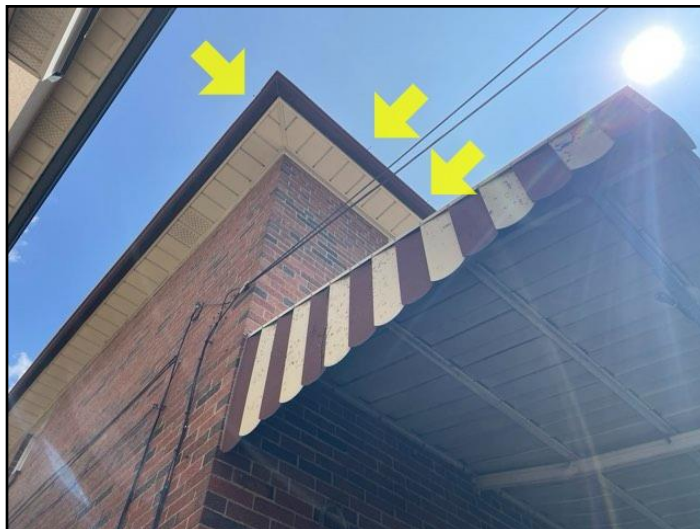
**Condition:** • Loose

Gutter spikes coming loose

*Loose*

**Task:** Repair

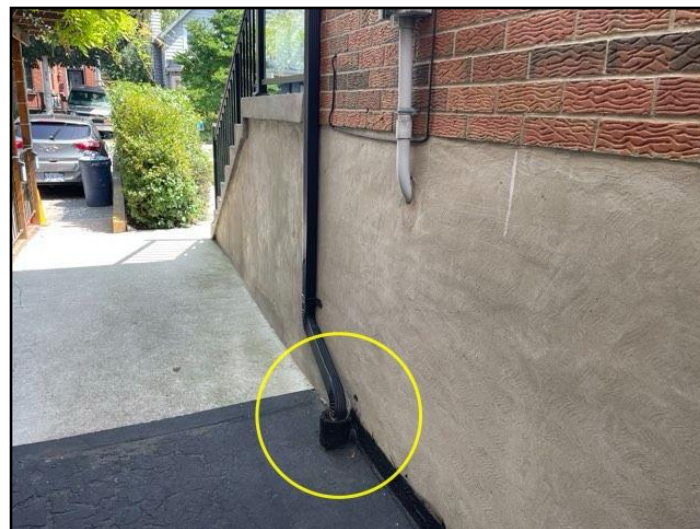
**Condition:** • [As of Dec 2016, a Toronto by-law requires downspouts to discharge above grade. Exemptions may be available in some cases. Below-grade downspouts may leak or be clogged, resulting in basement leakage. Click the line above for details.](#)

Toronto - Discharge below grade

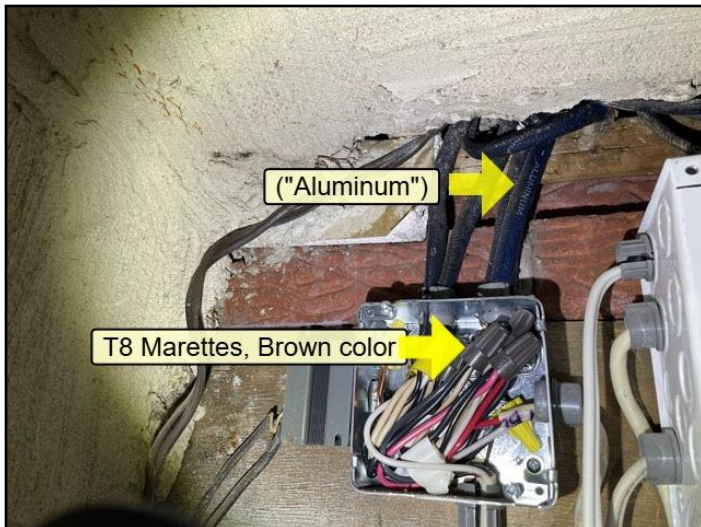
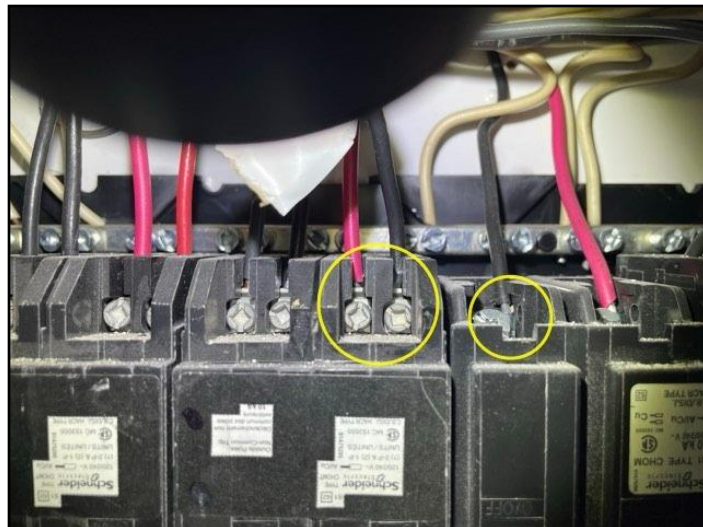
**Condition:** • [Noted in the home. Click here to see the Ontario Electrical Safety Authority's position on this wiring system.](#)

Some insurance companies may request an electrical safety inspection, and a few may insist on replacement of the aluminum wiring.

Noted in the home

Aluminum wires: Example, Panel

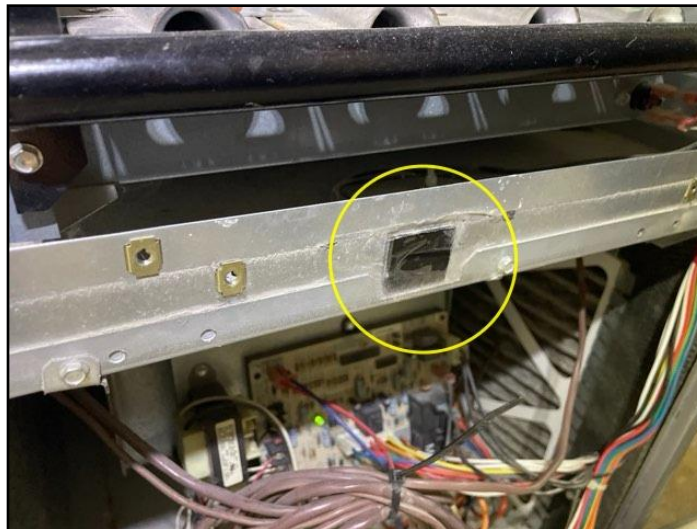
**Condition:** • Fan cover/access door interlock/safety switch inoperative

*Interlock switch taped down*

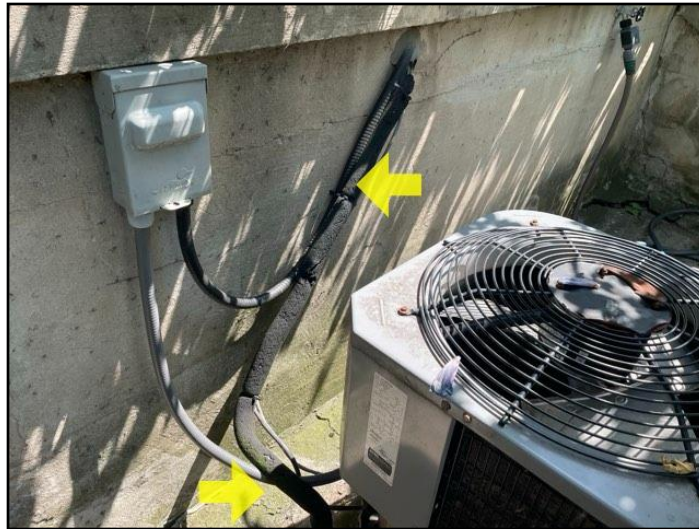
**Condition:** • [Insulation - missing](#)

*Insulation - deteriorating*

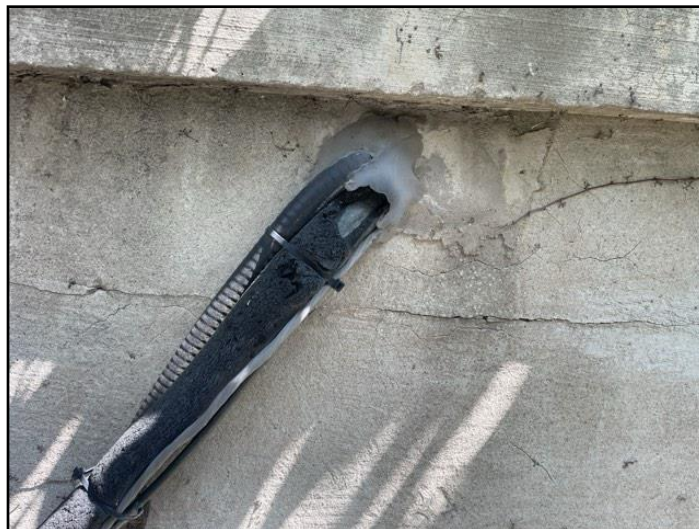
**Condition:** • [Poor seal at building](#)

*Poor seal at building*

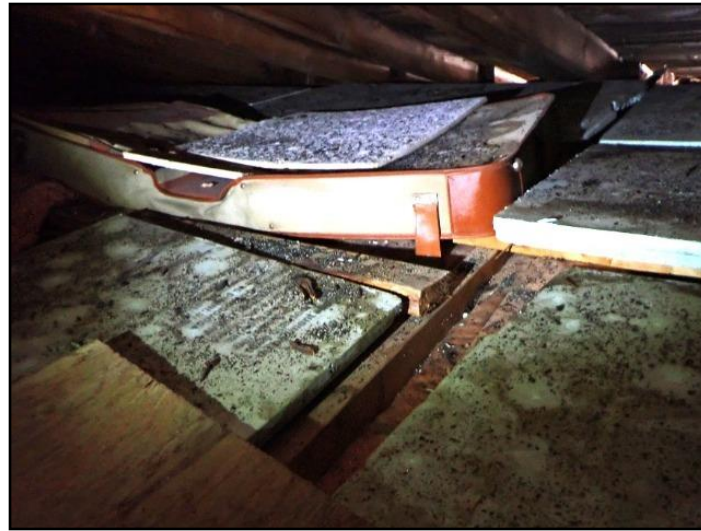
**Condition:** • Debris in attic

Debris in attic

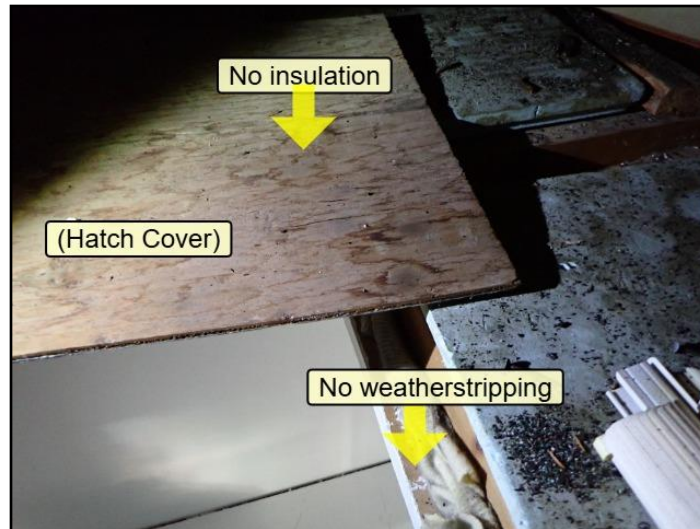
**Condition:** • [Not insulated and not weatherstripped](#)

*Not insulated and not weatherstripped*

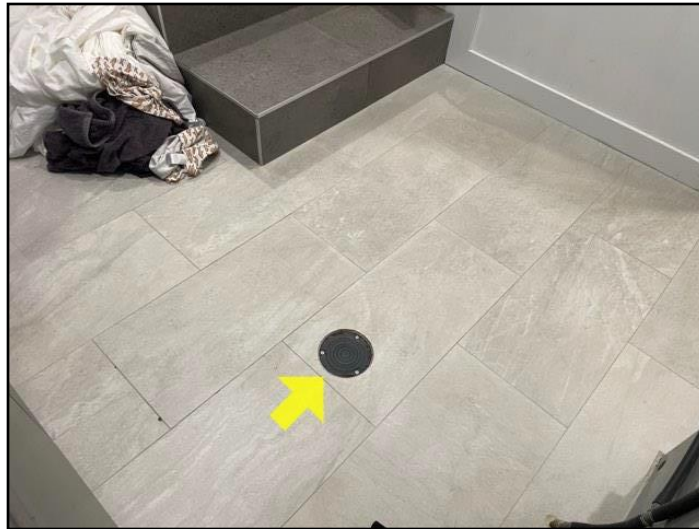
**Condition:** • [Obstructed](#)

*Obstructed*

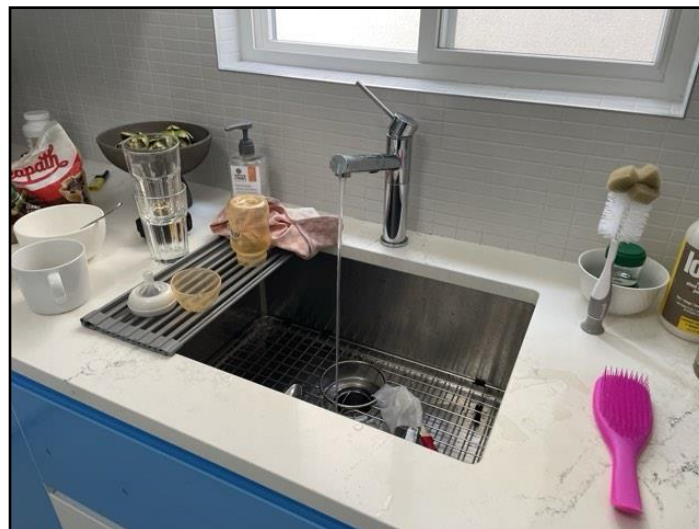
**Condition:** • Low water flow

*Low water flow*

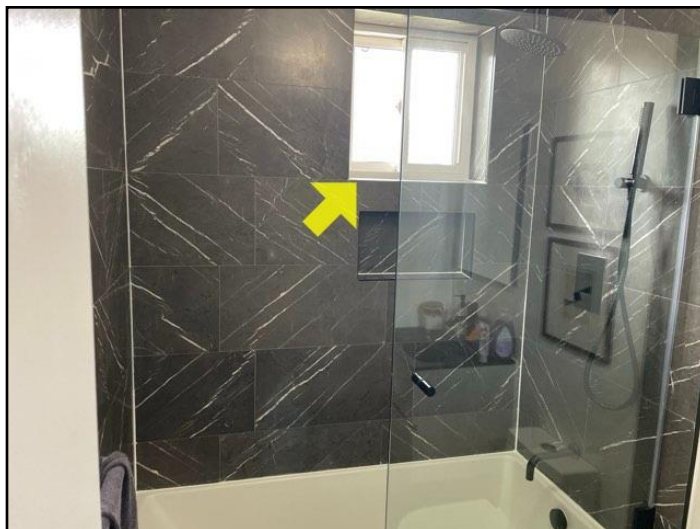
**Condition:** • Window in shower enclosure

*Window in shower enclosure*

**Task:** Protect the window with a covering or, at a minimum, keep the area well sealed to prevent moisture penetration into joints.

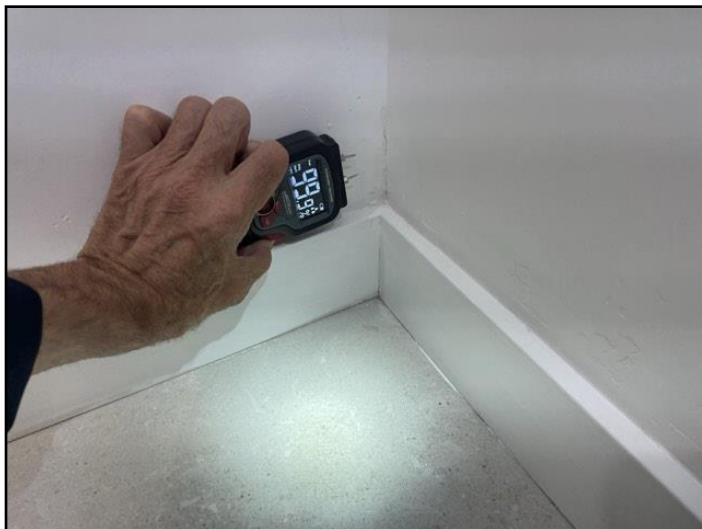
**Condition:** • Evidence of moisture noted

*Evidence of moisture noted*

**Task:** Ensure gutters and downspouts are working properly and exterior grade slopes down away from the home. Monitor the area for evidence of moisture, particularly in the spring when snow melts or after heavy or persistent rains.

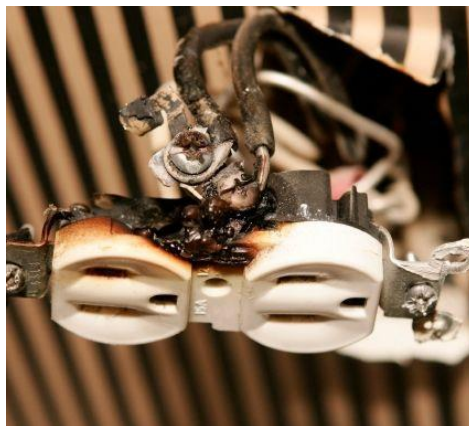
**Photo F1 – Failure of aluminum wiring terminations**

Reported problems with aluminum wiring have been related to the overheating and failure of aluminum wiring terminations. This is due to the tendency for aluminum to oxidize and its incompatibility with devices designed for use with copper wiring. Warm cover plates or discolouration of switches or receptacles, signs of arcing within switches or receptacles as per photo F1, flickering lights, or the smell of hot plastic insulation may be evidence of these problems.

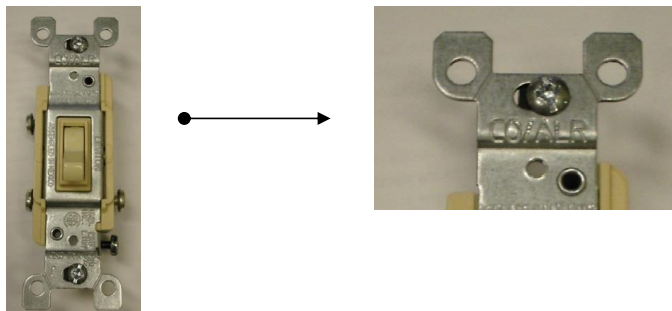
Photo F2 – Required marking for devices used with aluminum wiring

All terminations of aluminum conductors shall be to devices marked as per Table F1 and Photo F2; this includes the bare bond conductor. OESC Rule 12-118 3) provides two exceptions to this requirement. The first exception is for devices or fixtures with wire leads, in which case the joint between the wire lead and the aluminum conductor shall be made with a wire connector approved for copper to aluminum connections and marked as per Table F1. The second exception is the outlet box bonding screw, which does not require approval for connection of the aluminum bonding conductor.
