# Your Inspection Report

1 Rambert Cres  
Toronto, ON M6S 1E5

**INSPECTION DATE:**  
Tuesday, August 18, 2026

RE: Report No. 98895  
1 Rambert Cres  
Toronto, ON  
M6S 1E5

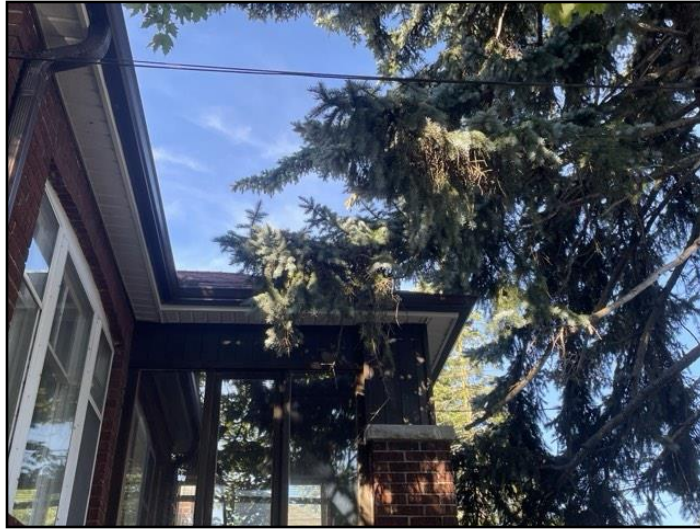
**Condition:** • Tree branches touching roof

*Tree branches touching roof*

**Task:** Trim tree branches

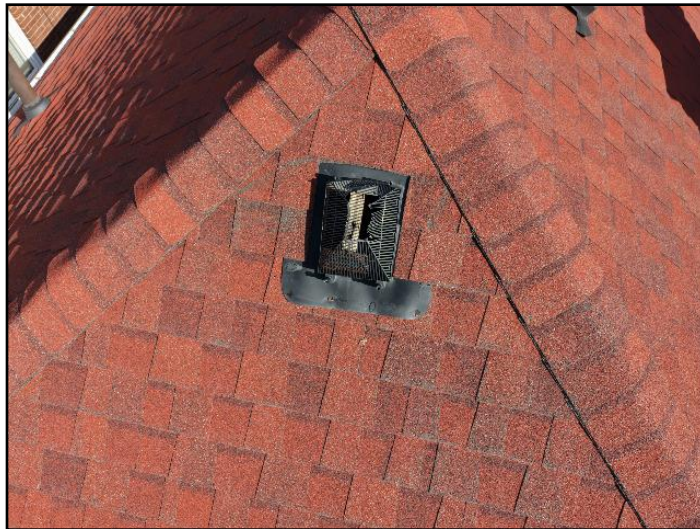
*Rear pitch*

**Condition:** • Damaged roof vent

**Task:** Replace

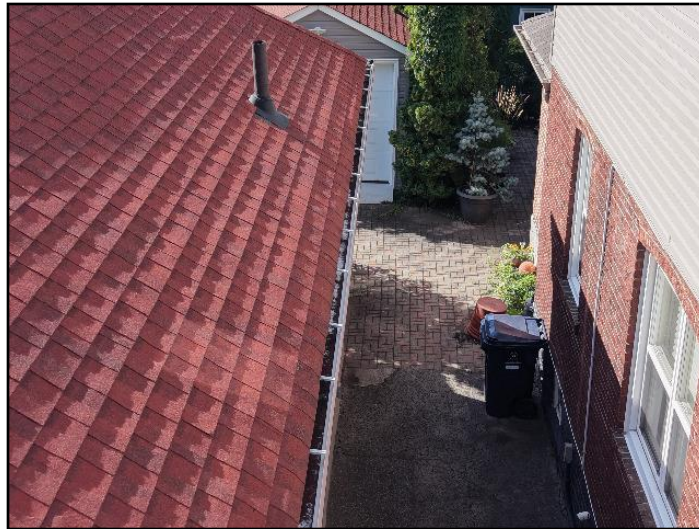
**Condition:** • Clogged

*Clogged*

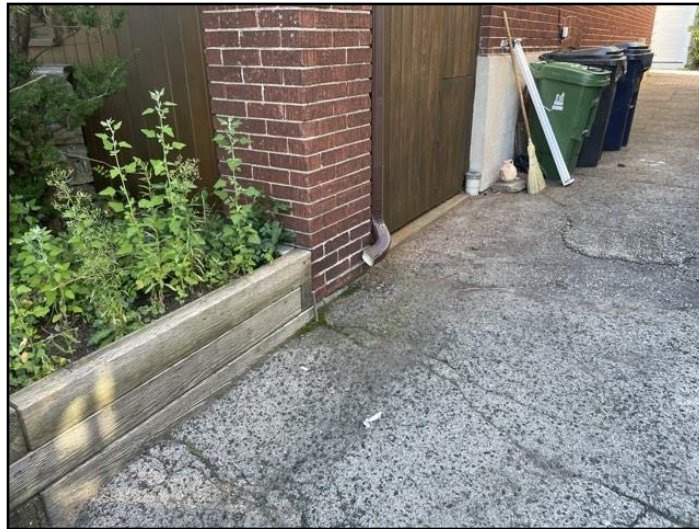
**Condition:** • Discharge too close to building

*Discharge too close to building*

Always transfer water as far away from the house as practical. However attention to erosion, tripping hazard, or creating a slippery ice surface should also be considered.

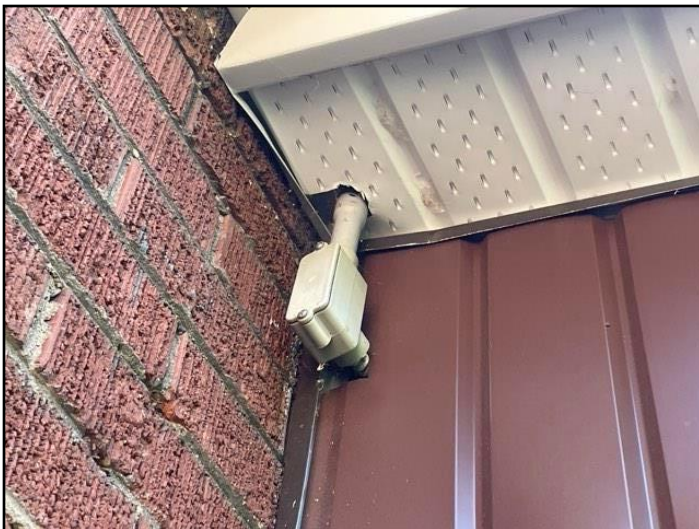
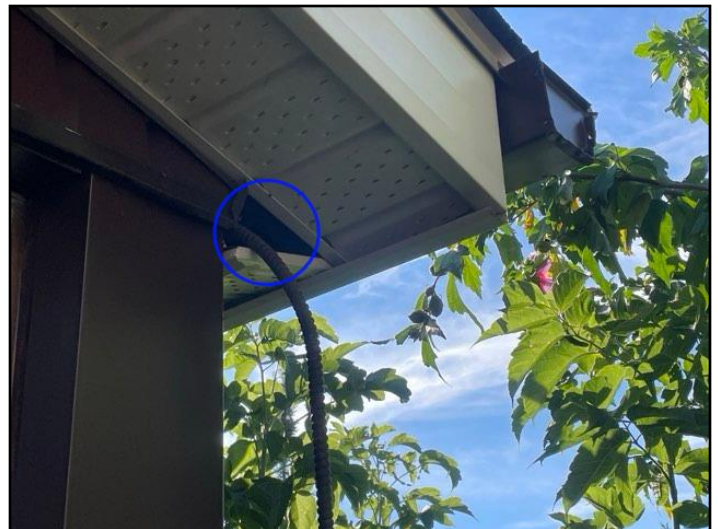
**Condition:** • Damage

*Damage*

**Task:** Repair/seal

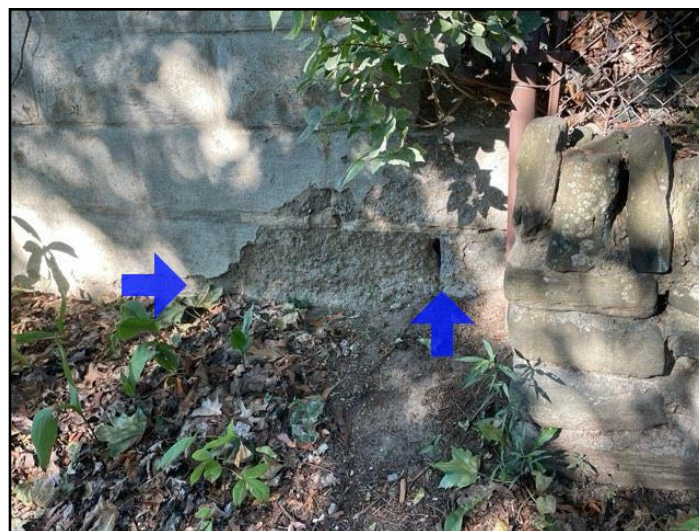
**Condition:** • Parging damaged or missing

*Parging damaged or missing*

**Task:** Repair

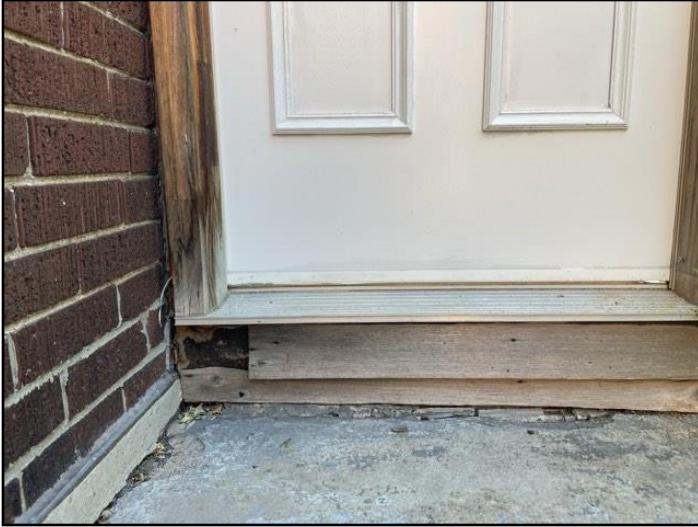
**Condition:** • Missing trim/insect damage.

Missing trim

**Task:** Repair

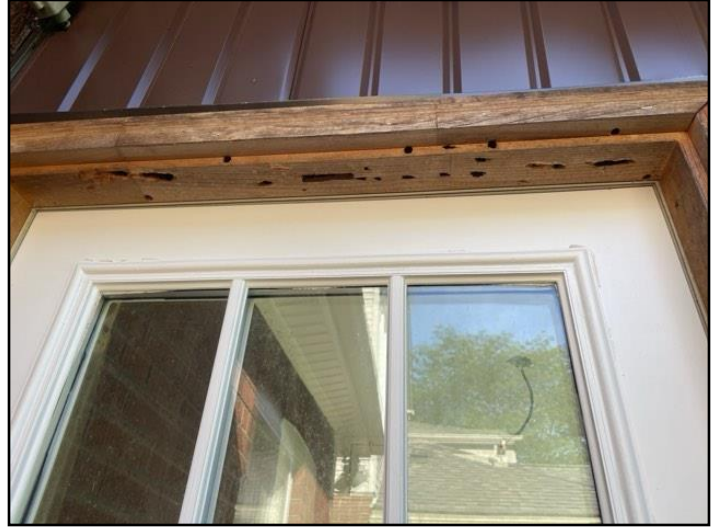
Holes in trim

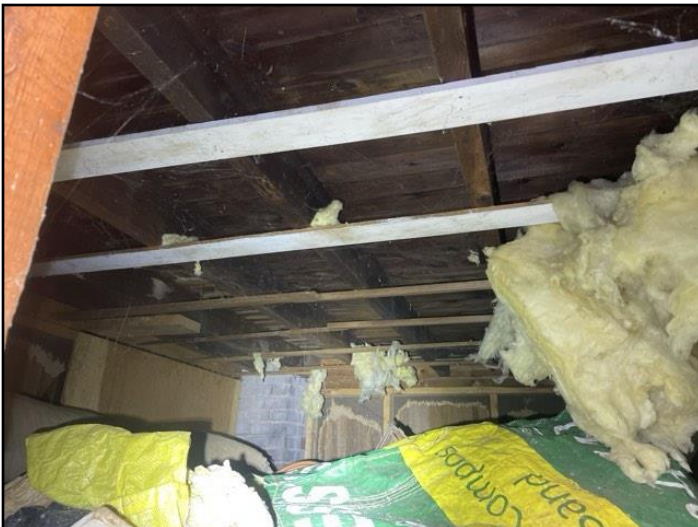
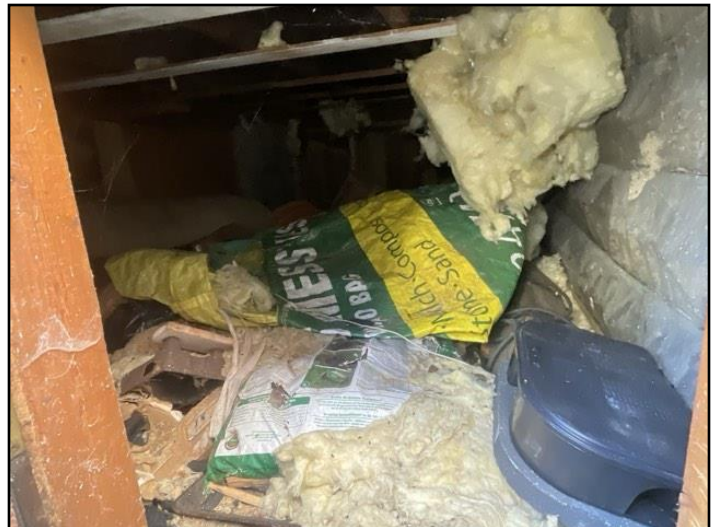
**Condition:** • Storage/debris. Collected storage and debris under the front porch may attract pests.

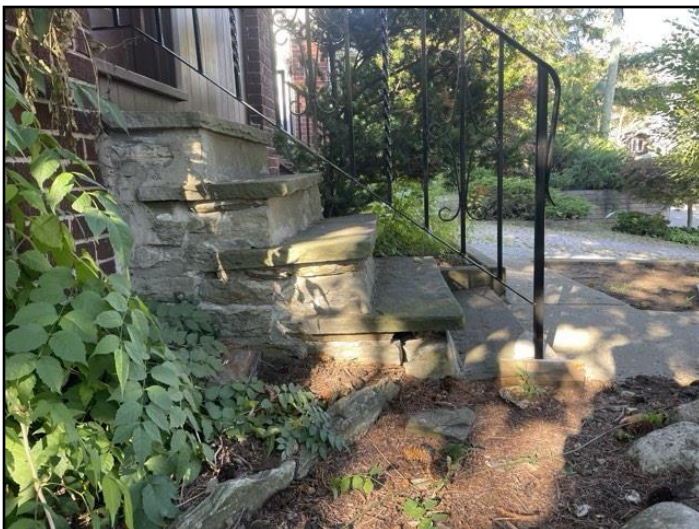
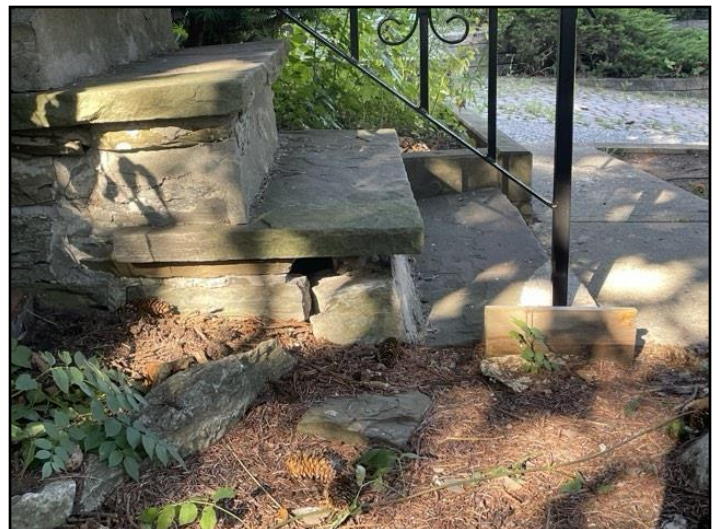
**Condition:** • Steps or landings settling or heaving

*Steps or landings settling or heaving*

**Task:** Repair/improve

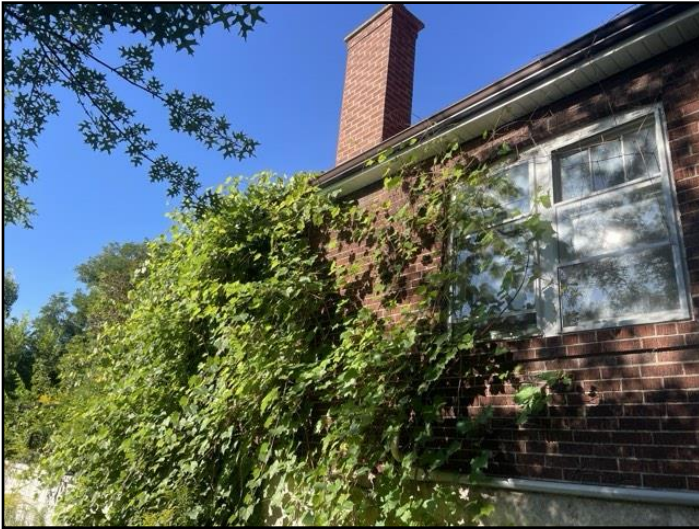
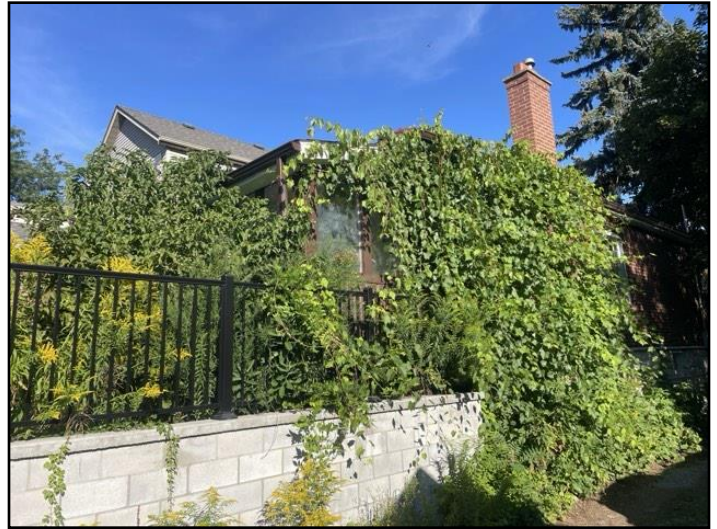
**Condition:** • Vines may damage the home over time. If vines are to remain, and we understand the aesthetic reasons for leaving them, we recommend controlling the growth so vines do not attach to wood surfaces or roofs, and do not clog gutters and downspouts.

*Vines may damage the home -*

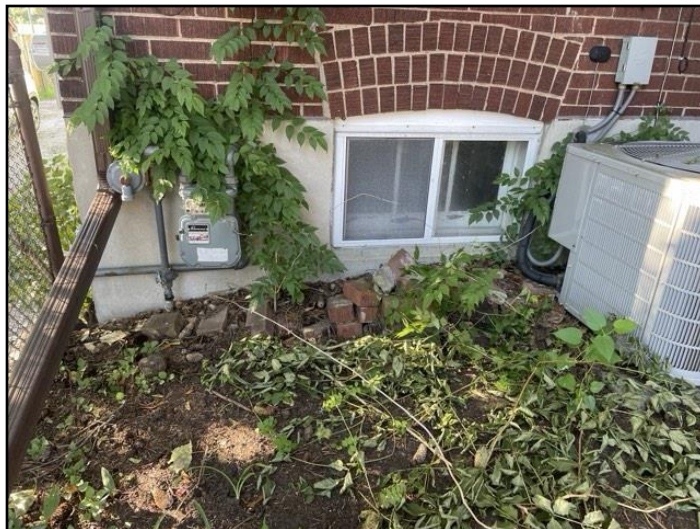
**Condition:** • The ground around some parts of the home does not slope to drain water away from the foundation.

*Lot grading*

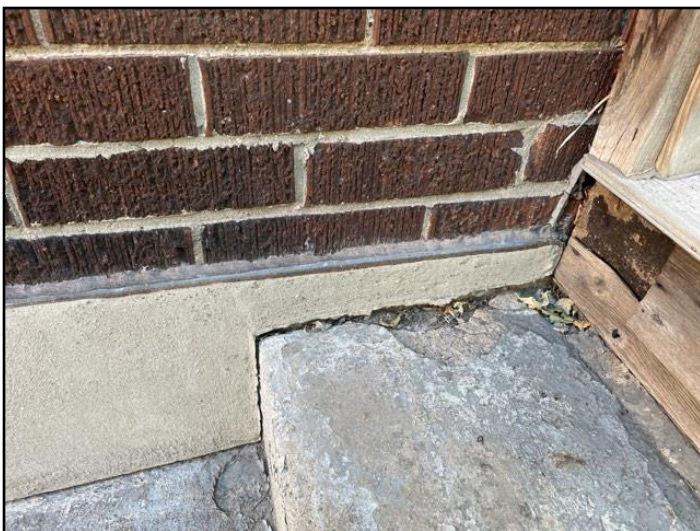
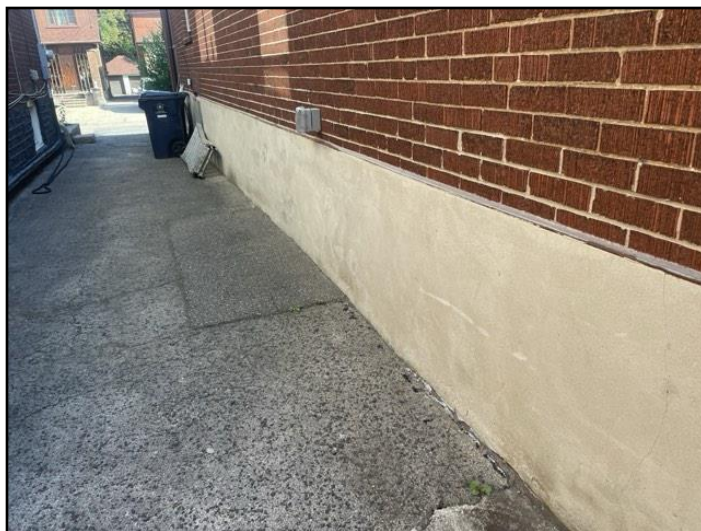
**Condition:** • Unsealed gap at building

*Unsealed gap at building*

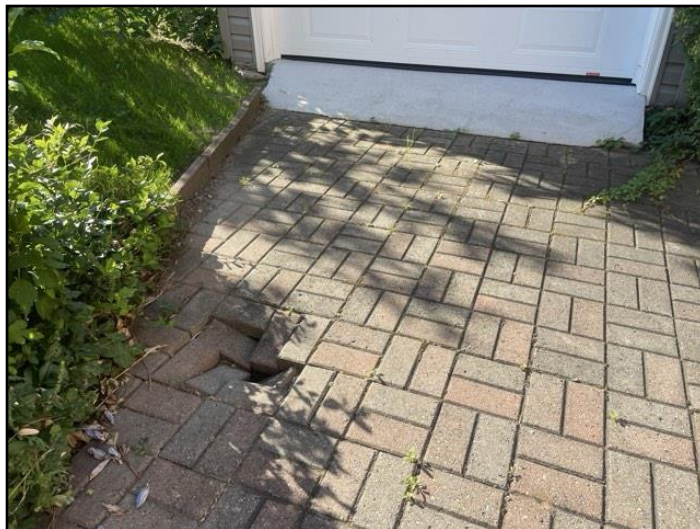
**Condition:** • Settlement

*Settlement*

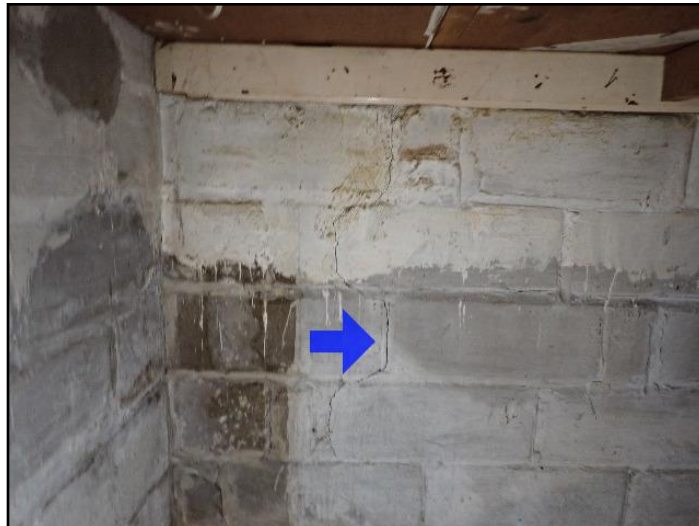
**Condition:** • Cracked

Crack was noted. it appears to follow the mortar line of the masonry block. It is not possible from a one-time visit to determine whether movement is ongoing, and if so at what rate.

*Cracked*

**Task:** Repair/Monitor

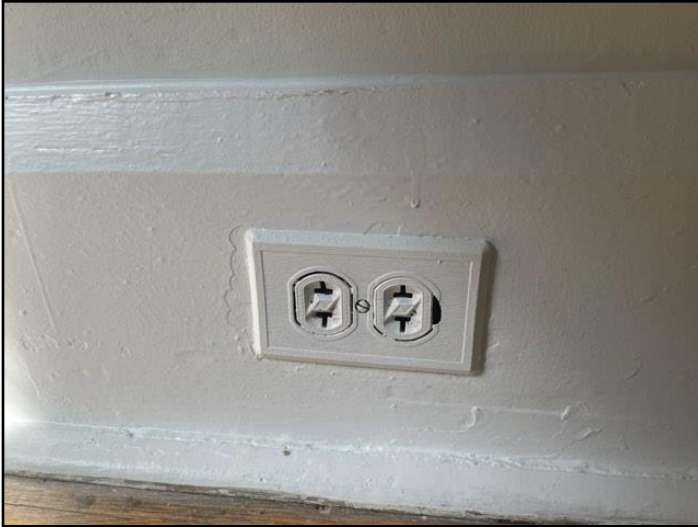
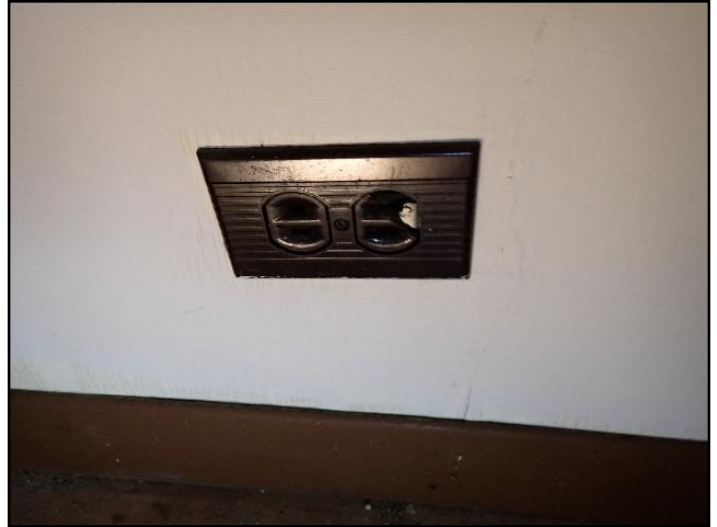
**DISTRIBUTION SYSTEM \ Outlets (receptacles)****Condition:** • Ungrounded

Although many of the circuits and the service panel have been upgraded some ungrounded outlets remain.

*Ungrounded*

*Ungrounded***Inspection Methods and Limitations****Inspection limited/prevented by:** • AFCIs (Arc Fault Circuit Interrupters) are not tested in a home that is occupied or where testing may cause damage. These should be tested monthly by the homeowner.**Inspection limited/prevented by:** • Main disconnect cover not removed - unsafe to do so.**Not included as part of a building inspection:** • Low voltage wiring systems and components • Testing of smoke and/or carbon monoxide alarms

**Location:** Various**Task:** Improve**Time:** When renovating**Cost:** \$1,500-\$3,000

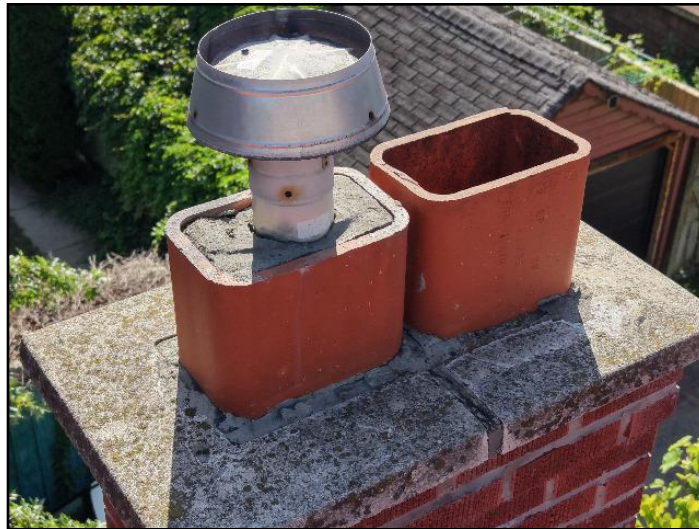
**Condition:** • Rain cap missing or damaged

*Rain cap missing or damaged*

**Task:** Provide / replace

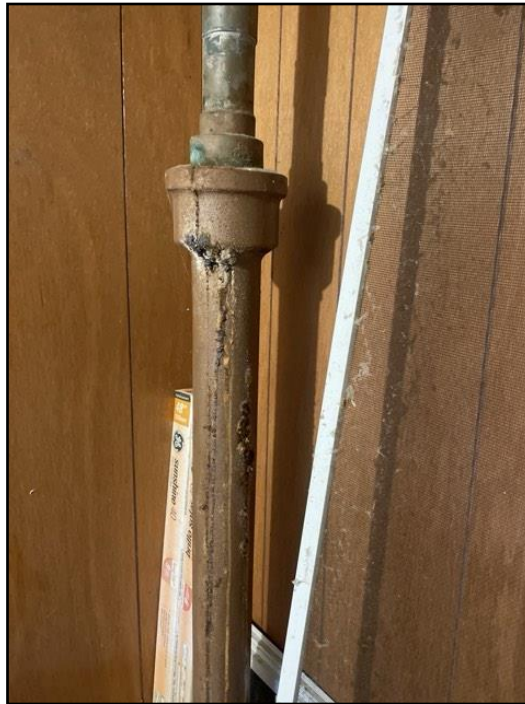
**Condition:** • The cast iron waste piping is near the end of its normal life expectancy and is prone to rusting through or splitting. Replacement may be required in the near future.

Cast iron old -

**Task:** Replace waste stacks

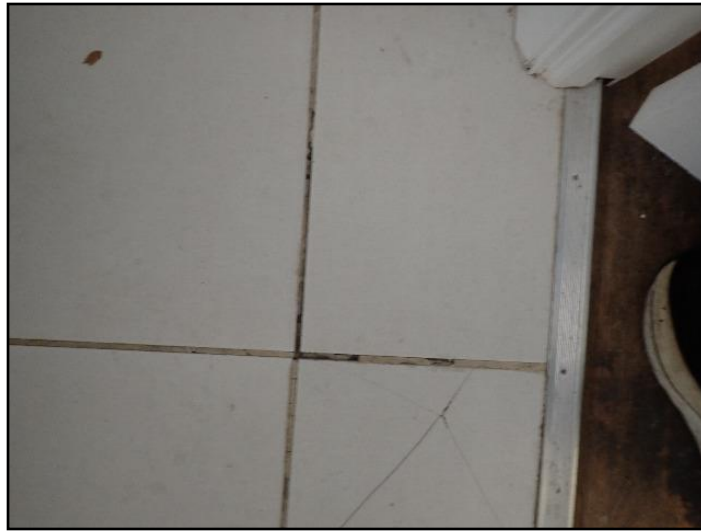
**Condition:** • Grout loose, missing or deteriorated

Bathrooms are older, and the grout and caulking are deteriorating and loose.

*Grout loose, missing or deteriorated*

**Task:** Repair grout - Re-caulk

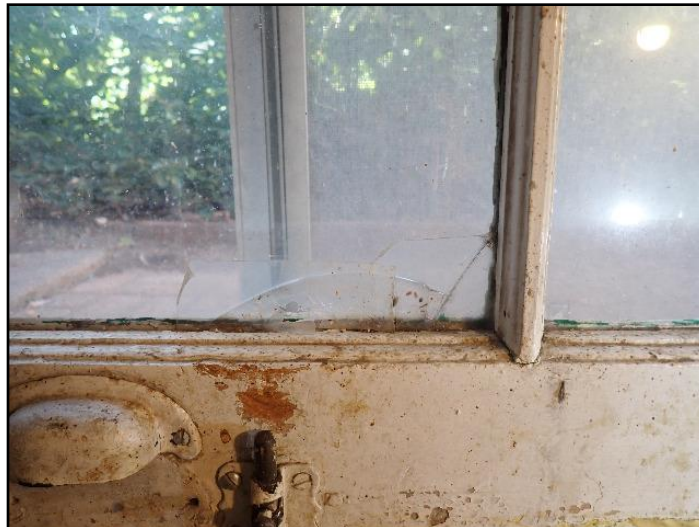
**Condition:** • Older windows

Windows are older wood framed units, with storm windows covering. The wood windows need periodic maintenance which may include cleaning and repainting, replacing the glazing putty and replacing cracked panes.

*Older window - Cracked pane*

**Task:** Refurbish or replace
