# HOME INSPECTION REPORT

217 Humberside Ave  
Toronto

Prepared by: Bob Papadopoulos P.Eng., RHI \*

Inspection Date: [Sept 16 2026](#)

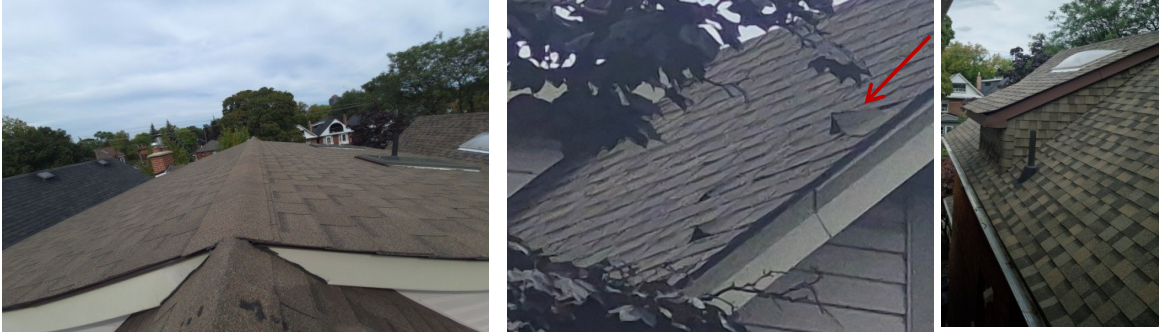
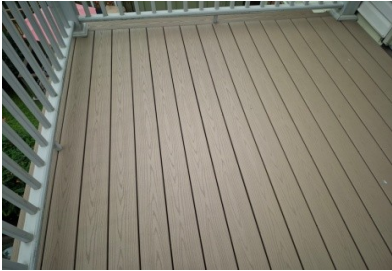
| <p>Sloped Surface: overall surface in good repair<br/> northeast: some shingle repairs required</p> <p>Skylight(s): low curb- monitor performance</p> <p>Chimney: rebuilt and in good repair</p> | | | |

Note: Recommend Annual Maintenance Contract for Roof Surface, Flashing Details and Chimney(s)

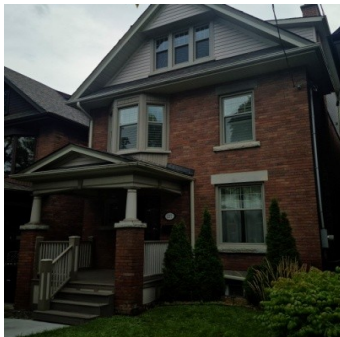
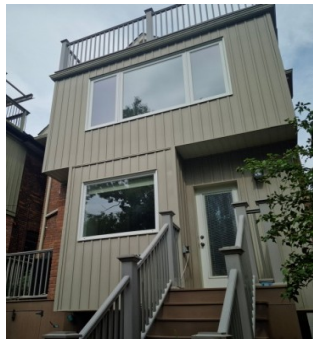
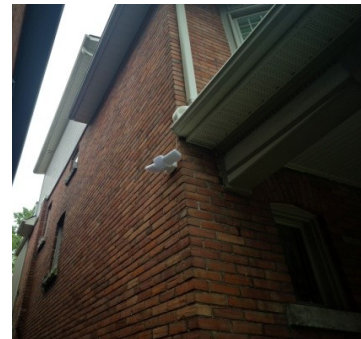
Brick: overall in good repair

Vinyl Siding: overall in good repair

DOORS/WINDOWS: overall in good repair

DECK(s): overall in good repair

PORCH overall in good repair

Note: Maintain Gutters & Downspouts annually. Extend Downspouts at least 6-feet away from the house

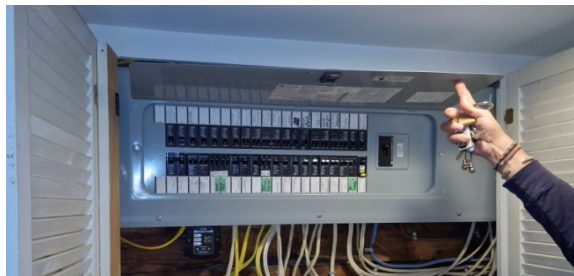
SERVICE ENTRANCE: **overall in good repair**  
SERVICE PANEL: **overall in good repair**  
**panel obstructed by cabinet - cover not removed**
