Roof Evaluation Meeting Summary

THE OWNERS, STRATA PLAN VR 788

ROOF EVALUATION

BRITANNIA PLACE – 251 WEST 4TH STREET, NORTH
VANCOUVER

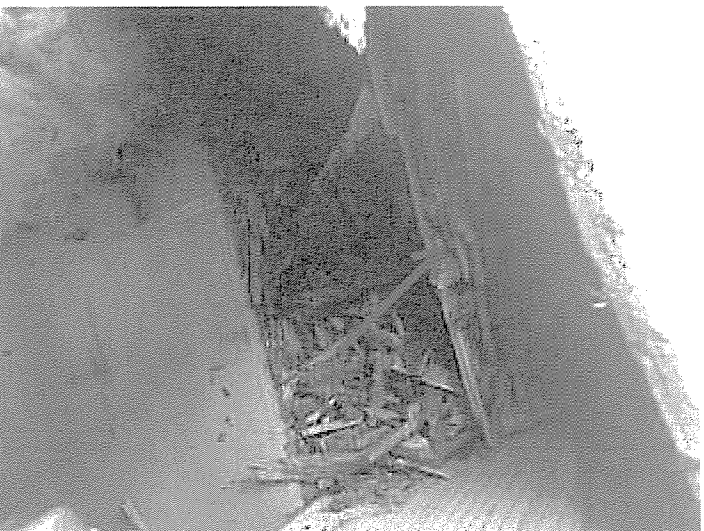
A test cut opening was performed at one location, on the main flat roof area shown on Drawing No. 1. The opening at this location (refer to Photo 2) revealed that the primary waterproofing membrane installed in 1995 was installed on plywood decking. Initially, the roof area in which the test opening was performed felt soft underfoot, as indicated on Drawing No. 1. The opening revealed that the membrane is completely debonded from the sheathing at this location, and that the plywood sheathing itself is completely deteriorated (refer to Photo 3), resulting in the tapered blocking telegraphing through the roof membrane.

We noted several additional areas which felt soft underfoot, indicating that water has likely resulted in deterioration of the decking at these locations. This increases the potential for leakage into the building and further concealed deterioration. Given the age of the membrane and concealed deterioration observed, the flat roof membrane has reached the end of its serviceable life and requires replacement.

Photo 3: Deteriorated Sheathing at Test Cut Opening 1

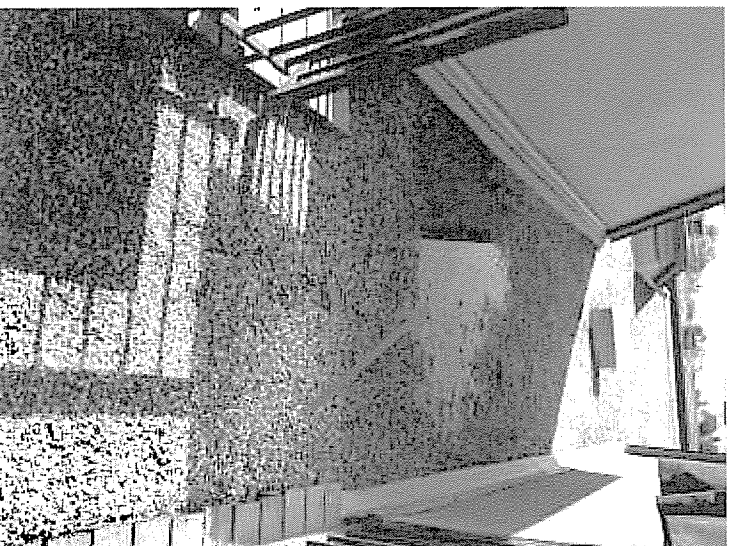
Although the roof is general well sloped by the tapered blocking, ponding was noted at one location shown on Drawing No. 1, on the flat roof area (refer to Photo 4). Water ponding accelerates aging of the membrane, and increases the potential of bulk water entering the building, should membrane failure occur.

Photo 4: Water Ponding on Flat Roof

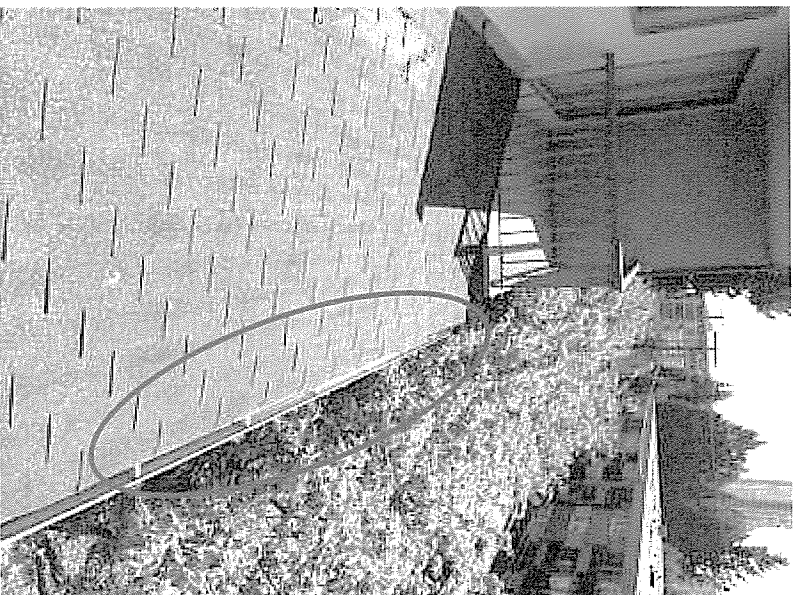
Photo 7: Gutter Warped/Rotating Down Length of Sloped Roof

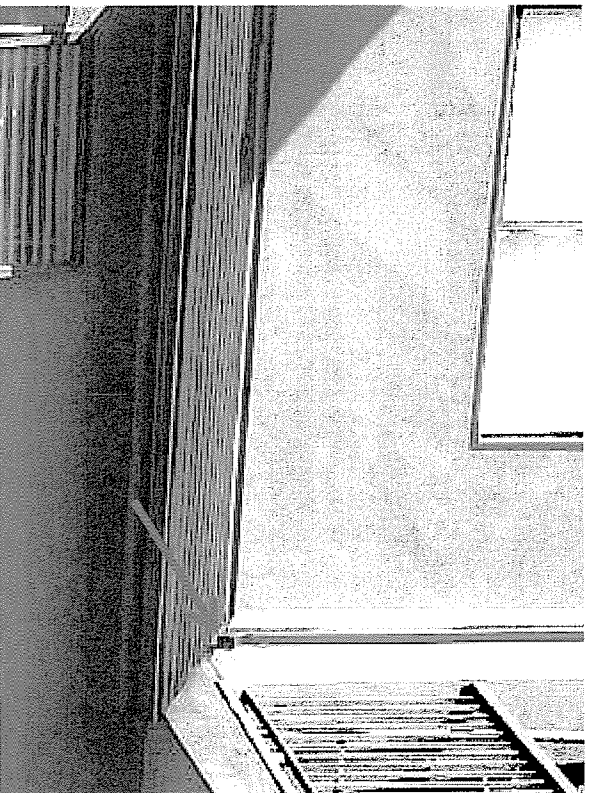
Photo 8: Downspout from Upper Gutters Draining onto Lower Roof Instead of into Eaves Trough

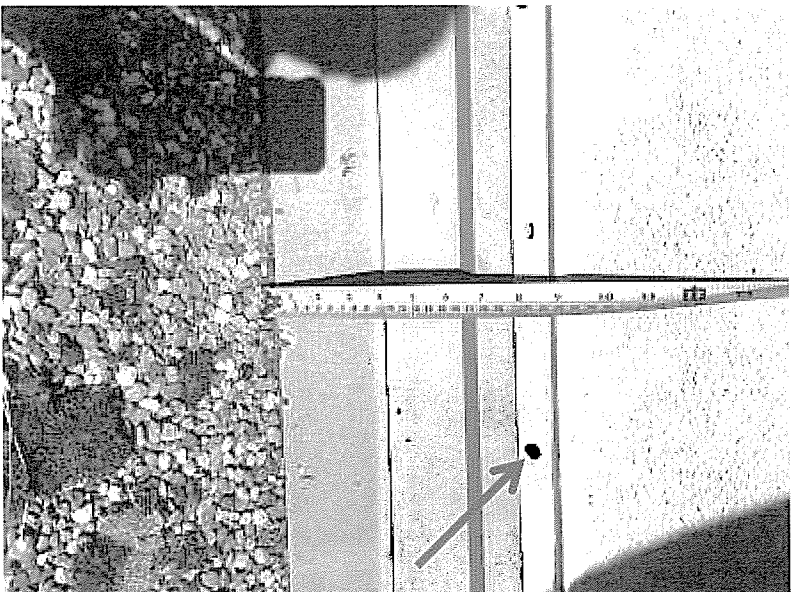
Corroded fasteners were noted at multiple locations, along with debonded sealants, and detached, loose counter flashings (refer to Photos 11, 12, 13, 14 and 15). Although flashings are in serviceable condition, they will require replacement as part of the membrane renewal project. Loose flashings should be re-secured to prevent blow-off, and reduce the risk of injury or damage to pedestrians or property, respectively.

Photo 11: Corroded Flashing Fastener

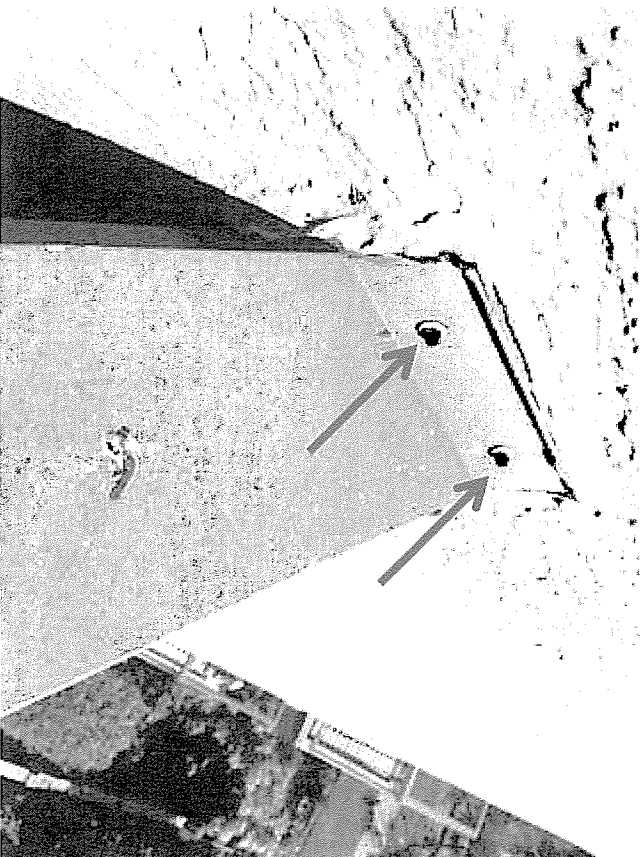
Photo 12: Corroded Flashing Fasteners

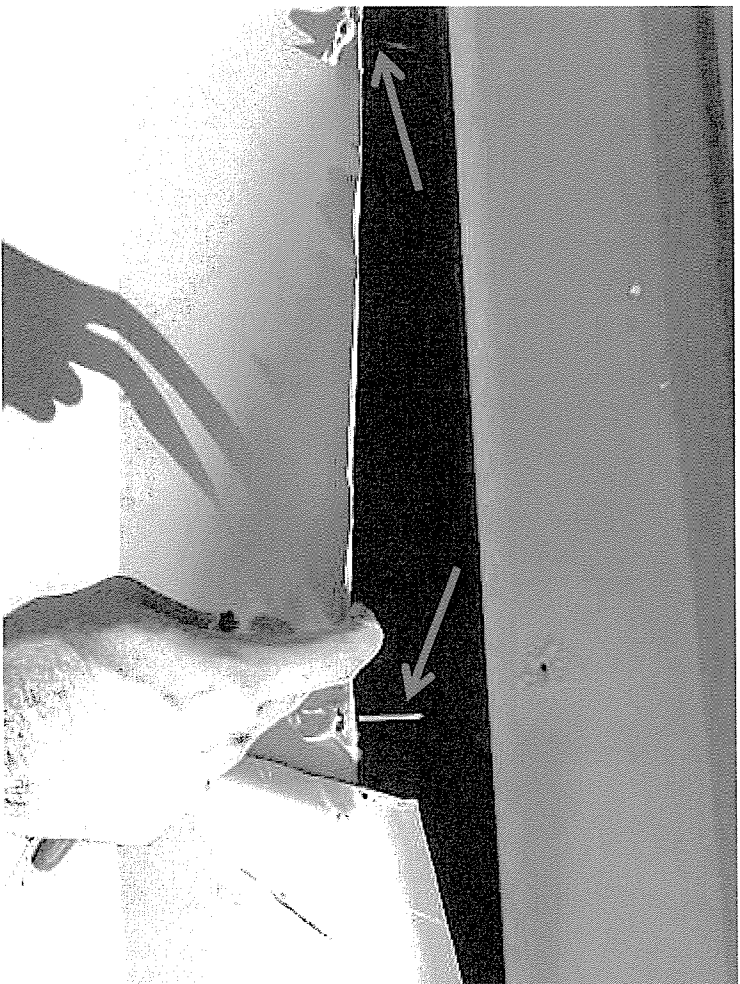
Photo 15: Corroded Fasteners at Detached Flashing

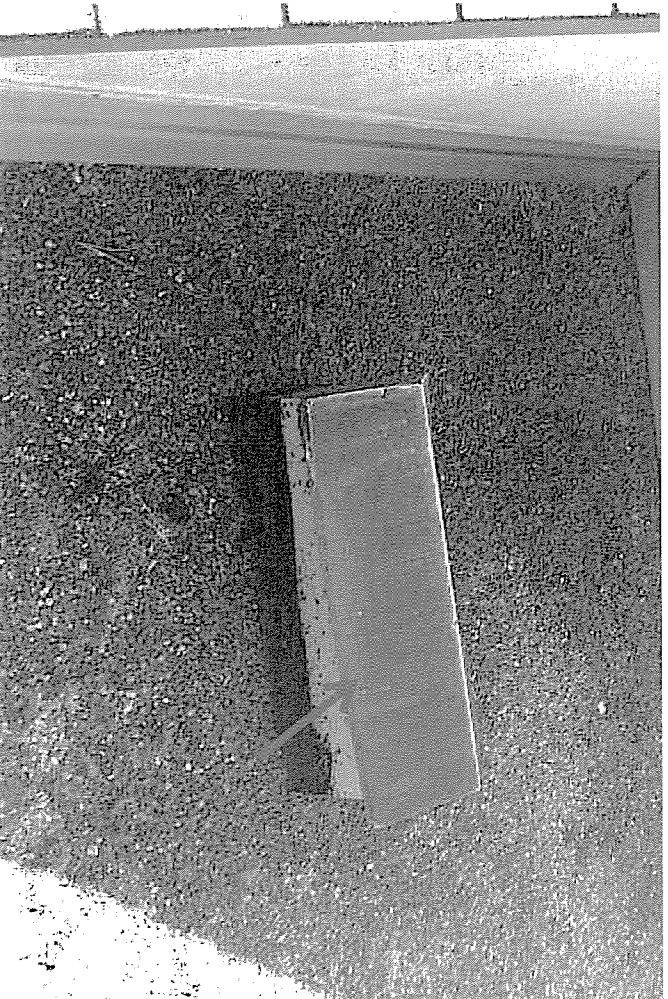
Doghhouse-style vent covers and Metal B-vent flashings located on flat and sloped roof areas are generally corroded and require replacement (refer to Photos 16 and 17).

Photo 16: Typical Corroded Doghouse-style Vent Cover

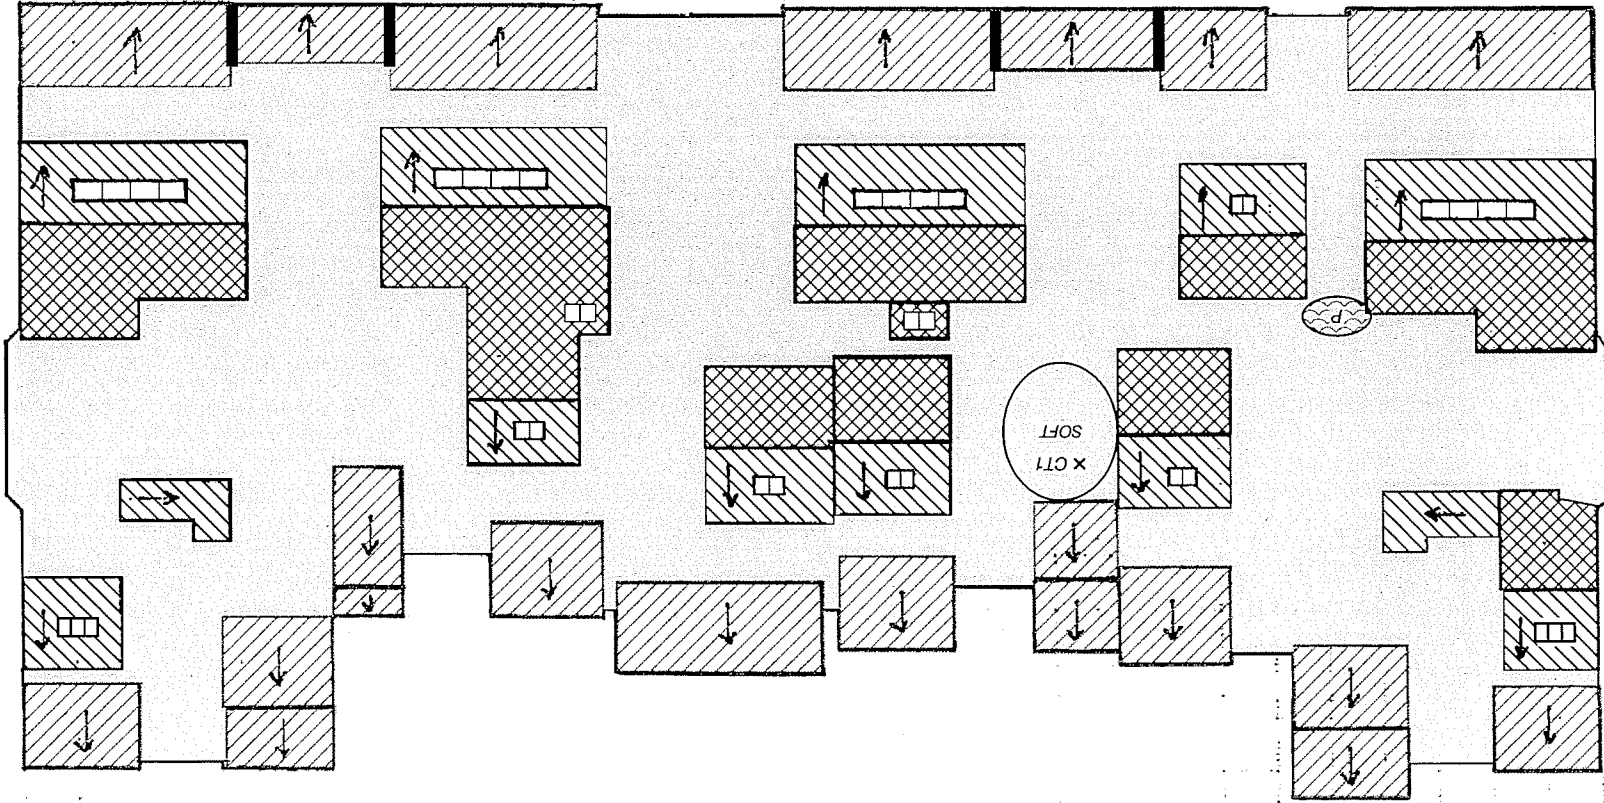
Drawing No. 1

At two locations on the south elevation, the low sloped roof sections tie in to adjacent balconies (refer to Photo 18 and Drawing No. 1). The new roof membrane would have to tie in to these balconies in order to provide a continuous waterproof layer. These balconies are currently waterproofed with a fiberglass membrane, which appears to be brittle and past its serviceable life. This would make it challenging to transition the two membranes.
