Inch By Inch Inspections Home Inspection Report

1681 Medallion Court, Mississauga, Ontario

Date of Inspection: 5/11/2023 Time: 2:00pm

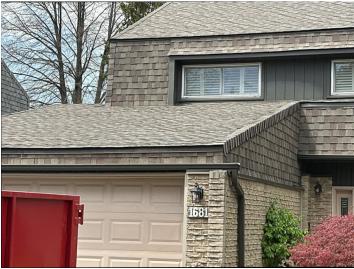
()Shingles are in good condition in visible areas only at time of inspection unless noted. Continue a yearly checkup and regular maintenance to prolong the life of the roof.

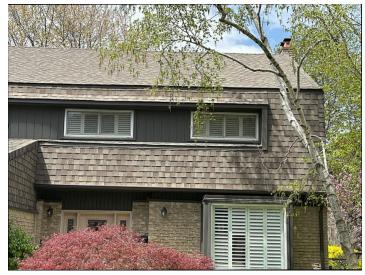
()Good at time of inspection only in visible areas only.

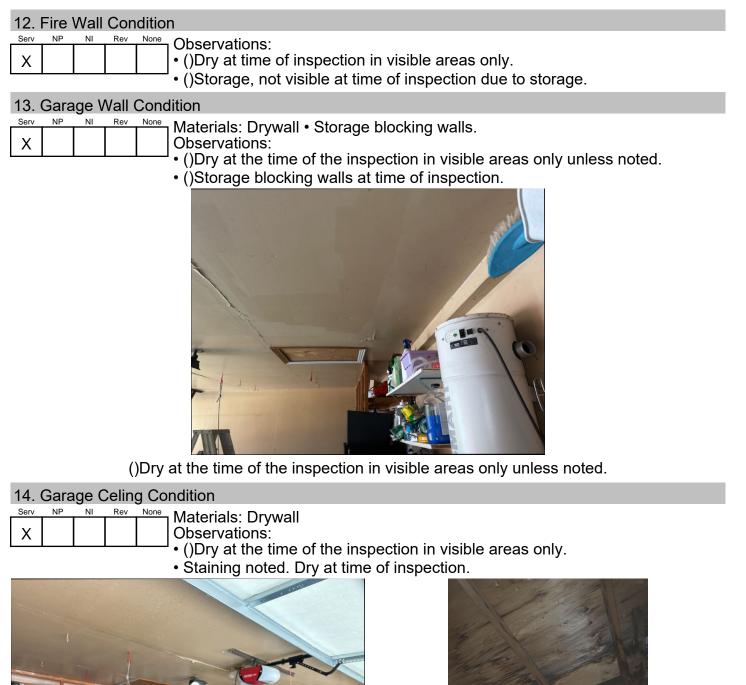
()Dry at the time of the inspection in visible areas only.

Staining noted. Dry at time of inspection.

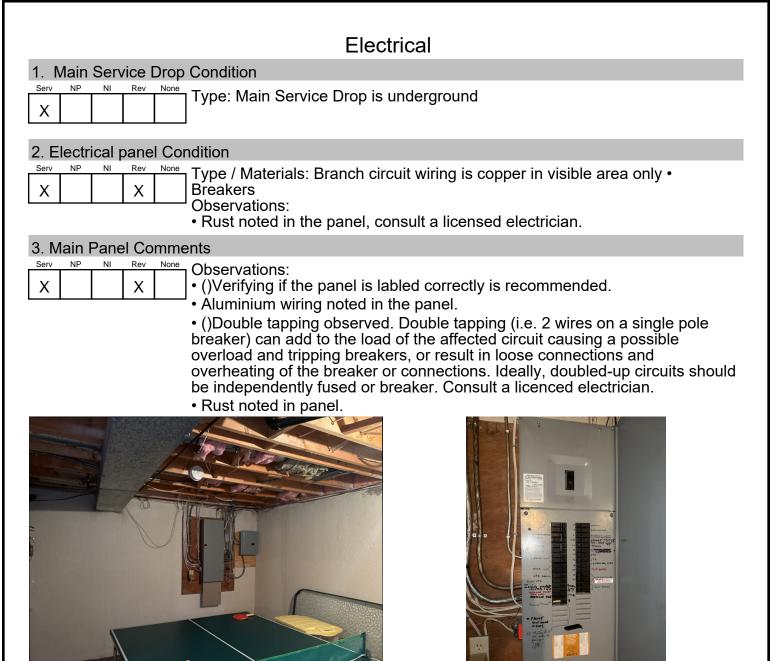
Panel

()Verifying if the panel is labled correctly is recommended.

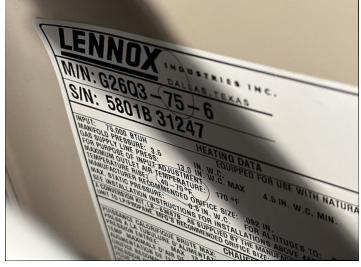
()Annual preventive maintenance is recommended.

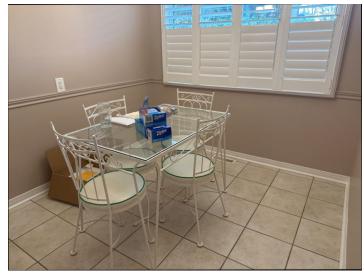
()Dry at the time of the inspection unless noted.

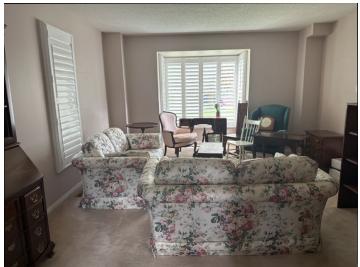
()Dry at the time of the inspection unless noted.

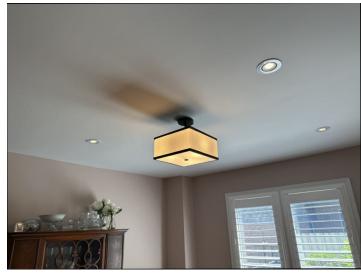
()Dry at the time of the inspection in visible areas ()Dry at the time of the inspection in visible areas only unless noted.

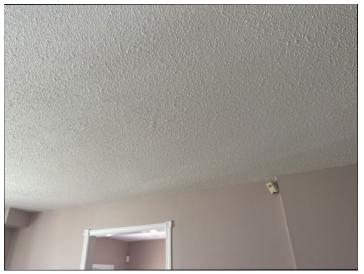
()Dry at the time of the inspection in visible areas ()Dry at the time of the inspection in visible areas only unless noted.

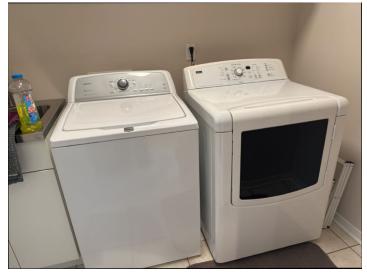
()Washer and Dryer
