## Home Inspection Report

2847 Wyndeatt Avenue  
Victoria, BC V9A 2L7

Date of Inspection: 06/17/2020

Inspection No. 1013-2-417

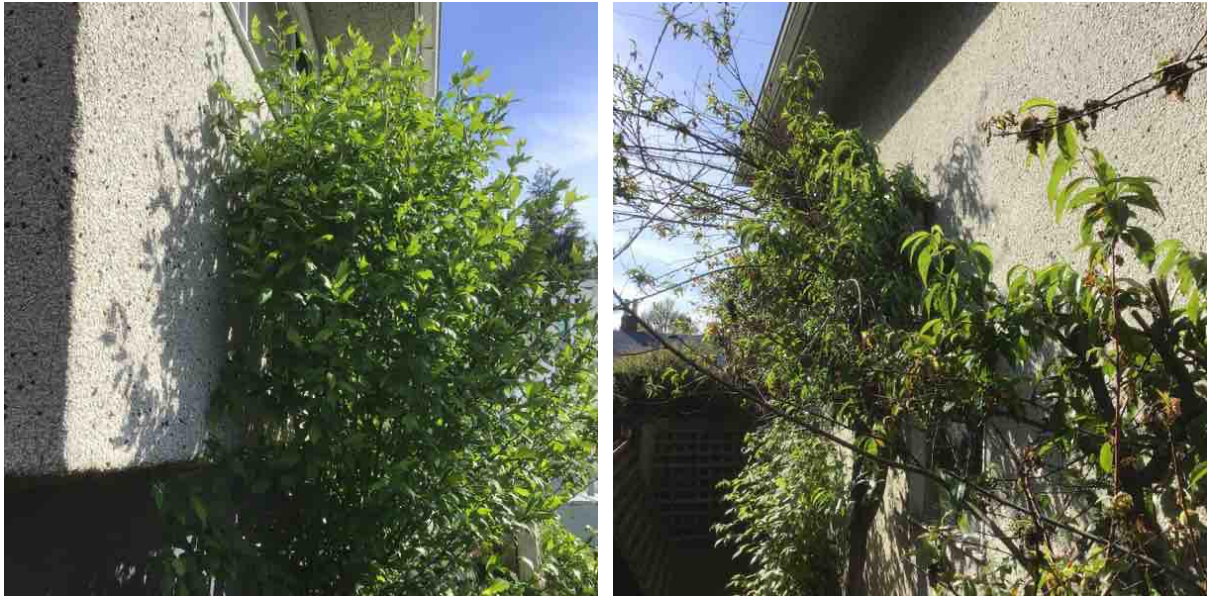
2.1.1 Prune vegetation a minimum of 12" away from exterior wall finish to help prevent premature deterioration and insect activity.

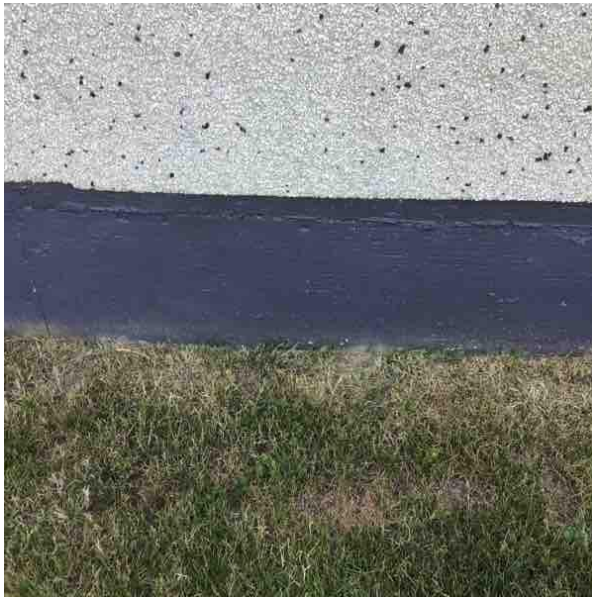
3.3.1 Inspected minor concrete cracks. This is normal for concrete. Minor movement can occur at these cracks. We recommend a good quality sealant be applied to prevent seepage.

3.3.2 The foundations are in typical condition relative to the age of the building.

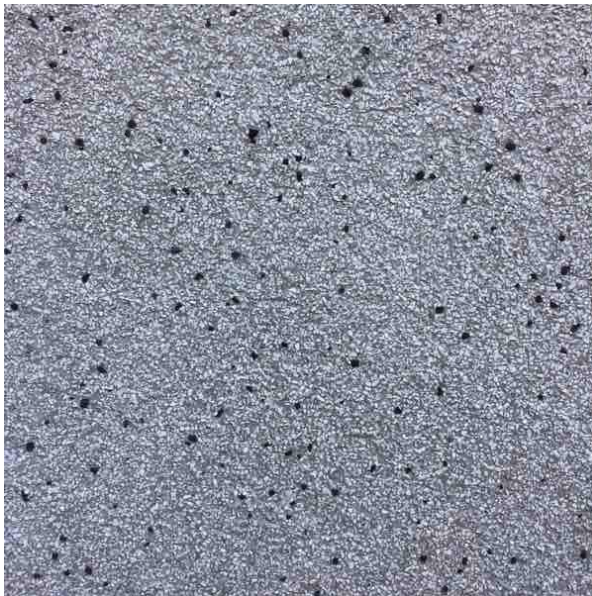
3.4.1 Stucco is in good condition. Minor cosmetic shrinkage cracks are inherently common and normally do not pose a concern.

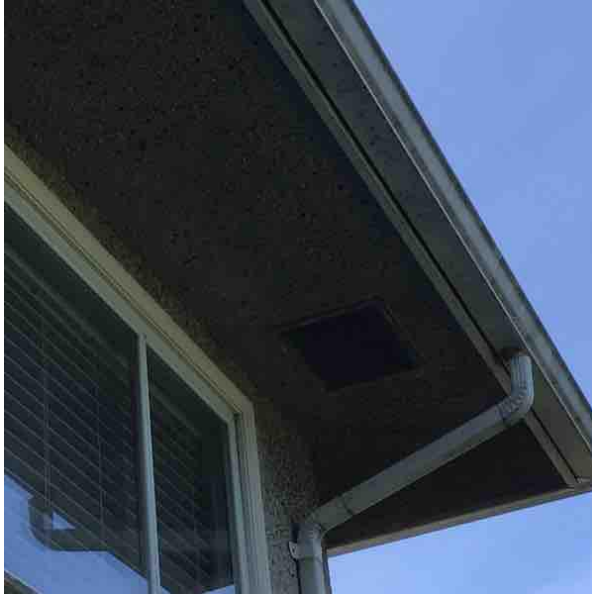
3.5.1 Stucco soffits appear in acceptable condition. Minor cracks are common and should be monitored. Secure or repair loose areas as they occur.

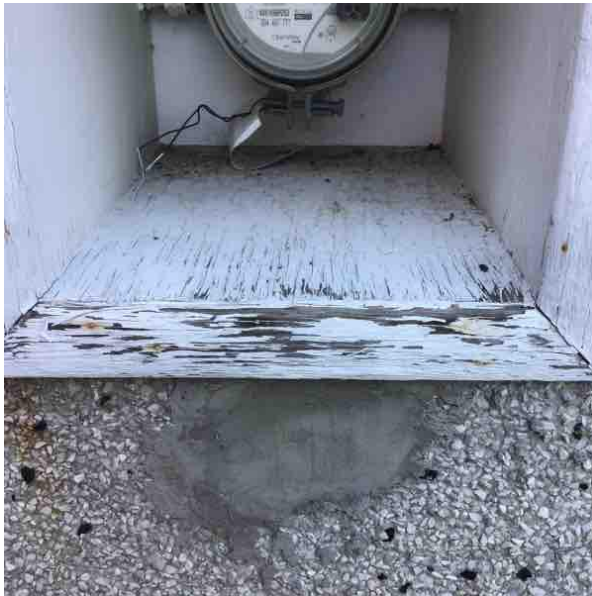
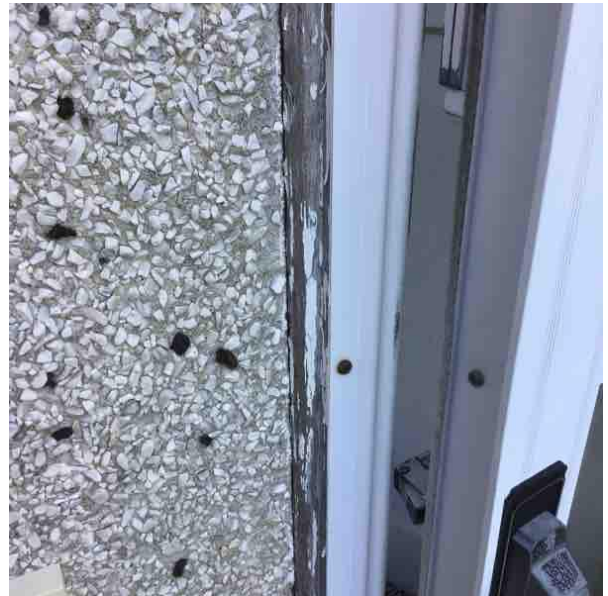
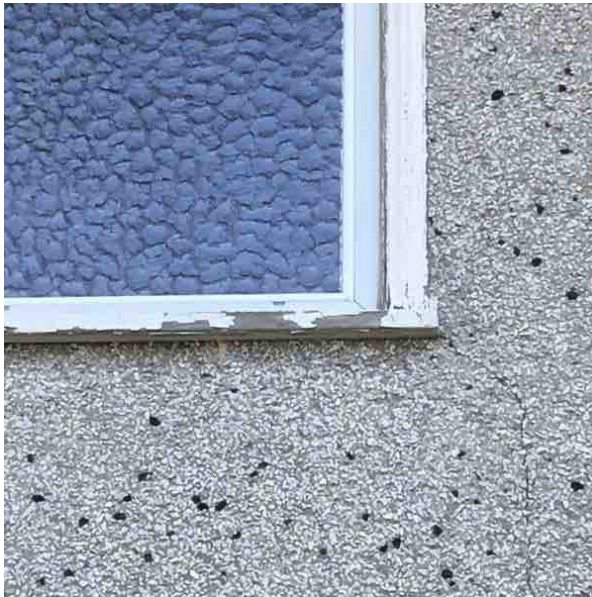
3.6.1 Exterior wood components should be kept in good condition to prevent deterioration. If bare wood is visible at any time through the coating, it is time to conduct maintenance. **(Throughout)**

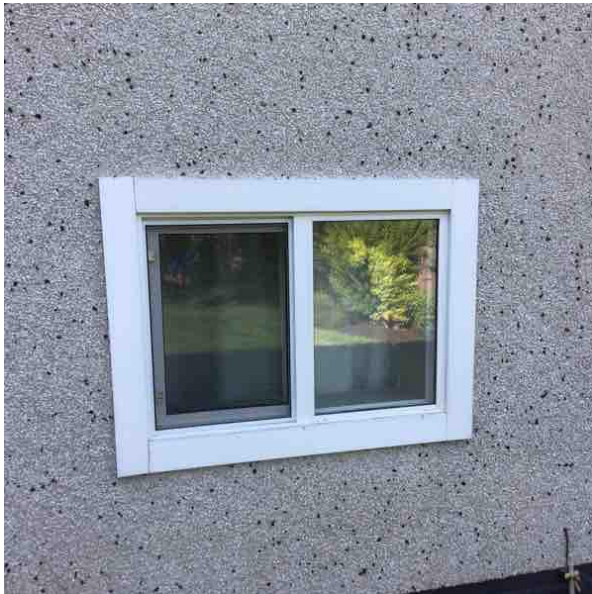
3.7.1 Inspected newer thermal windows in some/all areas, this is a nice upgrade feature.

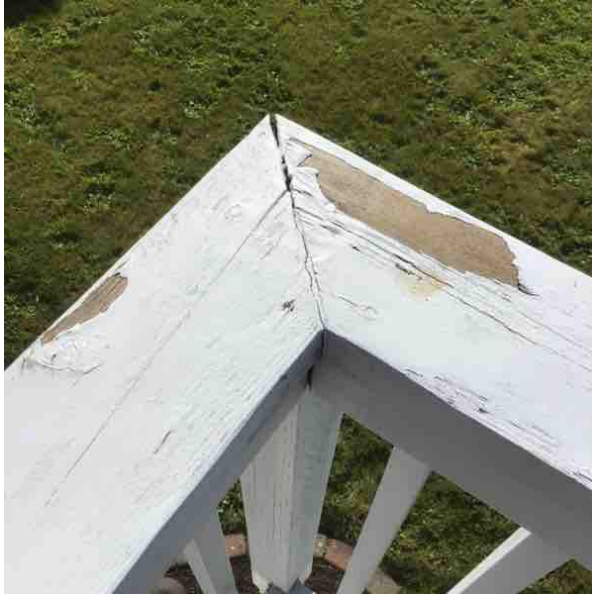
3.9.1 Railing would benefit from a fresh coat of paint/stain.

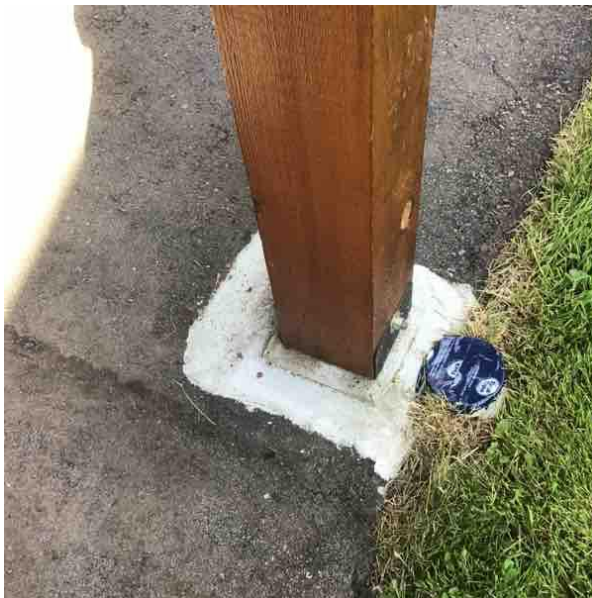
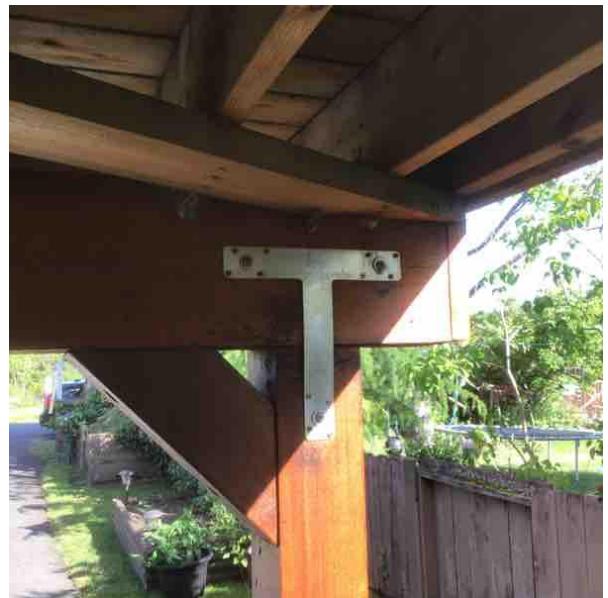
3.10.1 The deck structure is in good condition and appears to have good building practices in place.

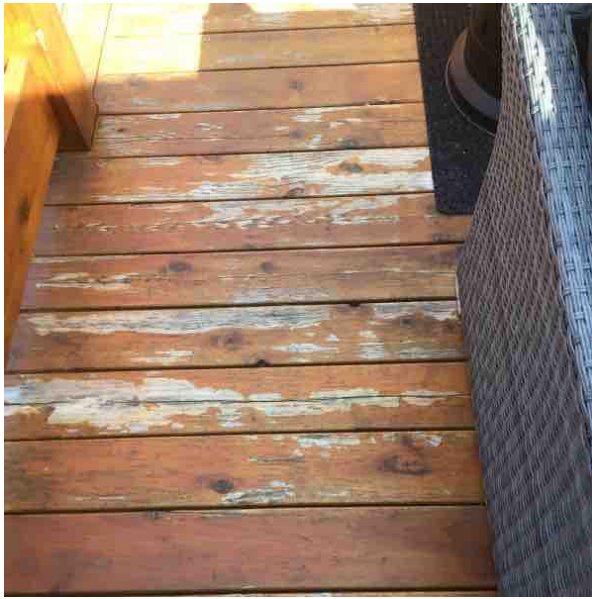
3.10.2 The decks would benefit from a fresh coat of paint/stain.

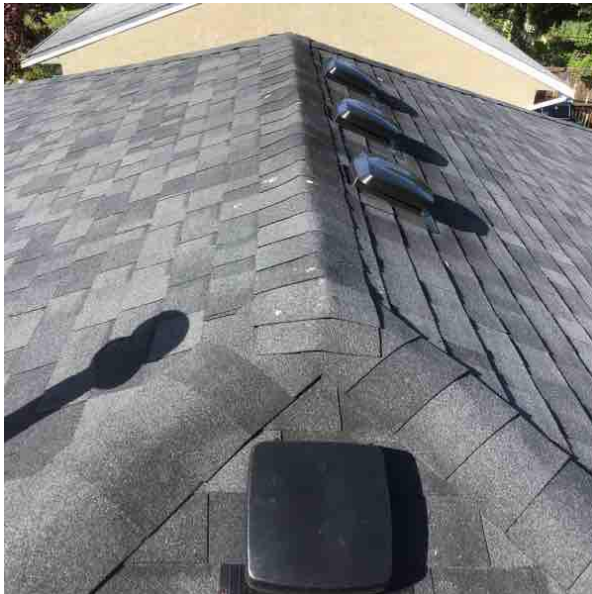
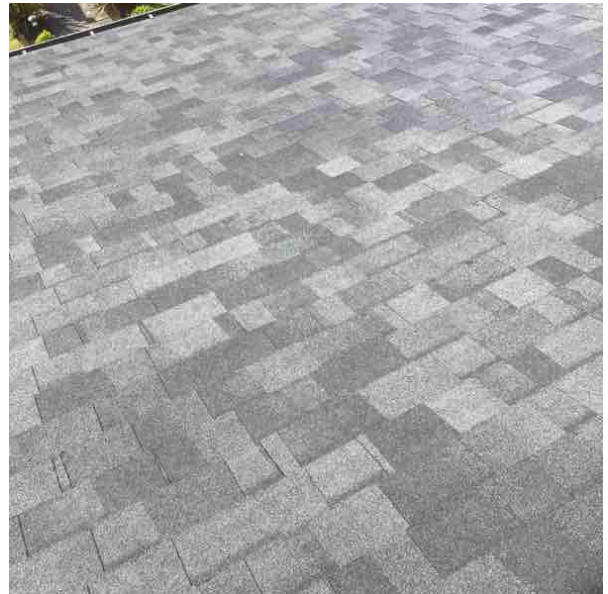
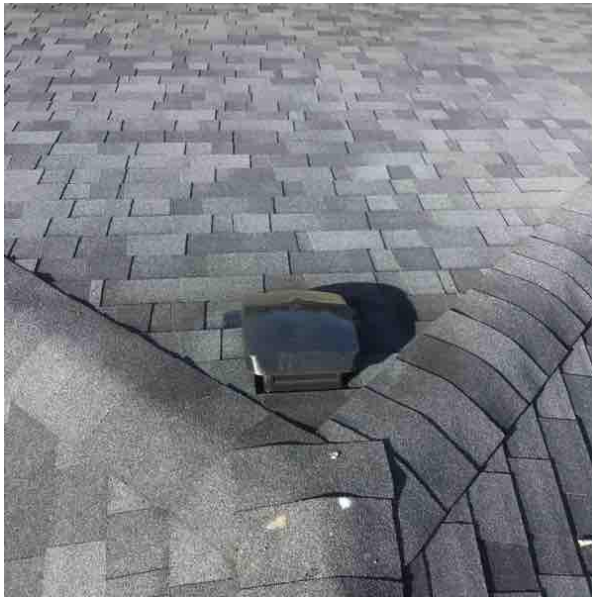
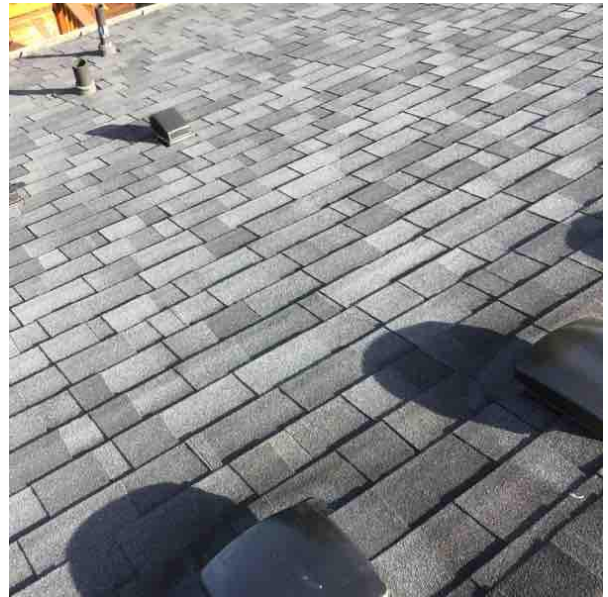
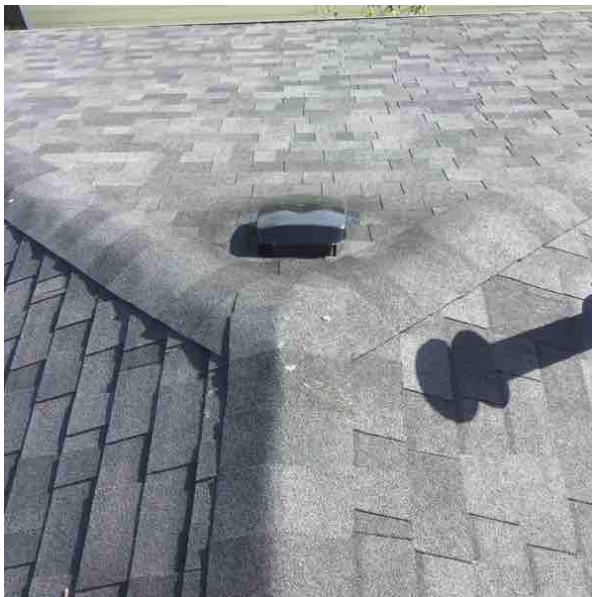
4.1.3 Roofing system is in good condition and appears to be standing up well. We advise routine inspections so maintenance can be identified.

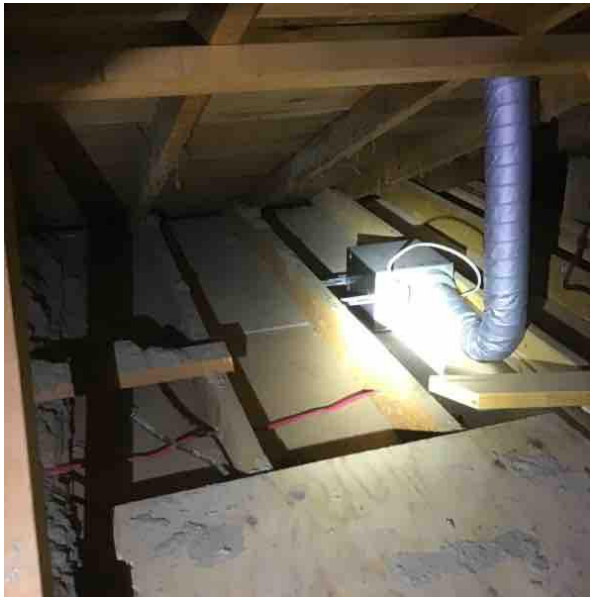
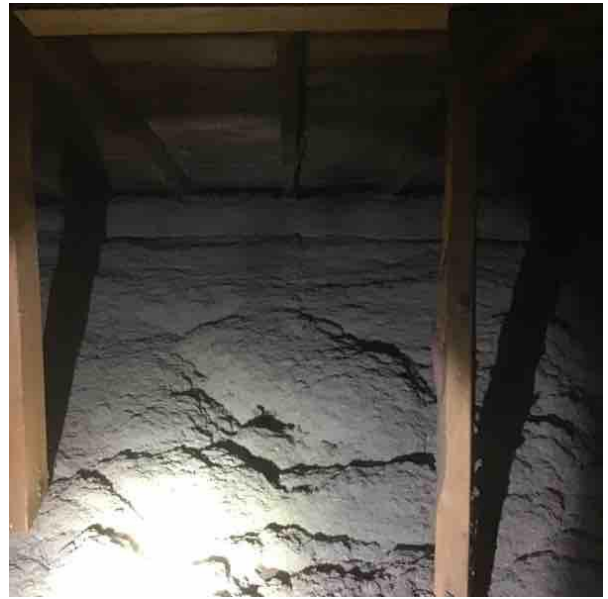
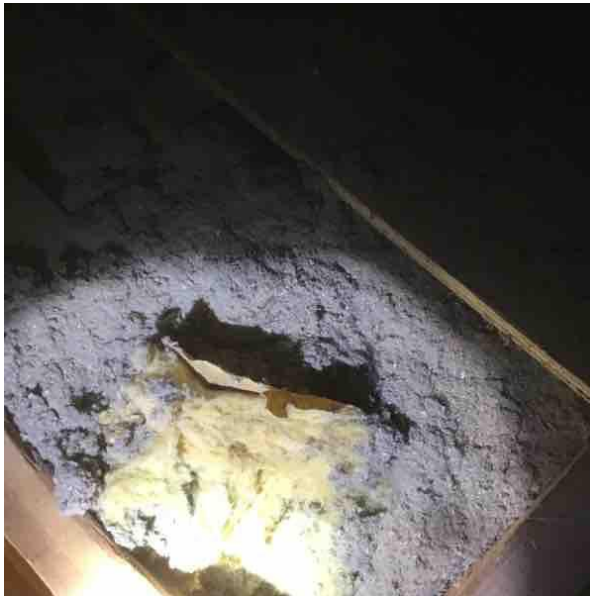
5.3.1 Home heating costs and interior comfort would benefit from increasing insulation levels to the current standard. Consult an insulation specialist for options and costs.

## 5.3.2 Approximate depth: 0-6"

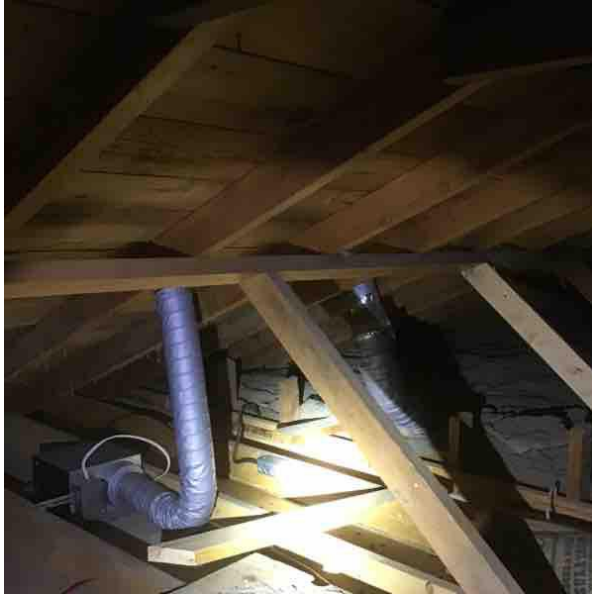
5.6.1 Ducting requires insulation when passing through an unheated space to reduce condensation build up and drips. Pre-manufactured insulated ducting works well. Repairs are recommended.

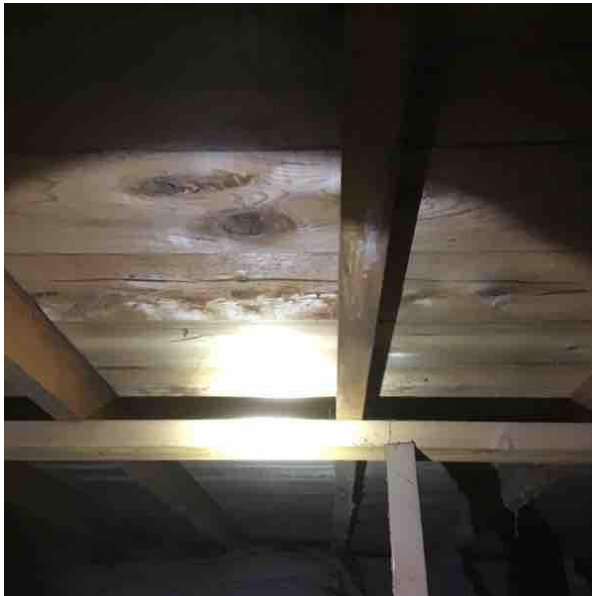
5.7.1 Attic sheathing is in good condition, no visible signs of organic growth. Attics should be checked routinely during winter months for leaks and moisture. This is the best way to spot early maintenance needs.

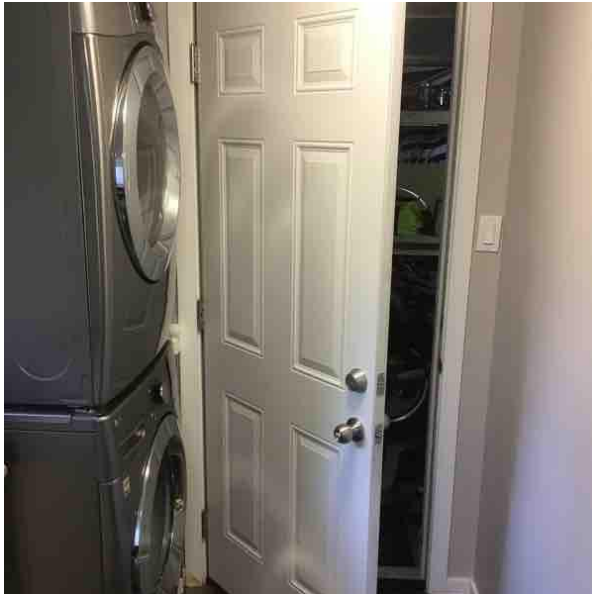
6.2.1 Adjust, install or replace door hardware to ensure integrity of fire and gas separation between garage and home.

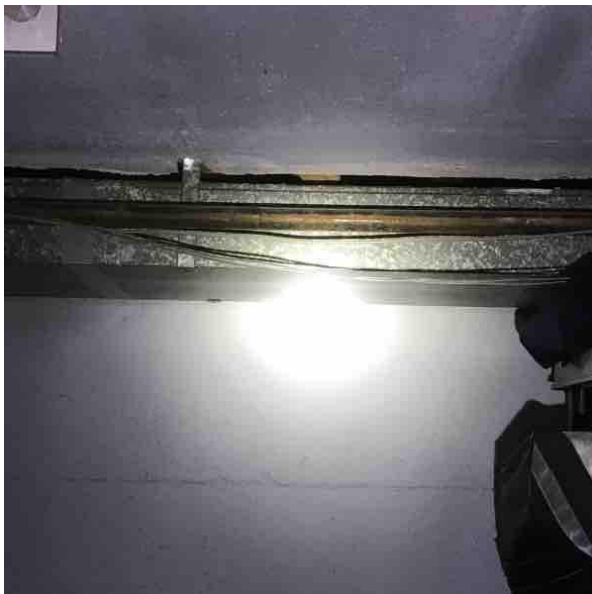
6.7.1 Missing or nonstandard fire barrier between garage and living area. This condition poses increased risk to occupant safety if parking a vehicle in the garage. Budget for repairs.

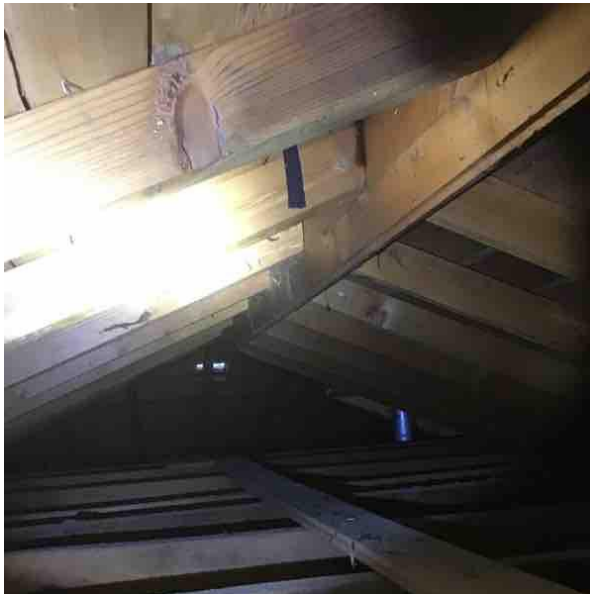
7.6.1 Roof framing appears in good condition, no visible signs of substantial structural movement.

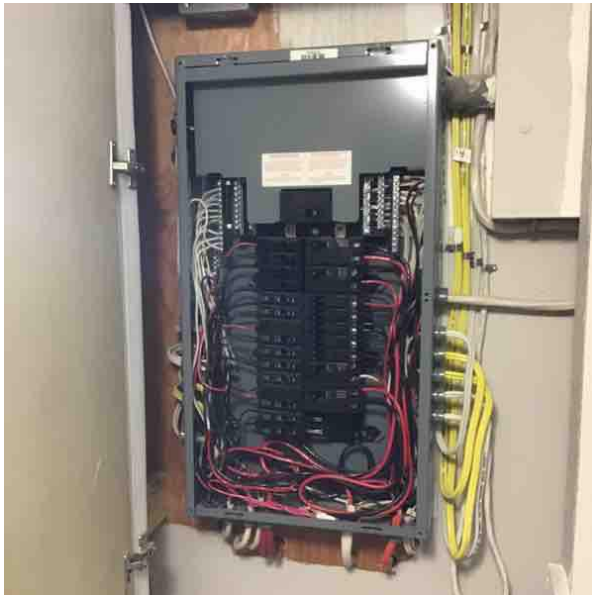
8.6.1 Branch circuits appear compatible with disconnect ratings.

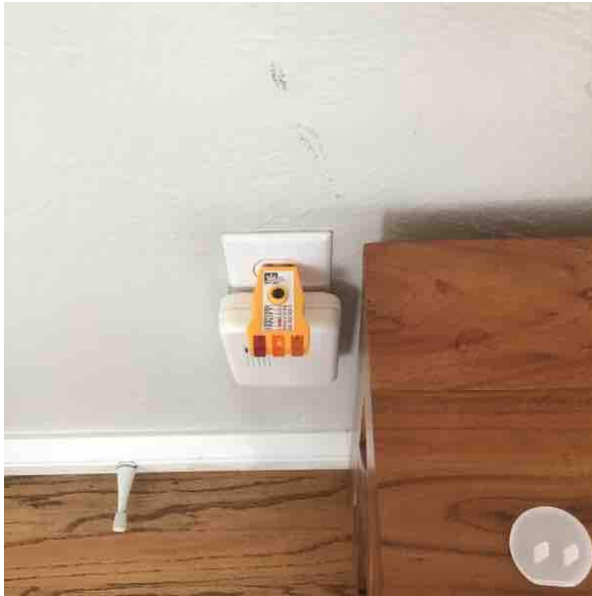
8.8.1 Original ungrounded wiring is still in use in some areas of the home. This is typical for homes of this age. Most of the wiring has been updated. Budget for wiring upgrades during any planned renovations or if problems develop with the old circuits.

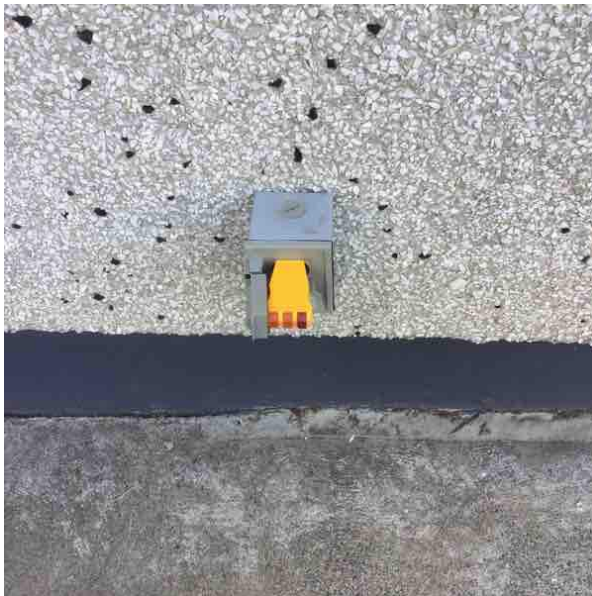
8.9.1 Exterior receptacles are safer when GFCI protected, recommend installing missing GFCI for added safety.

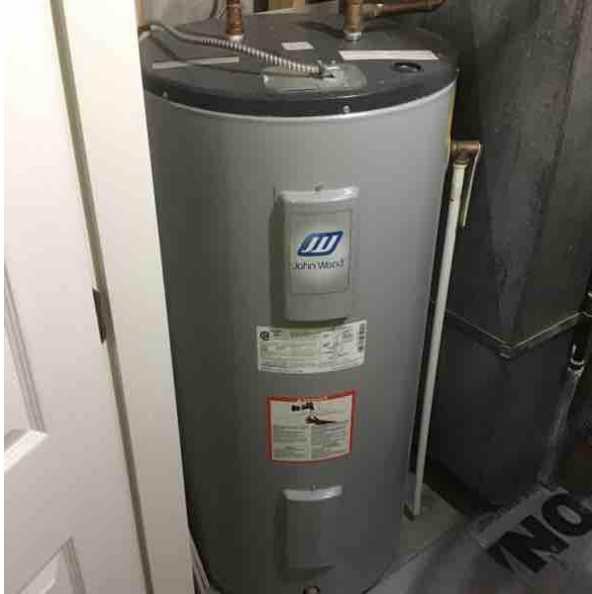
10.6.1 The water heater is at the end/has exceeded it's typical life expectancy and may fail at any time. Budget for replacement by a licensed plumber.

10.6.2 Strapping/anchoring water heater is recommended to resist seismic movement.

10.6.4 A 150-180L water heater is under sized for a home with additional living accommodations and the warranty may be void, a 270-280L water heater is better suited for this home. Monitor this water heater for early failure.

10.6.5 The manufacturers date on this water heater is 2013.

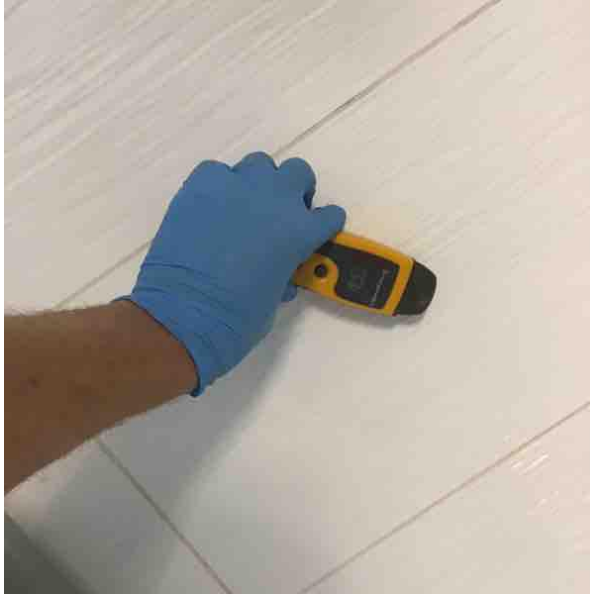
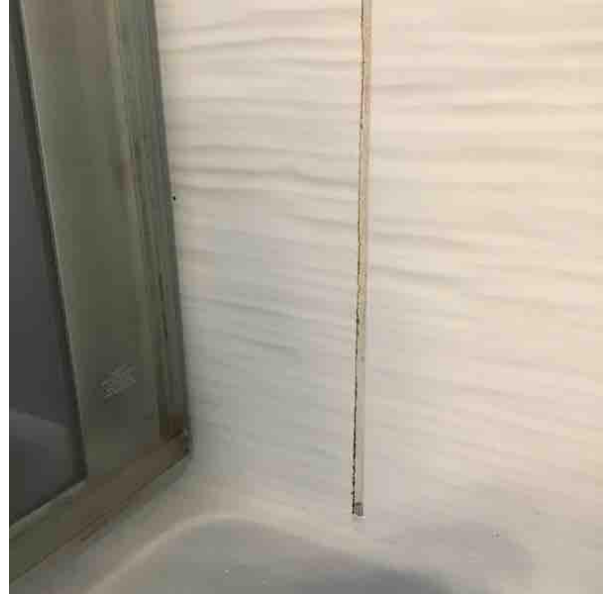
10.8.1 Grout or sealant is worn, missing or damaged and should be repaired to prevent moisture ingress.

10.8.2 We detected excess dampness behind the wall finish indicating possible trapped moisture. This condition may cause concealed damage. Conduct further review as required, budget accordingly for repairs. (Main Bathroom)

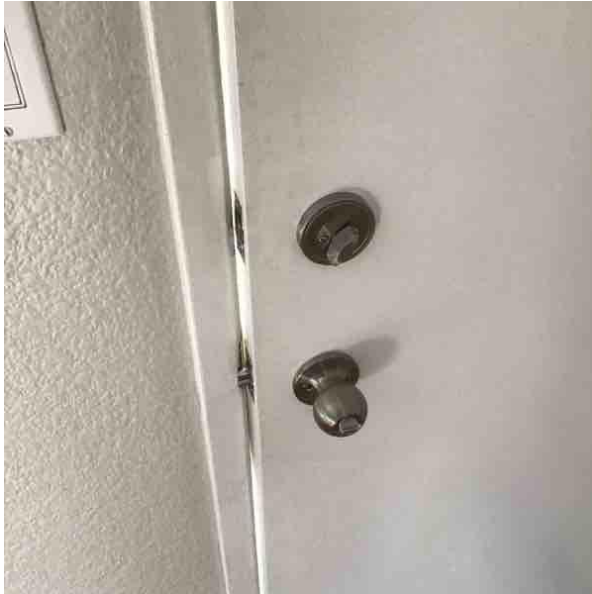
11.7.1 Door/hardware requires adjustment and maintenance to perform properly. (Foyer)

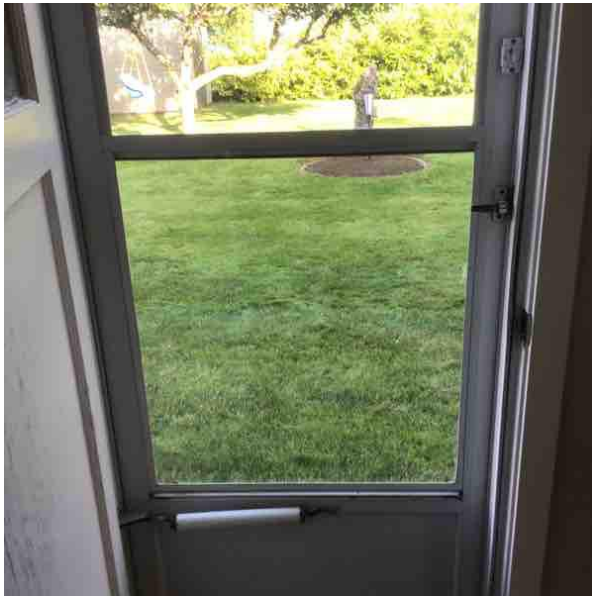
11.7.2 The storm door requires adjusting to work without rubbing/binding. (Rear Entry )
