Property Information Search

Limited Hazardous Materials
Survey Report
2771 Murray Dr., Victoria, BC

Reference: Limited Hazardous Materials Survey of 2771 Murray Dr., Victoria, BC

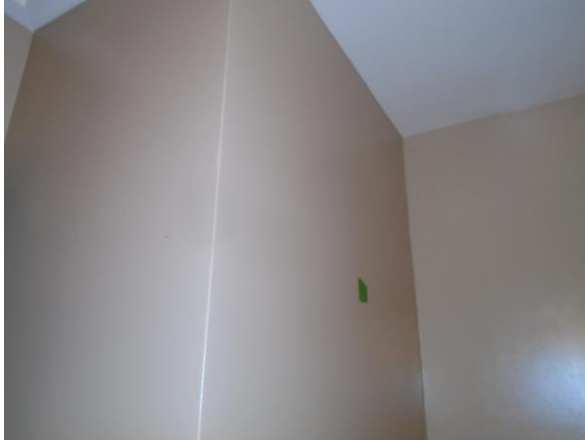
Photo 1: Smooth Plaster [2 layers] – Bathroom Wall (none detected)

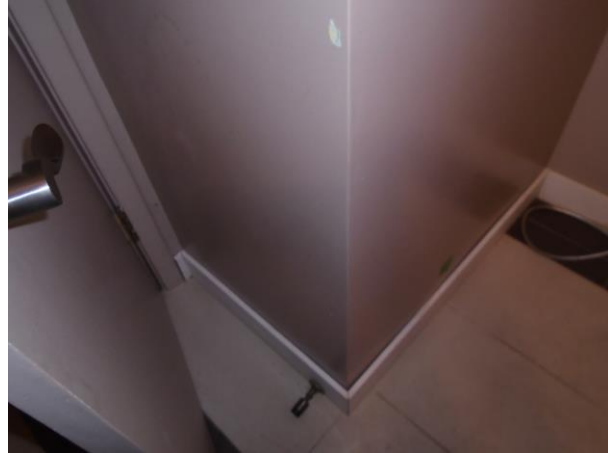
Photo 2: Smooth Plaster [2 layers] – Bathroom Wall (ND)

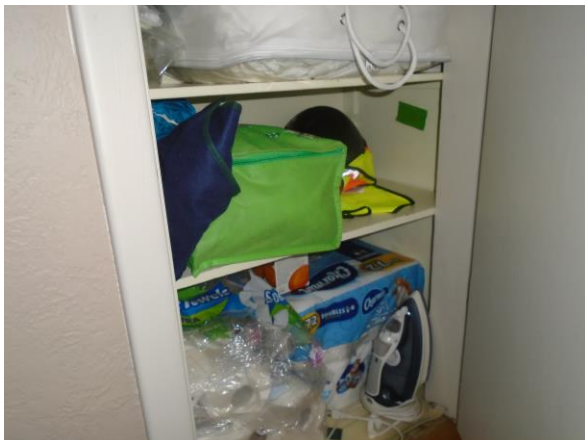
Photo 3: Smooth Plaster [2 layers] – Hallway Closet (ND)
