DEPRECIATION REPORT OF:  
1536 HILLSIDE AVENUE  
STRATA PLAN VIS2630  
VICTORIA, BRITISH COLUMBIA

JUNE 2018

Prepared for:  
The Owners of Strata Plan VIS2630  
c/o: The Strata Council for Strata Plan VIS2630  
1536 Hillside Avenue, Victoria, B.C.  
File # DP070H

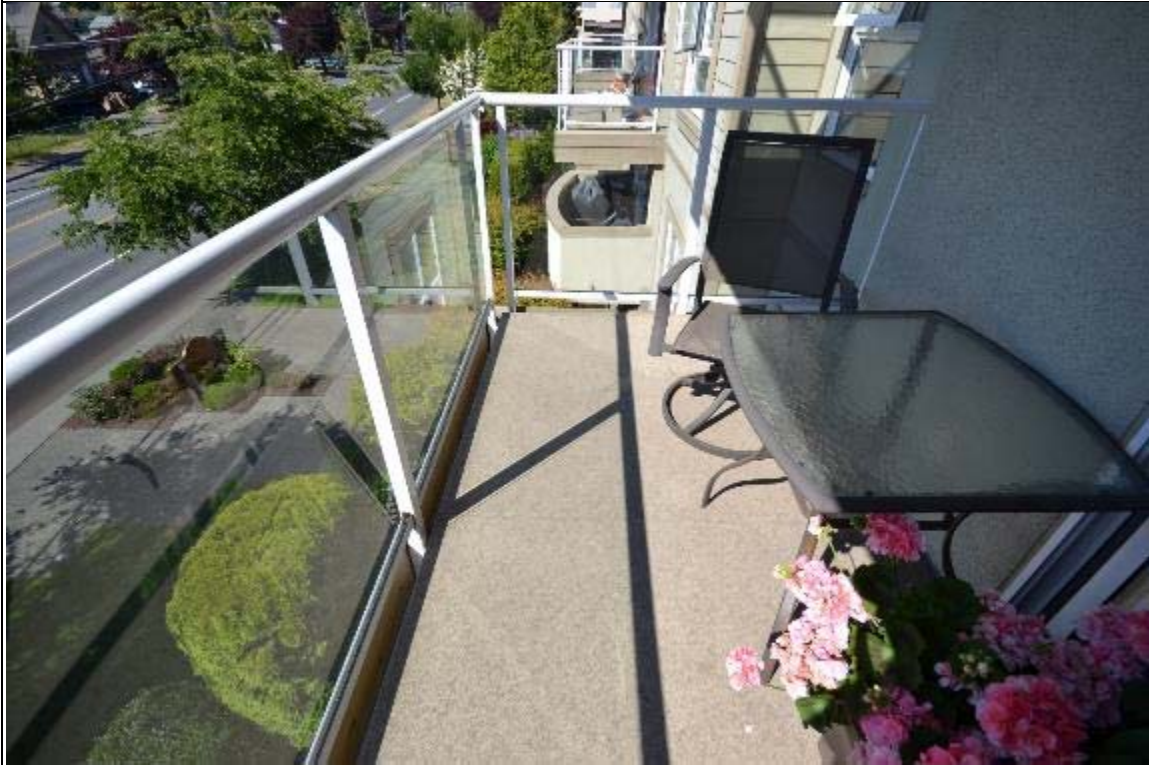
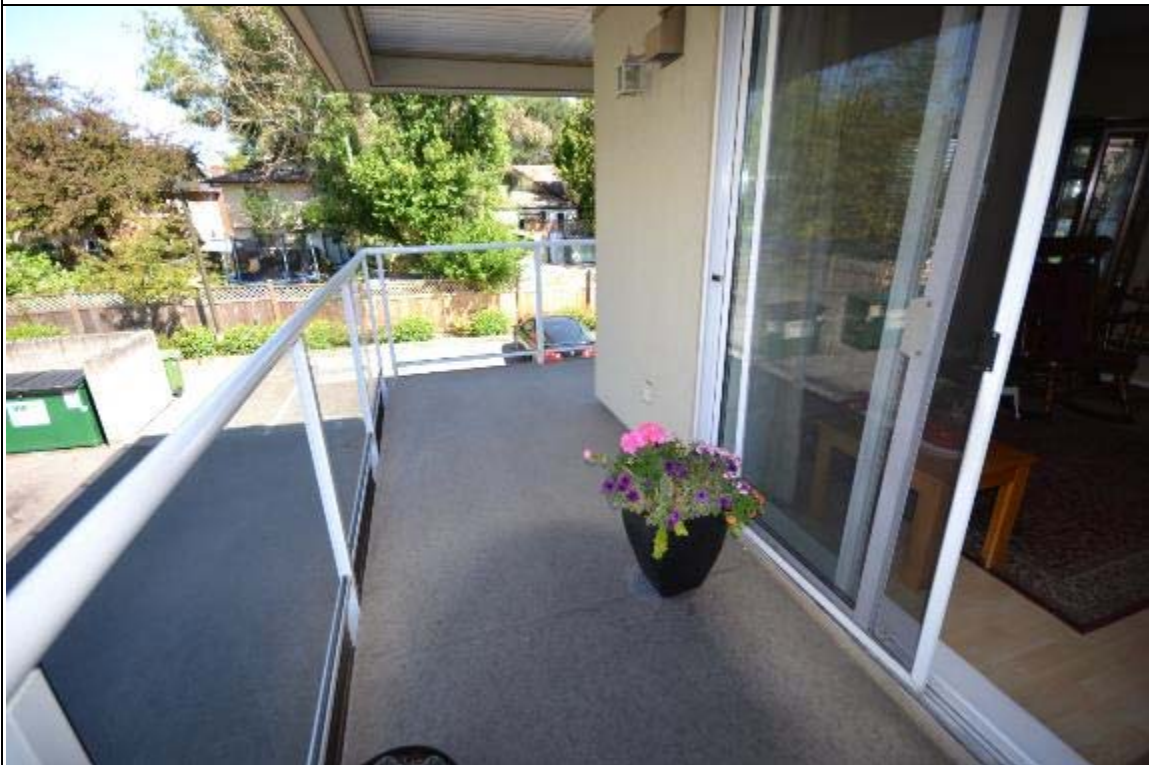
**Reserve Component: (2) Balconies (Membranes)**

View of Typical Balcony Membrane

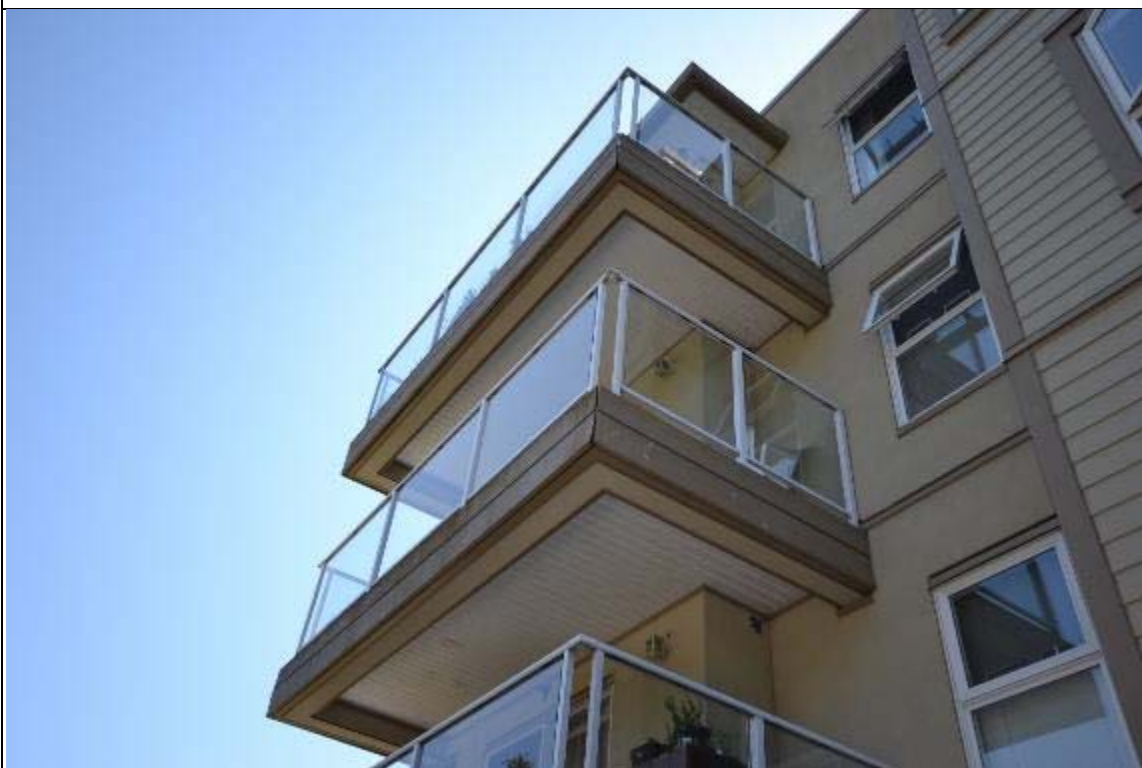
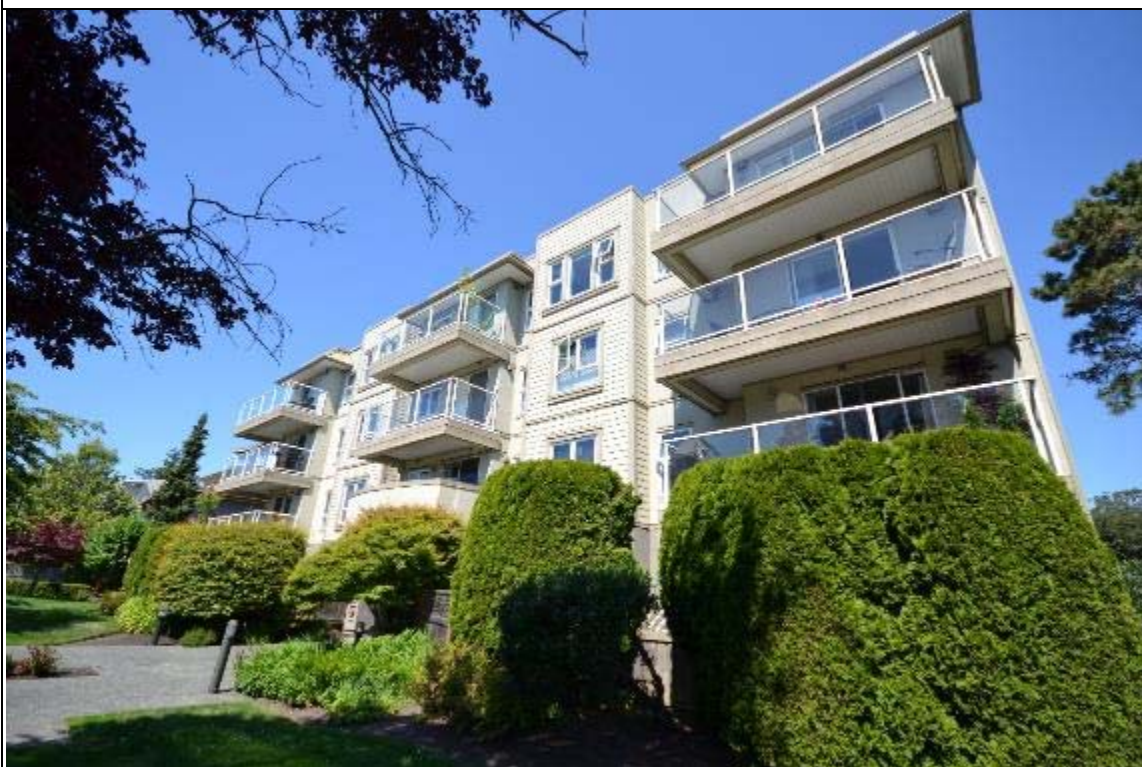
**Reserve Component: (3) Balconies (Structural)**

<b>Reserve Component: (3) Balconies (Structural)</b>									
<b>Component Description</b>	There are 21 cantilevered balconies distributed across the building. These wood framed structures have side mounted glass/aluminum railings, vinyl waterproof membranes, aluminum soffits and double fascia trim. This component reserves for structural repairs to the balconies at the end of their effective lifespan.								
<b>Financial Analysis / Repair History</b>	The original pony walls and guardrails were replaced in conjunction with the building remediation in 2008. Estimated cost of the guardrails in 2008 was \$43,000. There have been a couple of cases where a glass pane has shattered, however this has likely been due to impact rather than deterioration of the guardrails.								
<b>Potential Deterioration</b>	Like any wood frame structure, balconies will deteriorate over time and require repairs and eventual replacement. Deterioration is affected by factors such as exposure to the elements, water ingress, quality of original construction, and wear and tear. Guardrails may require re-painting or repair/replacement and glass is susceptible to impact damage.

View of Balconies

View of Typical Balcony Structures

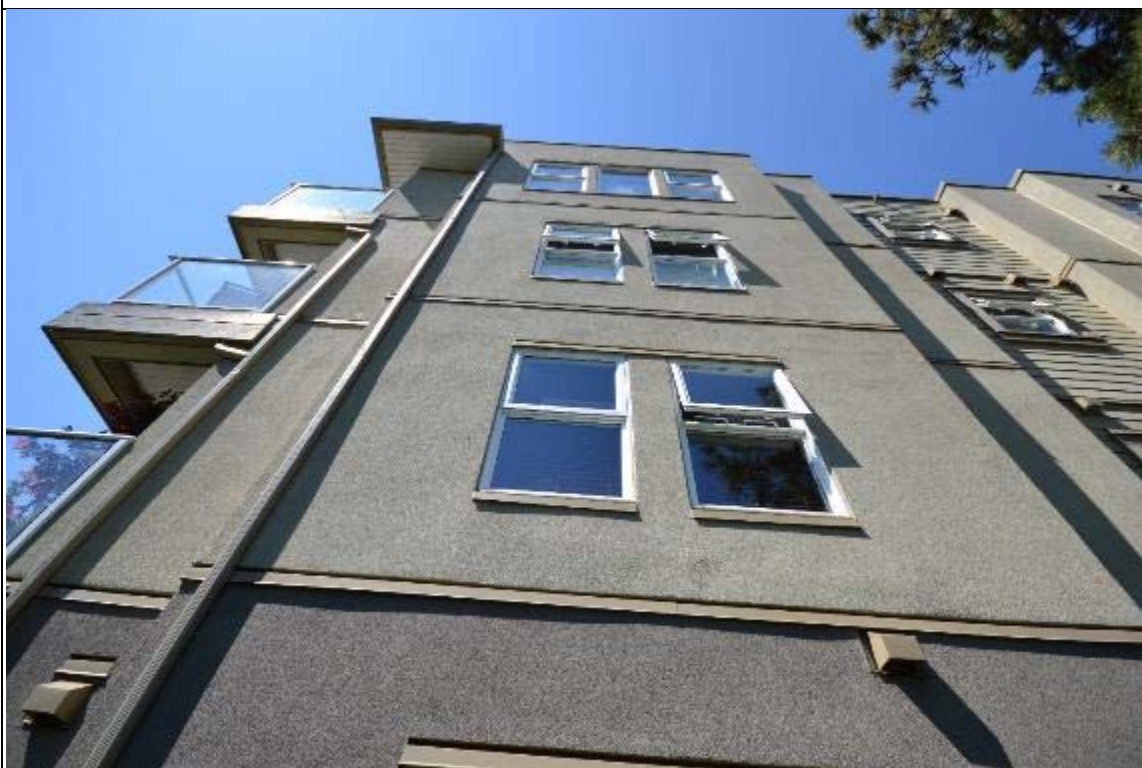
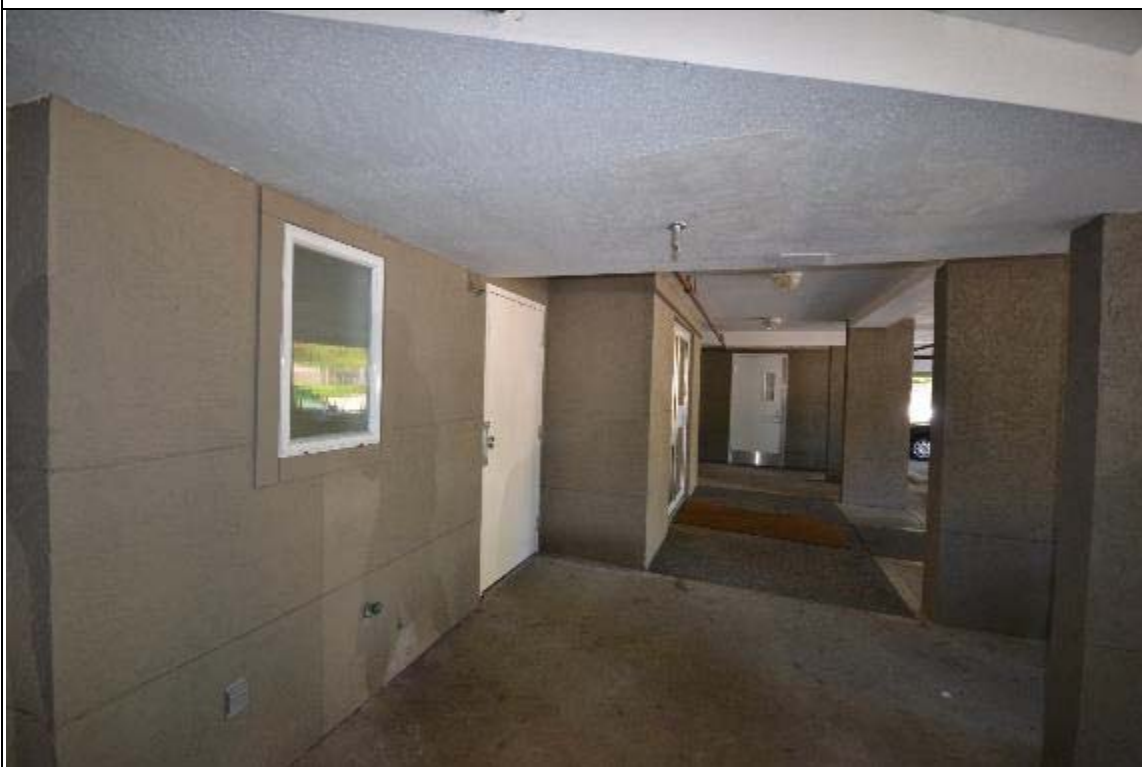
**Reserve Component: (4) Exterior Wall Cladding – Stucco**

<b>Reserve Component: (4) Exterior Wall Cladding – Stucco</b>									
<b>Component Description</b>	The majority of the building exterior is clad with acrylic stucco cladding on a strapped cavity rainscreen system. This consists of an acrylic colour coat over 2 base coats, over backing board on strapping. The strapping creates an airspace between the cladding and the sheathing enabling moisture to dissipate rather than enter the structure. A portion of the building envelope at the northern side of the ground floor is still the original cementitious stucco.								
<b>Financial Analysis / Repair History</b>	The building envelope was remediated in 2008 by RDH Building Engineering. The replacement cost of the original stucco was estimated at \$510,000 in 2008. This accounted for approximately 40% of the total \$1,265,000 remediation budget.								
<b>Potential Deterioration</b>	Stucco can crack, crumble, bulge or break loose due to weather exposure such as water and wind, building settlement, improper installation, impact damage, mold / algae and missing drip screens. UV light may deteriorate the durability and function of the stucco.

View of Rain Screen Stucco

View of Original Stucco

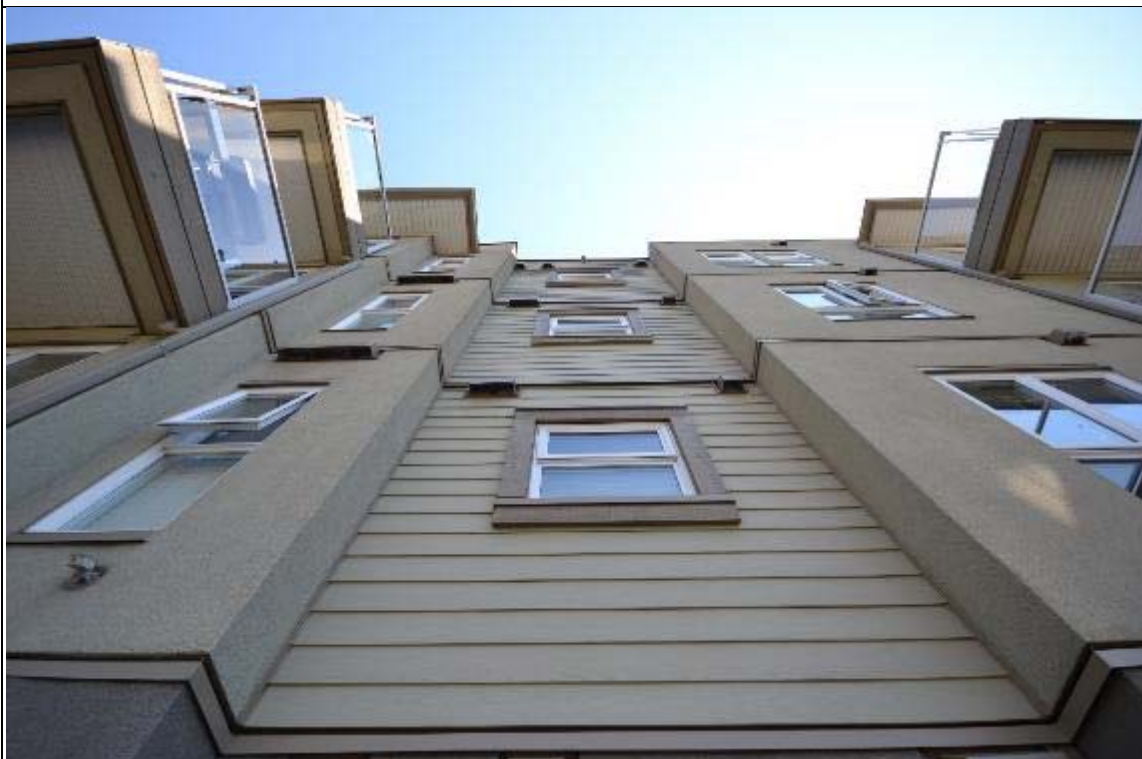
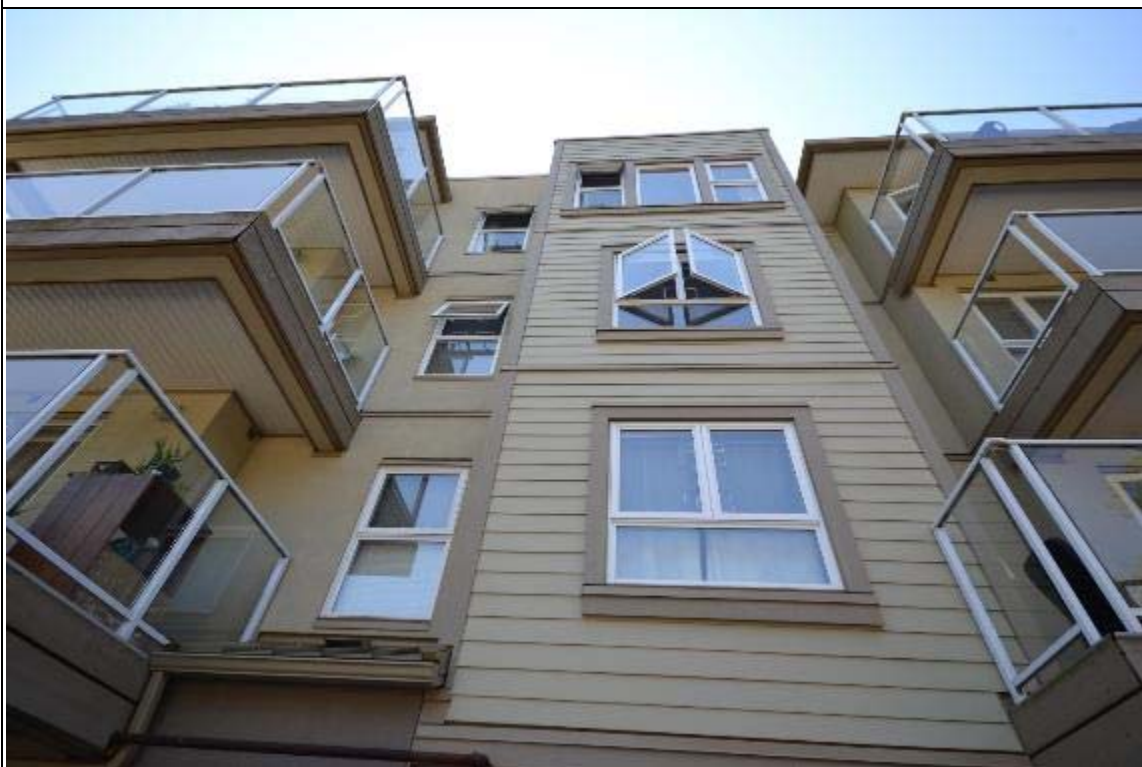
**Reserve Component: (5) Exterior Wall Cladding - Fibre Cement**

<b>Reserve Component: (5) Exterior Wall Cladding - Fibre Cement</b>		
<b>Component Description</b>	There is approximately 2,300 sq.ft. of horizontal fibre cement cladding on the building exterior. Similar to the stucco, the fibre cement is installed over a strapped cavity rainscreen system. This component will reserve for an allowance for repairs and partial replacement of the fibre cement siding as required.	
<b>Financial Analysis / Repair History</b>	The original horizontal wood siding was replaced with fibre cement siding as part of the 2008 remediation. There are no records of any major capital expenditures relating to the fibre cement siding.	
<b>Potential Deterioration</b>	Fibre cement is considered to be a durable cladding which is projected to last 50-100 years. However, if installed improperly it can crack. Fibre cement siding also requires paint to prevent water penetration.	
<b>Condition Analysis</b>	The fibre cement appeared to be in good condition as of the date of inspection. No signs of premature deterioration were noted.

View of Fibre Cement Siding

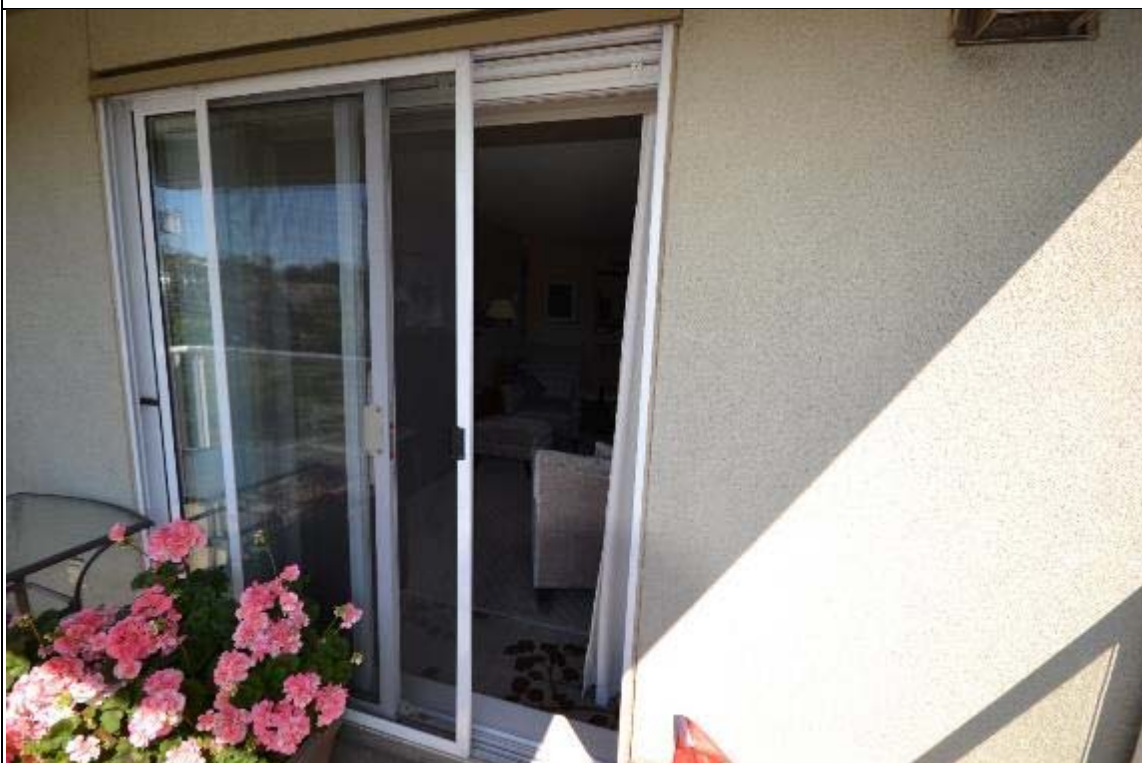
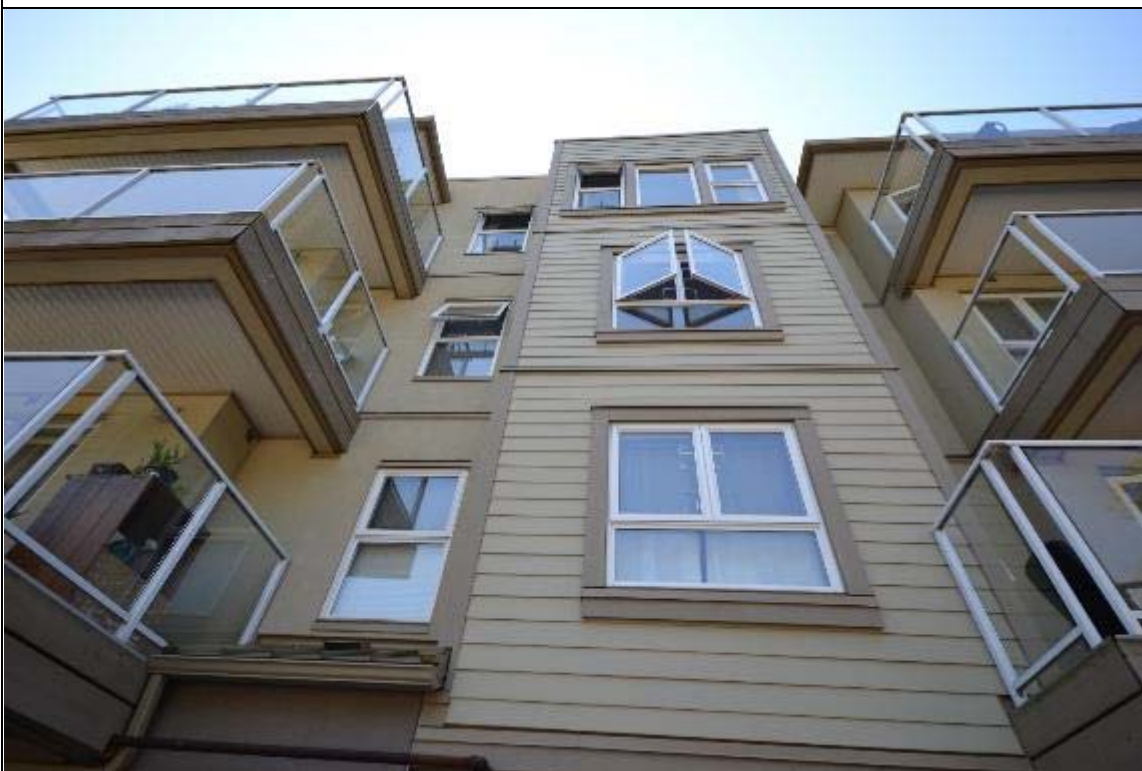
**Reserve Component: (6) Window Assemblies (7) Sliding Door Assemblies**

<b>Reserve Component: (6) Window Assemblies (7) Sliding Door Assemblies</b>		
<b>Component Description</b>	<p>Windows in the Subject development consist of glazed thermal units within vinyl frames. The opening mechanisms are a mixture of sliders, awning top or casement. Sliding glass doors are also vinyl framed thermal units.</p> <p>These components will reserve for the replacement of the window and sliding glass door assemblies at the end of their effective lifespans.</p>	
<b>Financial Analysis / Repair History</b>	Both the windows and sliding glass doors were replaced as part of the envelope remediation project.	
<b>Potential Deterioration</b>	<p>This includes various potential problems, such as: Seal breakage in double pane windows, discolouration, staining and cracking of frames, reduced performance of sliders, and cracked and broken glass caused by impact.</p> <p>Over time the sliders and rollers on the sliding glass doors will deteriorate, requiring replacement. Additionally, weather stripping will deteriorate and require replacement to maintain heat efficiency. These assemblies are also affected by the same deterioration associated with window assemblies as noted above.</p>

Typical Sliding Glass Door

View of Typical Window Assemblies

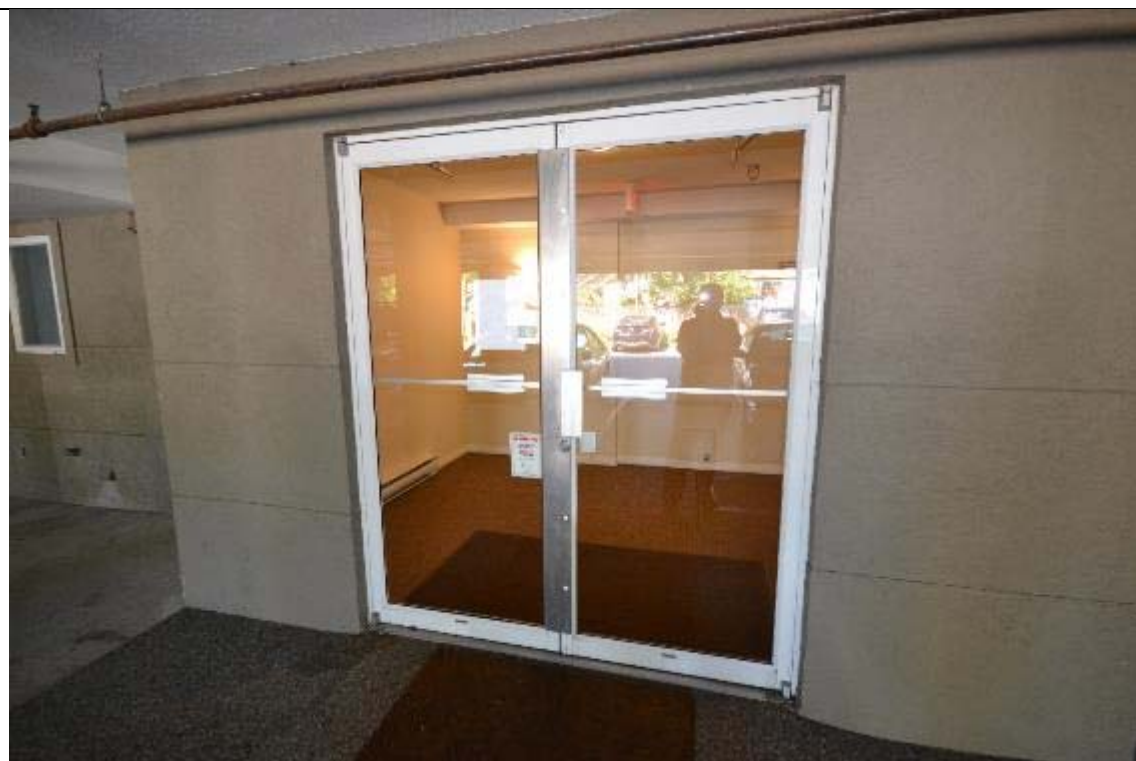
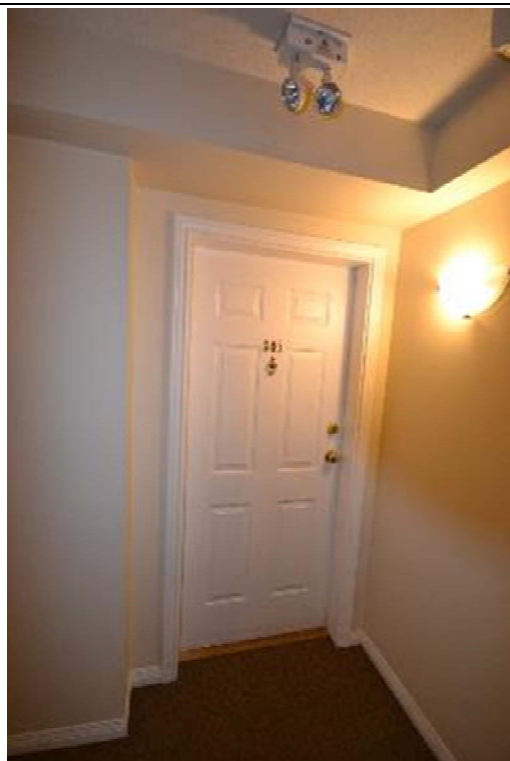
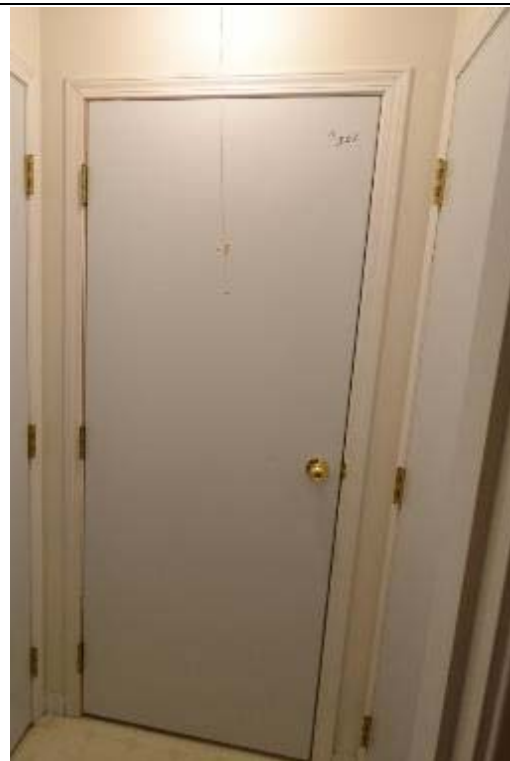
**Reserve Component: (8) Door Assemblies**

<b>Reserve Component: (8) Door Assemblies</b>													
<b>Component Description</b>	Door assemblies consist of suite entry doors, stairwell doors, common area doors, exterior service doors, and the main and rear building entrance doors. Doors range from fire rated swing doors to pressed metal service doors and glazed storefront type doors. This component will consider a periodic allowance for door repairs or replacements, including the frames, hardware, closers and mechanical elements such as electrical strike as required.												
<b>Financial Analysis / Repair History</b>	The suite doors were repainted in 2013 at the time of hallway painting. No other records of major door repair or replacement have been reported. The stairwell and service door handles were changed in 2015 at a cost of \$700. The glazed front and rear door assemblies were retained during the building remediation at the recommendation of the engineering firm.

Rear Entry Doors

Typical Suite Door

Storage Locker Door

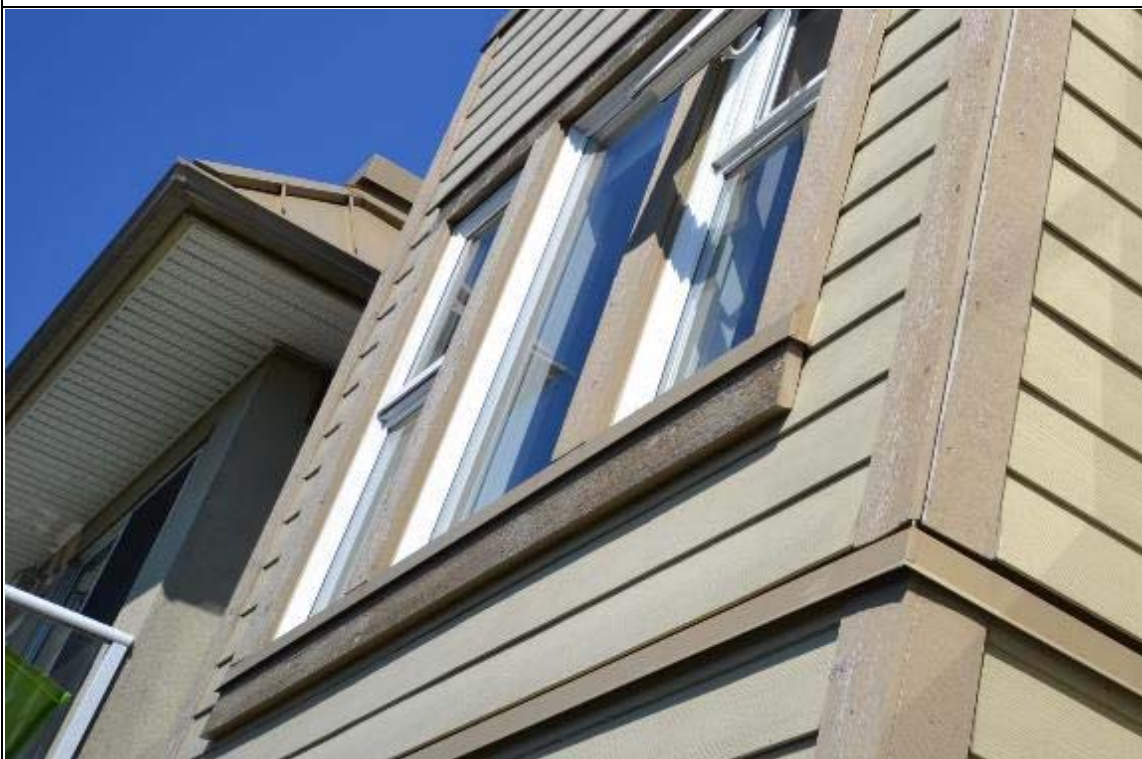
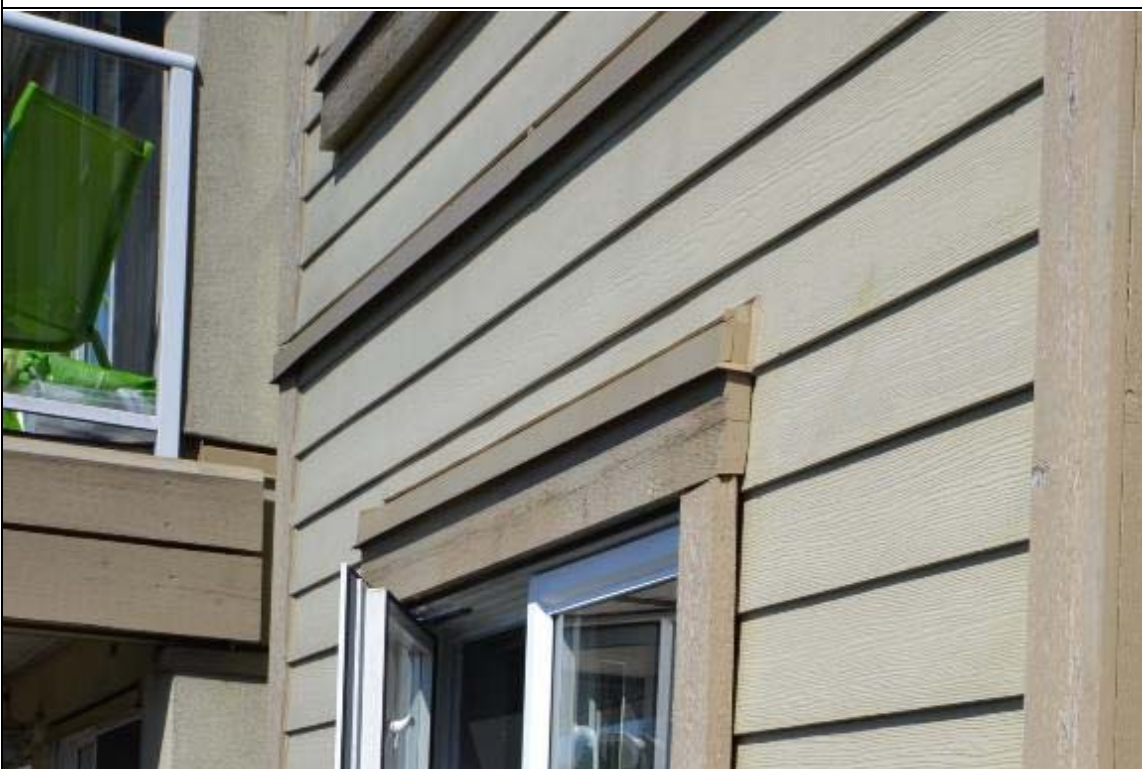
**Reserve Component: (9) Exterior Painting, Caulking and Repair – Wood Trim**

<b>Reserve Component: (9) Exterior Painting, Caulking and Repair – Wood Trim</b>									
<b>Component Description</b>	This component considers the maintenance of the wood trim and balcony fascia through regular painting, caulking and minor repairs as required.								
<b>Financial Analysis / Repair History</b>	It is reported that the strata corporation intends to complete any exterior caulking required in the near future. There were no records of painting or repairs to the trim since its installation in 2008.								
<b>Potential Deterioration</b>	<p>Potential deterioration of this component is predominantly due to age and exposure to the elements. UV radiation and water are key contributors to the breakdown of paint. Deterioration typically involves fading, chipping and cracking of the paint.</p> <p>Wood siding and trim board is susceptible to moisture, which could cause twisting, bowing, cupping, or rotting. It can also be affected by insect infestation or impact damage. Poor installation can also cause premature deterioration. Regular maintenance and painting will help to extend the life of the wood.</p> <p>Caulking relies on flexibility to maintain seals between building materials and is attacked and gradually succumbs to elements such as sunlight, rain and temperature fluctuations. The caulking hardens and cracks allowing water penetration and heat loss.</p>

Paint Showing Deterioration and Wood Beginning to Cup

Paint Showing Deterioration and Wood Beginning to Cup/Crack

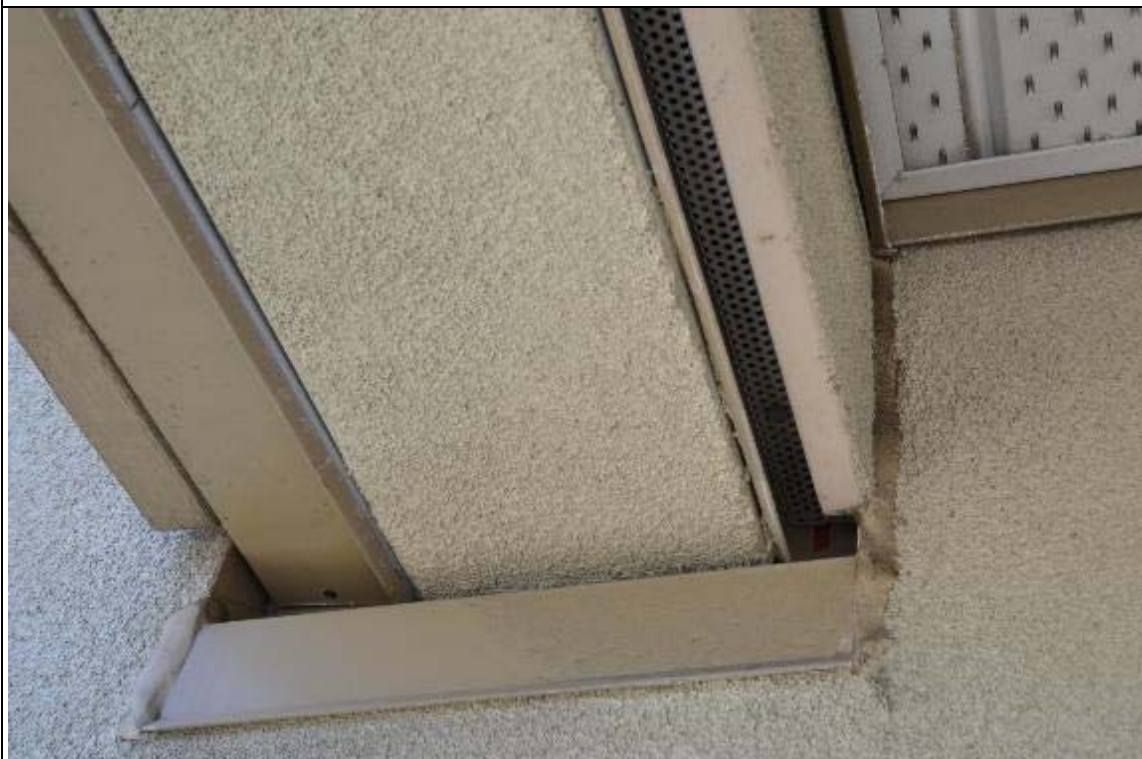
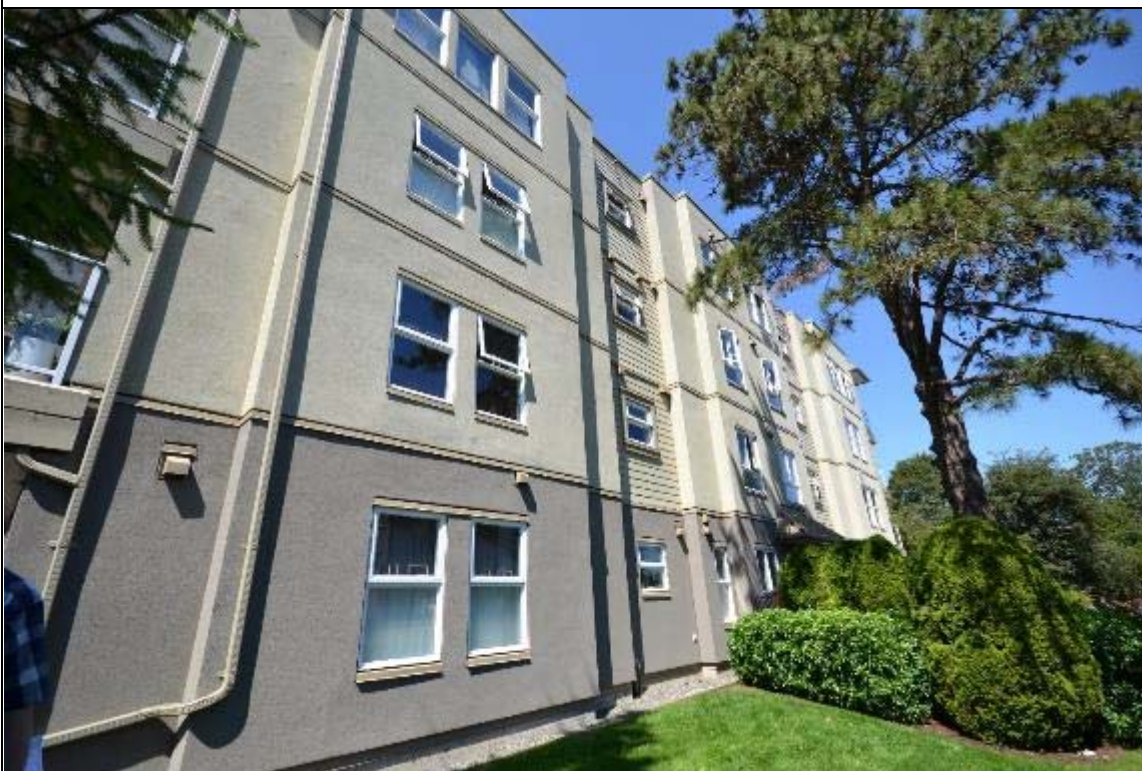
**Reserve Component: (10) Exterior Painting and Caulking – Stucco and Fibre Cement**

<b>Reserve Component: (10) Exterior Painting and Caulking – Stucco and Fibre Cement</b>									
<b>Component Description</b>	<p>The building exterior is clad with stucco, both cementitious and acrylic, and fibre cement siding. This component reserves for the periodic re-painting of the exterior cladding.</p> <p>Additionally, this component reserves for any re-caulking needs required at the time of painting.</p>								
<b>Financial Analysis / Repair History</b>	The building exterior has not been re-painted since the remediation in 2008. It is reported that the strata corporation intends to complete any exterior caulking required in the near future.								
<b>Potential Deterioration</b>	<p>Potential deterioration of this component is predominantly due to age and exposure to the elements. UV radiation and water are key contributors to the breakdown of paint. Deterioration typically involves fading, chipping and cracking of the paint.</p> <p>Caulking relies on flexibility to maintain seals between building materials and is attacked and gradually succumbs to elements such as sunlight, rain and temperature fluctuations. The caulking hardens and cracks allowing water penetration and heat loss.</p>

Typical Caulking

Painted Building Exterior

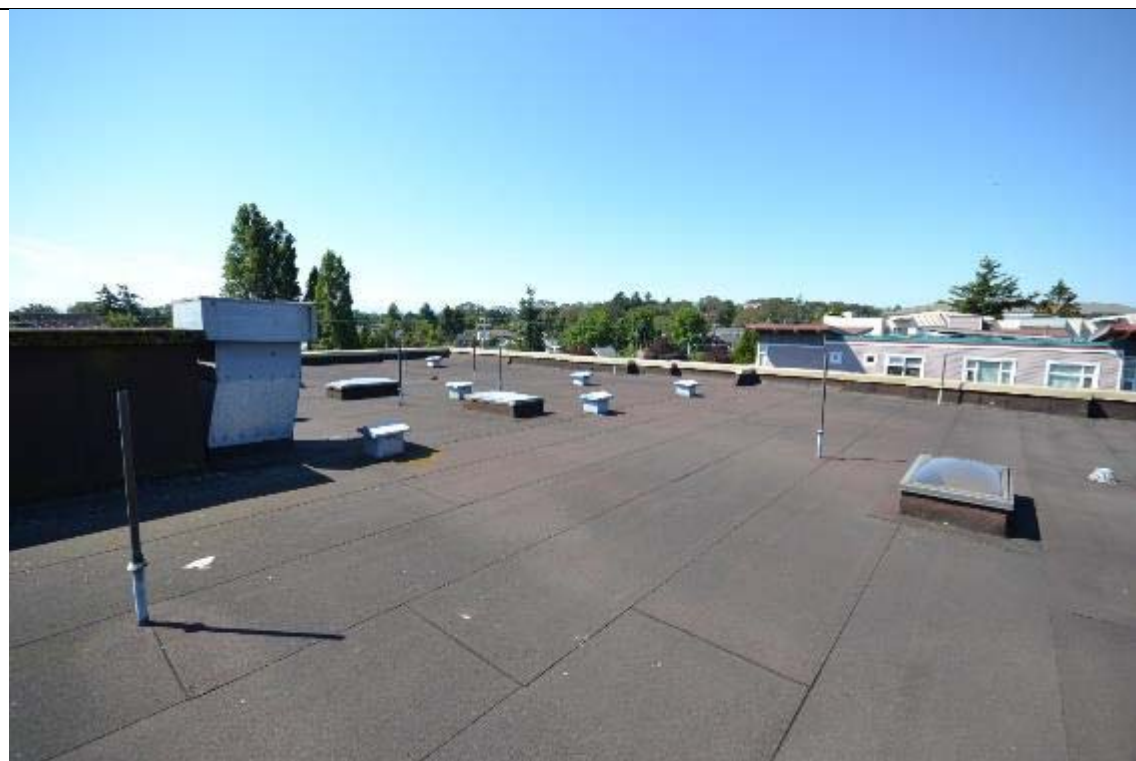
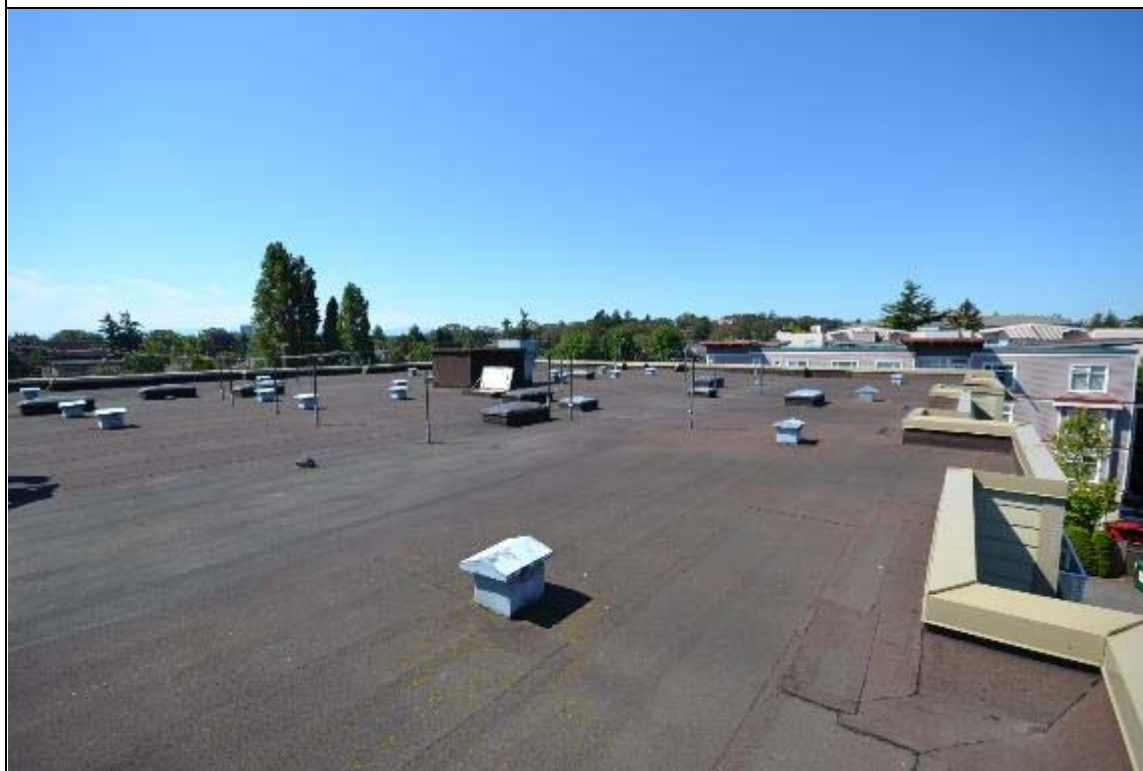
**Reserve Component: (11) Roofing, Flashing and Drainage – Flat Roof**

<b>Reserve Component: (11) Roofing, Flashing and Drainage – Flat Roof</b>									
<b>Component Description</b>	The main building roof is covered with 2-ply SBS torch-on membrane assembly. Flashings are painted metal and drainage is through interior roof drains and scupper type drains. This component will reserve for the replacement of the roofing and associated flashings and drains at the end of their effective lives. Also included would be the replacement of the 13 skylights.								
<b>Financial Analysis / Repair History</b>	The torch-on roof membrane is reportedly original to the Subject building with only minor repairs and maintenance performed since original construction.								
<b>Potential Deterioration</b>	<p>The key function of the torch-on roofing membrane is achieved through its durable coverage of the roof deck. Penetrations, exposure or traffic cause premature failures of the product. Over time the torch-on product will deteriorate with age and lose flexibility resulting in lost adhesion and cracking.</p> <p>Flashings can deteriorate over time, losing their ability to effectively shed water. Roof drains are susceptible to corrosion and rusting over time. Additionally, they can become clogged with organic debris.</p> <p>The skylights and seals are primarily susceptible to weather damage caused by rain, snow and sun. Manufacture defects and improper installation can also be a factor in causing premature deterioration.</p>

View of Roof

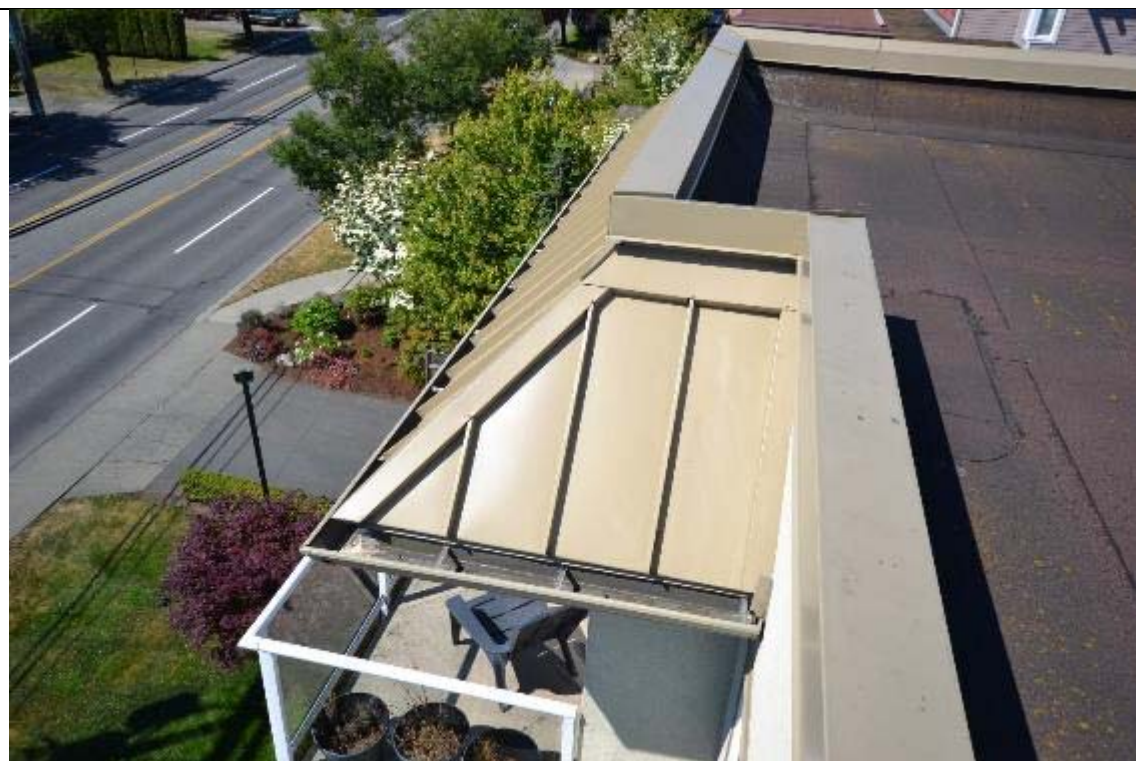
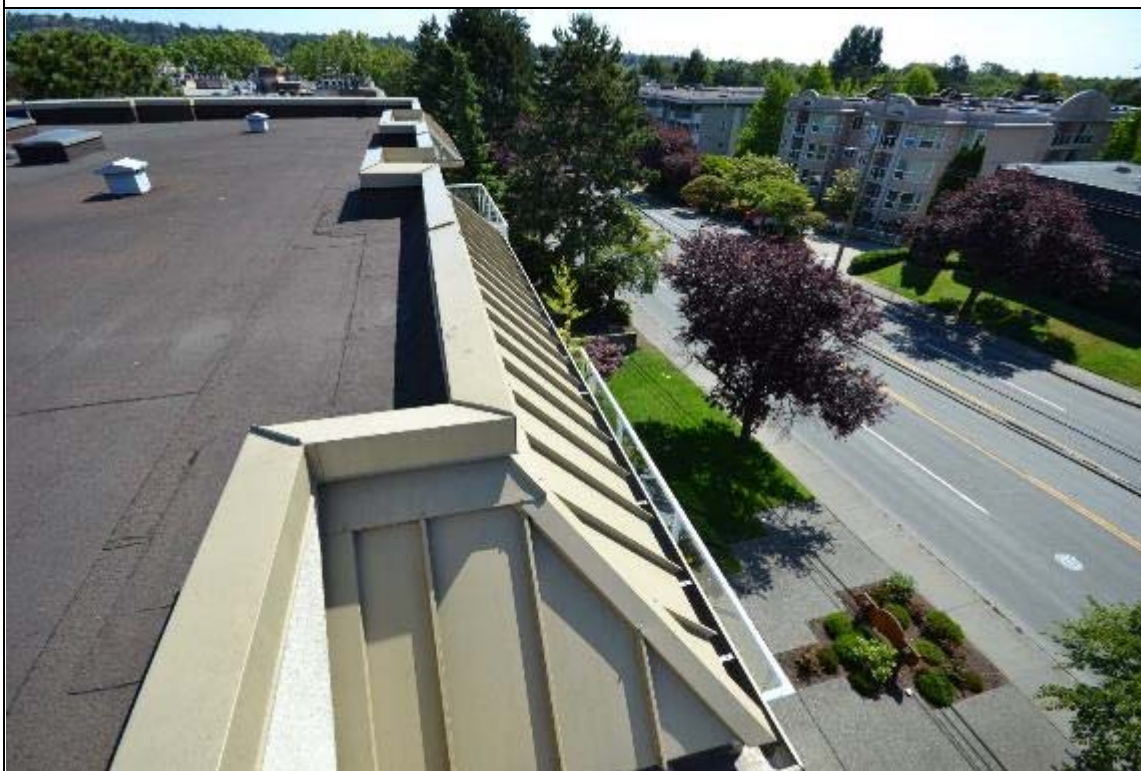
**Reserve Component: (12) Roofing, Flashing and Drainage – Sloped Roof**

<b>Reserve Component: (12) Roofing, Flashing and Drainage – Sloped Roof</b>									
<b>Component Description</b>	There are several canopies which provide coverage to the 4 <sup>th</sup> floor balconies and portions of the ground floor patios. Additionally, there are some other small sloped roof sections along the ground floor. These canopies are roofed with standing seam metal roofing over a water-shedding membrane and drain to a gutter/downspout system. This component will reserve for replacement/repair of the metal roofing and associated drainage.								
<b>Financial Analysis / Repair History</b>	The canopies were added to the building during the 2008 remediation.								
<b>Potential Deterioration</b>	<p>Metal roofing is durable, however, if not properly maintained or protected, some issues such as corrosion/rust could occur. Proper installation is also key, as this assists in proper protection from moisture and the elements. Impact damage can occur over time, as well as loosened fasteners. This would generally necessitate localized repair rather than complete replacement. Obsolescence can also be a factor in the deterioration of this material.</p> <p>Over time the coating will fade and eventually fail. This could lead to replacement for cosmetic reasons, or could lead to a point where the metal is painted. Once re-painted, this must be done on a periodic and on-going basis.</p>

View of Roof
