DEPRECIATION REPORT OF:  
1536 HILLSIDE AVENUE  
STRATA PLAN VIS2630  
VICTORIA, BRITISH COLUMBIA

JUNE 2018

Prepared for:  
The Owners of Strata Plan VIS2630  
c/o: The Strata Council for Strata Plan VIS2630  
1536 Hillside Avenue, Victoria, B.C.  
File # DP070H

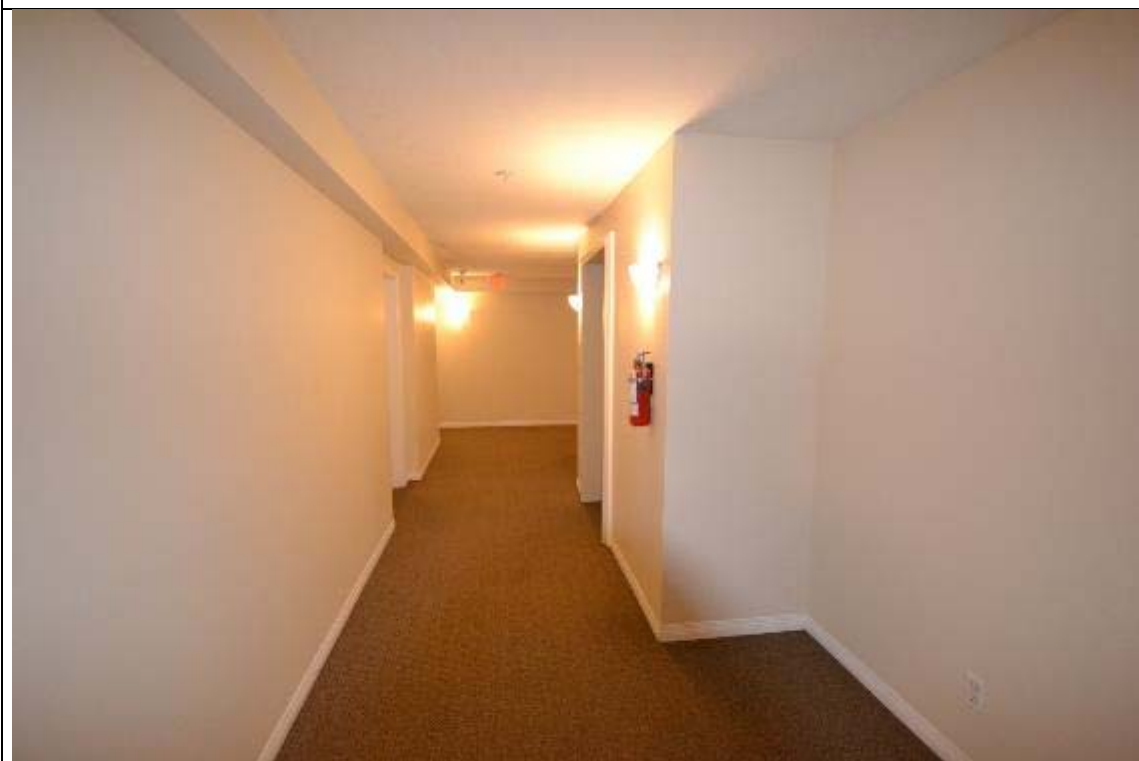
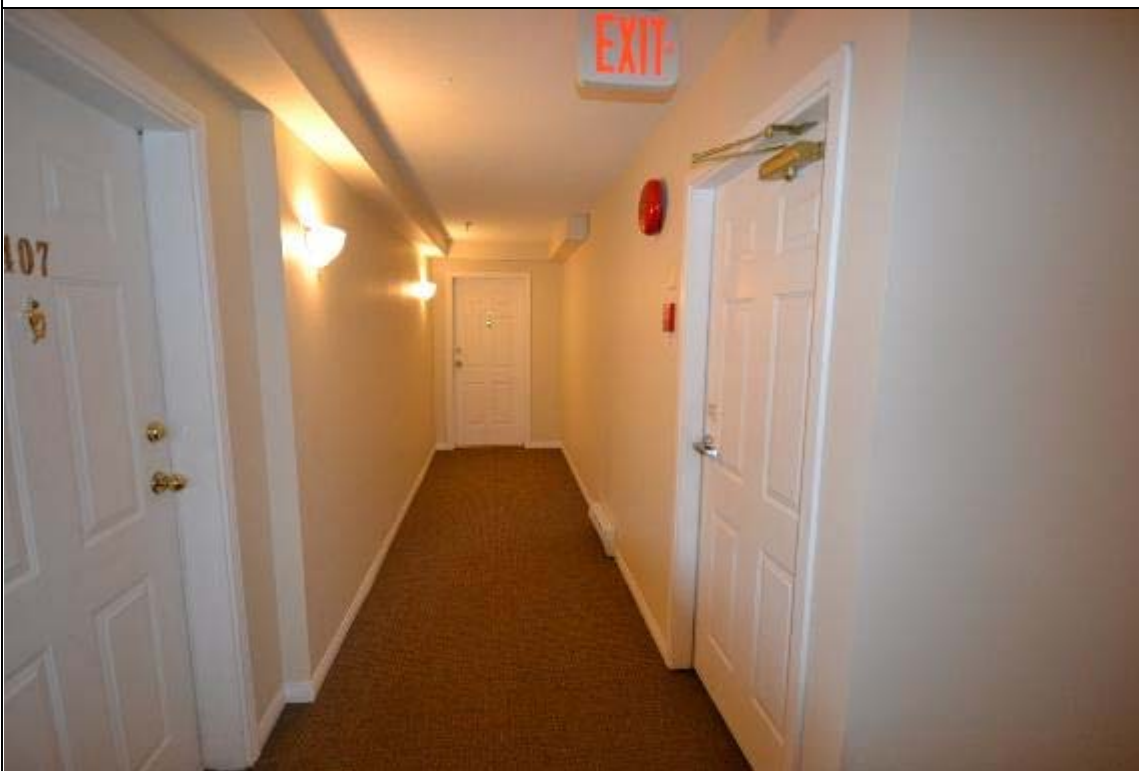
**Reserve Component: (14) Corridor Finishes and Decorating**

<b>Reserve Component: (14) Corridor Finishes and Decorating</b>									
<b>Component Description</b>	This component includes the paint on the ceilings, walls and any mouldings in the common areas of the building. There is very little in the way of wall decoration. Walls have a paint finish and ceilings are textured/painted.								
<b>Financial Analysis / Repair History</b>	Common areas were painted in 2013 at a total reported cost of \$7,263.20.								
<b>Potential Deterioration</b>	The typical deterioration of this component is caused by wear and tear, vandalism or impact. Paint will fade over time and will begin to look aged and dirty. Aesthetics play a large role in the determination of the replacement of this component.								
<b>Condition Analysis</b>	There was no major deterioration of the paint in the common areas of the building.								
<b>Life Cycle Analysis</b>	<table> <tr> <td>Date of Acquisition:</td> <td>2013</td> </tr> <tr> <td>Normal Life Span</td> <td>10 Years</td> </tr> <tr> <td>Effective Age</td> <td>4 years</td> </tr> <tr> <td>Remaining Life Span</td> <td>6 years</td> </tr> </table>	Date of Acquisition:	2013	Normal Life Span	10 Years	Effective Age	4 years	Remaining Life Span	6 years

Date of Acquisition:	2013								
Normal Life Span	10 Years								
Effective Age	4 years								
Remaining Life Span	6 years								
<b>Unit Quantity And Cost Estimates</b>	<table> <tr> <td>Unit Quantity</td> <td>8,300 sq.ft.</td> </tr> <tr> <td>Unit Cost Estimate</td> <td>\$1.08</td> </tr> <tr> <td>Current Repair Cost Estimate</td> <td>\$9,000</td> </tr> <tr> <td>Estimated Year/s of Major Repair or Replacement</td> <td>2024</td> </tr> </table>	Unit Quantity	8,300 sq.ft.	Unit Cost Estimate	\$1.08	Current Repair Cost Estimate	\$9,000	Estimated Year/s of Major Repair or Replacement	2024
Unit Quantity	8,300 sq.ft.								
Unit Cost Estimate	\$1.08								
Current Repair Cost Estimate	\$9,000								
Estimated Year/s of Major Repair or Replacement	2024								
<b>Additional Comments</b>	No deficiencies noted.

Typical Hallway Finish

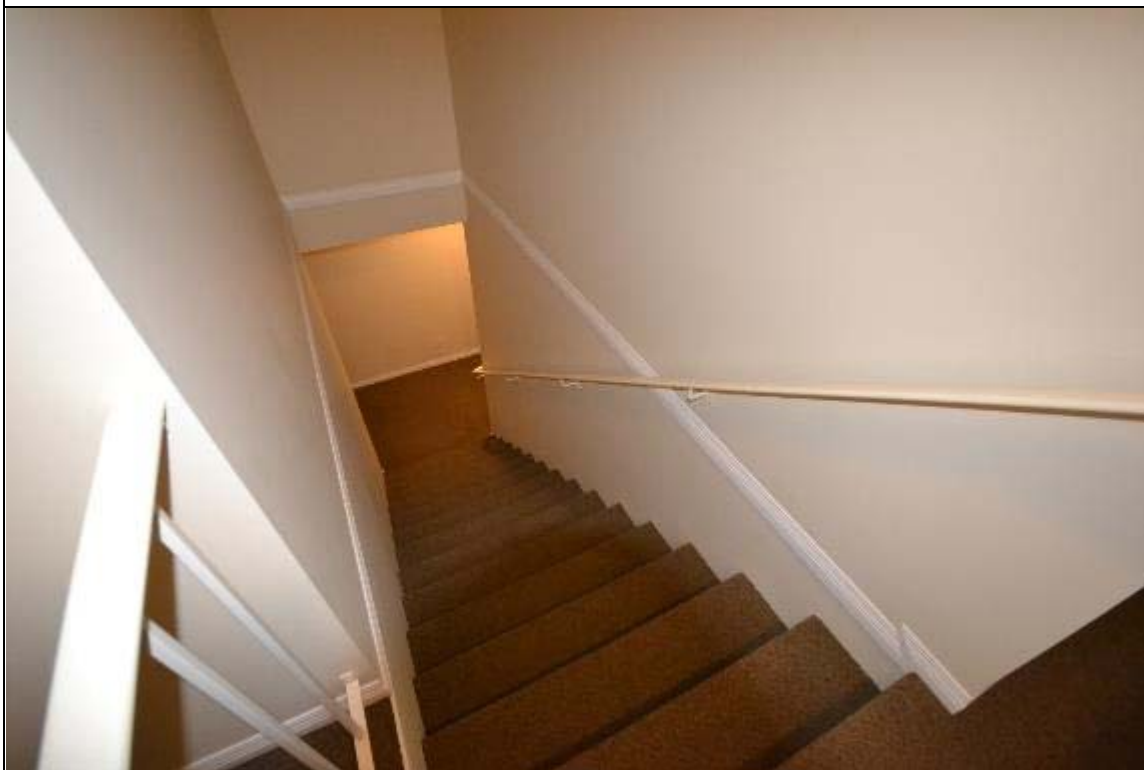
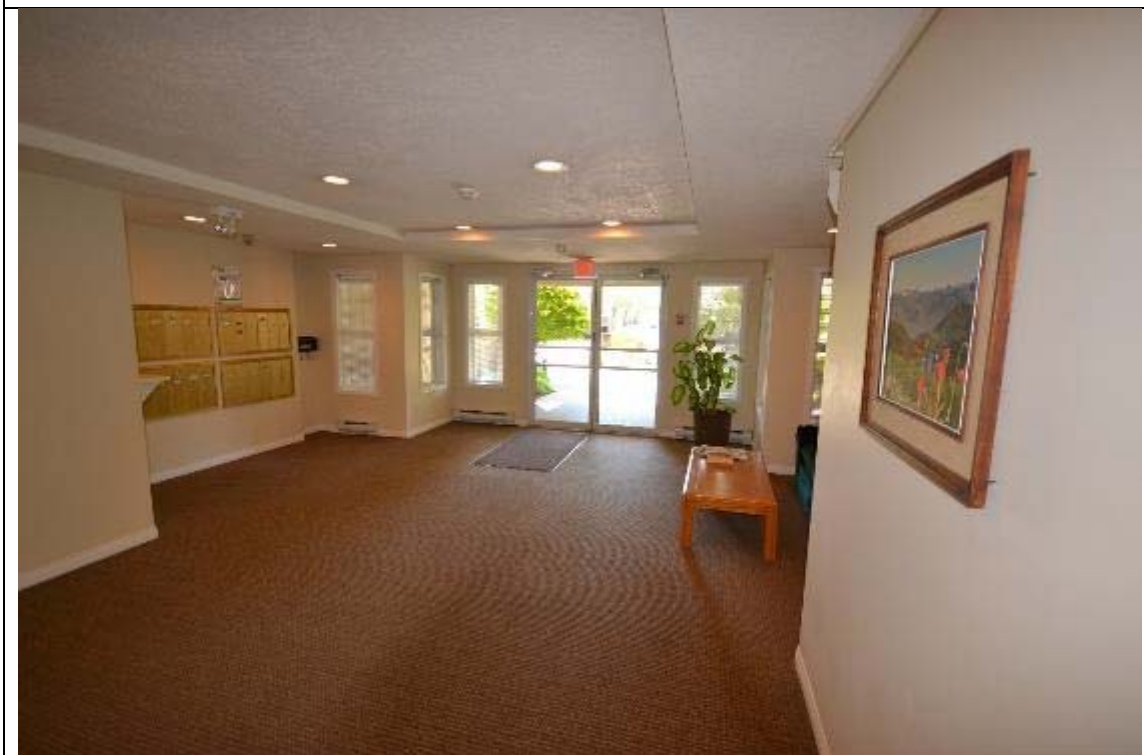
**Reserve Component: (15) Common Area Flooring -Carpet**

<b>Reserve Component: (15) Common Area Flooring -Carpet</b>									
<b>Component Description</b>	This reserve item is for corridor and stairwell carpeting, as well as in the activity room. The materials are rated as average in terms of quality and grade. There are two types of carpeting, one in the corridors and one in the stairwells, which is a typical design choice.								
<b>Financial Analysis / Repair History</b>	The carpeting was reportedly replaced in 2008 at a total cost of ± \$25,000. There has been some discussion surrounding replacing the carpet in the lobby with tile, however this has been delayed until such a time as the carpet begins showing visible signs of wear and deterioration.								
<b>Potential Deterioration</b>	Carpet wears out over time from traffic, spills and other soiling. Ultimately aesthetics is the key factor in the decision to change this component.								
<b>Condition Analysis</b>	The carpet appeared to be in good condition. No deficiencies or major areas of concern were noted.

Typical Common Stairwell Carpet

Typical Common Carpet

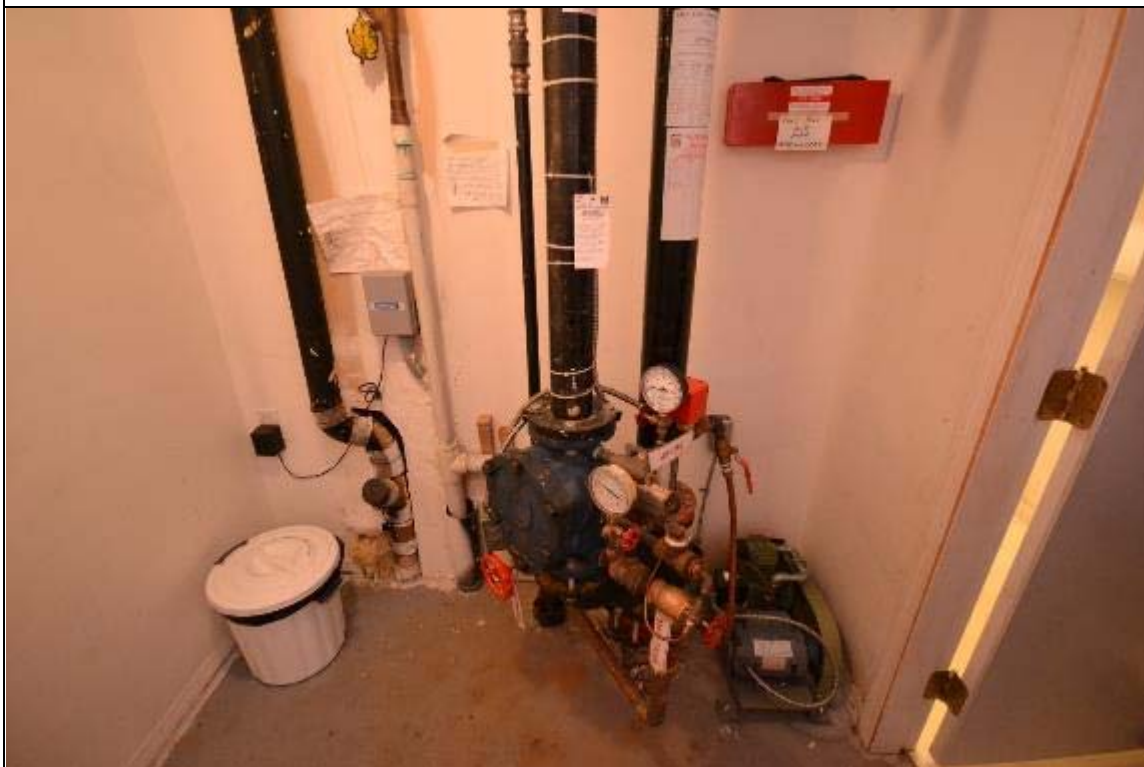
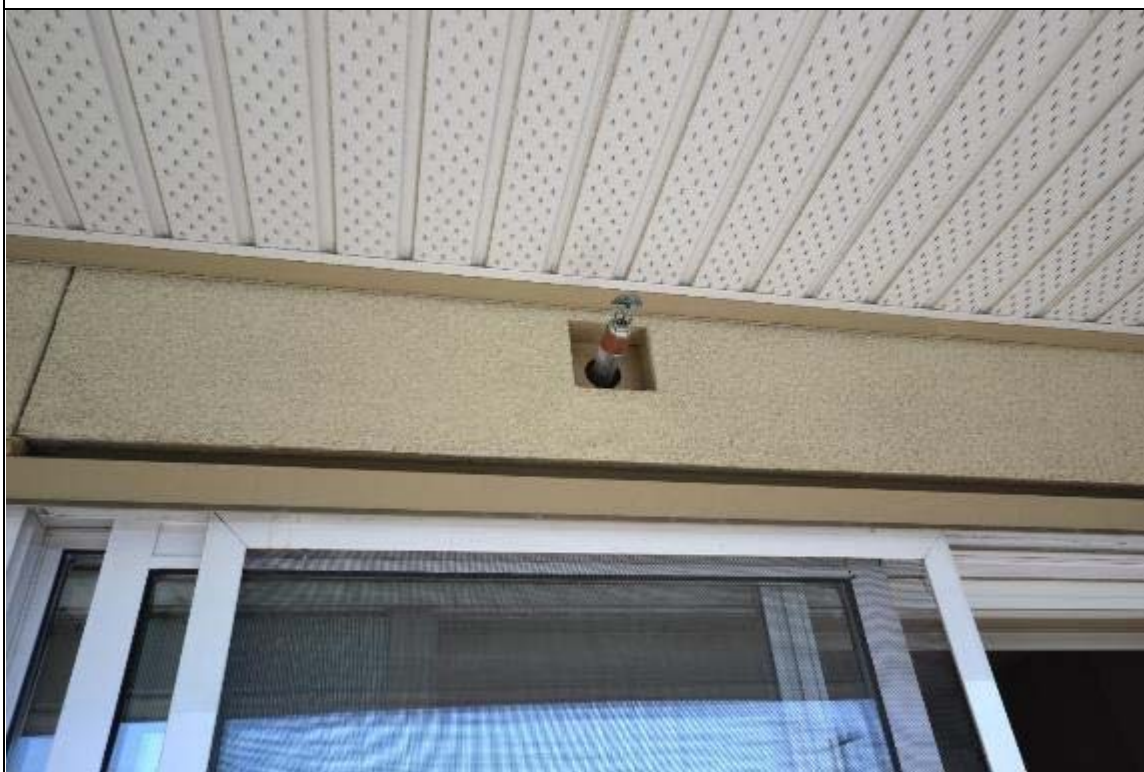
**Reserve Component: (18) Fire Suppression System**

Dry Pipe Valve and Compressor

Exterior Sprinkler Head

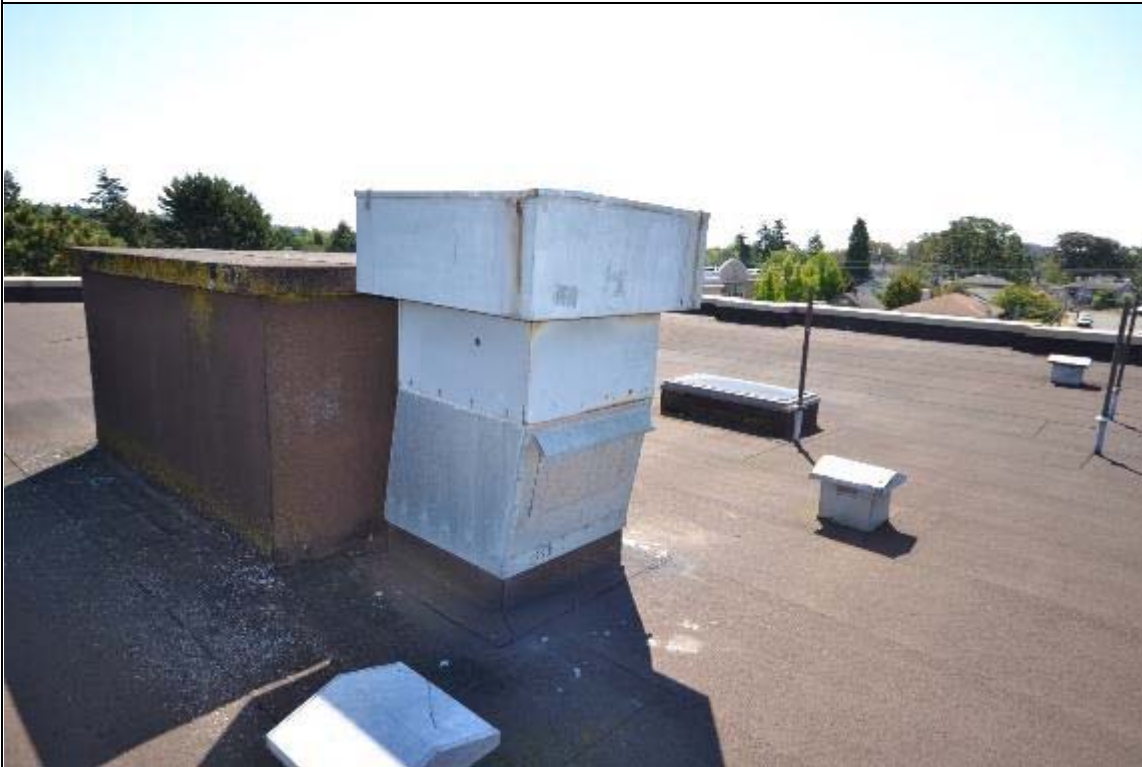
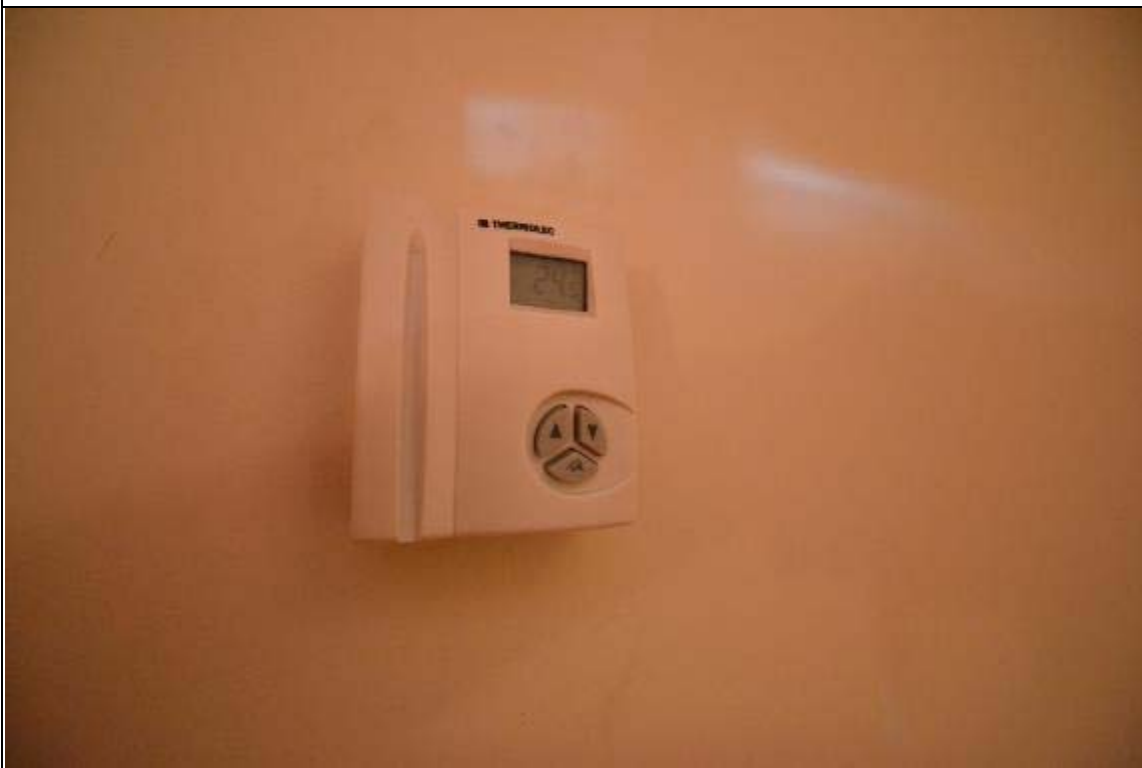
**Reserve Component: (19) Common Area – Heating and Ventilation Systems**

<b>Reserve Component: (19) Common Area – Heating and Ventilation Systems</b>		
<b>Component Description</b>	The common area heating and ventilation systems consist of a make-up air unit for the main hallways and electric baseboard heaters in the common areas. This component will reserve for the replacement of the make-up air system.	
<b>Financial Analysis / Repair History</b>	The in-line duct heater was replaced in 2017 at a cost of ±\$3,100. This included the installation of a thermostat on the fourth floor. The fan motor, a pulley and belt were replaced in early 2018. The total cost of repairs was \$1,078.59.	
<b>Potential Deterioration</b>	Deterioration of the common area heating and ventilation systems is primarily from wear due to use. Mechanical and electrical parts wear over time and require repair or replacement. The majority of these repairs or replacement of parts generally gets covered under a mechanical maintenance agreement. Over time, the entire units require replacement or re-building due to corrosion, inefficiency, catastrophic failure or obsolescence.

Rooftop Make Up Air Unit

New Thermostat for RTU

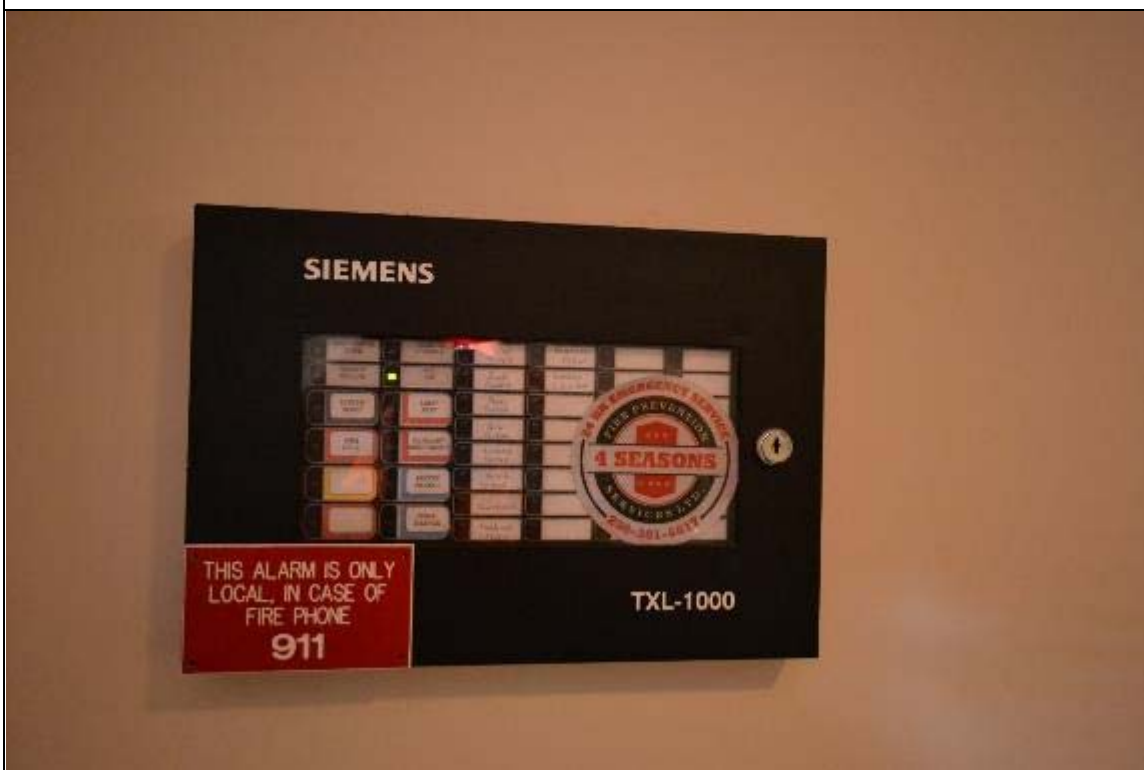
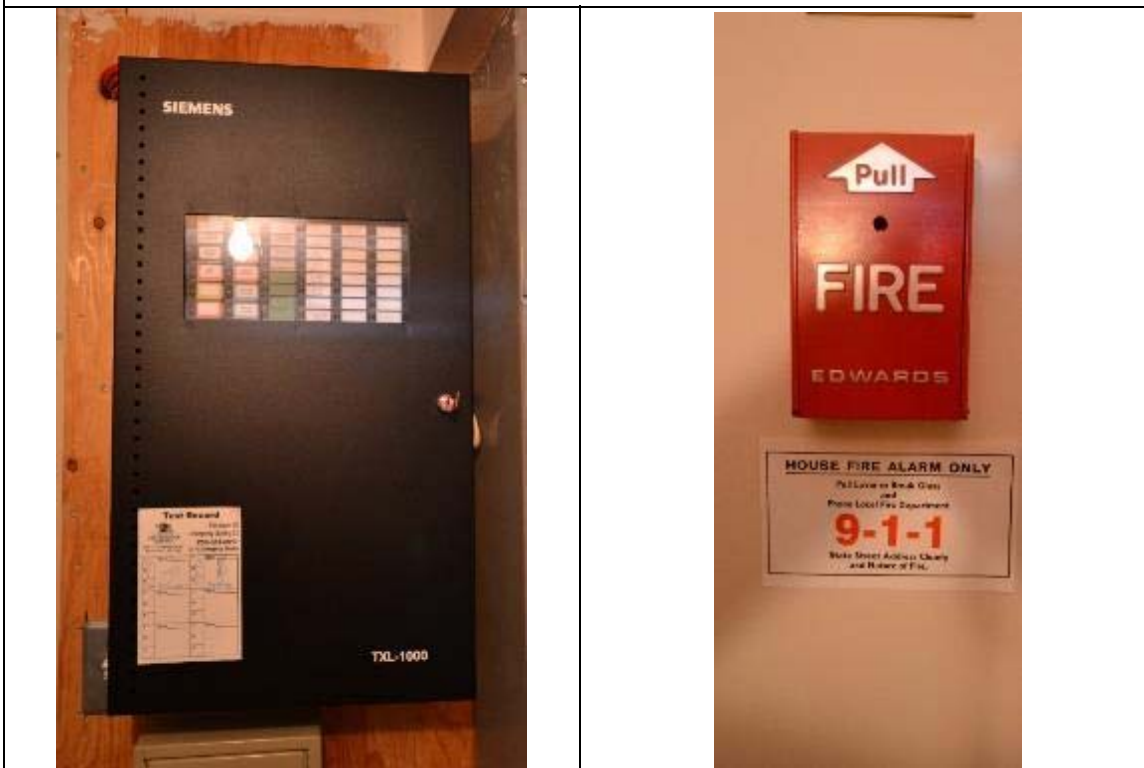
Reserve Component: (21) Fire Alarms and Safety System

<b>Reserve Component: (21) Fire Alarms and Safety System</b>									
<b>Component Description</b>	This includes the Siemens Fire Alarm Control Panel and Annunciator Panel; the devices such as pull stations, smoke and heat detectors, trouble and tamper devices and wiring end of line resistors etc. It also includes emergency lighting for the complex.								
<b>Financial Analysis / Repair History</b>	It is reported that 4 Seasons Fire Protection replaced the FACP and FAAP in June 2011 at a reported cost of \$2,899.								
<b>Potential Deterioration</b>	As the system gets older and codes change, systems become outdated. Mechanical and electrical failures of switches and devices such as heat and smoke detectors. Dust and construction damage are also circumstances that cause premature deterioration or failure. Much of this deterioration is handled through ongoing maintenance.								
<b>Condition Analysis</b>	The equipment is assumed to be in good condition throughout, with annual testing and replacement of any faulty equipment.

Fire Alarm Control Panel

Annunciator & Pull lever

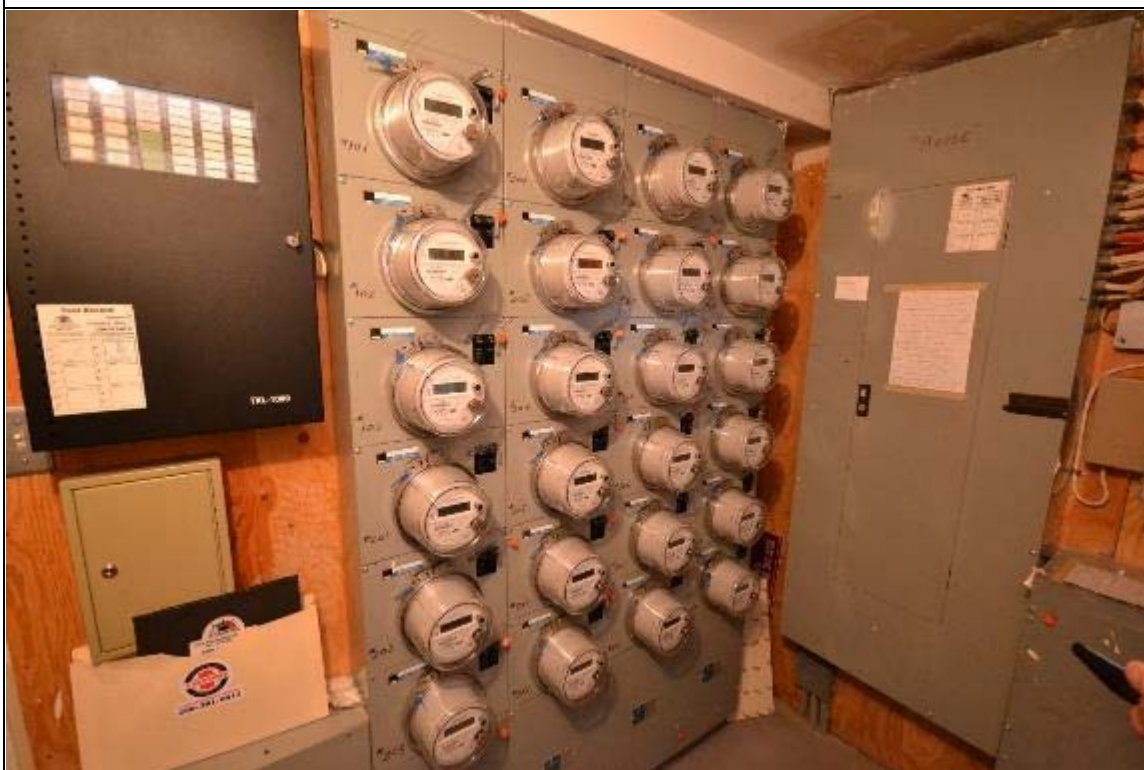
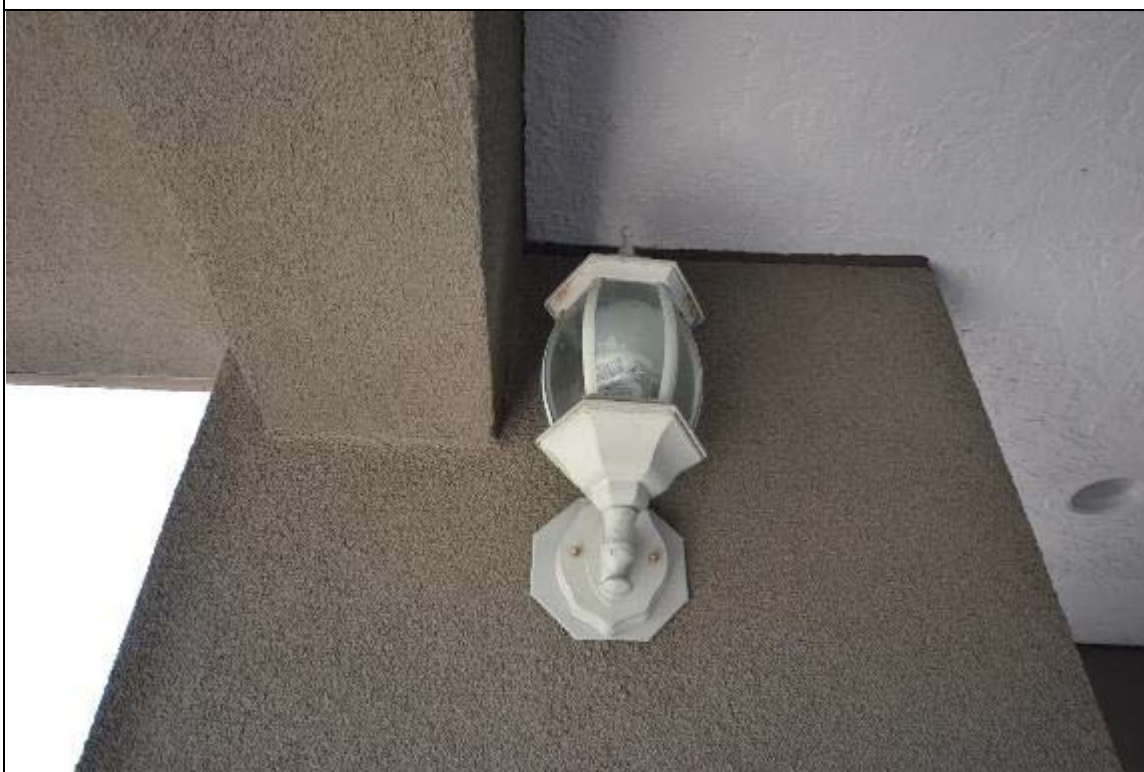
**Reserve Component: (22) Electrical Power and Distribution / Common Lighting**

<b>Reserve Component: (22) Electrical Power and Distribution / Common Lighting</b>									
<b>Component Description</b>	This component includes the electrical power main feed, distribution systems and distribution panels. The end devices are the responsibility of the unit owner. There is an 1,200-ampere main disconnect, several sub services and individual unit meters. Lighting fixtures consist of standard ceiling or building mounted incandescent fixtures. Also included are the parking lot lighting standards. This component is based upon an allowance per square foot of building area.								
<b>Financial Analysis / Repair History</b>	There was no maintenance or expenditure information available relating to the electrical power or lighting equipment.								
<b>Potential Deterioration</b>	Potential deterioration is caused by overloading, improper phase balance, single phasing or power failure causes heat from built up resistance to possibly damage insulation or melt conductors. Improper or loose connections could also shorten life or melt conductors. Exterior lighting fixtures can deteriorate over time due to exposure to the elements. Replacement can also be required due to obsolescence, physical damage due to vandalism or impact, and catastrophic failure.

Electrical Room

Exterior Light Fixture

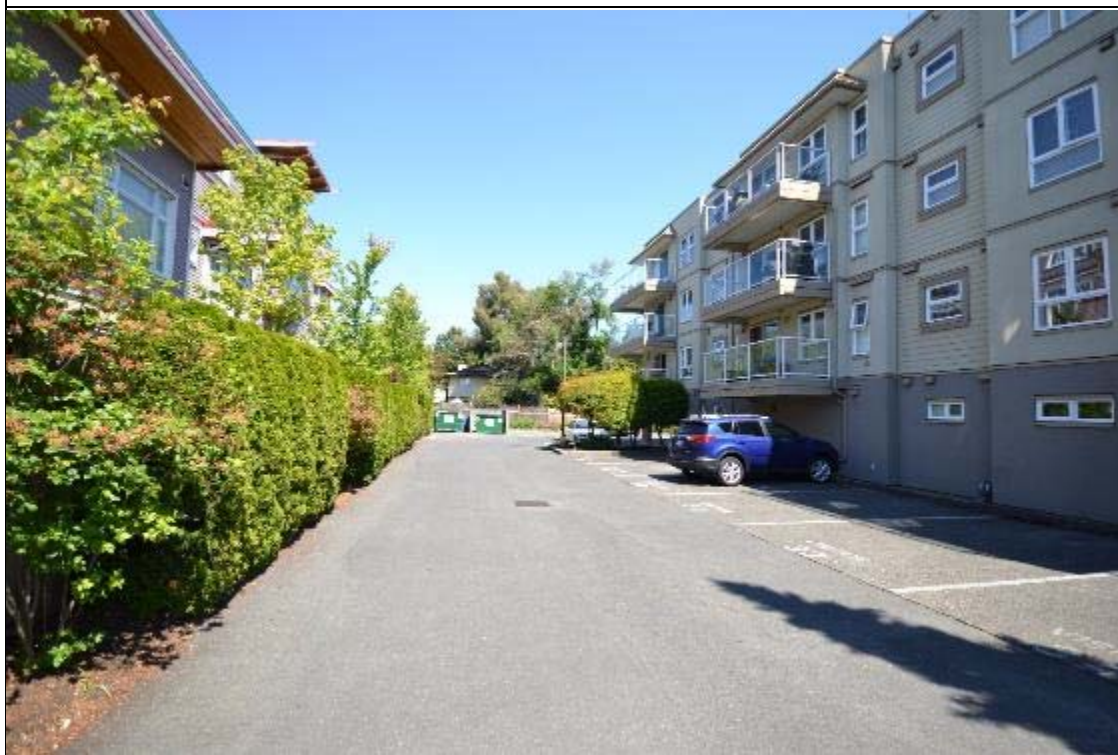
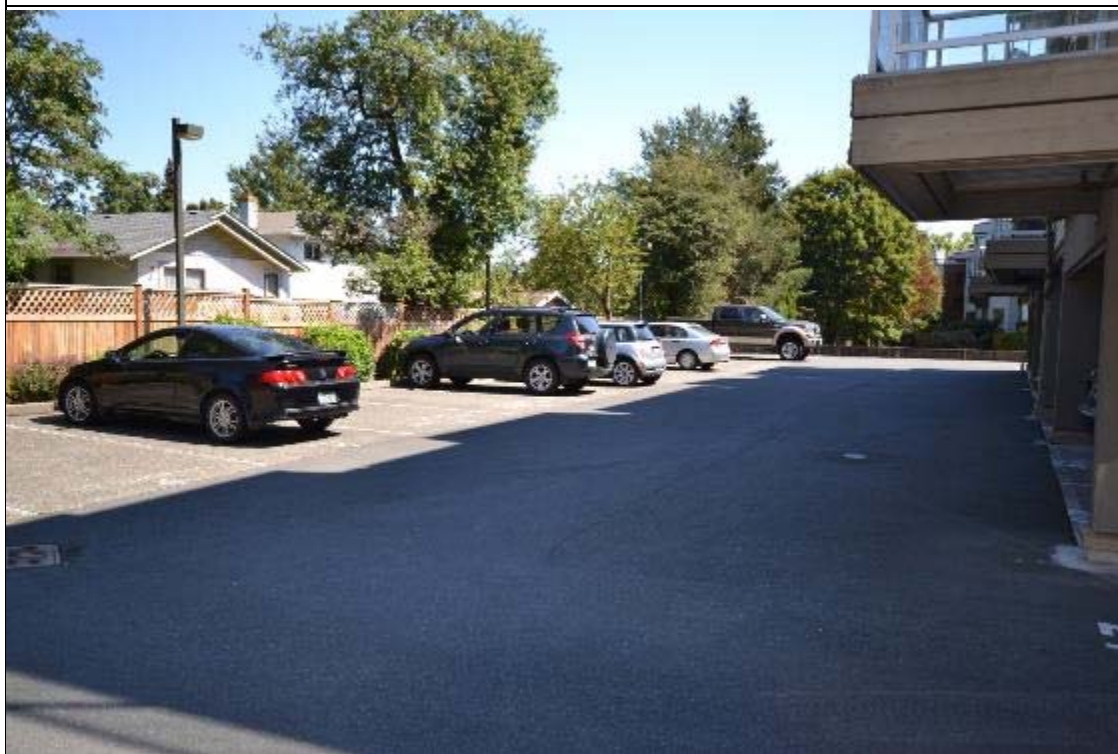
**Reserve Component: (24) Asphalt Paving**

Asphalt Driveway

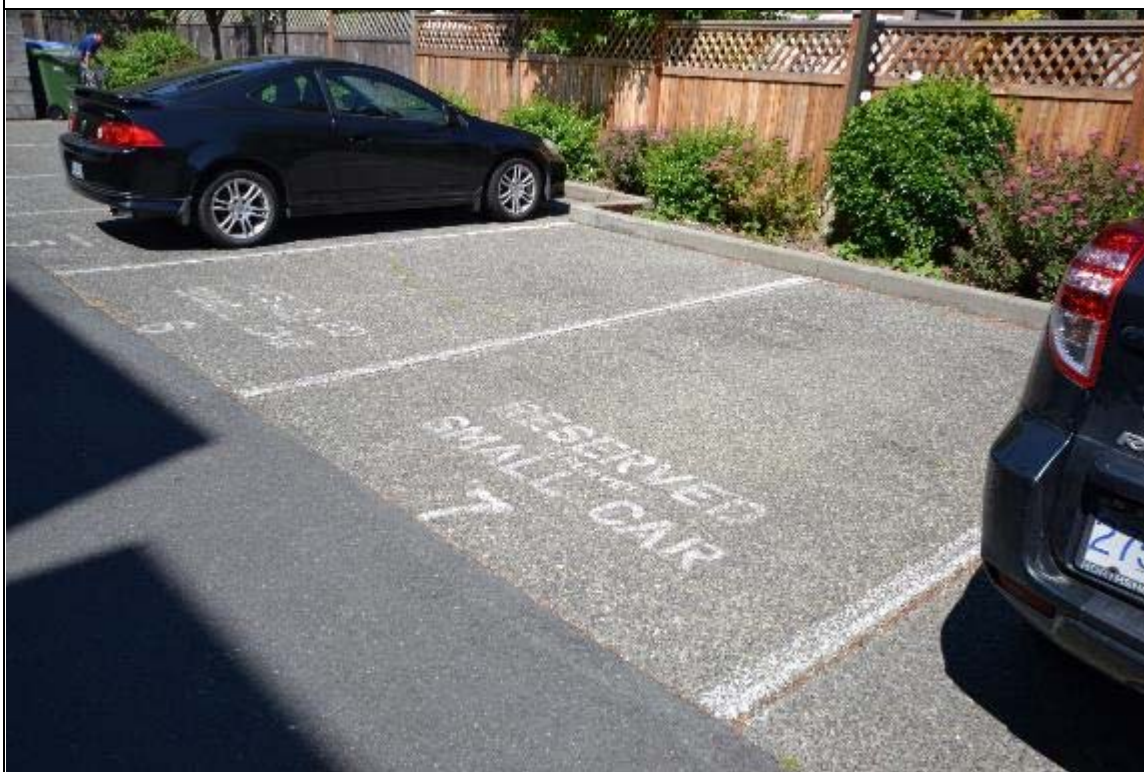
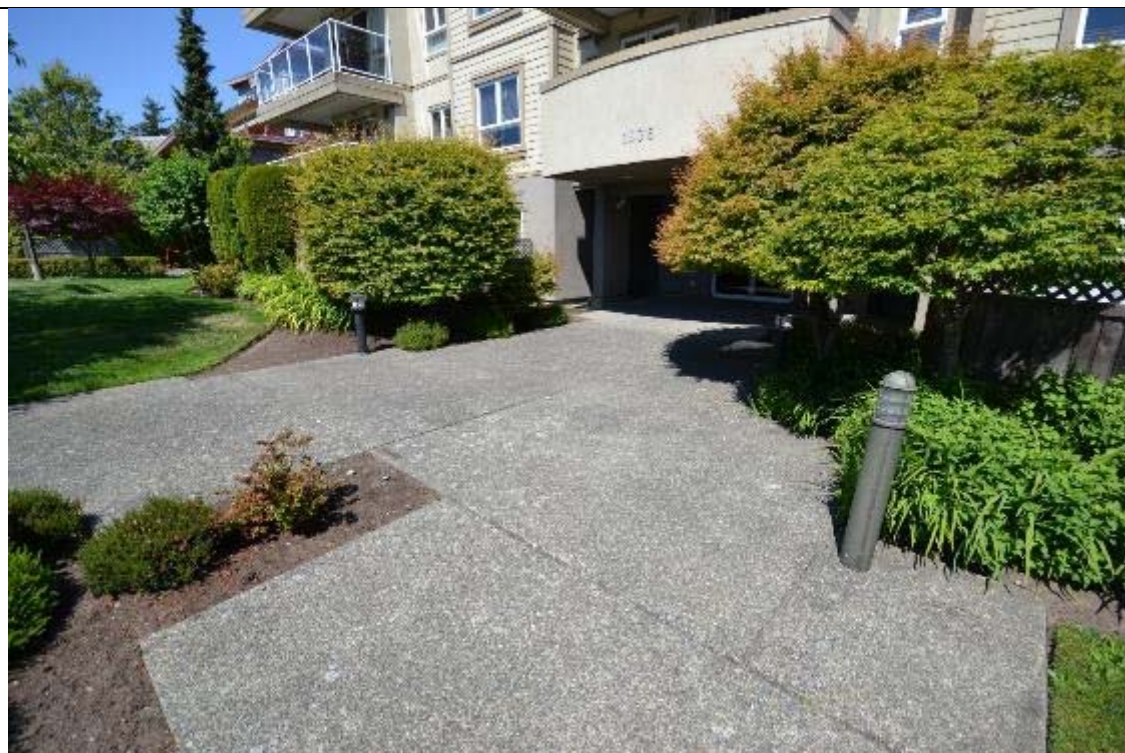
**Reserve Component: (25) Concrete Paving, Patios, Planters and Walkways**

<b>Reserve Component: (25) Concrete Paving, Patios, Planters and Walkways</b>									
<b>Component Description</b>	This component will reserve for a periodic allowance to cover required repairs to the concrete elements present on the common property. This would include the parking stalls, the concrete under the second level of the building, the front entryway, concrete walkways, curbing, and planters. Also included would be any required repairs to the concrete patios. This component is based upon a periodic allowance.								
<b>Financial Analysis / Repair History</b>	The patios were rebuilt in 2008 with a self-adhered membrane underneath a concrete slab.								
<b>Potential Deterioration</b>	Concrete walkways and driveways can crack and settle over time. Deterioration can be caused by impact, vandalism, deterioration of the substrate etc.								
<b>Condition Analysis</b>	There were no immediate concerns noted pertaining to the elements that make up this component. No major cracking or deterioration was noted.

Concrete Parking Stalls

Common Front Entry Concrete

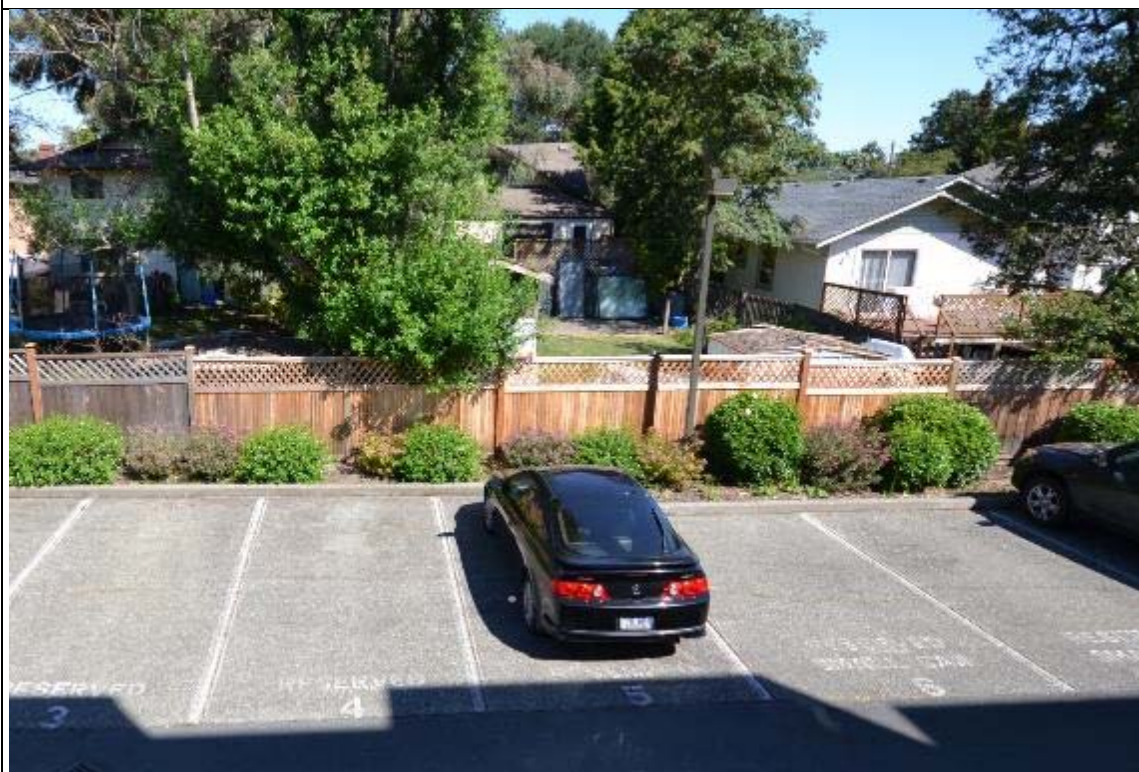
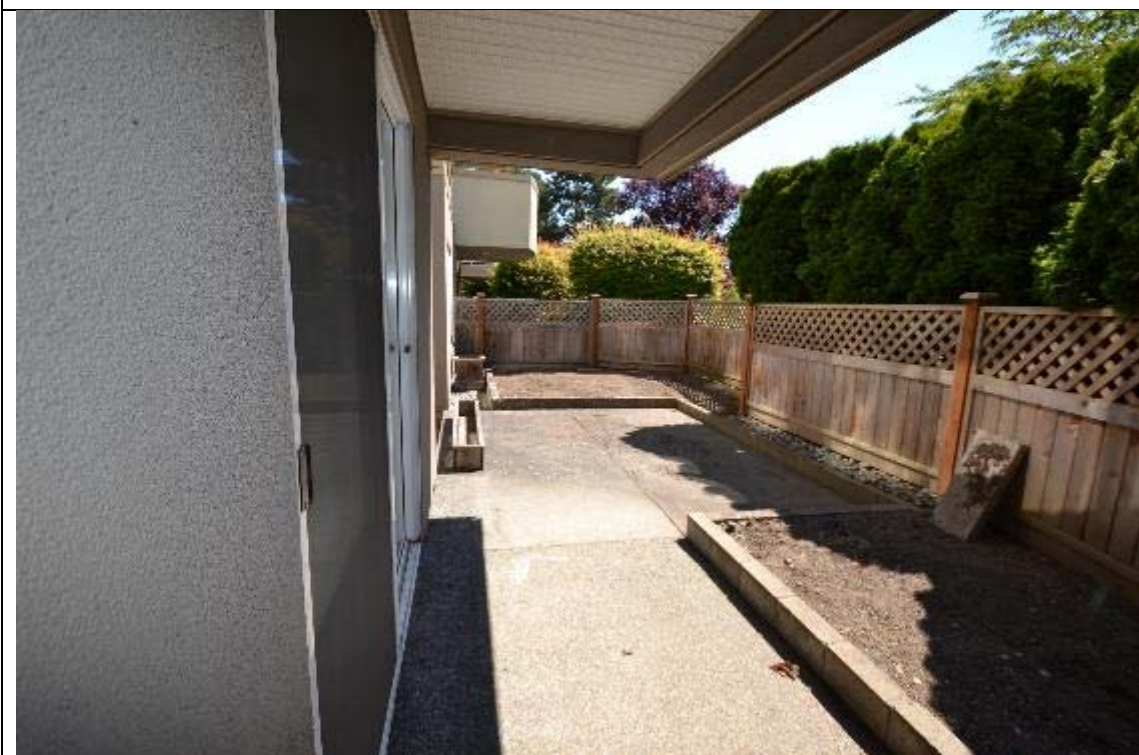
**Reserve Component: (26) Fencing**

<b>Reserve Component: (26) Fencing</b>		
<b>Component Description</b>	This component will reserve for the replacement of the wood perimeter fencing as well as the fencing that surrounds the ground floor patios. This consists of 4-6' fencing, some with lattice top.	
<b>Financial Analysis / Repair History</b>	Some panels of the perimeter fencing were replaced in 2016 at a cost of ±\$2,300.	
<b>Potential Deterioration</b>	The posts can rot near or at ground level requiring replacement. The stain can degrade requiring re-staining and the above ground portions of the fence can rot as they age.	
<b>Condition Analysis</b>	The fencing appeared to be in good condition. Required repairs have been made of the years when needed. The posts are now in metal brackets to help with deterioration.	
<b>Life Cycle Analysis</b>	Date of Acquisition:	Varied
	Normal Life Span	20 Years
	Effective Age	5 years
	Remaining Life Span	15 years

Rear Fencing

View of Patio Fencing

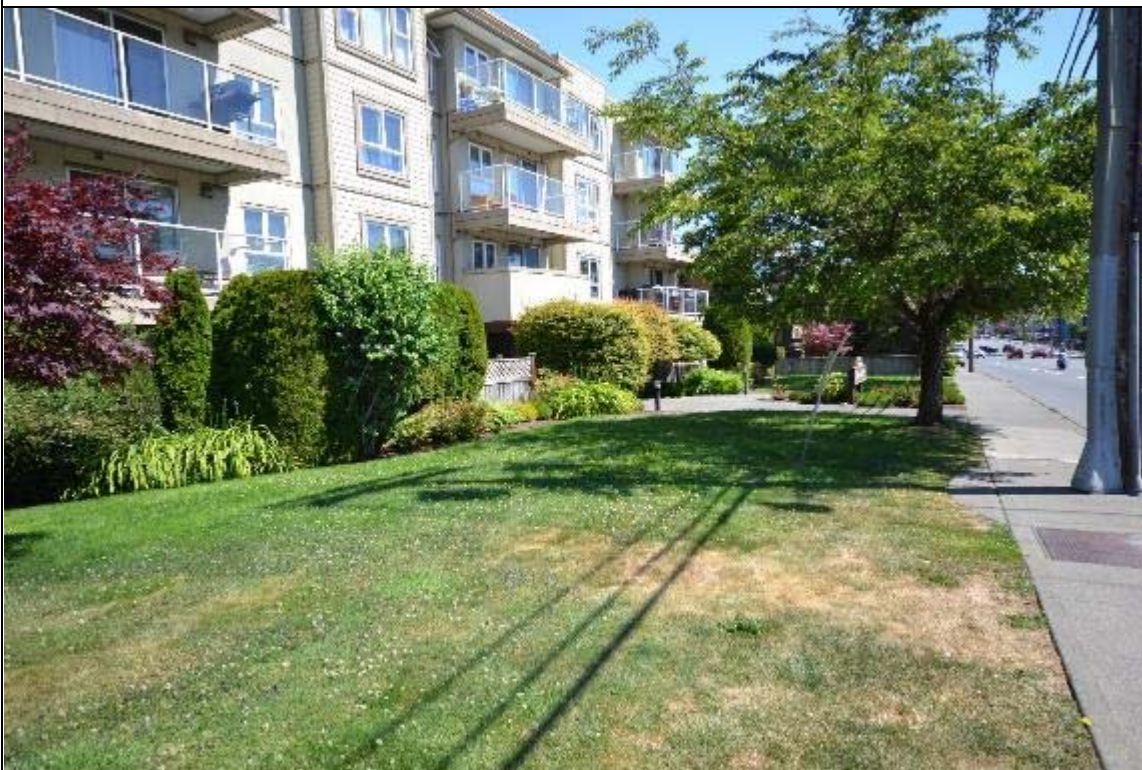
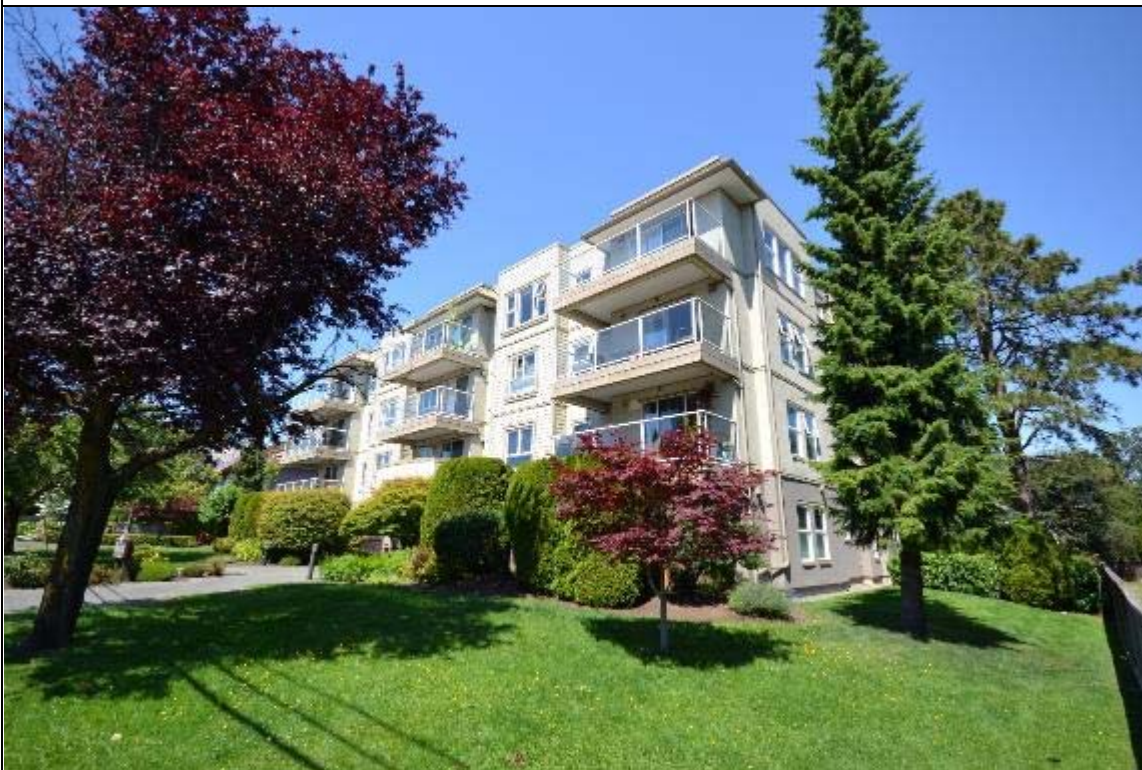
**Reserve Component: (27) Landscaping and Irrigation**

<b>Reserve Component: (27) Landscaping and Irrigation</b>									
<b>Component Description</b>	This component includes all landscaped areas including hard and soft landscaping areas, trees, shrubs and flowerbeds. Also included in this component is the 6-zone irrigation sprinkler system.								
<b>Financial Analysis / Repair History</b>	Some repairs have been required to the sprinkler system over time. The Strata is giving contemplation to the requirement of a backflow valve on the sprinkler system.								
<b>Potential Deterioration</b>	Landscaping and irrigation can vary in terms of their lifespan, with soft landscaping potentially damaged, by disease, drought or soil erosion. Irrigation systems are susceptible to improper fall maintenance which can result in the requirement to replace heads and ruptured piping.								
<b>Condition Analysis</b>	At the time of inspection, the landscaped areas were in good condition. There are quantities of mature shrubbery and trees surrounding the property, which enhance the quality of landscaping. Continued manicuring and maintenance will provide long-term life of this component. There were no reported issues with the irrigation system.

Typical Landscaping
