The District of Saanich | Inspection Services

FINAL BUILDING

Project Ref: V3617R01_hms_ver2

Reference: Hazardous Materials Survey – 576 Whiteside Avenue, Victoria, BC

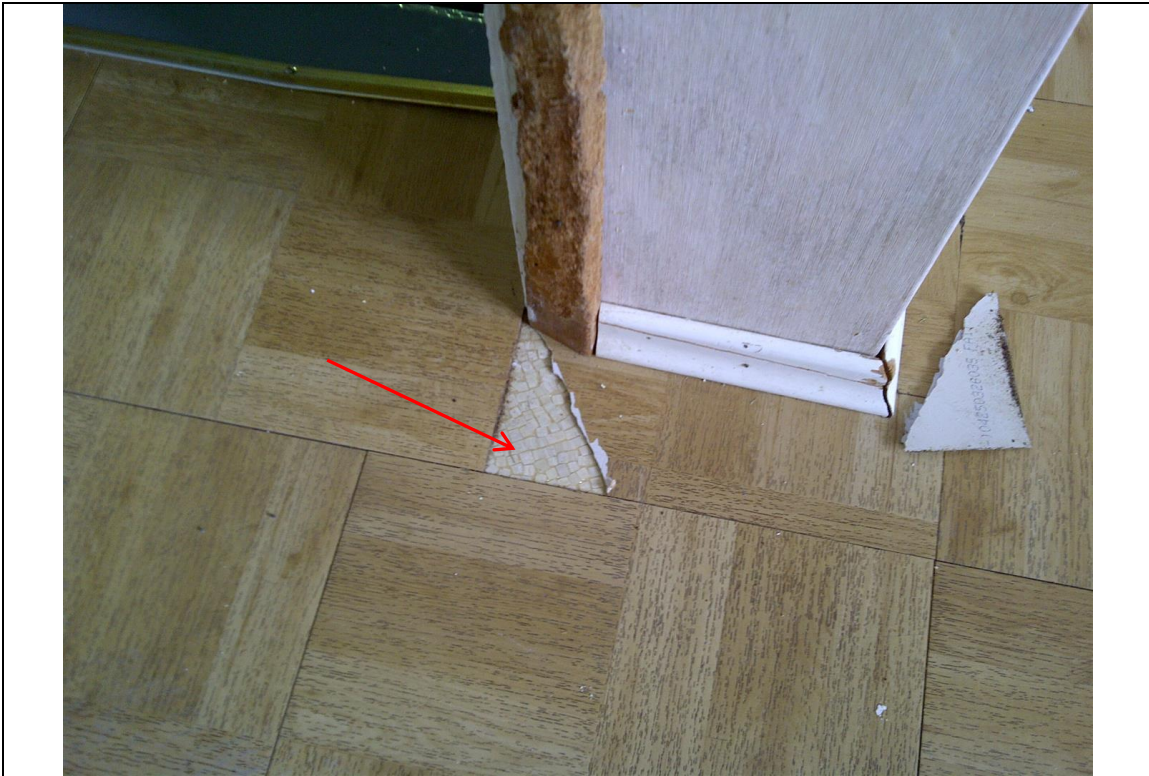
Sample No.	Location	Material	Asbestos (%)
V1962-16801-001	Attic	Vermiculite	1% Actinolite
V3617-17517-003	Kitchen	Vinyl sheet flooring	40% chrysotile
V3617-17517-008	Basement	Furnace duct tape	95% chrysotile

Photo 1	Date: June 7, 2013	Location: Kitchen
Description: Underlying layer of vinyl sheet flooring was found to contain asbestos

The removal of asbestos containing **vermiculite in the attic** and **vinyl sheet flooring from the subfloor** should be conducted using **High Risk** asbestos abatement procedures. These procedures must be utilized by a qualified contractor and include as a minimum requirement:

The removal of asbestos containing **vinyl sheet flooring with the subfloor intact** should be conducted using **Modified High Risk** asbestos abatement procedures. These procedures must be utilized by a qualified contractor and include as a minimum requirement:

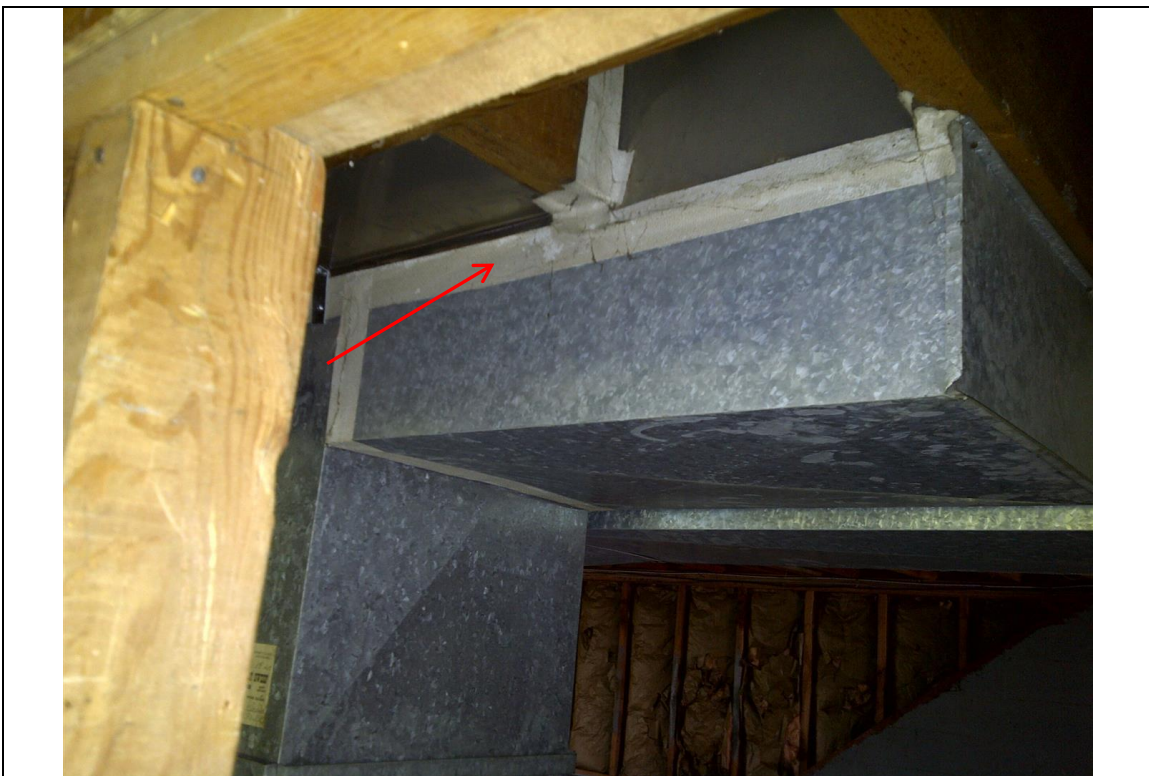
Photo 2	Date: June 7, 2013	Location: Basement
Description: Furnace duct tape was found to contain asbestos

The removal of asbestos containing **furnace duct tape** should be conducted using **Moderate Risk** asbestos abatement procedures. These procedures must be utilized by a qualified contractor and include as a minimum requirement:

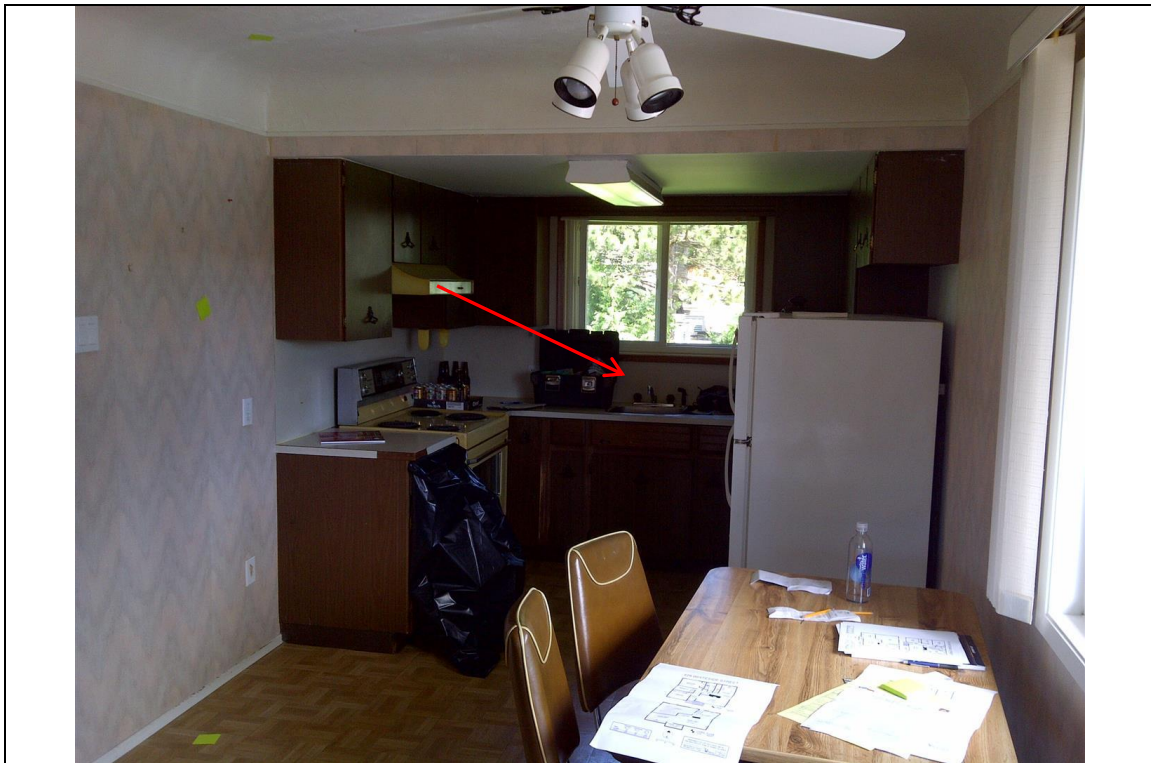
Sample No.	Location	Material	Analysis: Lead (Pb)	
			Pb (µg/g)	Pb (%)
L-1	Kitchen wall	yellow paint on plaster	17600	1.7600
L-2	Bedroom wall	mocha paint on plaster	32.0	0.0032
L-3	Basement floor	grey paint on concrete	77.8	0.0078
L-4	Basement floor	Green paint on concrete	218	0.0218

Two (2) lead paint samples contained lead at a concentration that **exceeded** the limit of 0.009%.

Photo 1	Date: June 7, 2013	Location: Kitchen
Description: Paint sampled from the back wall was found to contain elevated levels of lead

In order to control worker exposure to lead paint particulate, any cutting, burning, grinding, sanding or other disturbance of identified lead painted surfaces should be conducted following appropriate safe work procedures. Procedures will vary depending on the nature of the work but should consider, as a minimum, the following:

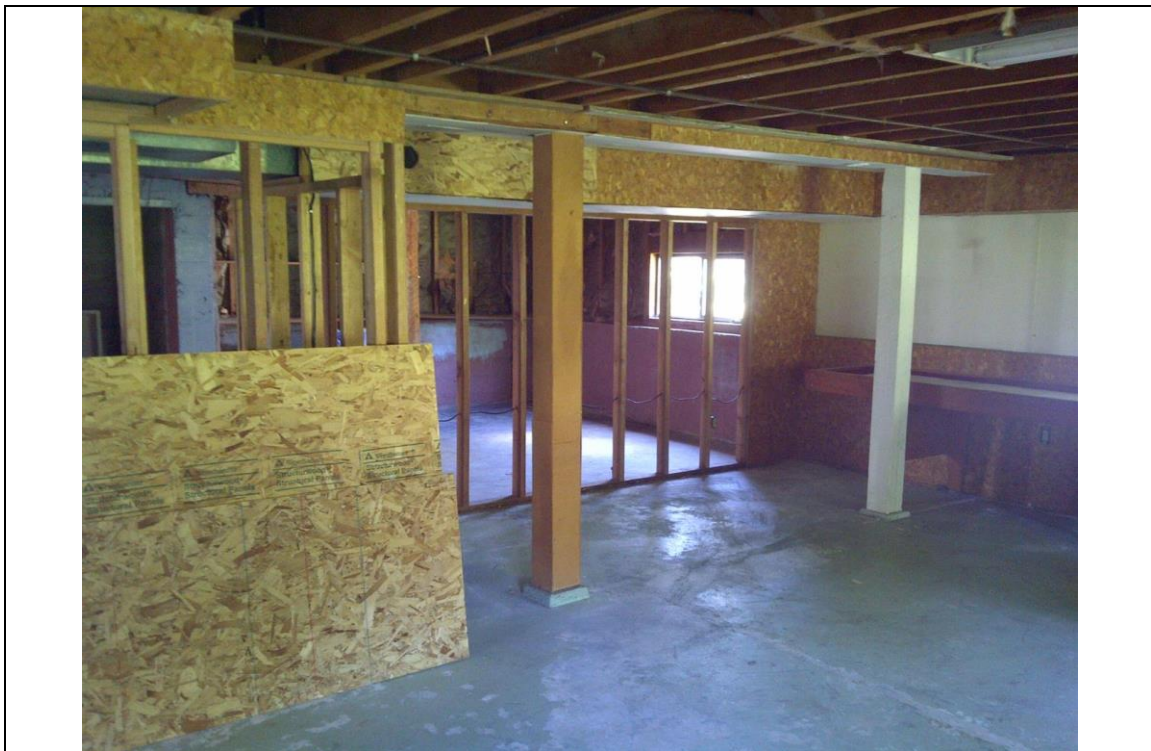
Photo 1	Date: June 7, 2013	Location: Basement
Description: Green paint sampled from the floor was found to contain elevated levels of lead
