2016 DEPRECIATION REPORT UPDATE FOR

Silverwood at Thetis Cove
121 Aldersmith Place
View Royal, BC

June 23, 2016

Project Number: 161-02286-00

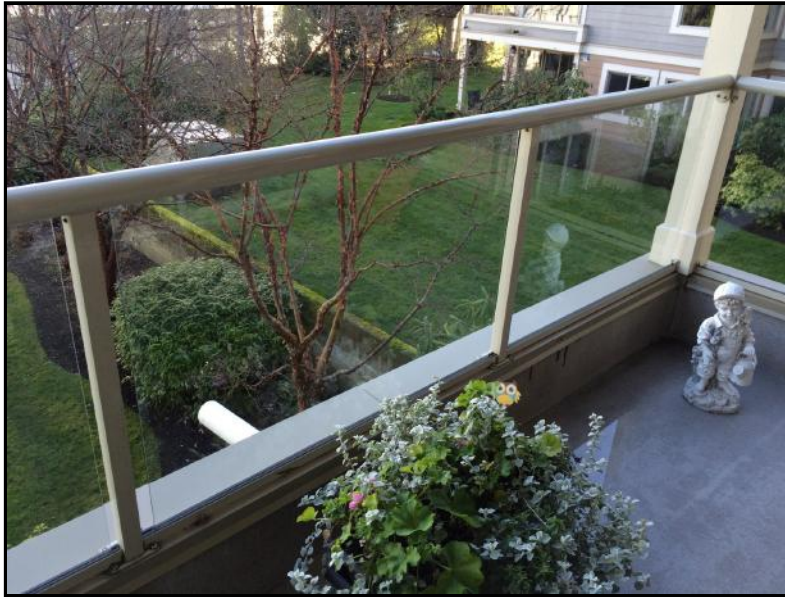
Photo No. 6: Balcony Railings

Balconies that were reviewed appeared to be in good condition. Some instances of pooling water were noted near curb walls. Railings were hand-tested and felt secure, fasteners did not exhibit signs of corrosion. The improvements to the balcony post trim are performing well and are expected to be maintained through the operating budget. Maintenance expenses such as railing review, fastener replacement and localized membrane repairs are assumed to be financed through the operating budget. Within the next five years the balcony membranes are expected to be replaced as they reach the end of their expected service lives. The option to phase the replacement by addressing the open fourth-level balconies first, followed by the covered third and second levels is considered, however savings in cost and disruption favours full, single-phase replacement.

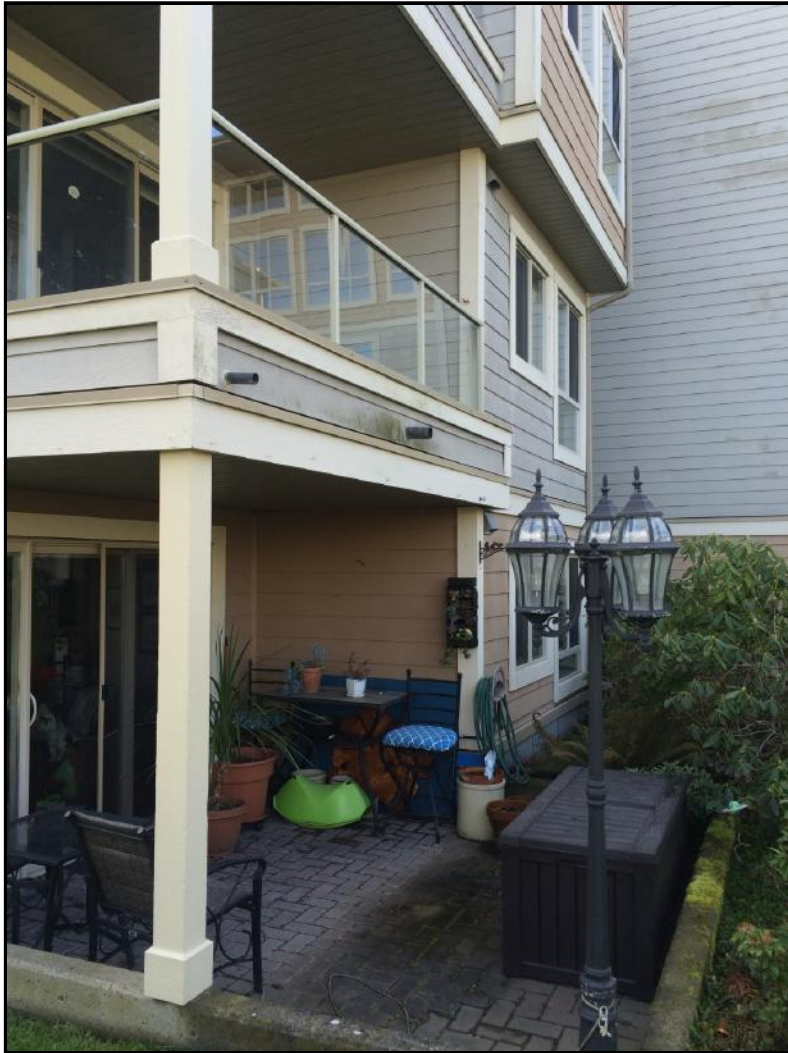
Photo No. 7: Balcony Posts

2013: Replace deteriorated wood trim at base of balcony posts with fiber-cement board and sealant, \$42,000, as documented by Silverwood at Thetis Cove 35 Year Maintenance Plan.

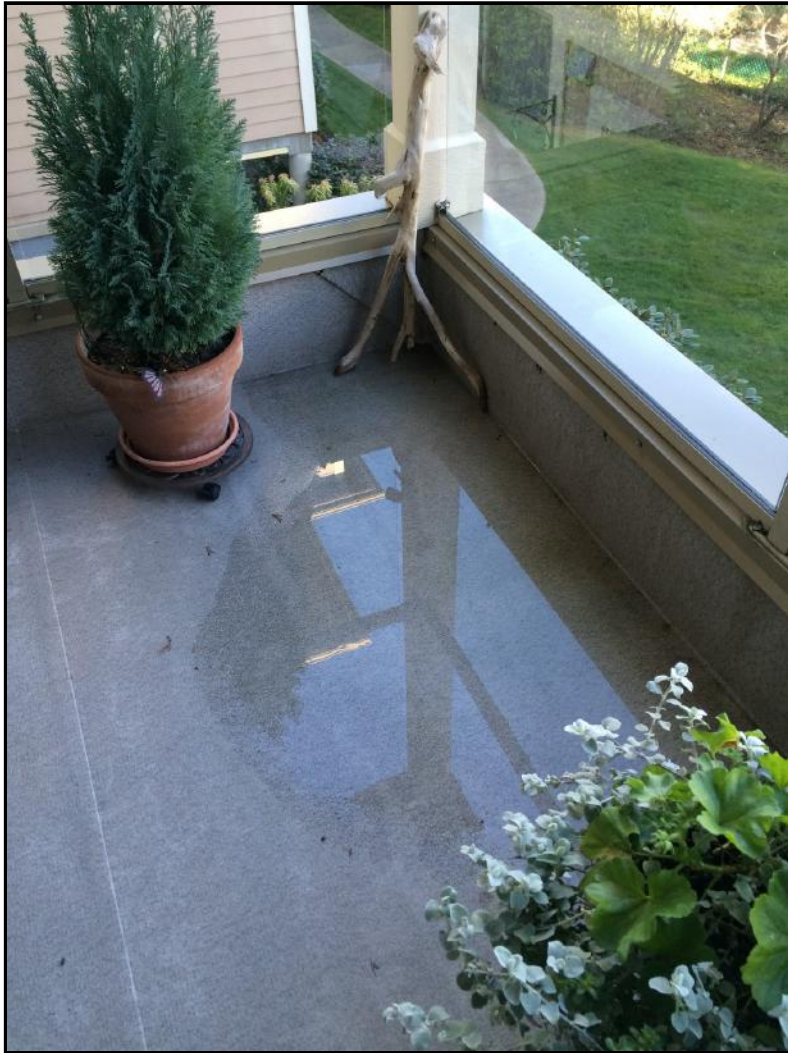
Photo No. 8: Balcony Waterproofing

2010: Replace fourth-level balcony membrane and upgrade drainage capacity to 3"x3" with funnels to merge together and then again to main downspouts from sloped roof gutters, \$5,418, as documented by Silverwood at Thetis Cove 35 Year Maintenance Plan.

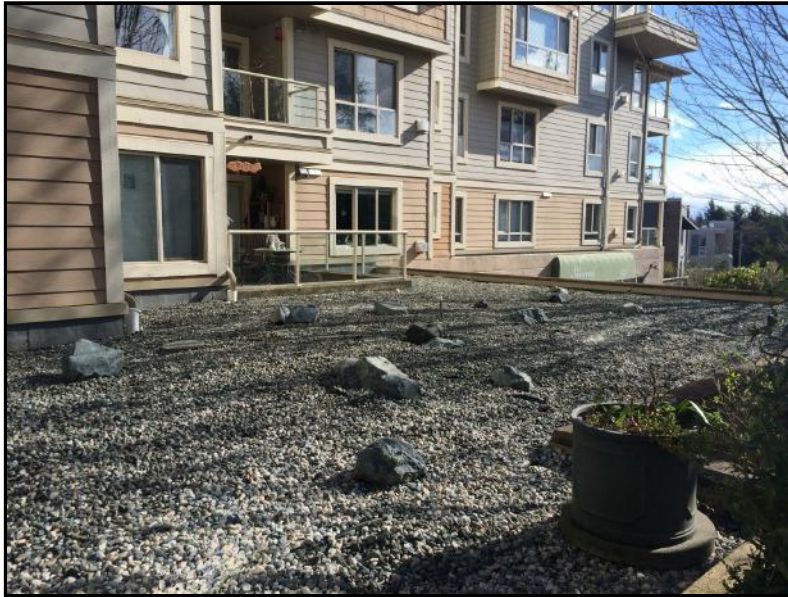
Photo No. 9: Parkade Roof Membrane

The parkade is generally in good condition. A leak near the gate entrance was first observed by residents in 2015 after work had been performed on the gravel ballast overhead roof. Efflorescence and slight water staining were also noted at the cold joints (ceiling to wall) within the storage rooms. Based on current conditions, capital expenditures are not anticipated within the reporting term for the parkade structure. Isolated leaks and cracks are expected to be addressed on an as-needed basis as part of ongoing maintenance. Replacement of the buried waterproofing membrane may be required within the next 30 years. The cost to replace the membrane is budgeted so that the Strata can proactively plan towards its' replacement. Monitoring the membranes condition by regularly reviewing the interior of the parkade for leaks and efflorescence is recommended.

| Project Name | Present Cost | Inflated Cost | First Occur. | Cycle | # Occurrences | CL | Status |
|--|---|---|---|---|---|---|---|
| Project Notes: This project allows for replacement of the 2-ply SBS waterproofing membrane. The work includes excavate fill, remove old membrane, install 2 ply SBS membrane, drainage mat and reinstate backfill, including the vegetation, landscaping, and pavement. | | | | | | | |

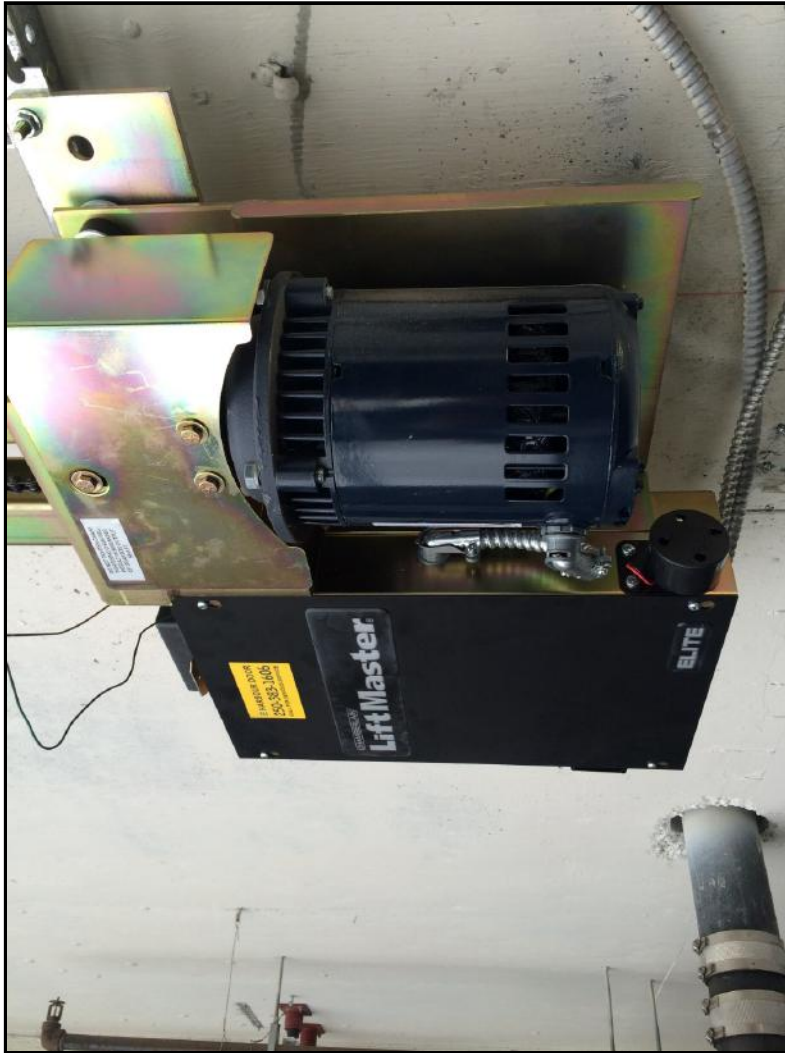
Photo No. 11: Parkade Motor

2014: Replaced parkade overhead gate motor with commercial grade motor, \$3,500, as documented by Silverwood at Thetis Cove 35 Year Maintenance Plan.

| Project Name | Present Cost | Inflated Cost | First Occur. | Cycle | # Occurrences | CL | Status |
|--|---|---|---|---|---|---|---|
| Project Notes: This project allows for replacement of the overhead gate motor every 15 years. | | | | | | | |

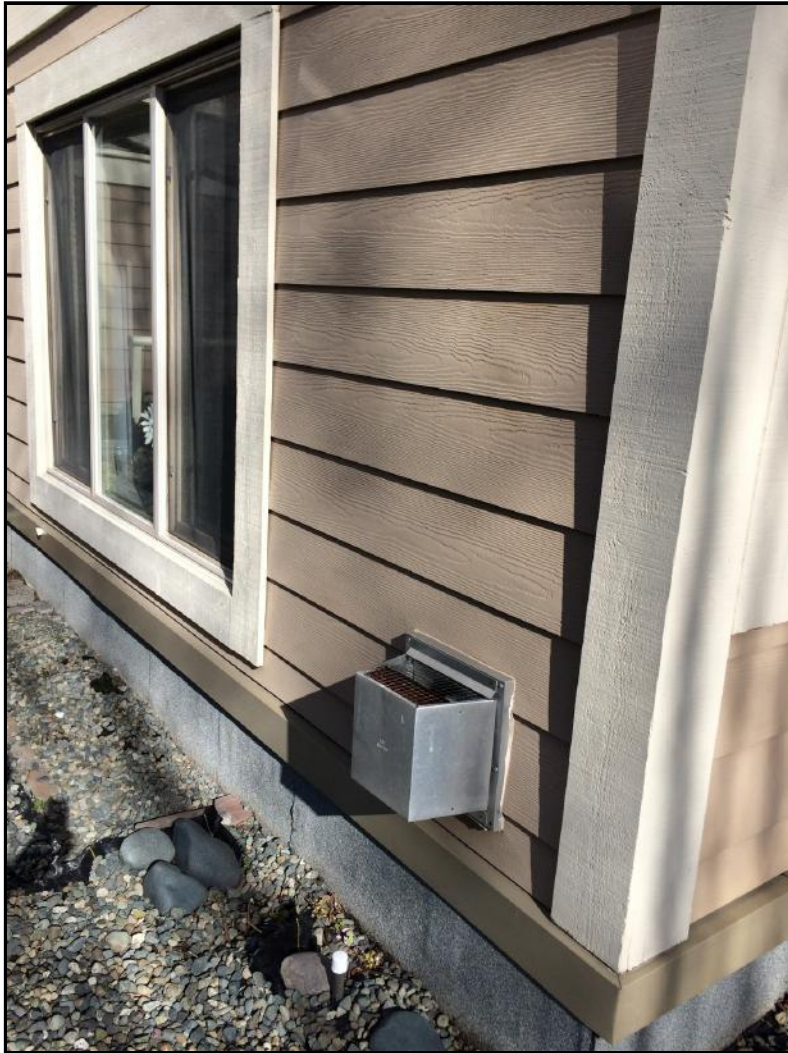
Photo No. 12: Fiber Reinforced Concrete (FRC) Siding

The exterior walls appeared to be good condition. Paint is holding well at parged concrete, fibre-cement siding and wood trim. Painting of wood trim is recommended every 10 years, and fiber-cement board and parging every 20. This schedule aligns full paint renewal every second cycle for cost savings. During installation the fibre cement boards had sealant applied between their butt joints. This has resulted in an aesthetic irregularity between field and joint paint wearing at different rates. When the fibre-cement is painted these areas can be addressed by sanding the sealant and repainting to form a consistent aesthetic. It is reasoned that board replacement is addressed through operating expenses. Parging and Fibre-cement board may last 70 years or more with regular painting and is thus not expected for replacement within the reporting period. Wood trim is budgeted to be renewed with vinyl window replacement after 40 years of service (2039).

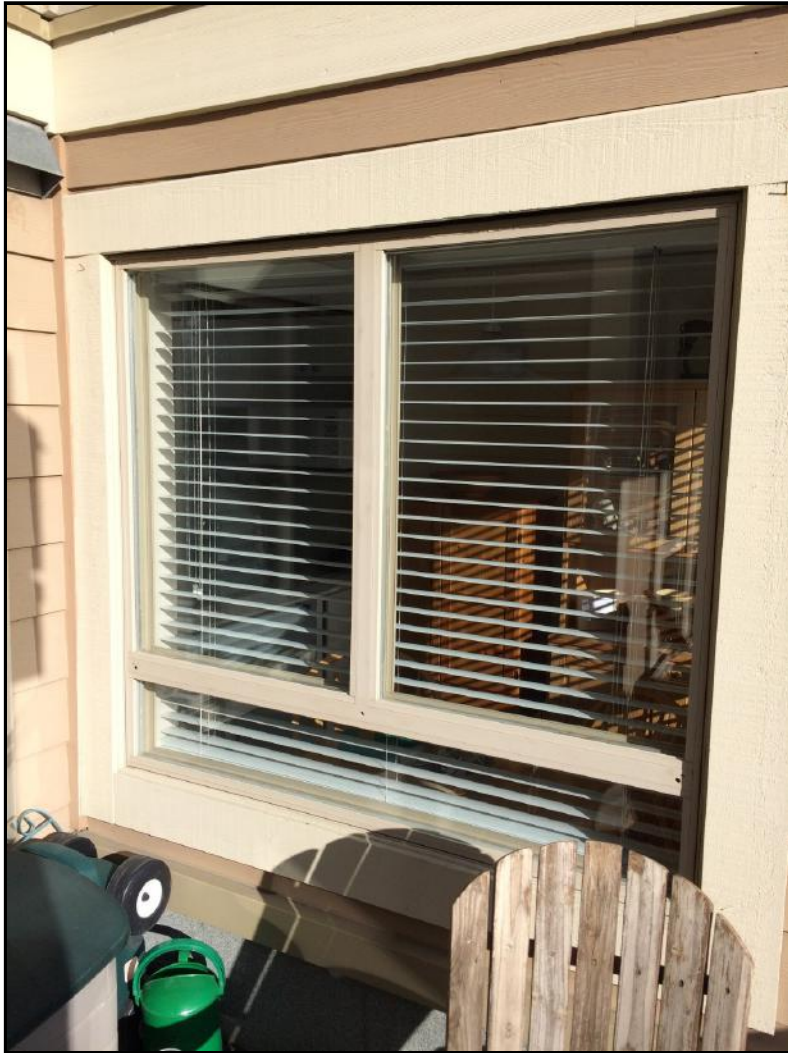
Photo No. 13: Vinyl Windows

Council members did not indicate any reports of water or excessive air leakage through the windows. We noted no evidence of water leakage in the areas reviewed. Weather-stripping on operable windows, where seen, was in serviceable condition. Some amount of IGU replacements should be expected on an annual basis, but based on the currently reported replacement requirements (which have been limited to about two units per year), we assume glass replacement will be managed from operating funds rather than capital, so no budget is included here. We assume ongoing repairs (i.e., replacing weather stripping and rollers, adjusting frames, etc.) will also be completed on an as-needed basis as a maintenance expense. Based on age and reported performance, full replacement of the window system may not be required within the report term, however a replacement budget is provided, after the average 40-year service life is reached, for Strata planning purposes.

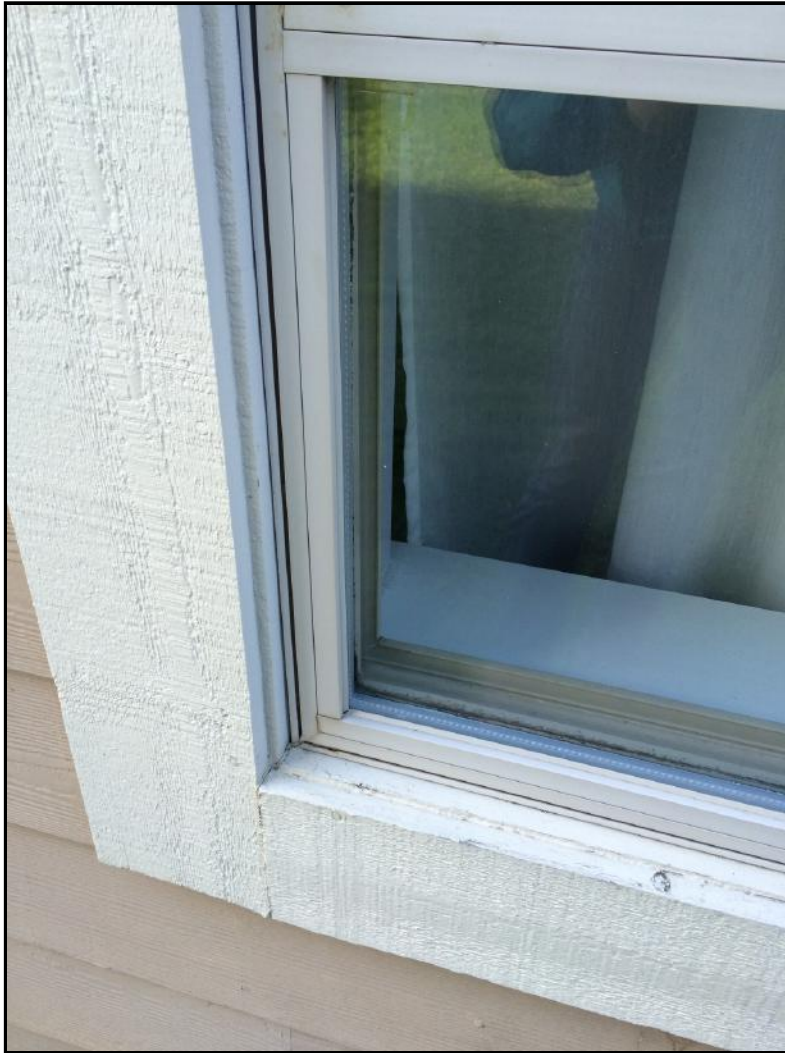
Photo No. 15: Caulking - Fenestration Sealing

The window to wall joints are protected by wood trim. Sealant was not observed at the jambs. There may be a concealed seal that complies with the BC Building Code to "Caulk between dissimilar materials".

| Project Name | Present Cost | Inflated Cost | First Occur. | Cycle | # Occurrences | CL | Status |
|---|---|---|---|---|---|---|---|
| Project Notes: This project allows installation of sealant at the window and door jambs and all joints in the wood trim. Subsequent renewals will require first removing the sealant in place and installing new sealant. Note: The lack of sealant should not result in the failure of the rainscreen wall system; however, the lack of sealant is allowing excess water to directly enter and thus load the window and door trim, particularly at the sill. Installing sealant should prolong the life of the wood trim. | | | | | | | |

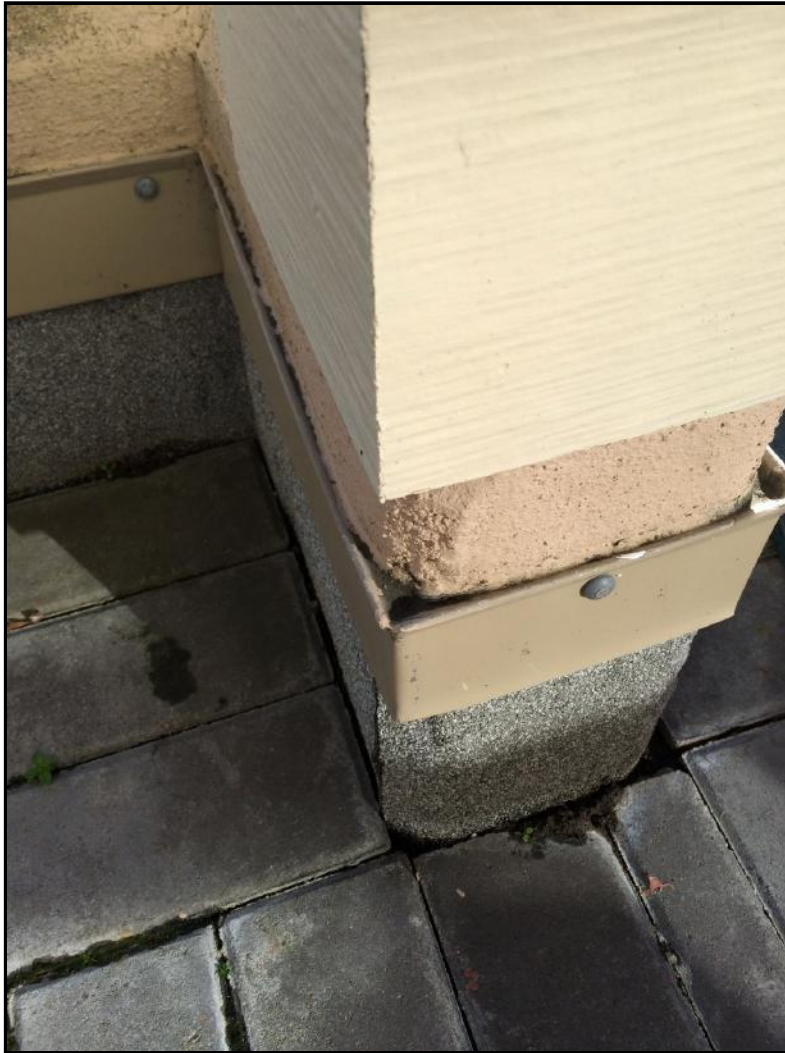
Photo No. 17: Patio Waterproofing - Over Conditioned Living Space

Council was not aware of any concerns for these patio roofing areas. A concealed waterproofing membrane generally serves 40 years, a replacement budget is scheduled to occur with the parkade roof membrane replacement in 2039.

| Project Name | Present Cost | Inflated Cost | First Occur. | Cycle | # Occurrences | CL | Status |
|---|---|---|---|---|---|---|---|
| 2.4.1 Patio Waterproofing - Over Conditioned Living Space Over guest suite/amenities room, overlooking the green house | \$18,720 | \$29,520 | 2039 | 40 yrs | One time | 3 | Forecasted |

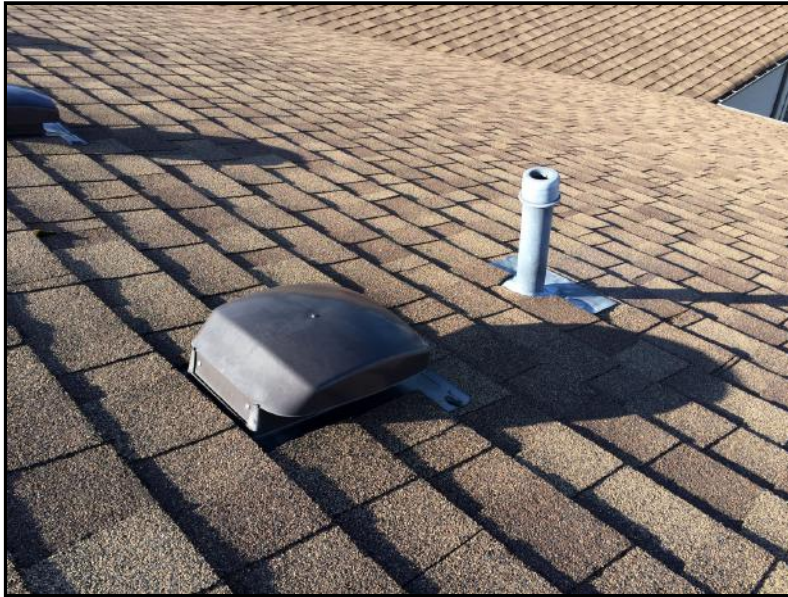
Photo No. 18: Asphalt Shingles

The asphalt shingle roof was observed in good condition from grade and hatch-access view points. Asphalt shingle and metal gutter replacement is scheduled after 25 years of service. Roof review, gutter cleaning, and localized repairs are assumed to be financed through the operating budget periodically.

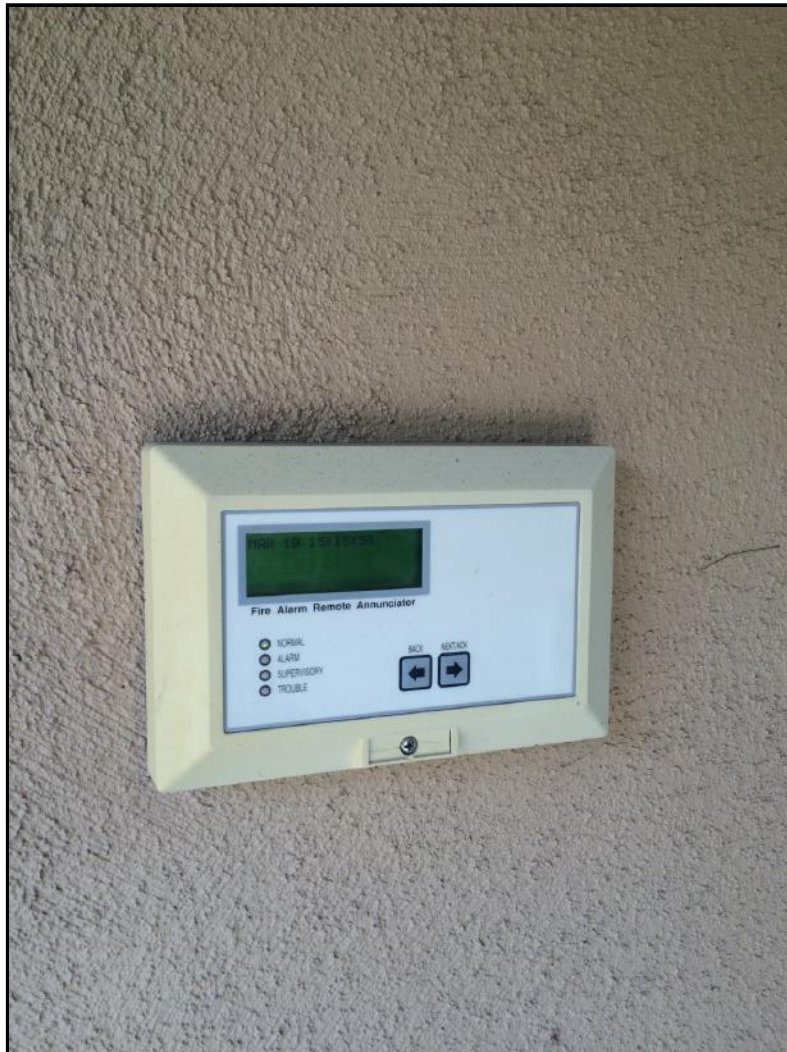
Photo No. 20: Fire Alarm System

TROY Fire and Safety conducted annual inspection and testing of the fire alarm system in April 2016. No major operational concerns were reported in their inspection report, or noted during our review. Minor repairs and replacement of bells, pull stations, and detectors, as identified by ongoing inspections, are expected to be completed as part of annual maintenance.

Fire alarm panels have a typical service life of about 15 to 20 years, but can often remain in service longer if replacement parts are available. Although parts for the EST 2 unit are readily available, TROY now deals with Tyco Simplex products and is recommended a Simplex panel for replacement. We assume that the new panel will be compatible with the existing system, re-using the majority of field devices and wiring. This may not be possible. Further review (which is beyond the scope of this mandate) is needed to confirm this. If the devices and wiring were to require replacement, the cost would be significantly higher.

| Project Name | Present Cost | Inflated Cost | First Occur. | Cycle | # Occurrences | CL | Status |
|--|---|---|---|---|---|---|---|
| <p>Project Notes: This project allows for replacement of the fire alarm and annunciator panels. It assumes that the new panel will be compatible with the existing devices and wiring; if this is not the case, the budget will need to be adjusted accordingly.</p> | | | | | | | |

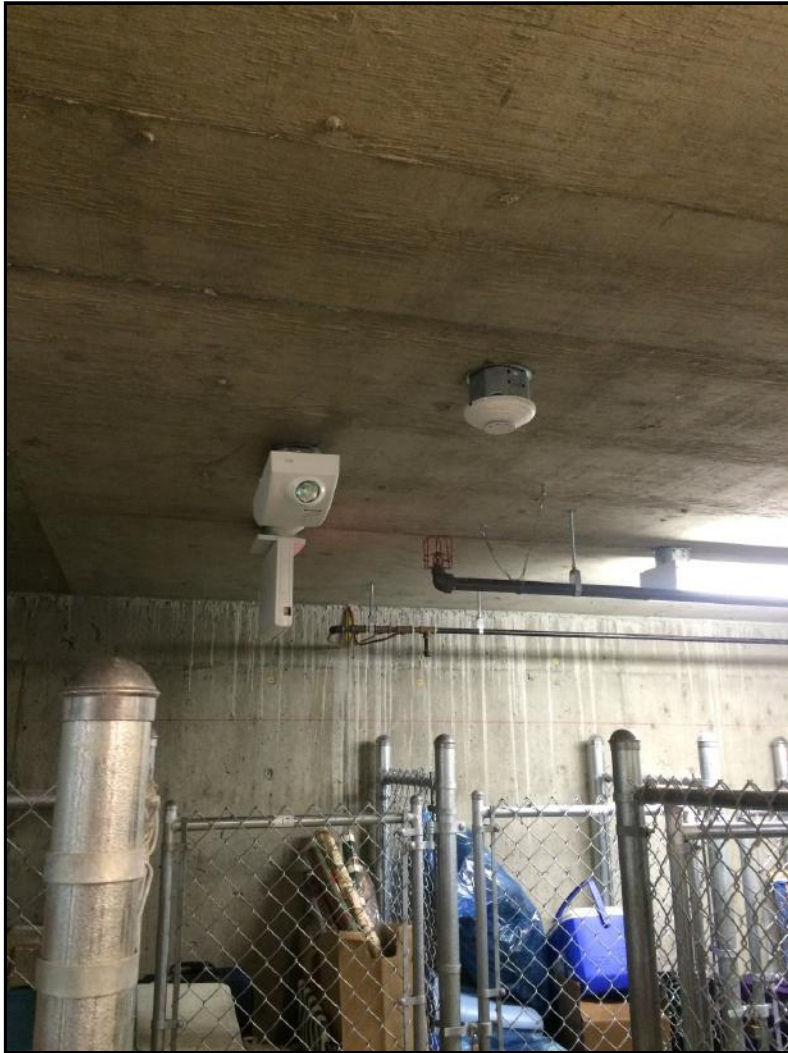
Photo No. 21: Lighting Emergency

Emergency lighting was functional, where checked. TROY indicated seven battery and one exit sign deficiencies in their most recent inspection dated March 2016. Given the limited extent of emergency power systems we assume they will be repaired/replaced as part of ongoing maintenance activities.

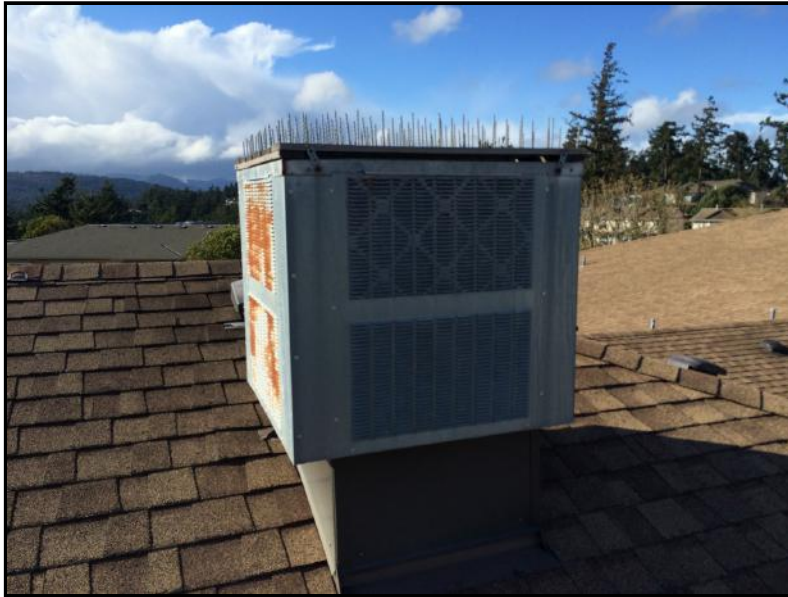
Photo No. 33: Air Handling Unit

The air-handling units were operating at the time of our site review. Corrosion was observed on exterior surfaces of units, however the interior condition of each unit was not visible during our review. Applying rust inhibiting paint may improve service life.

This type of equipment has a standard service life of about 20-25 years. However, it can last much longer with maintenance as many of the components can be changed without replacing the unit outright. Victoria JetVac typically conducts annual preventative maintenance and servicing of the equipment. The cost of this work, and any localized repairs, are assumed to be a maintenance expense.

Given the age of the AHUs we recommend planning replacement in 2019.

| Project Name | Present Cost | Inflated Cost | First Occur. | Cycle | # Occurrences | CL | Status |
|---|---|---|---|---|---|---|---|
| 6.1.1 Replace AHUs | \$12,420 | \$13,180 | 2019 | 20 yrs | 2 | 3 | Forecasted |

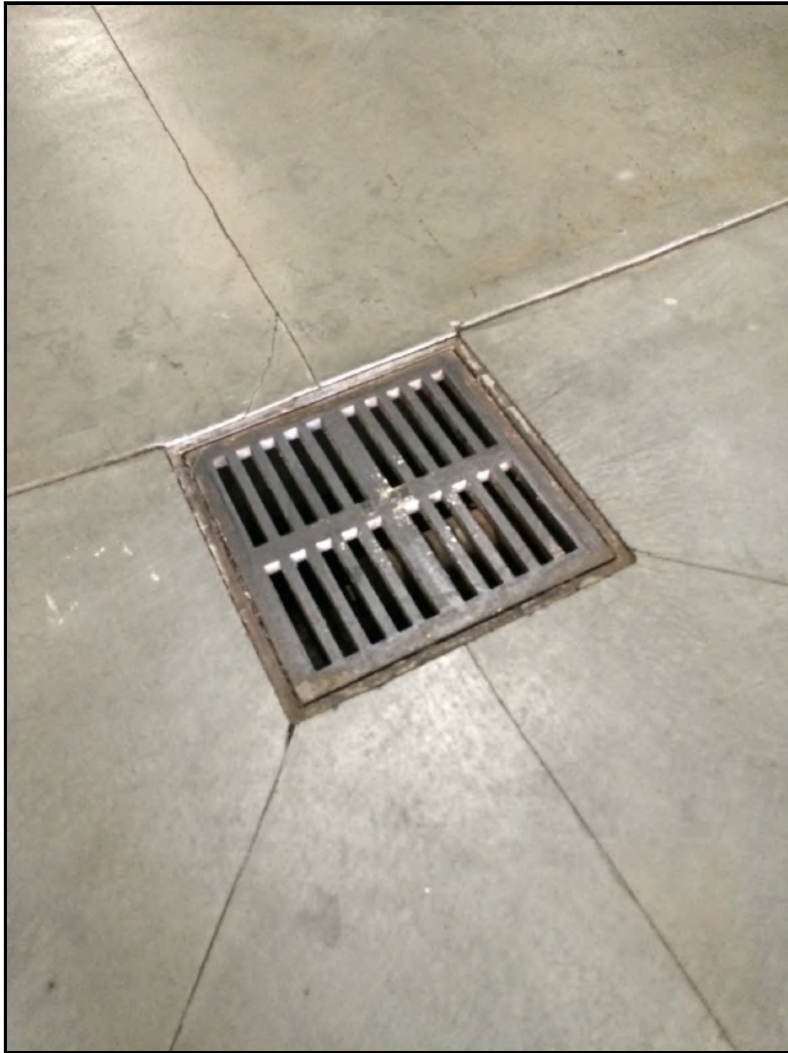
Photo No. 35: Storm Drain

The condition of buried services could not be confirmed. The east portion of landscaping can become saturated with storm events; drainage otherwise appears to be performing adequately. We recommend that drains be flushed and scoped annually at a minimum. This maximizes the service life of the piping and also helps identify repair needs. We assume this will be done as part of ongoing maintenance.
