INSPECTION REPORT

1041 FIRBIRN RD
ROBERTS CREEK, BC V0N 2W5

Prepared for: ANTHONY BROWTON
Inspection Date: Monday, December 4, 2017
Prepared by: Tom Pape

RE: Report No. 1159
1041 Firbirn Rd
Roberts Creek, BC
V0N 2W5

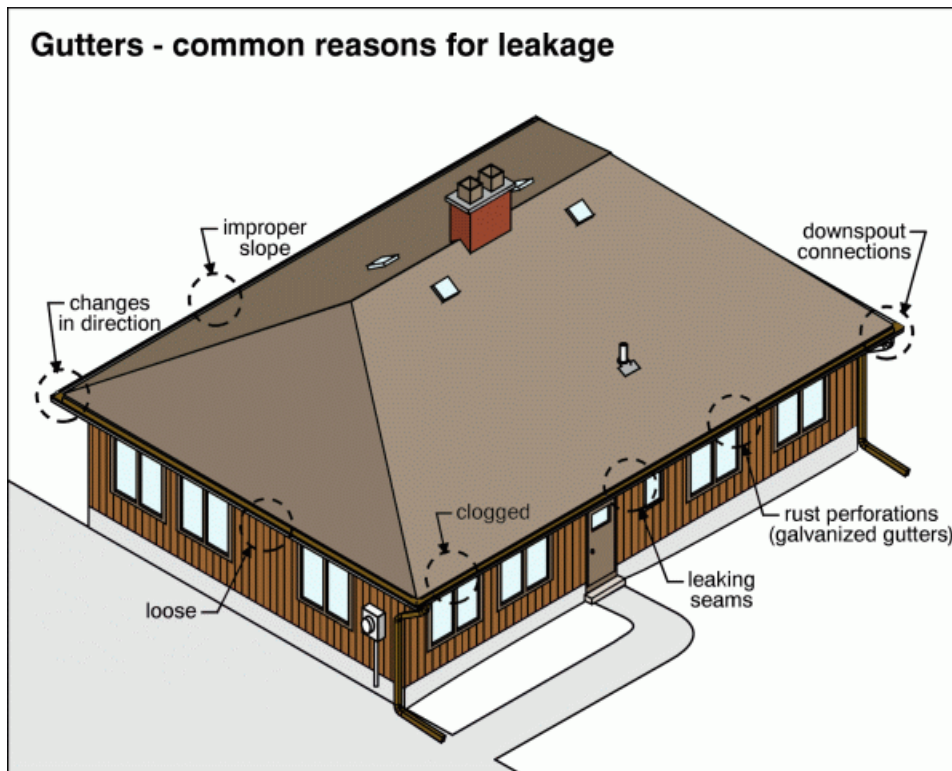
3. Condition: • [Clogged](#)

Implication(s): Chance of water damage to contents, finishes and/or structure

Task: Clean

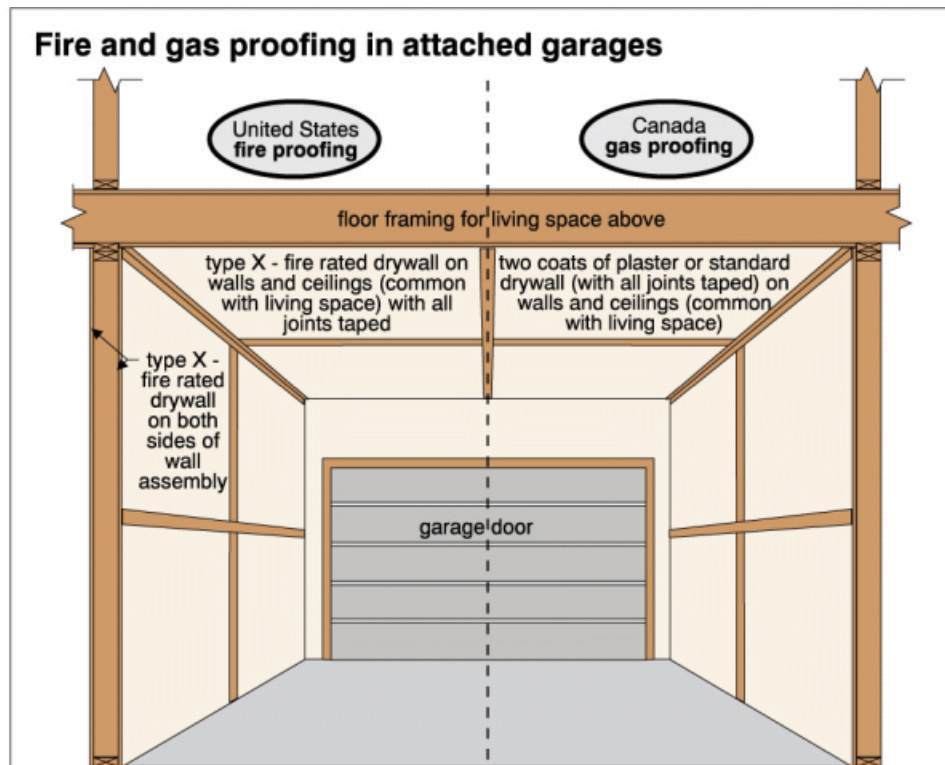
8. Condition: • Garage Loft is not adequately separated with gastight ceiling/floor and door therefore it should not be considered a permanent living space due to potential Carbon Monoxide fumes from vehicles parked in garage . Presently the loft is used as the owner's office and extra sleeping quarters.

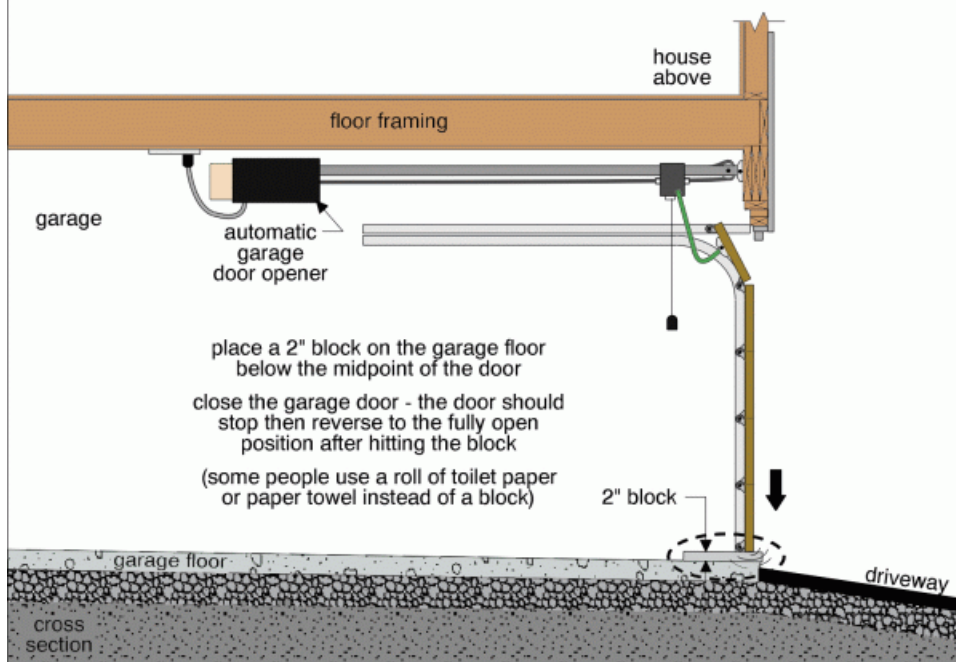
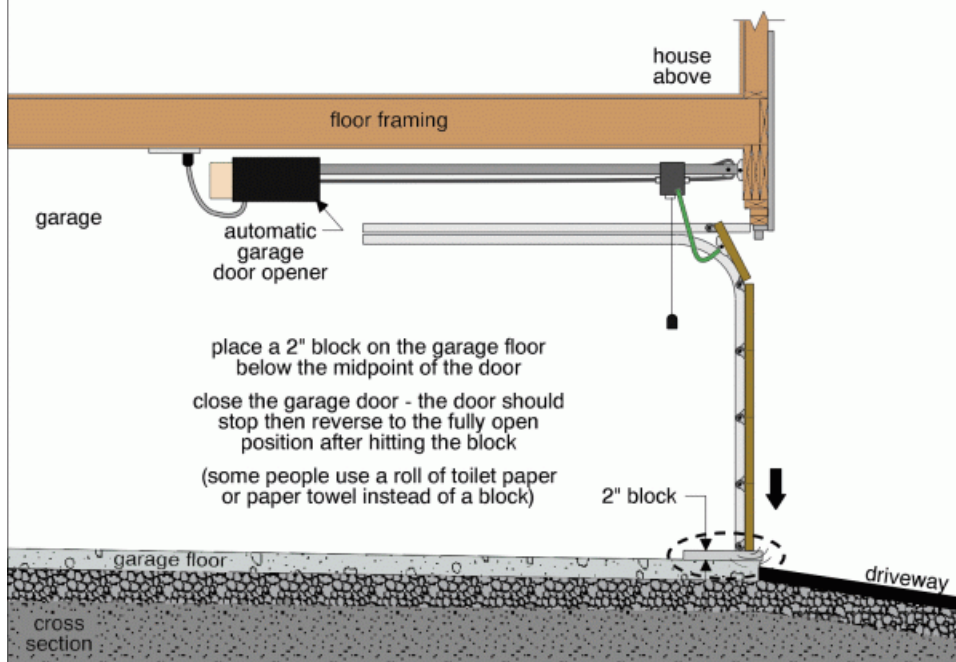
9. Condition: • [Fails to auto reverse](#)

Testing automatic reverse

Adjust Main House Garage opener to unsure retraction if obstacle or person is in the path of the door when closing.

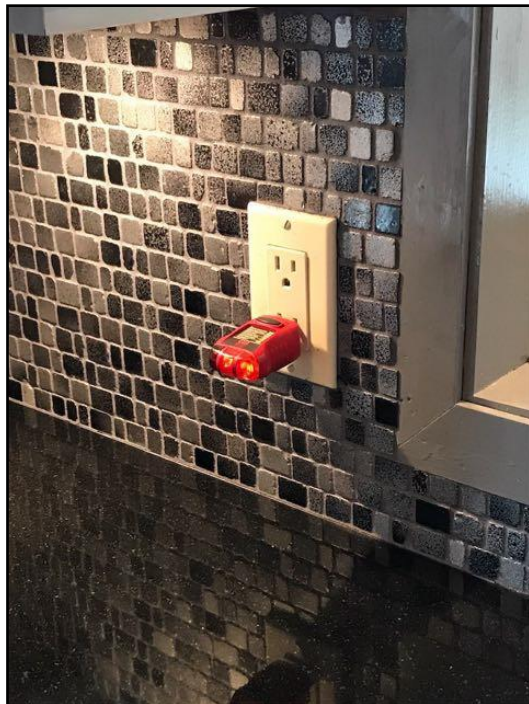
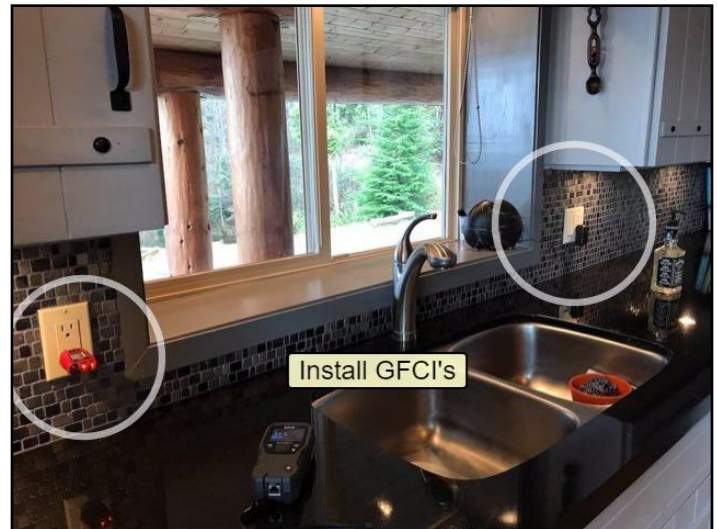
81. No GFCI

82. No GFCI
