1041 Firbirn Rd, Roberts Creek, BC December 4, 2017

Report No. 1159

www.truestarhomeinspections.com

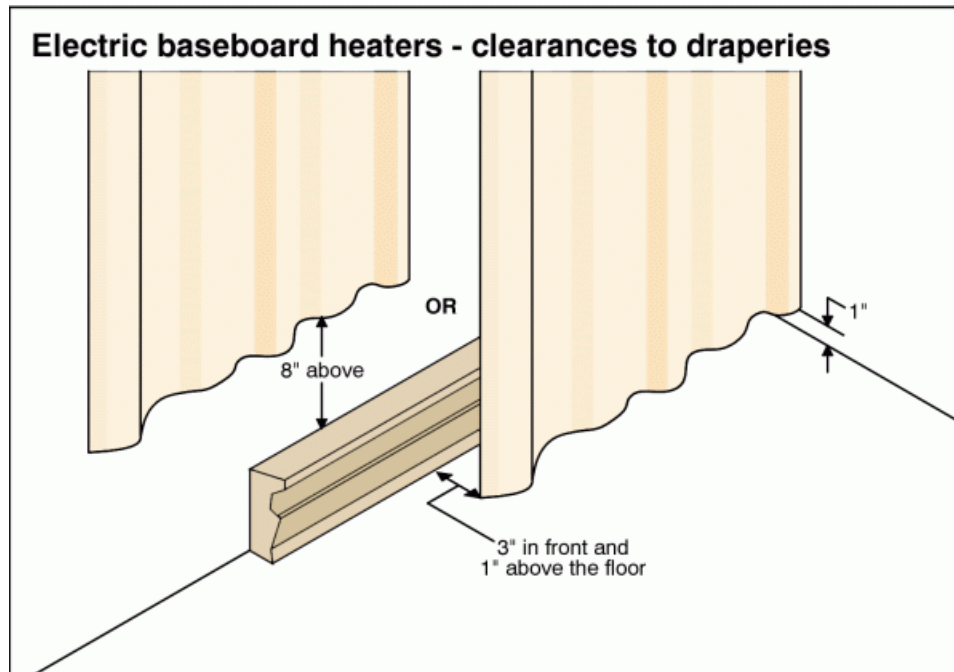
10. Condition: • [Obstructed heaters](#)

Ensure proper clearance around baseboard heaters.

Implication(s): Fire hazard | Reduced comfort

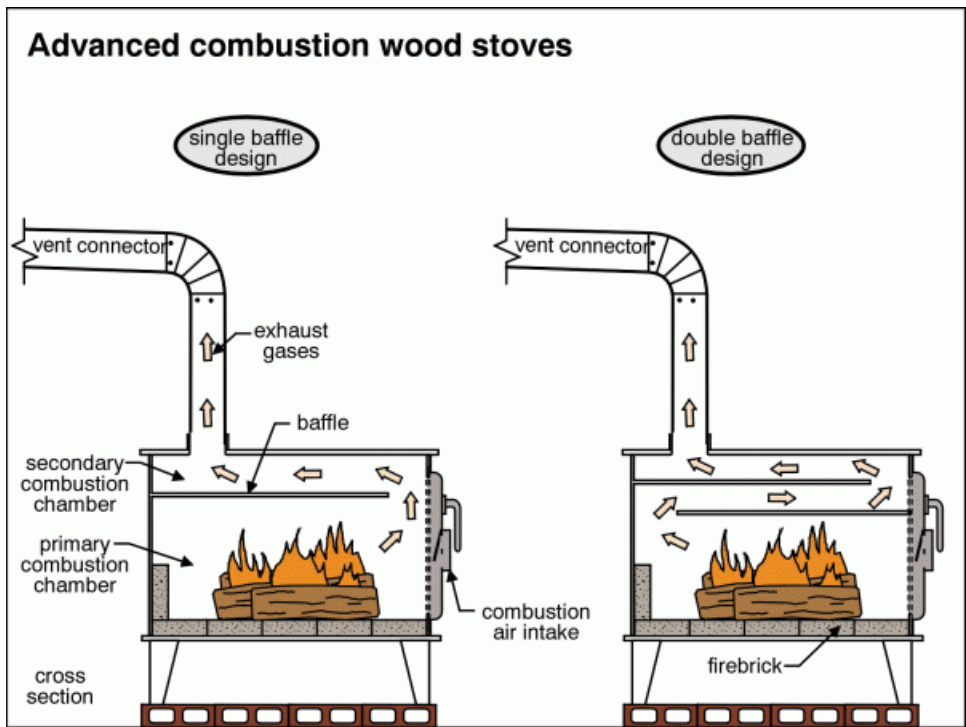
12. Condition: • [WETT Inspection \(Wood Energy Technology Transfer\)-](#)

Is recommended in order to obtain adequate house insurance coverage.

Request previous WETT Certificate from Owner and verify compliance with insurance broker.

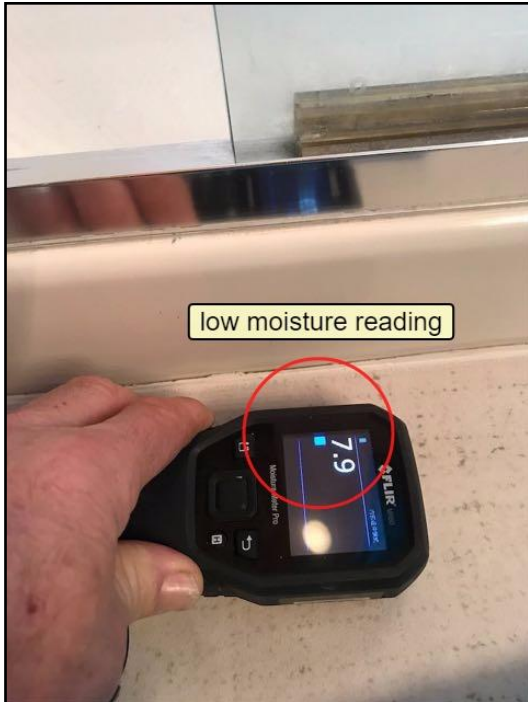
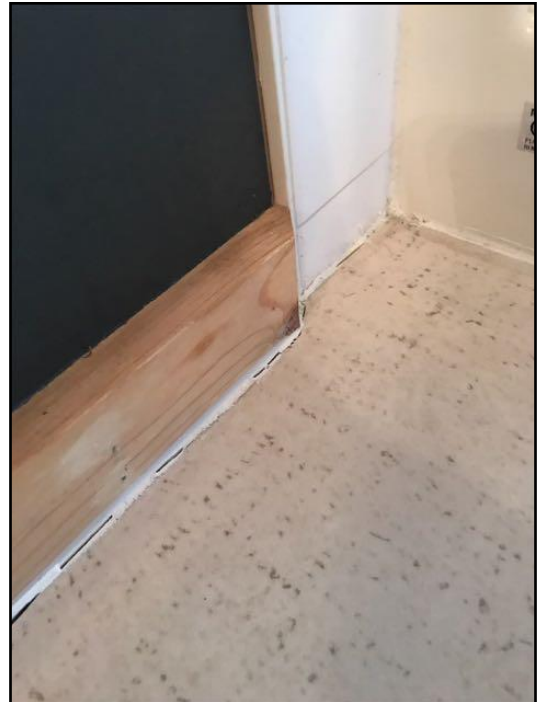
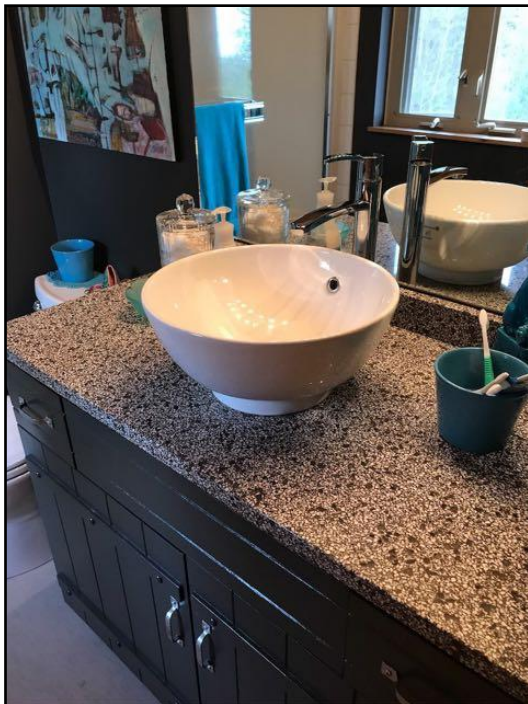
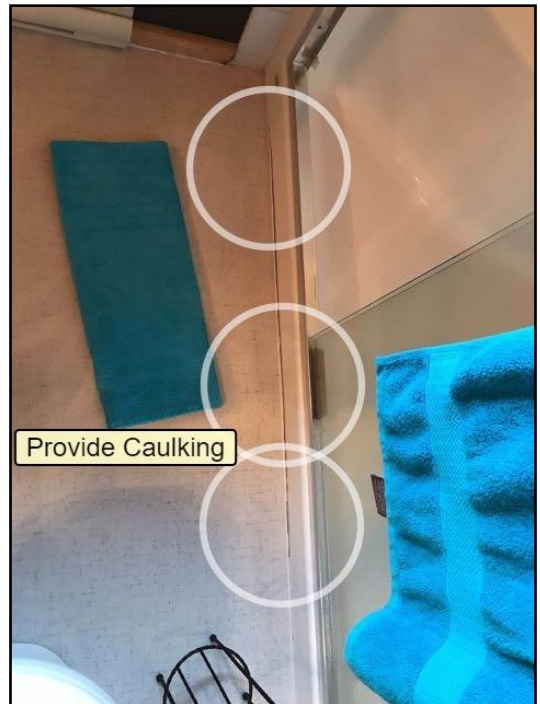
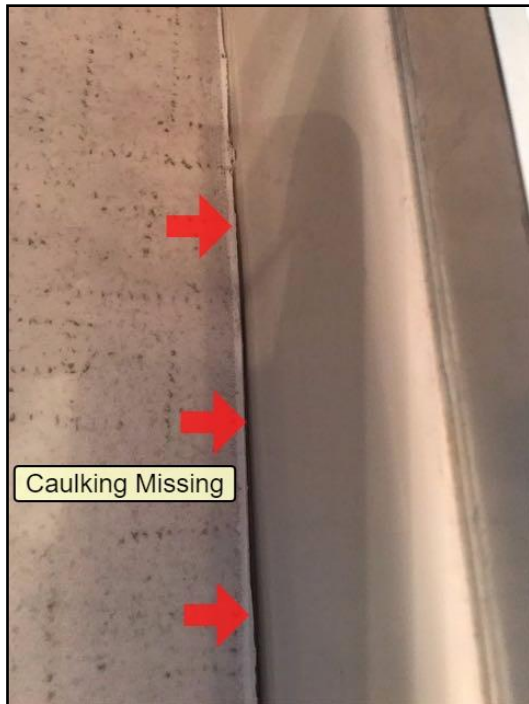
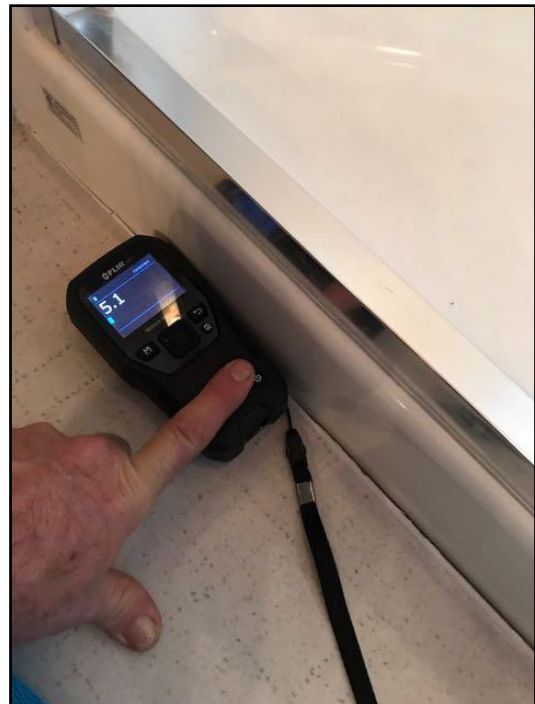
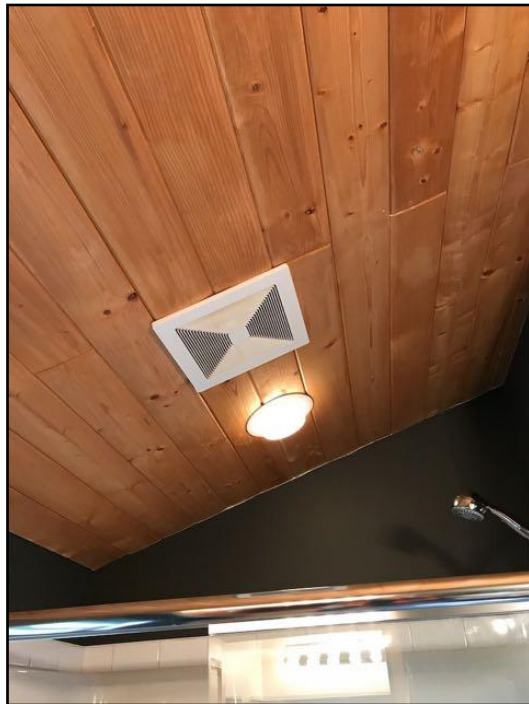
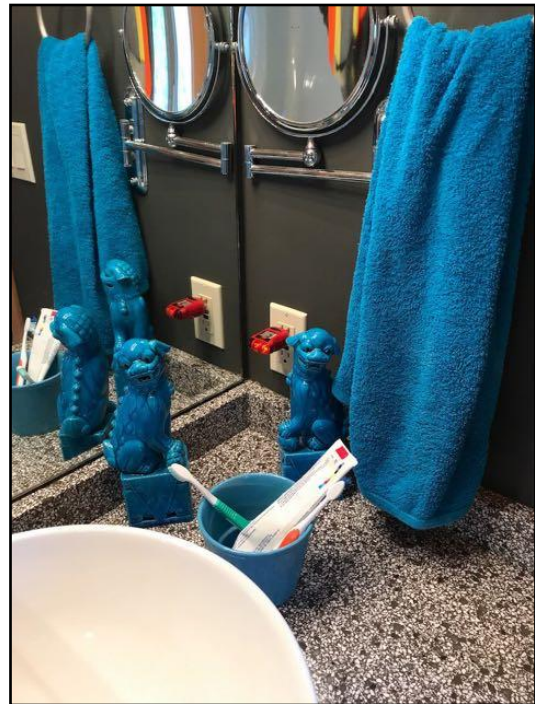
General: • Master Bathroom- Caulking Missing at Shower enclosure base. Improve

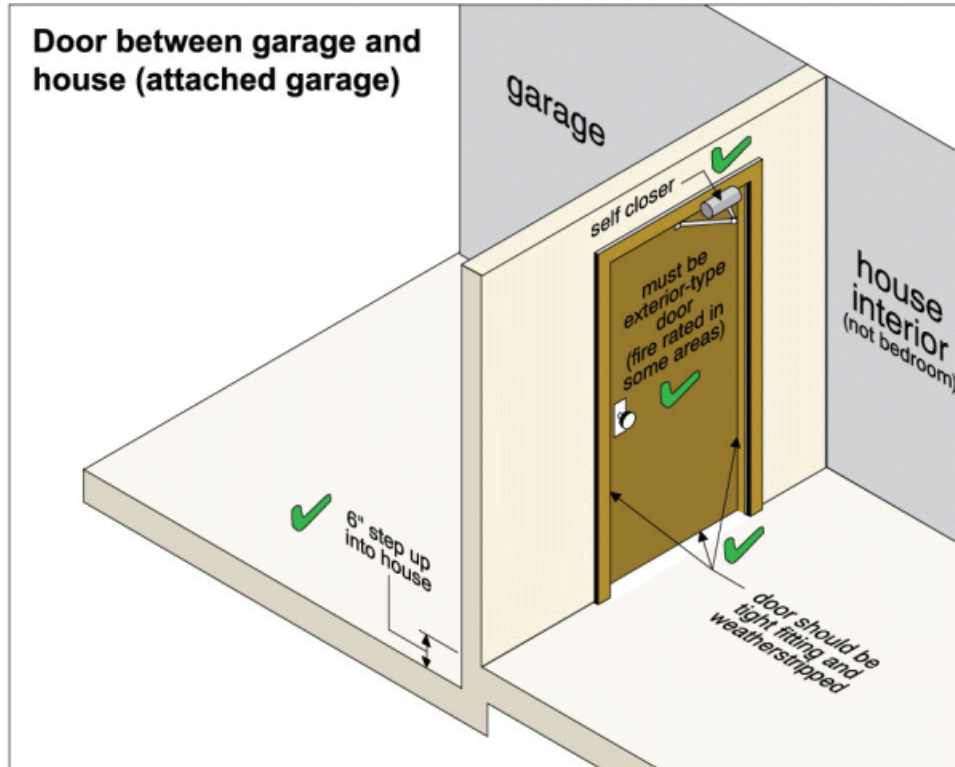
16. Condition: • Ensure Mandoor is self closing tightly.

Implication(s): Safety Issue
