Engineering Assessment of
Groundwater Flow

September 26, 2013 Rev 0

Re: **Islandview Lanes, 728 Gibsons Way, Gibsons, BC
Lot M Block 7 District Lot 688
Engineering Assessment of Groundwater Flow**

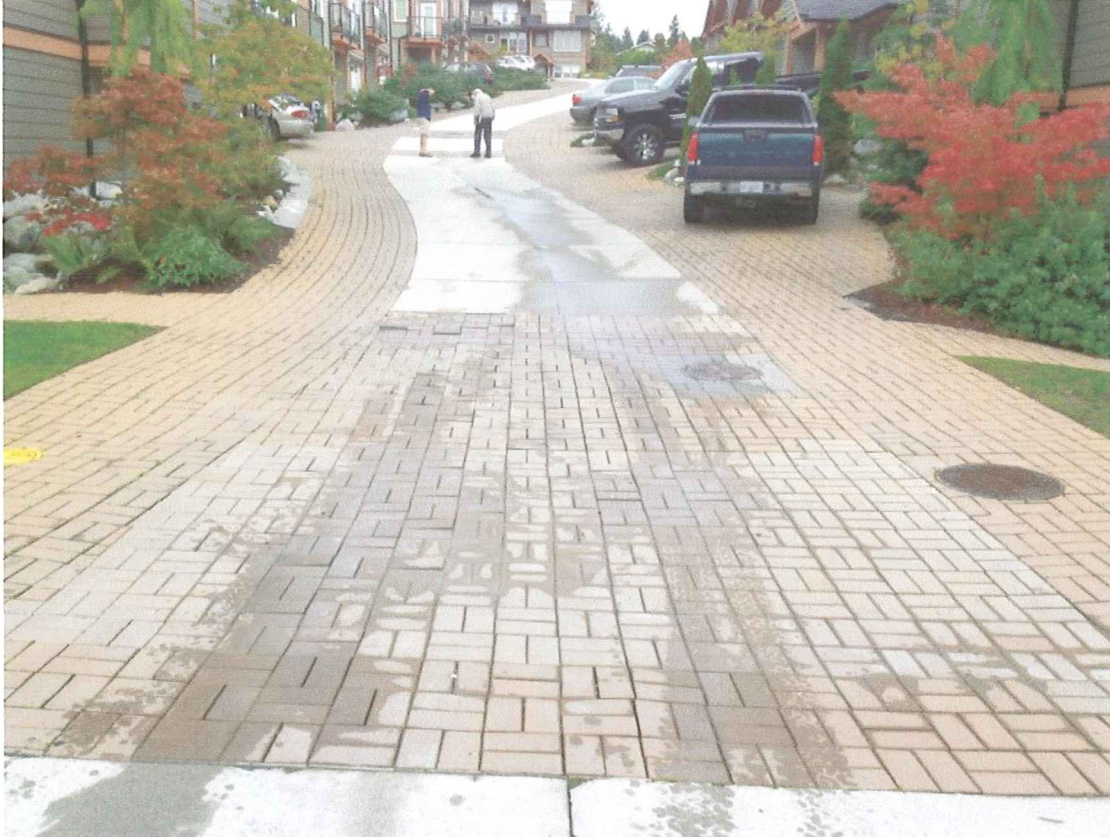
The driveway was constructed with impermeable concrete center panels and permeable brick shoulders and parking pads. Figure 2 shows that the center concrete pads seem to be floating on a saturated base with water exuding between the panels. In fact, when a local truck drove over the concrete panels, water could be seen oozing from the middle crack. Lower down, near the entrance, the brickwork appears to be floating on a saturated base with water clearly evident between the bricks. The obvious conclusion is that water is pooling under these surfaces. This is shown in greater detail in Figure 3.

Figure 2, Evidence of high ground water at the driveway entrance.

This photo shows evidence of groundwater surfacing via the driveway. The photo was taken on 16 September 2013. The previous day saw a significant rainfall event wherein greater than average mm rainfall/hour occurred. Vehicle loading of the concrete pads resulted in water being extruded out from underneath. Pedestrian loading was sufficient to cause water extrusion on the brickwork.

This effect is only prominent on the lowest portion of the development driveway, i.e. the portion between the pedestrians and the viewer's location. This corresponds to the section between Unit 6 and the entrance. A similar, albeit lesser, effect of groundwater extrusion on the brickwork between Unit 9 and Unit 6 was also evident.

1. A French drain on the west side of the property originating from at least the area of unit 6 down to the front of the parcel could reduce ground water influx from upslope sufficiently to allow the groundwater retention system to function as planned. However this drain needs somewhere to empty out. This drain should be at a depth sufficient to intercept the majority of groundwater flow.

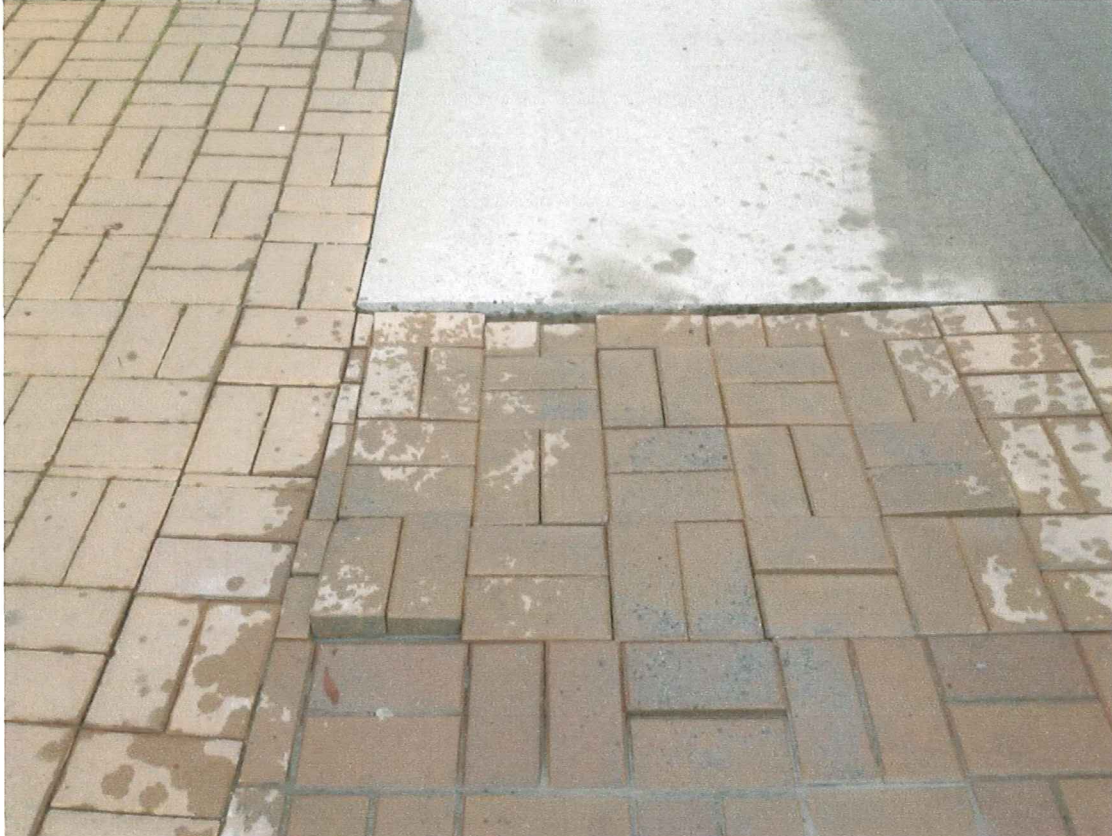
Figure 3, Close up view of brickwork with groundwater extrusion.

It is evident that this portion of the driveway is saturated with groundwater. Compared to adjacent areas this should have drained already. In fact the area surrounding the entrance also exhibited high ground water level and spongy behavior.

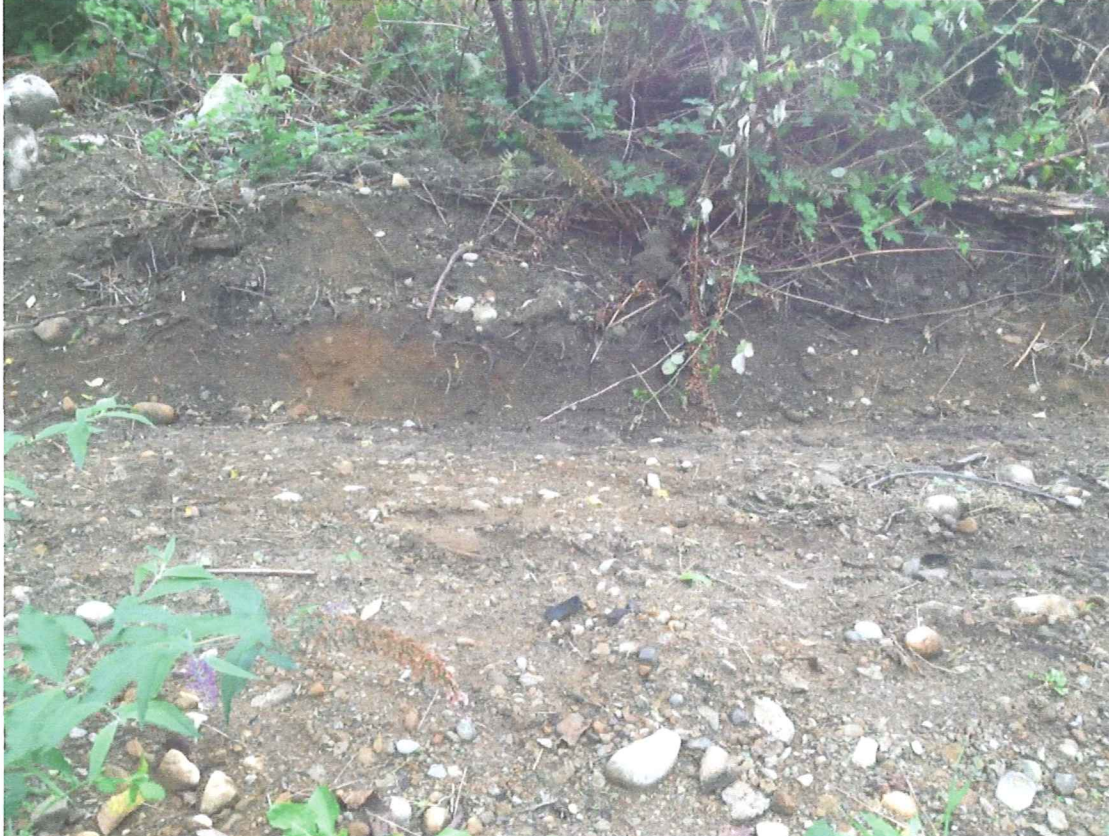
Figure 4, Soil profile from adjacent (upper) parcel.

Observation of the surface and near-surface soils of the adjacent upper parcel indicates that the upper soil horizon common to this area is loamy sand with reasonable cobble content. In this regard surface water will penetrate with a strong vertical component until it reaches either a more restrictive horizon or a barrier horizon of either hardpan or bedrock at which point the major flow component will become largely horizontal. Once a condition of saturation occurs (usually adjacent to the restrictive horizon) horizontal flow will occur with less resistance.

As there appears to be no swale or French drain on the high (west) side of the development to divert groundwater this flow will concentrate through more free flowing portions of the development. This effect will be more pronounced with increased precipitation during a finite time period.

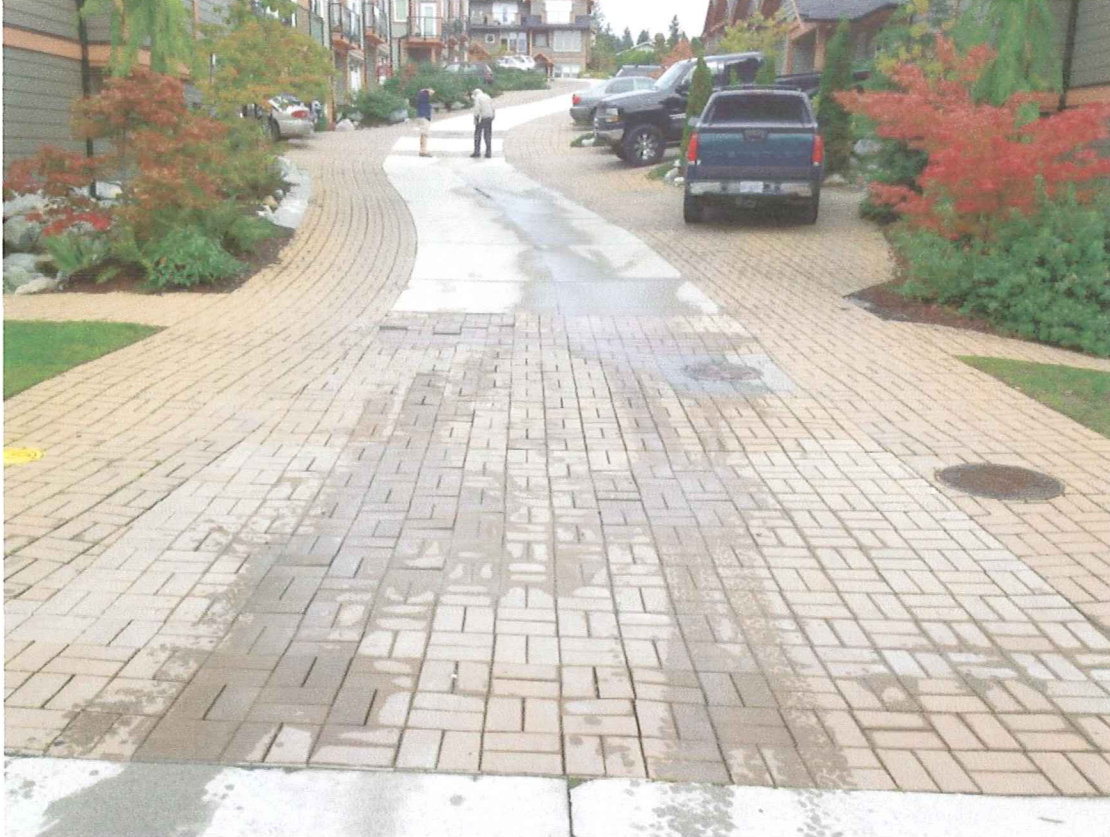
The driveway was constructed with impermeable concrete center panels and permeable brick shoulders and parking pads. Figure 2 shows that the center concrete pads seem to be floating on a saturated base with water exuding between the panels. In fact, when a local truck drove over the concrete panels, water could be seen oozing from the middle crack. Lower down, near the entrance, the brickwork appears to be floating on a saturated base with water clearly evident between the bricks. The obvious conclusion is that water is pooling under these surfaces. This is shown in greater detail in Figure 3.

Figure 2, Evidence of high ground water at the driveway entrance.

This photo shows evidence of groundwater surfacing via the driveway. The photo was taken on 16 September 2013. The previous day saw a significant rainfall event wherein greater than average mm rainfall/hour occurred. Vehicle loading of the concrete pads resulted in water being extruded out from underneath. Pedestrian loading was sufficient to cause water extrusion on the brickwork.

This effect is only prominent on the lowest portion of the development driveway, i.e. the portion between the pedestrians and the viewer's location. This corresponds to the section between Unit 6 and the entrance. A similar, albeit lesser, effect of groundwater extrusion on the brickwork between Unit 9 and Unit 6 was also evident.

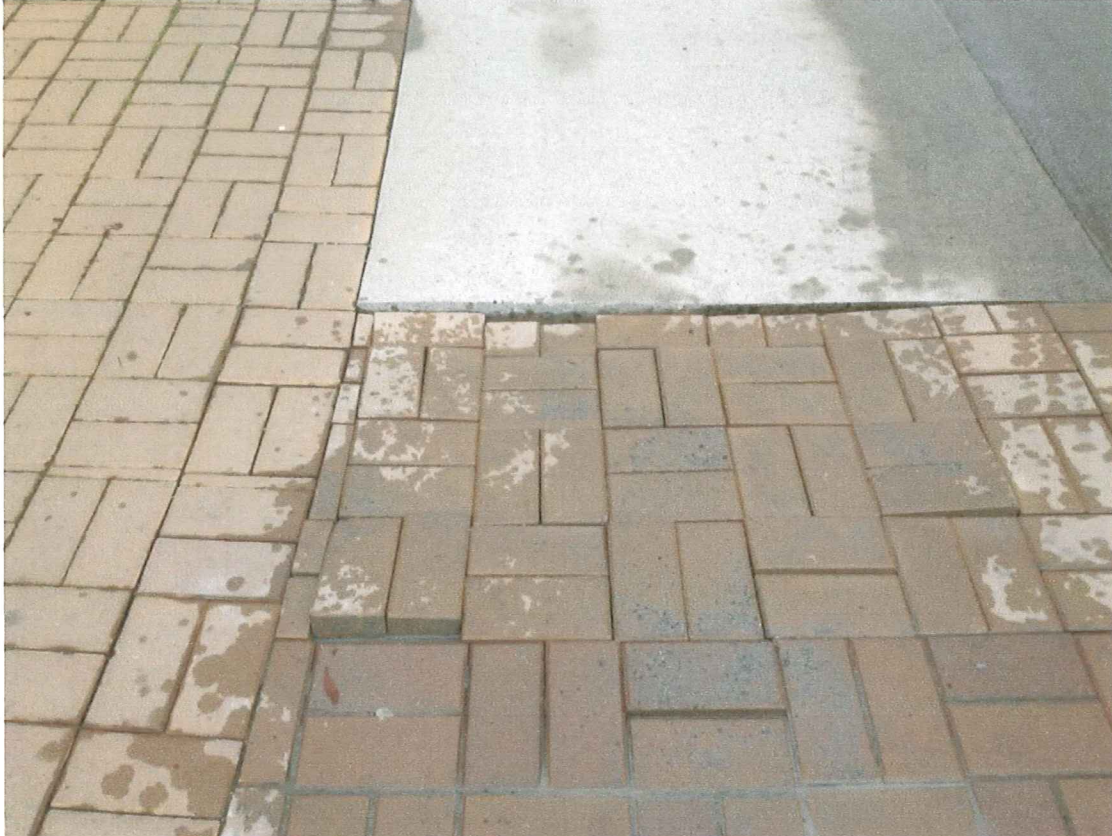
Figure 3, Close up view of brickwork with groundwater extrusion.

It is evident that this portion of the driveway is saturated with groundwater. Compared to adjacent areas this should have drained already. In fact the area surrounding the entrance also exhibited high ground water level and spongy behavior.

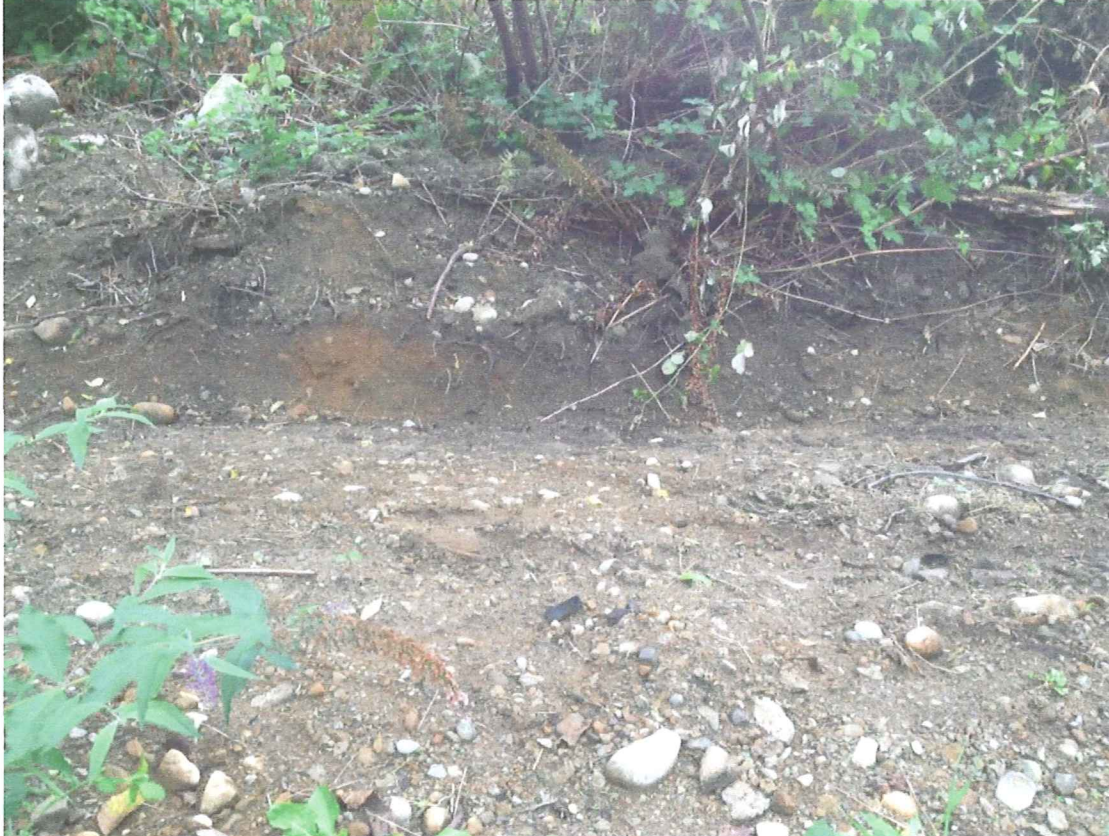
Figure 4, Soil profile from adjacent (upper) parcel.

Observation of the surface and near-surface soils of the adjacent upper parcel indicates that the upper soil horizon common to this area is loamy sand with reasonable cobble content. In this regard surface water will penetrate with a strong vertical component until it reaches either a more restrictive horizon or a barrier horizon of either hardpan or bedrock at which point the major flow component will become largely horizontal. Once a condition of saturation occurs (usually adjacent to the restrictive horizon) horizontal flow will occur with less resistance.

As there appears to be no swale or French drain on the high (west) side of the development to divert groundwater this flow will concentrate through more free flowing portions of the development. This effect will be more pronounced with increased precipitation during a finite time period.
