YOUR Inspection Report

702 Gibsons Way
Gibsons, BC V0N 1V9

Friday, October 21, 2016

RE: Report No. 1120, v.3
702 Gibsons Way
Gibsons, BC
V0N 1V9

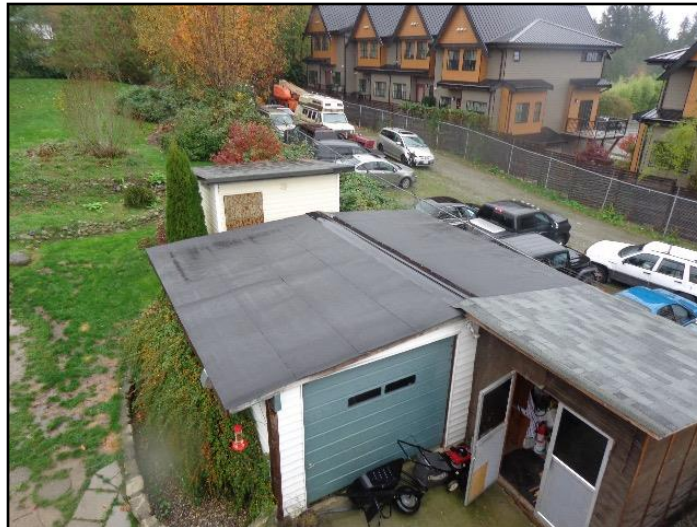
There is torch on membrane on the out buildings.

1. Modified bitumen membrane

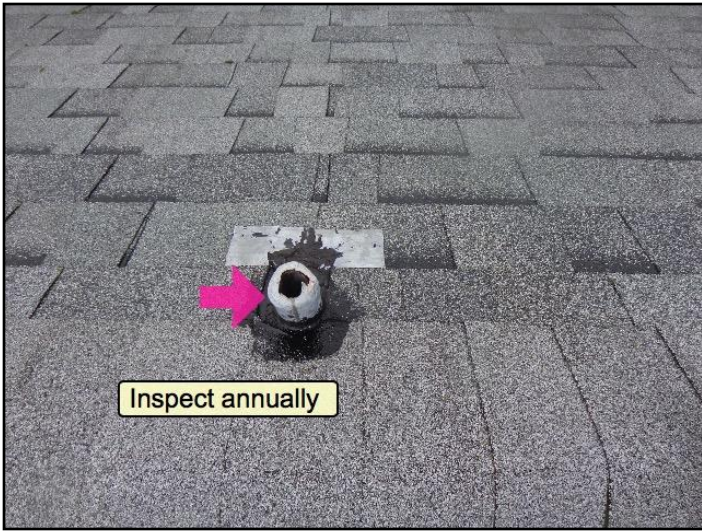
2. Condition: • The vent stack flashings on the roof have been caulked on the upper side of the vent stacks. This may have been done as preventative maintenance or to repair leaking seams. Monitor the caulking on an annual basis and replace cracked or missing caulking as part of the home's annual tune up and maintenance.

2. Vent stack

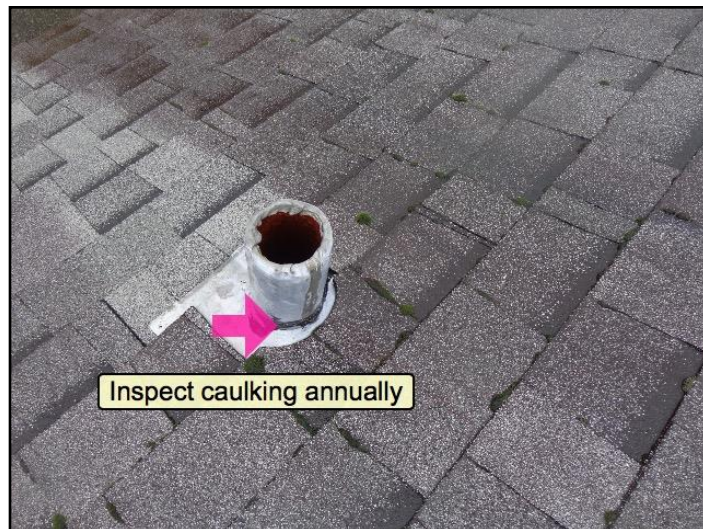
4. Vent stack

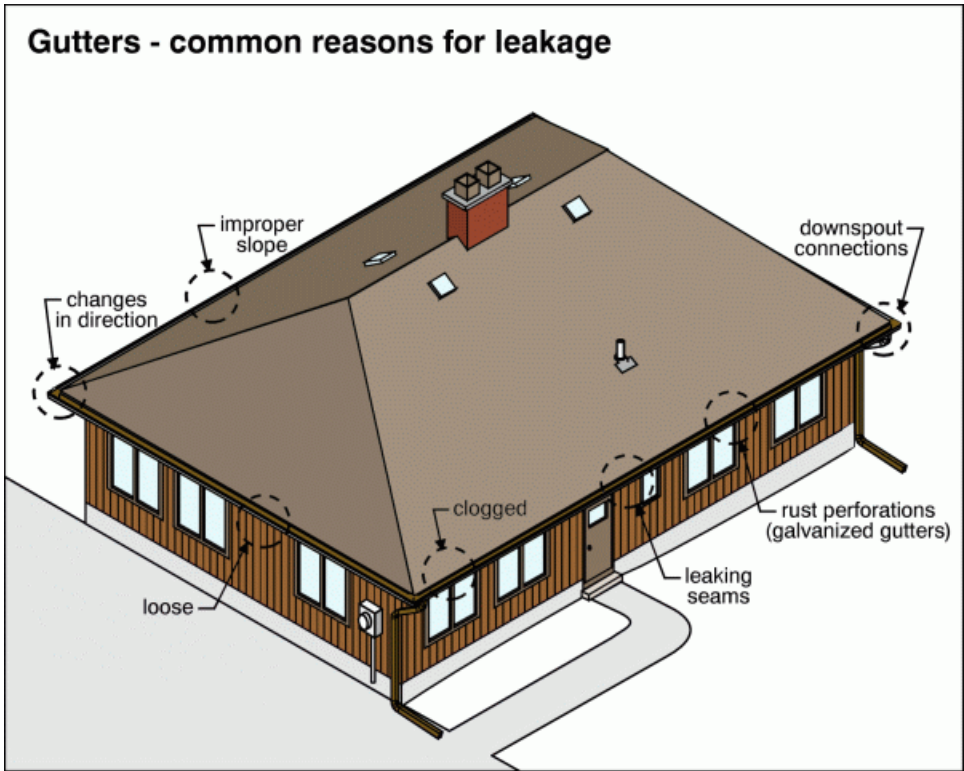
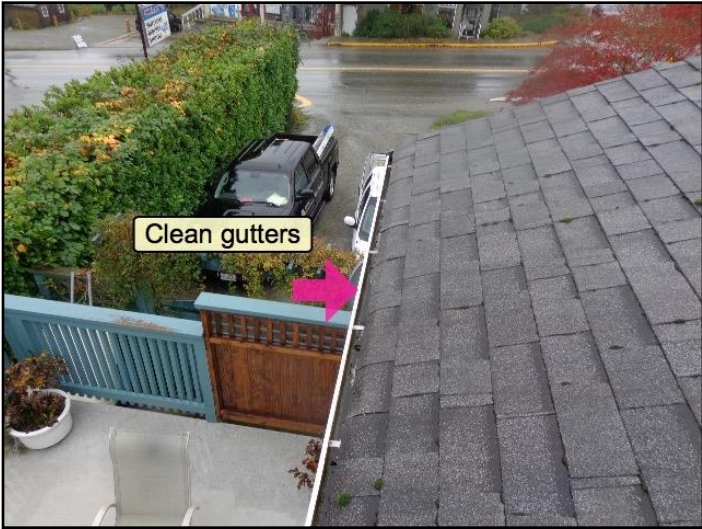
3. Condition: • [Clogged](#)

Implication(s): Chance of water damage to contents, finishes and/or structure

5. Clogged

Task: Clean

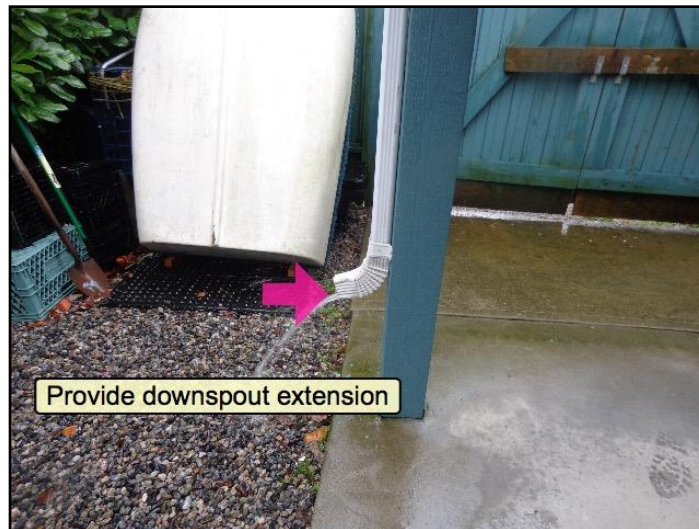
4. Condition: • [Should discharge 6 feet from building](#)

Implication(s): Chance of water damage to contents, finishes and/or structure

6. Should discharge 6 feet from building

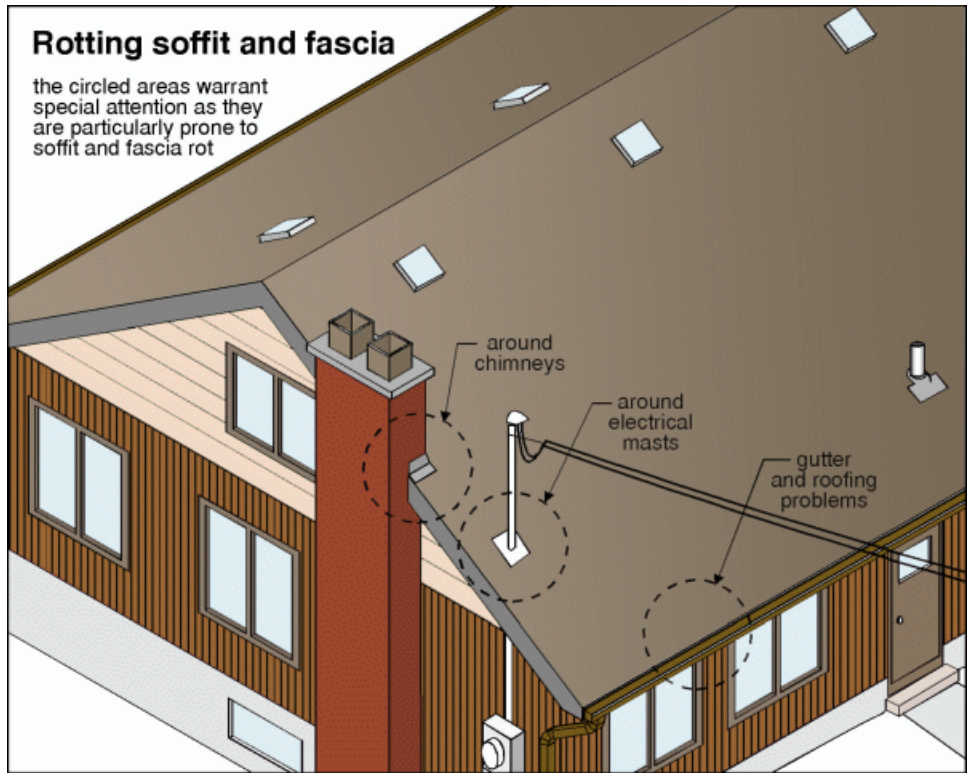
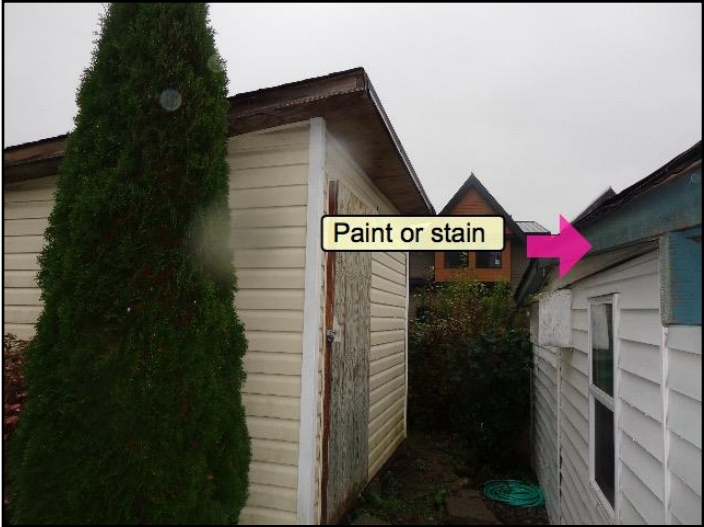
5. Condition: • [Paint or stain needed](#)

Implication(s): Cosmetic defects | Chance of water damage to contents, finishes and/or structure | Shortened life expectancy of material

7. Paint or stain needed

Scrape and apply paint or stain to the fascia. Reset protruding nails and re nail any loose fascia. Replace rotten end boards on fascia. Complete repairs prior to applying paint or stain.

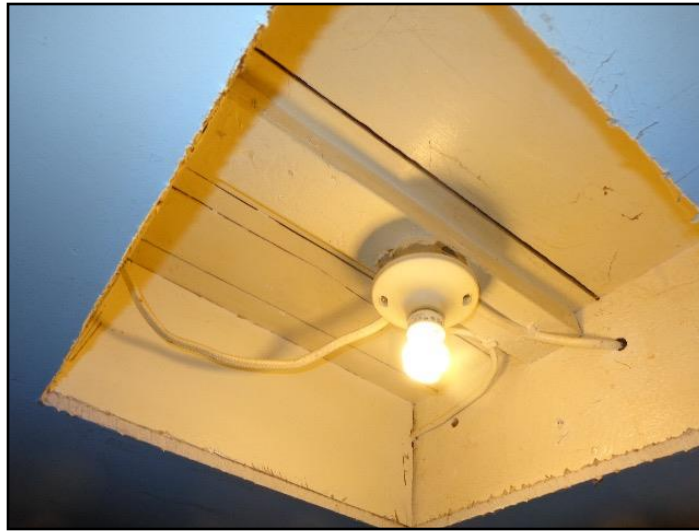
- Further evaluation of the recessed lighting in the basement is required to evaluate potential fire risk.

Implication(s): Possible fire risk.

8. Recessed lighting

Task: Further evaluation

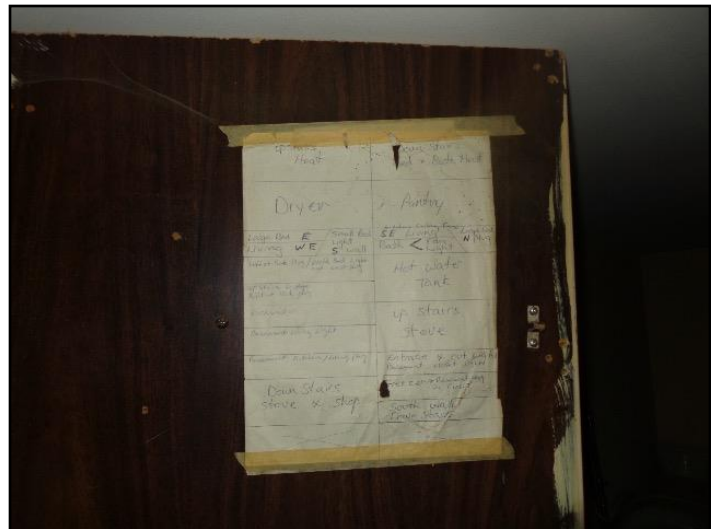
10. Condition: • [Circuits not labeled](#)

9. Circuits not labeled properly

Task: Improve

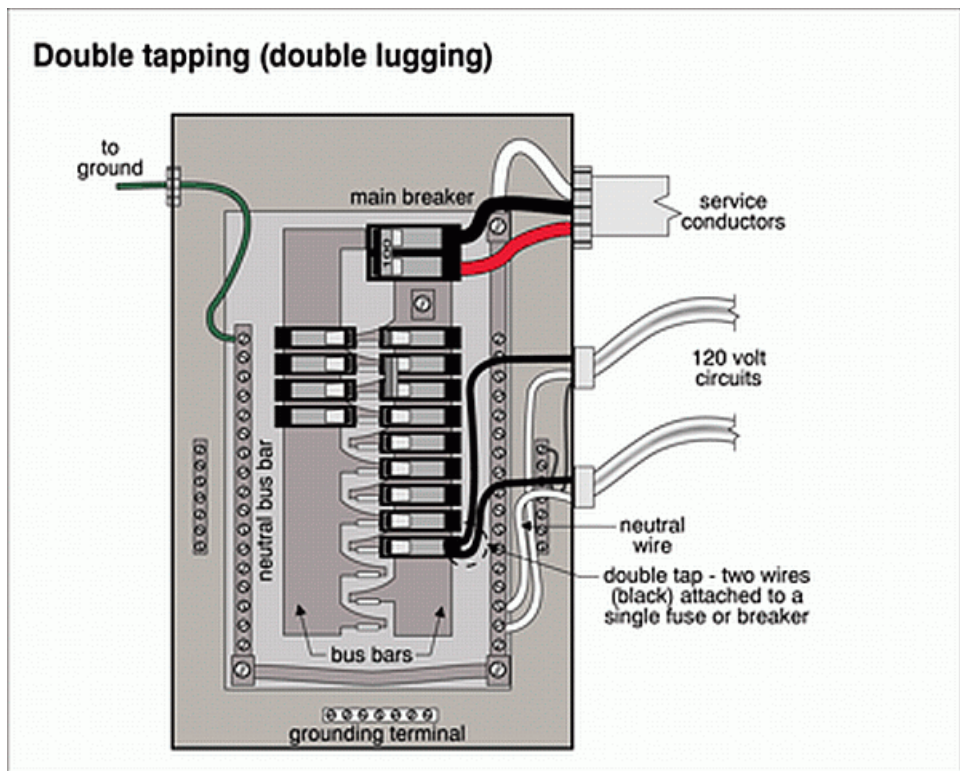
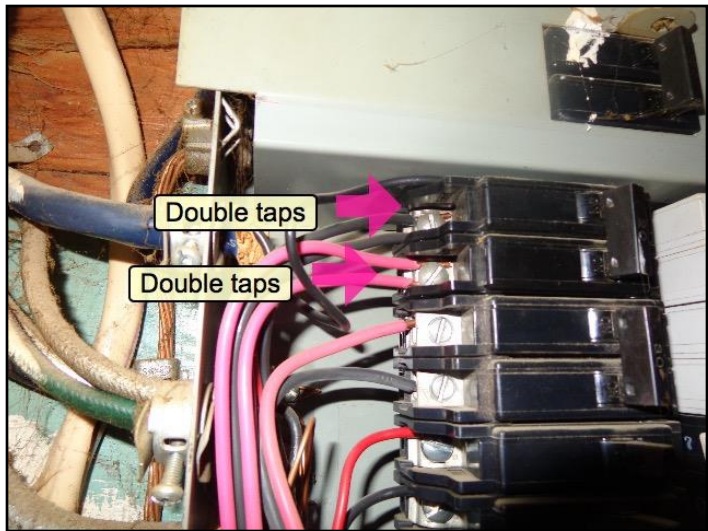
There are two double taps in the main panel box. Further evaluation by a licensed electrician is required.

11. Condition: • [Double taps](#)

Implication(s): Fire hazard

10. Double taps

Task: Further evaluation

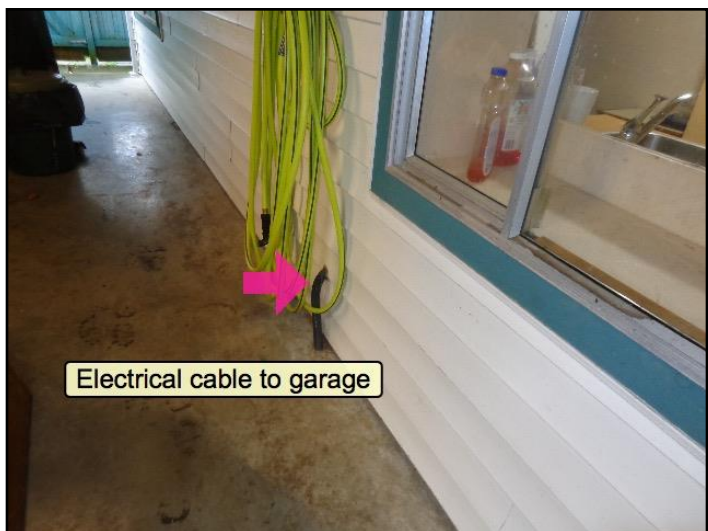
12. Condition: • The electrical cable supplying power from the main house to the garage is braided aluminum. The home owner stated he used braided aluminum connected from the downstairs stove to the garage panel box. I recommend further evaluation by a licensed electrician. Ensure the electrical connectors are compatible for the copper/aluminum connection.

11. Braided aluminum

Task: Further evaluation

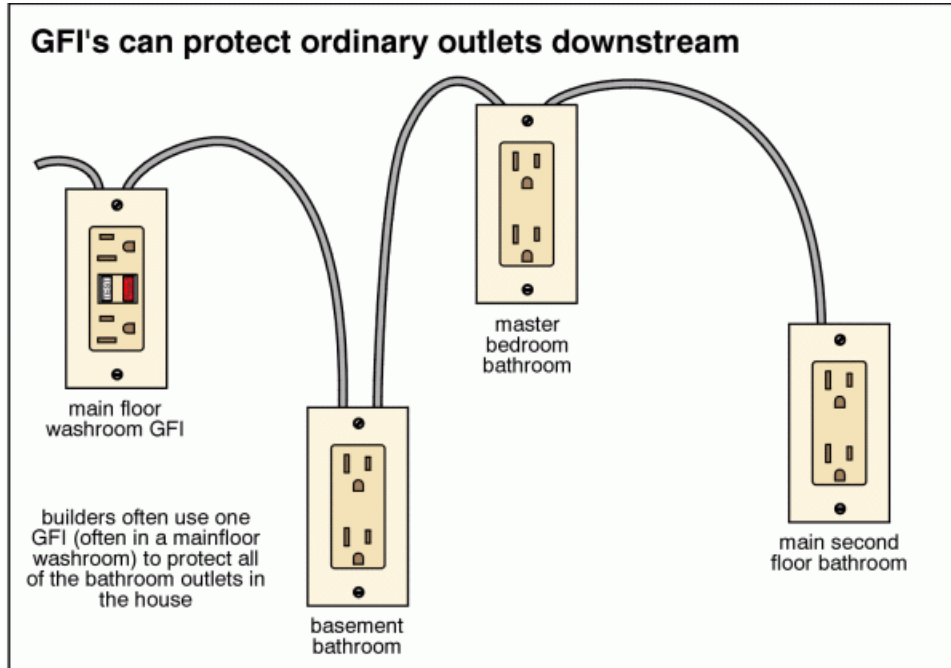
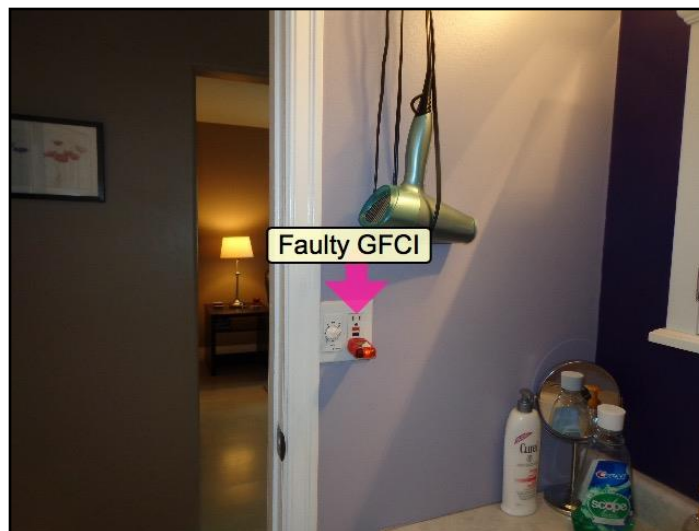
13. Condition: • The GFCI in the main floor bathroom is defective and will not trip when tested. Replace GFCI.

12. Replace GFCI

Task: Replace

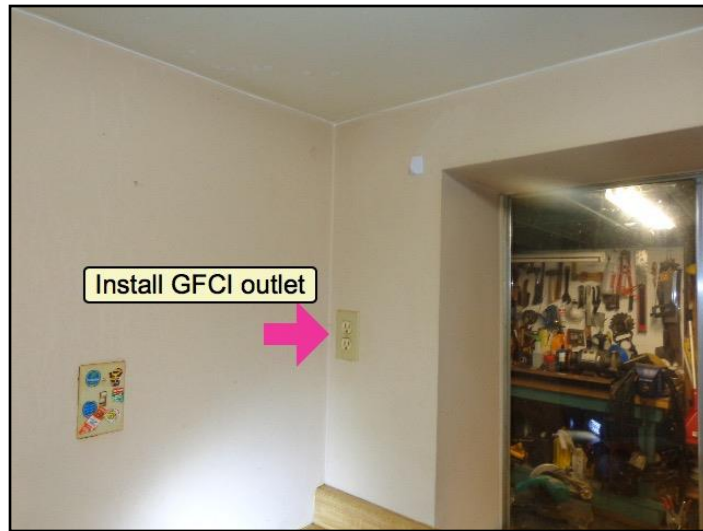
14. Condition: • Install GFCI in outlet adjacent to the basement kitchen sink.

13. Install GFCI

Task: Provide

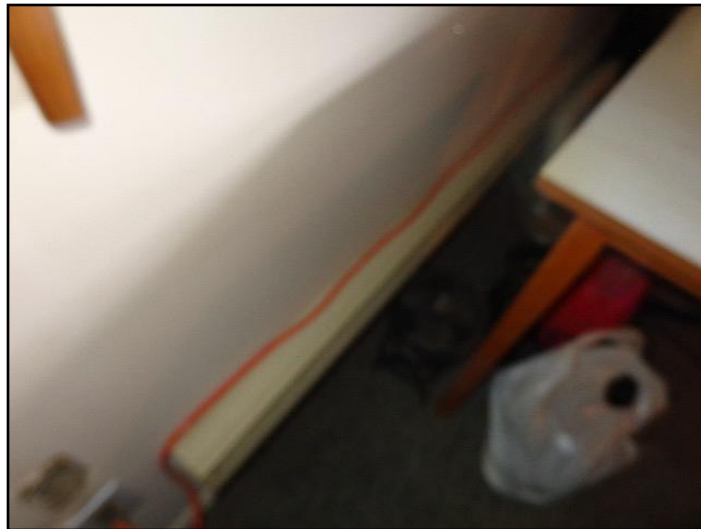
• Clean the baseboard heating fins and straighten bent heating fins. Remove the electrical cord off the baseboard in the basement suite living room.

14. Cord on baseboard

Task: Clean

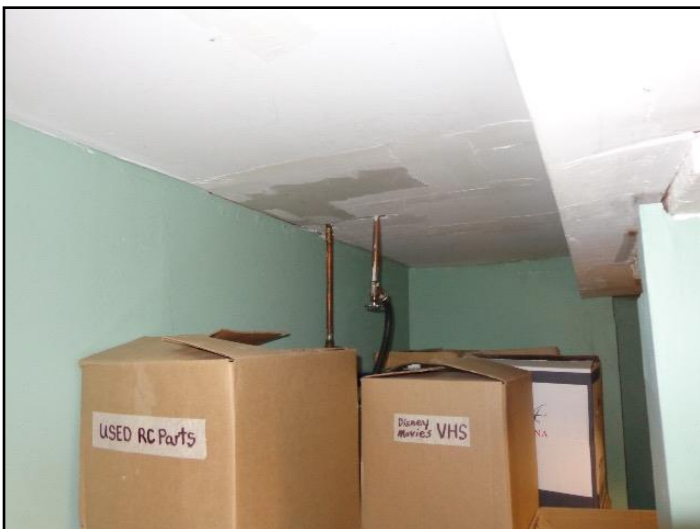
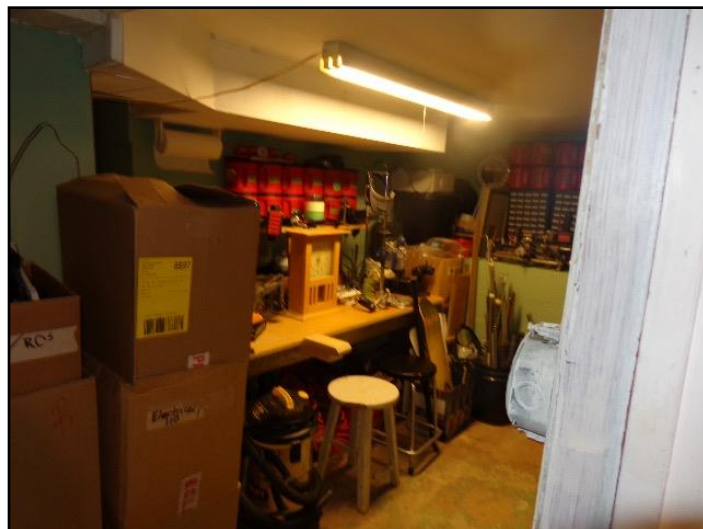
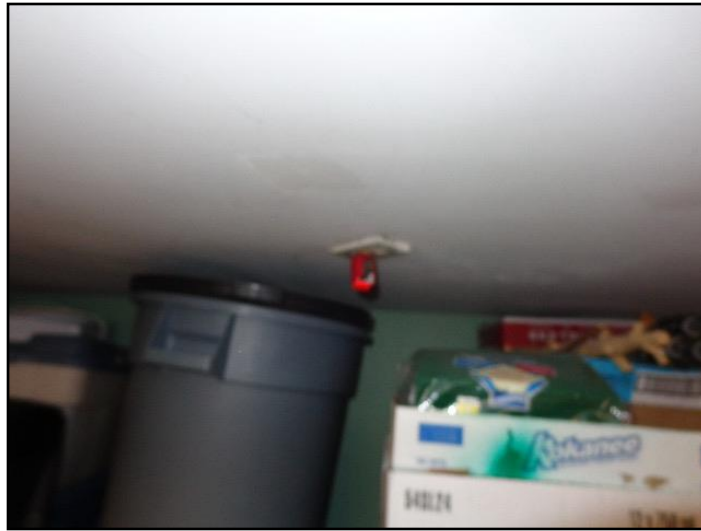
- Inspection limited/prevented by:** • Floor drain could not be found.
- Inspection limited/prevented by:** • The main water shutoff for the home could not be found possibly due to the large amount of household storage in the basement.

15. Storage

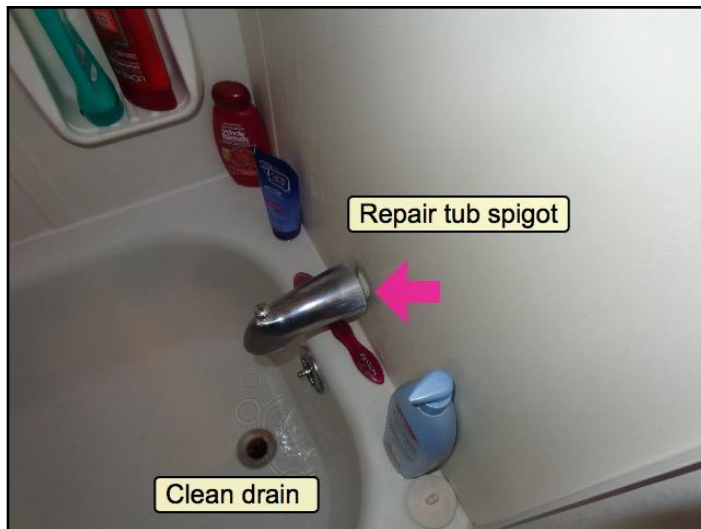
19. • The upstairs bathtub drains slow. Clean tub drain and replace tub spigot with correct tub spigot .

Implication(s): Tub drains slowly, may over flow, possible water damage, possibility of water leaking into wall behind the tub spigot.

18. Clean drain, repair tub spigot

Task: Further evaluation

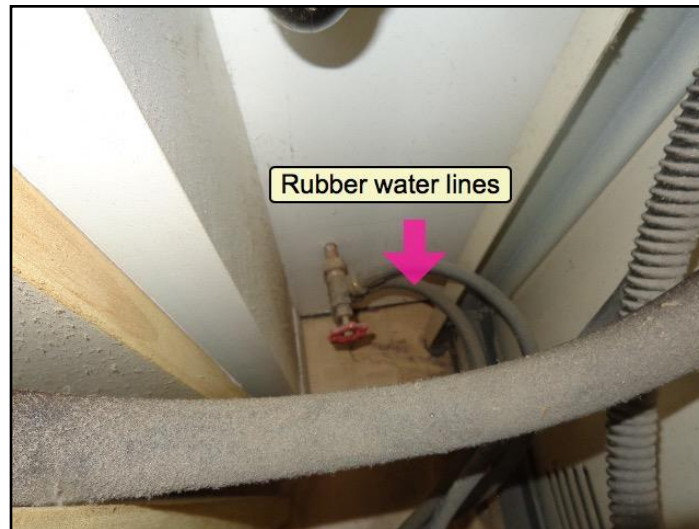
19.

21. Condition: • I strongly recommend metal braided water lines on the washing machine.

Implication(s): Possible water damage to failed rubber washing machine water lines.

Task: Provide

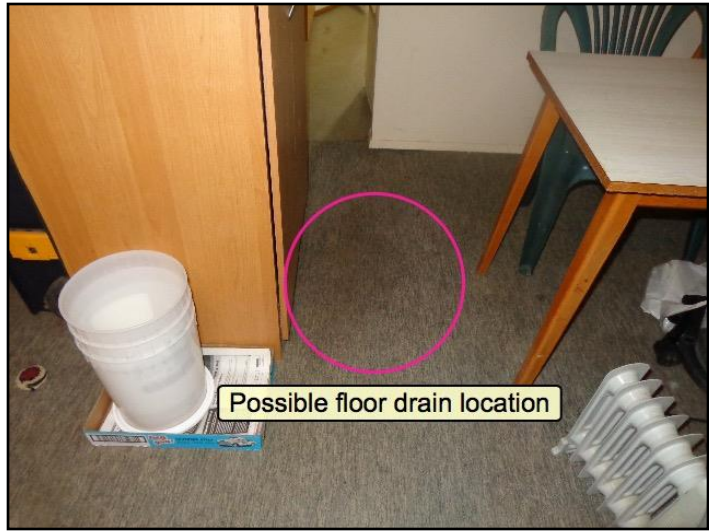
22. Condition: • [Not found](#)

The floor drain in the basement was not found. Locate and open floor drain if possible, the present owner may be of some assistance.

Implication(s): Chance of water damage to contents, finishes and/or structure

20. Possible floor drain location

Task: Request disclosure

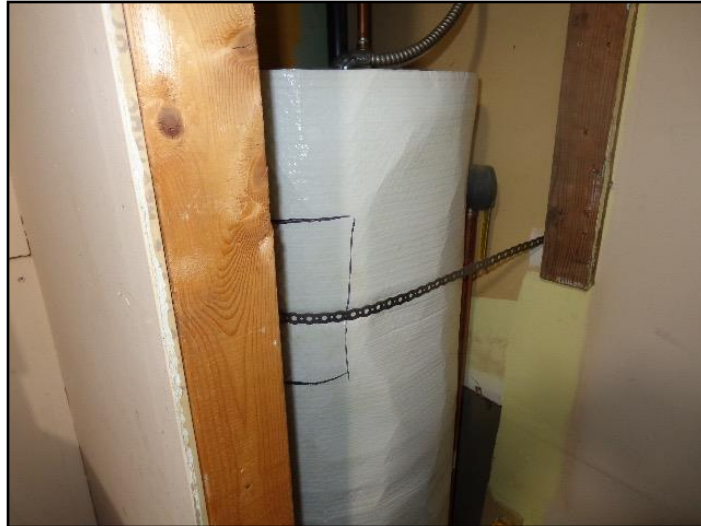
General: • The age, make, size and model of the water heater could not be determined due to the insulation blanket on the water heater.

21. Water heater in blanket

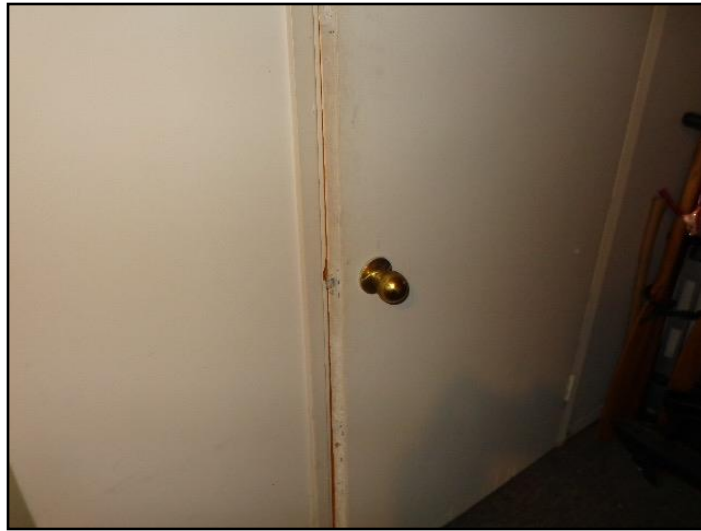
23. • The basement bathroom door will not close, repair or replace the door.

22. Bathroom door basement

Task: Repair or replace

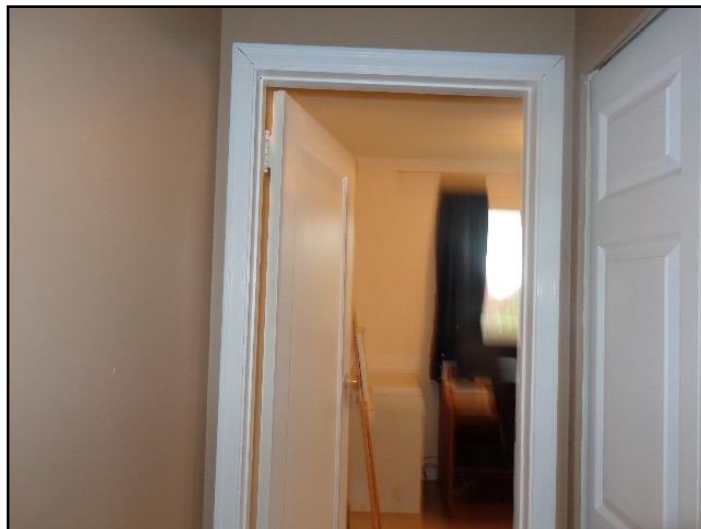
24. • The door to the den/office on the main floor binds, rehang door.

23. Rehang door to den

Task: Repair or replace

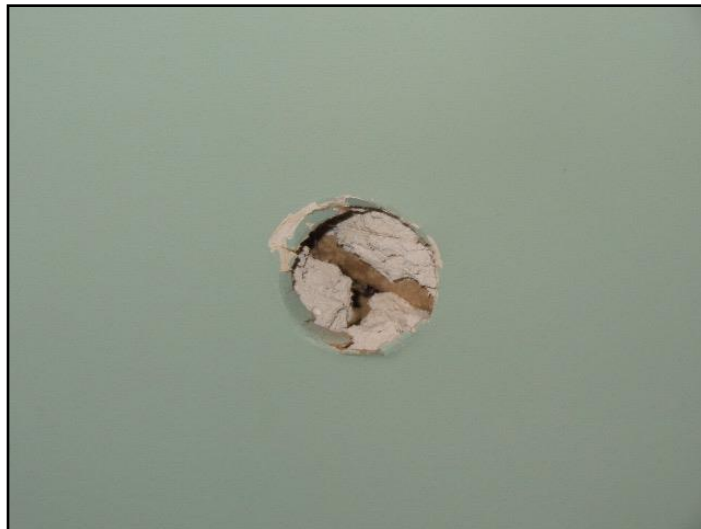
26. • Repair hole in wall caused by door knob in master bedroom wall.

24. *Repair hole*

Task: Repair

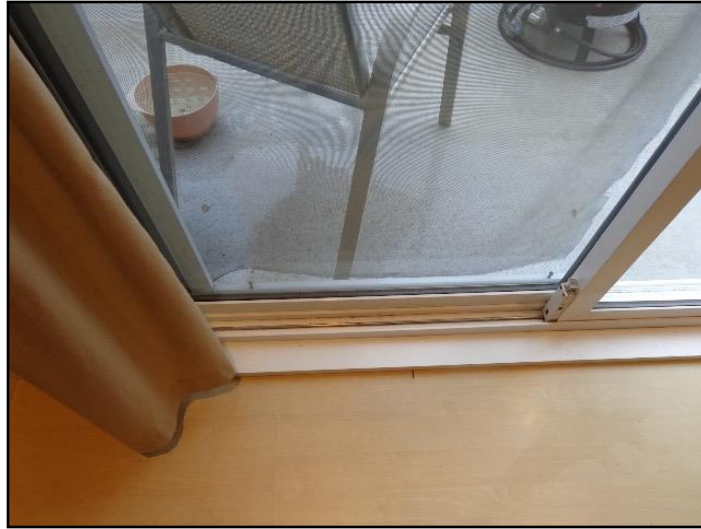
28. • Repair or replace the screen on the sliding patio door .

25. Repair screen

Task: Repair or replace

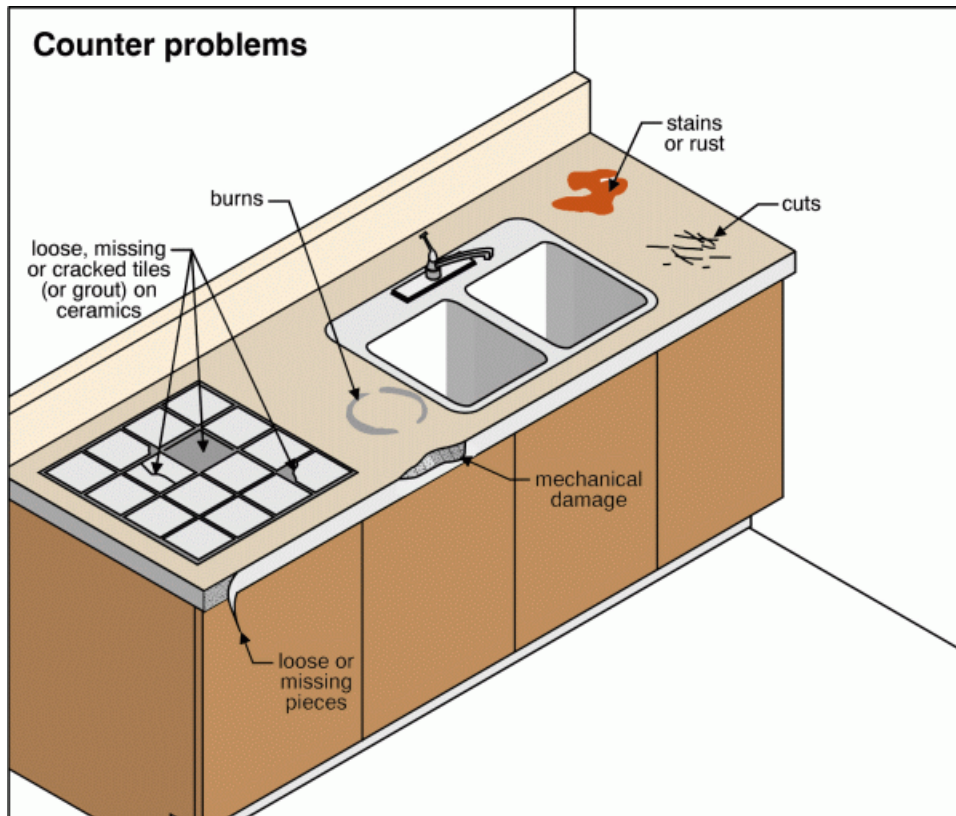
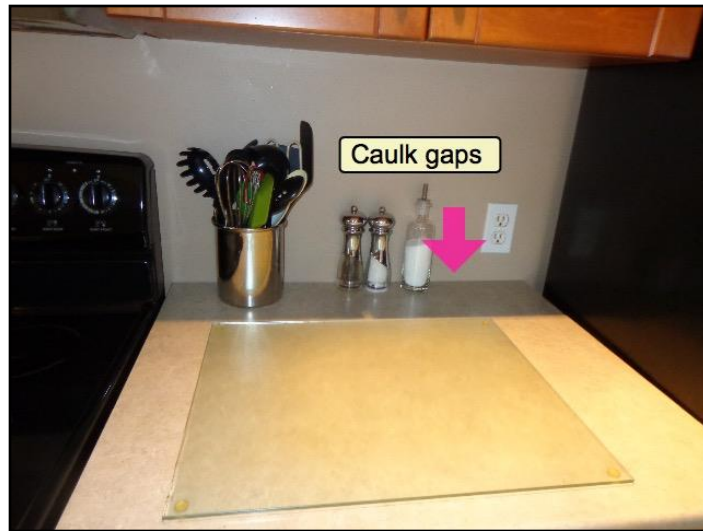
29. Condition: • Caulk back splash in upper kitchen where back splash meets wall.

Implication(s): Hygiene, possible water damage.

26. *Caulk backsplash*

Task: Improve
