SLOPE STABILITY EVALUATION

**8606 SASKATCHEWAN DRIVE NW
EDMONTON, ALBERTA**

LOT 2, BLOCK A, PLAN 2010HW

CTA File No. 02-1781

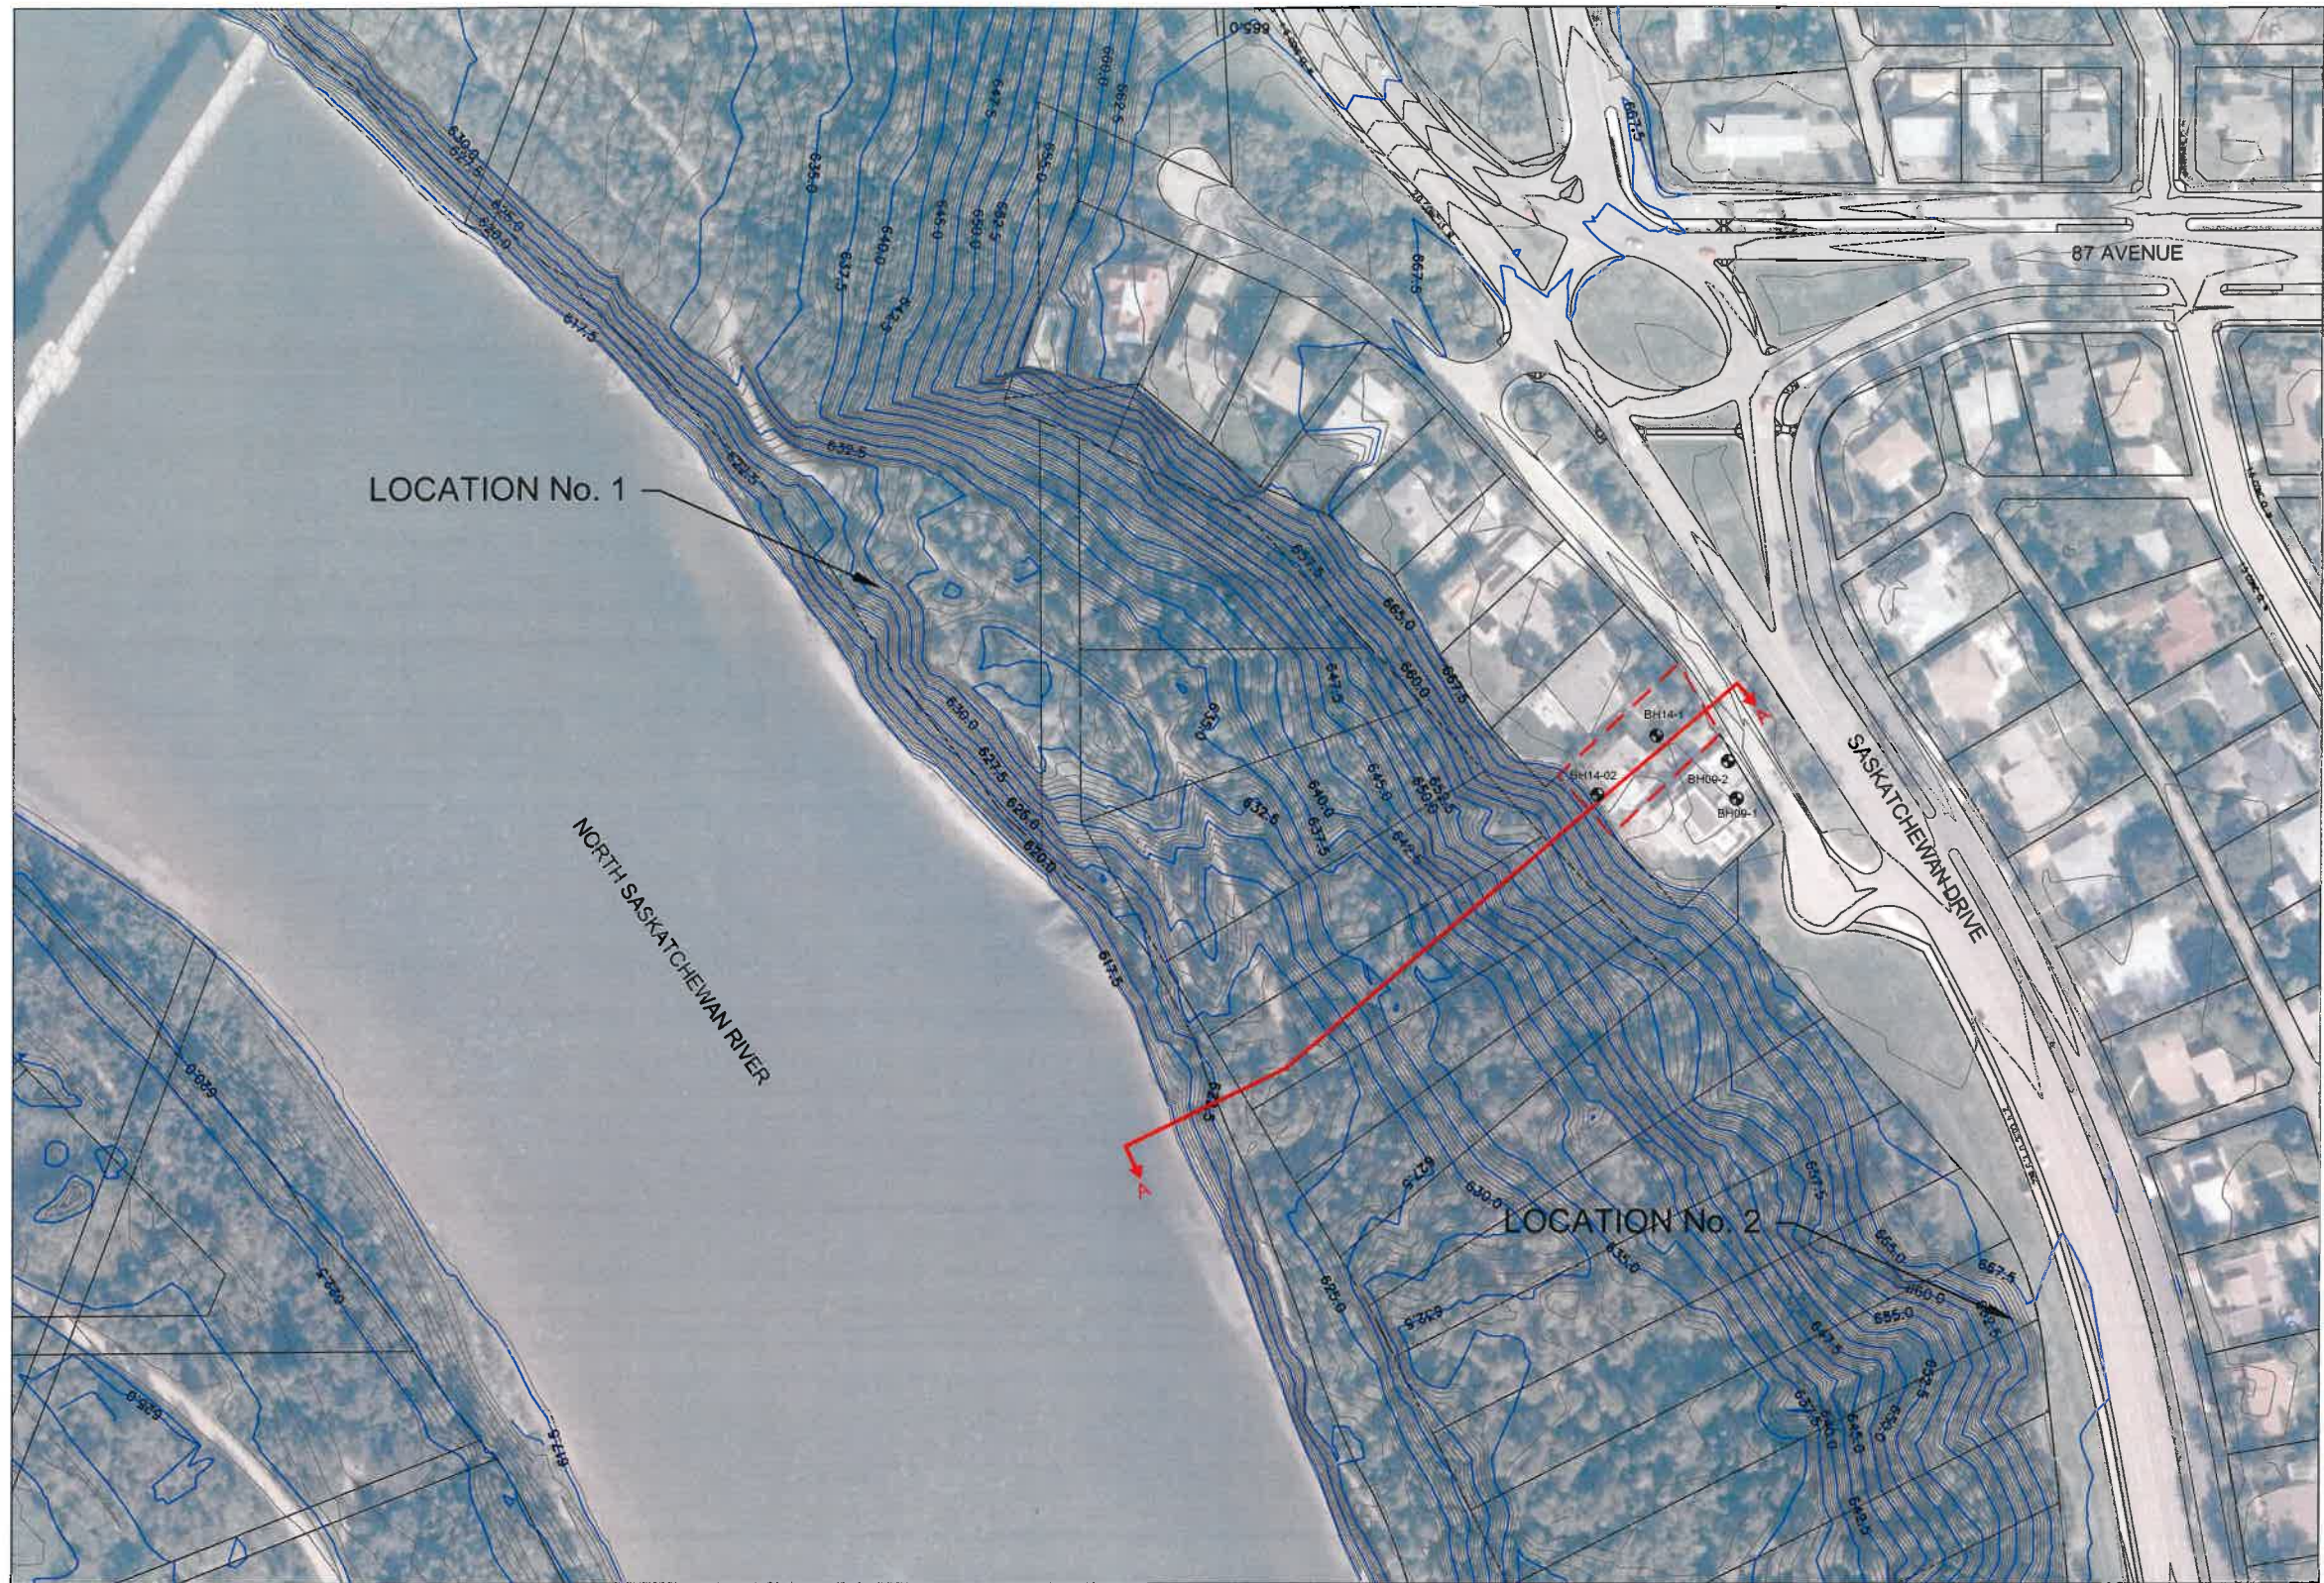
A-2

Surface contours of the slope conditions in vicinity of the subject site are presented on Drawing No. A-2, Appendix A, with a typical profile of the slope adjacent to the site presented in Cross-Section "A-A", Drawing No. A-3, Appendix A.

Near the river edge and at the location of the clearing in the historical air photos, a sign was observed for an underground power line right-of-way extending along the clearing alignment. The location of the power line is indicated on Drawing No. A-1 (Location No. 1). The portion of the alignment over the lower flat portion of the slope was free of vegetation, through the upper portion (along the 1: 1.7 slope) was well-vegetated with mature tree growth.

Additionally, about 130 m downstream of the subject site, some slumping of a tall steep (portion of the valley slope that extends directly to the river was observed (as indicated on Drawing No. A-2, Location No. 1), to be further discussed in Section 7.1.2.

As outlined in Section 6.1.2, about 130 m downstream of the subject site, some slumping of a tall steep (portion of the valley slope that extends directly to the river was observed (as indicated on Drawing No. A-2, Location No. 2), was observed during the site review and historically identified during the air photo study.

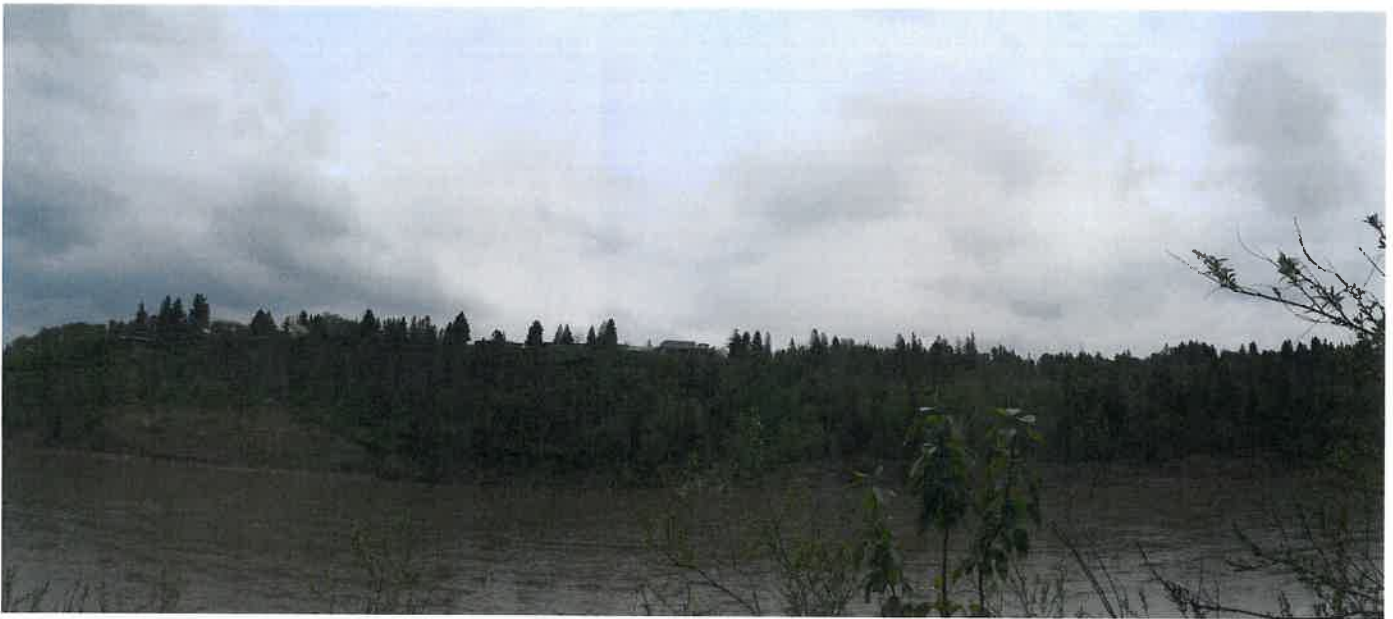
Photo 1: Slope adjacent to subject site (looking east from west side of river).

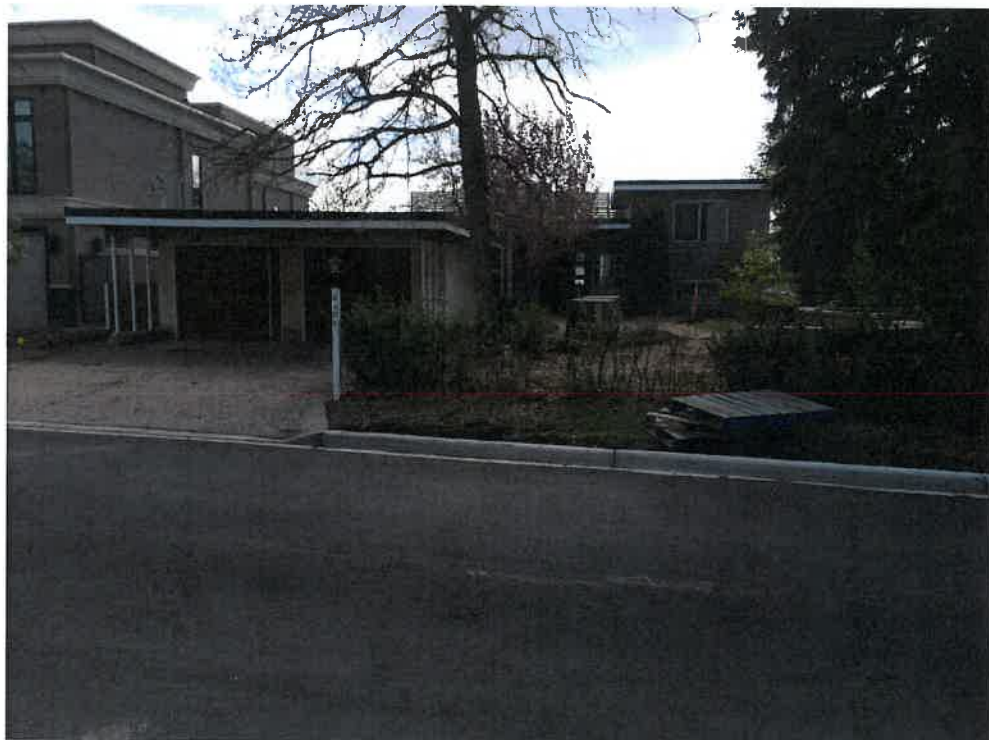
Photo 2: Existing residence at subject site.

Periodic monitoring of slope conditions during demolition and backfilling should be conducted by CT & Associates Engineering Inc. to ensure no impacts to the existing slope conditions.

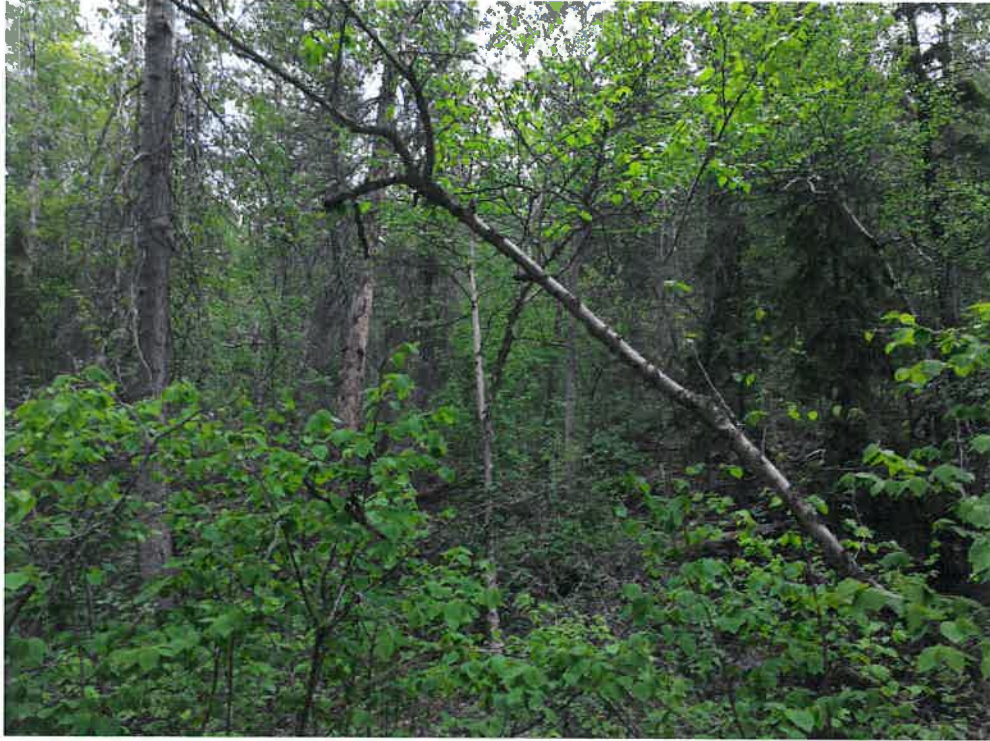
Photo 3: Typical slope and vegetation conditions.

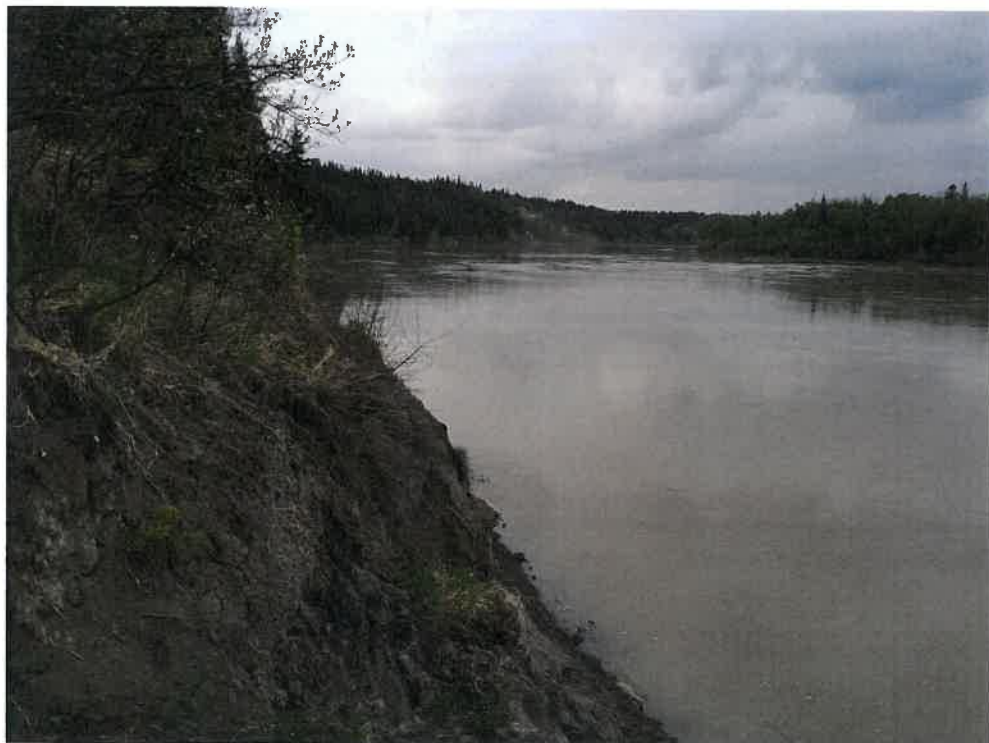
Several isolated locations of bank erosion along the river edge were observed, (each less than 3 to 5 m long and in the order of 1 m to 2 m retrogression), typical of the Edmonton river valley and commonly observed at locations of small culvert pipes along the public walkways (thus creating concentrated flows). The river bank edge, where such erosion was observed is separated from the steeper portions of the slope by a 40 m wide relatively flat area with heavy and mature vegetation.

Photo 4: Typical riverbank conditions.
