## **Geotechnical Investigation for the Proposed Development**

**6515 145A Street NW  
Edmonton, Alberta**

File No. A-0277  
February 29, 2016

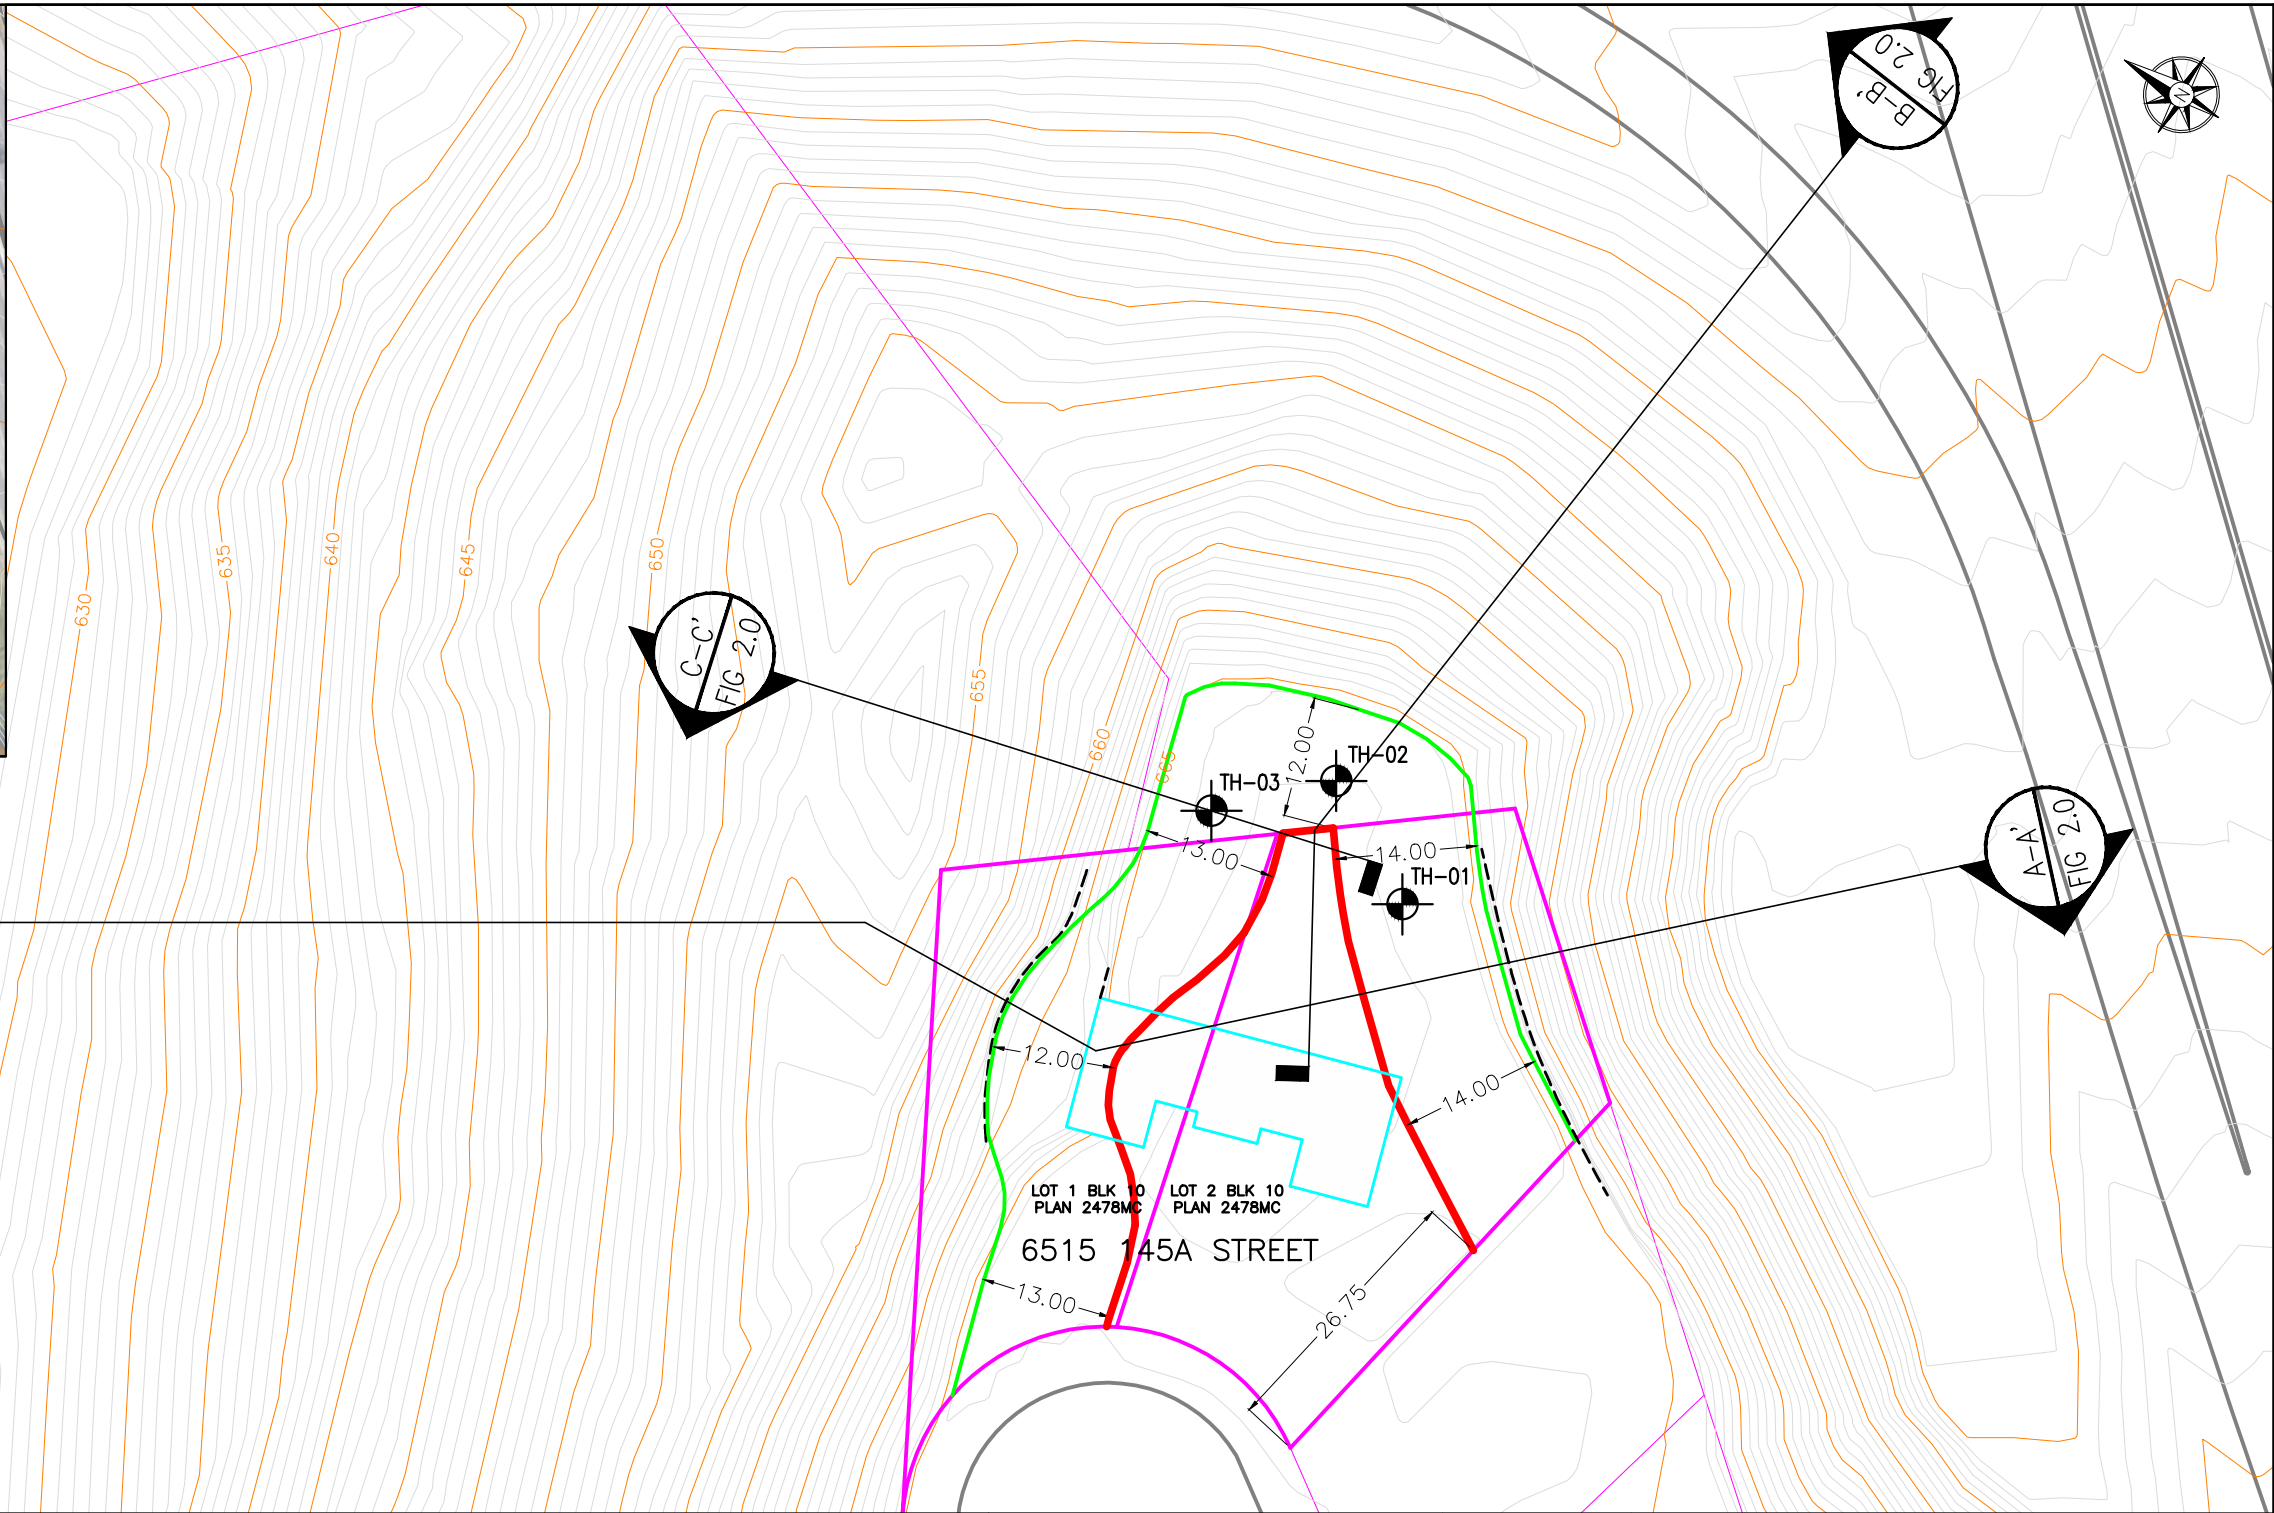
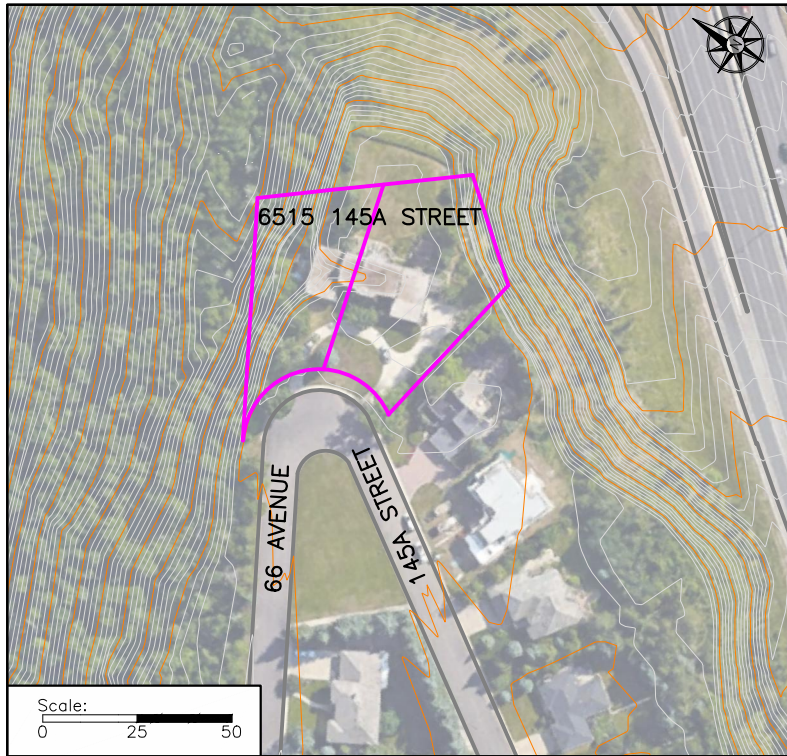
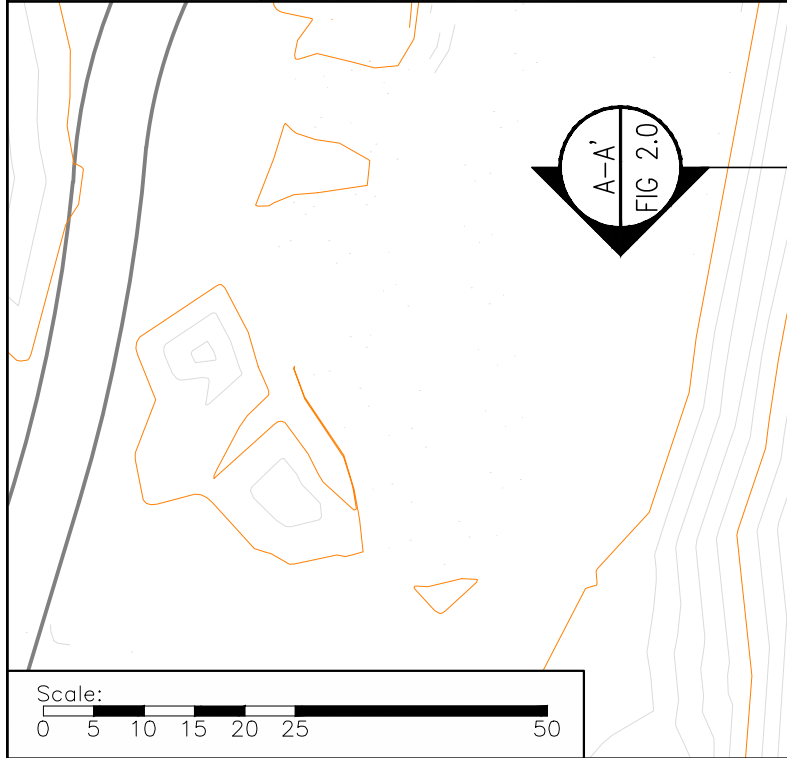
<b>LWL ENGINEERING LTD.</b> Geotechnical Engineering Consultant			
		TITLE GEOTECHNICAL INVESTIGATION - 6515 145A Street NW SITE PLAN	
CLIENT BIRKHOLZ HOMES INC.		SCALE AS SHOWN	
PROJECT NO. A-0277		DRAWING NO. FIGURE 1.0

Based on this analysis, the setback line for foundation walls of the proposed development from the TOB perimeter was established for the existing site conditions and is shown on Figure 1.0 in Appendix A. The setback distance from the East Slope is superseded by the legal property limit, which is farther away from the TOB than the established setback line (it is approximately 12 m from the top of bank at its closest point). This is shown on the plan view in Figure 1.0 in Appendix A.

Based on the slope stability analysis, the setback line for the rear foundation of any future primary dwelling or structure should be set as shown in Figure 1.0 in Appendix A. The setback distance along the North Slope varies between 12 and 13 m due to the variable geometry of the slope. The setback distance from the South Slope is 14 m, and from the East Slope it is 8 m. The actual setback distance from the East Slope is governed by the legal limit and will be greater than the stability analysis derived setback of 8 m.
