DEPRECIATION REPORT

VR 1551—"145 on Twelfth"
145 East 12th Street
North Vancouver, BC
2013

October 30, 2013

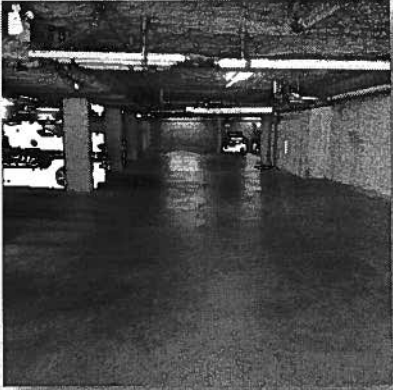
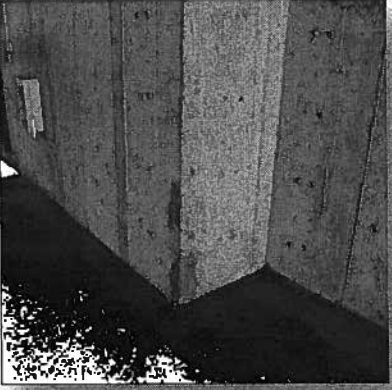
Component 1		Building - Structural and Architectural	Substructure and Underground Garage

Component Description	This component includes all below-grade portions of the building including footings, basement floors, walls, ceilings, columns, membrane, and expansion joints. These are typically poured concrete or masonry block. Although foundation is life of building, prudent reserve budgeting for repairs are based on a budget cycle expected lifespan.		
Reserve History	Year of Acquisition	1985	
	Description	Original to the building.	
Potential Deterioration	Potential deterioration includes water and road salt penetration of the surface of the concrete in the underground garage. Salt corrosion and water penetration of reinforcing rebar and freeze-thaw cycles could spall concrete in ceilings and walls in underground. Hydraulic pressure caused by poor drainage and settling could also cause concrete cracking. The membrane can be damaged by cracked concrete, wear and tear, and material breakdown due to age.

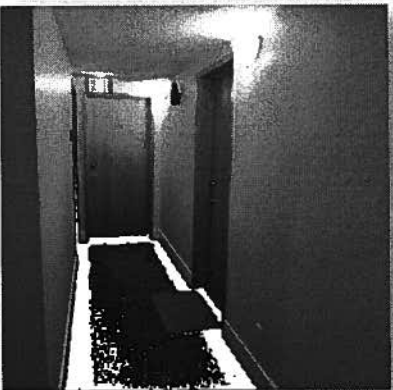
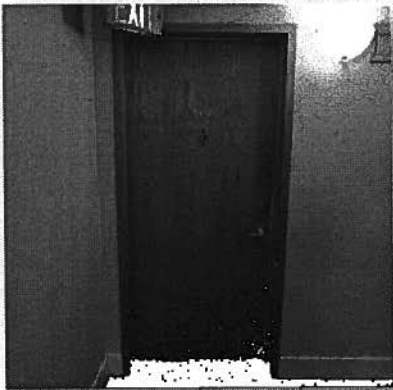
Component Description	Common door assemblies are generally manufactured or pre-hung fire-rated wood doors. These doors are manufactured to the standard fire prevention ratings of 20-minute, 45-minute, 60-minute, and 90-minute. Fire-rated doors are an integral part of not just the building's passive fire-protection system but the building's overall fire protection.				
Reserve History	Year of Acquisition	1985			
	Description	Original to the building.			
Potential Deterioration	Door hardware is subject to failure due to the constant usage in high traffic areas, such as busy corridors. Constant usage can lead to misalignment. Other common issues are holes or openings in the door assembly, improper gaps, and failure to latch.				
Condition Analysis	Based upon a partial visual-inspection, this component appears to be in average condition for its age.

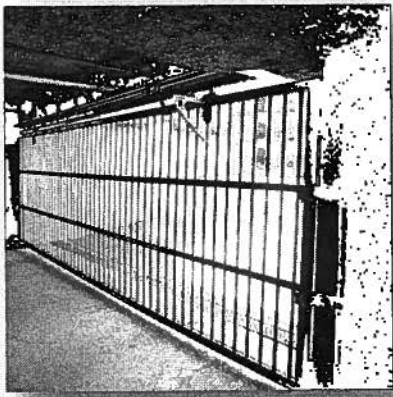
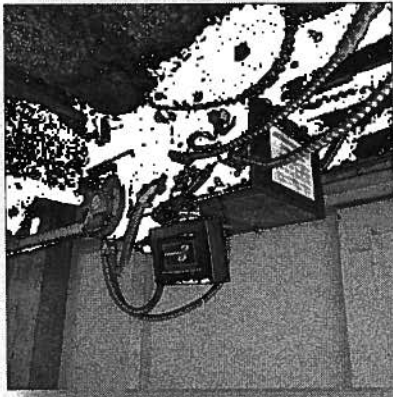
Component Description	A typical overhead door consists of several panels hinged together that roll along a system of tracks guided by rollers. Security gates are used to control vehicle access to specific areas. Gates are typically operated electronically, either by remote control or through some type of secure access system such as an intercom or card / fob reader.				
Reserve History	Year of Acquisition	1985			
	Description	Door original to the building, with remote opener replaced approximately 2006.			
Potential Deterioration	The track and rolling mechanism is subject to wear and tear. Electronic failure of controls and access equipment. Mechanical failure of wheels or operator. Accidental collision or physical damage from shifts in building envelope. Exposure to the elements including corrosion. The bearings, hinges, and rollers should be lubricated for proper and safe operation. The torsion springs should also be lubricated with a light coat of penetrating oil to reduce the friction between the coils, eliminate any noise, and increase the life of the springs.

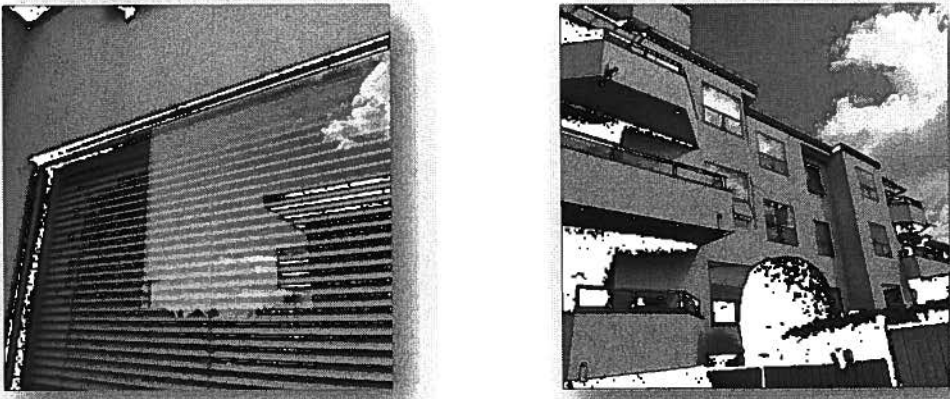
Component Description	The window assemblies are the exterior windows that are installed in the living areas as well as the common areas. These windows are typically replaced with double-pane units with fixed or sliding portions. The frames are aluminum.				
Reserve History	Year of Acquisition	1985			
	Description	Partial replacement (estimated at 50%) of the windows has taken place over approximately the past 5 to 10 years.			
Potential Deterioration	Windows are primarily susceptible to impact damage and tearing of screening material. Frames and sliders can deteriorate due to exposure to the elements and sunlight causing oxidation. Failure or deterioration of the seals can cause fogging and moisture on the inner panes of the window.				
Condition Analysis	Based upon a partial visual-inspection, this component appears to be in average condition for its age.

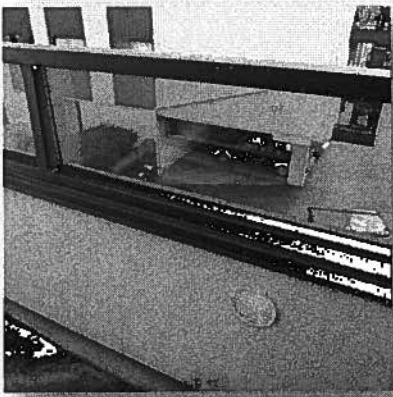
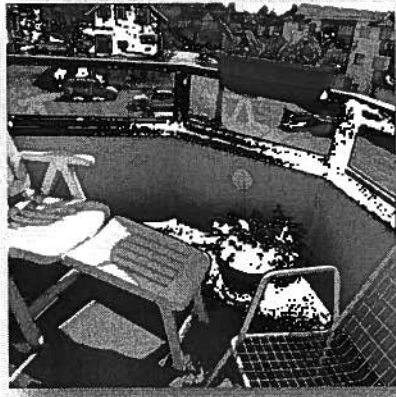
Component Description	Railings are an integral part of the building safety structure. Typical construction may includes a rail system with posts bolted to the floor and wall. The subject balconies have a pony wall with wood railing and glass inserts.				
Reserve History	Year of Acquisition	2003			
	Description	Component has been repaired / replaced since original construction.			
Potential Deterioration	Railings can suffer from various deterioration, due primarily to exposure to the elements. Water can cause the wooden structure to rot and weaken, penetration into concrete will weaken fasteners. Impacts can break glazing and dent metals. Railings can be replaced for aesthetic reasons.				
Condition Analysis	Based upon a partial visual-inspection, this component appears to be in average condition for its age.

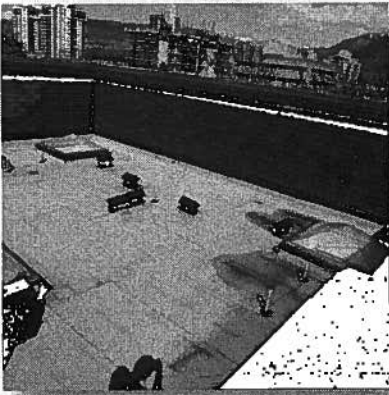
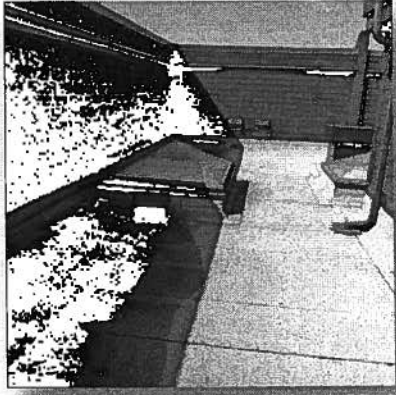
Component Description	Modified Bitumen – also known as Torch-On - is an evolution of asphalt roofing. It is made from asphalt and a variety of modifiers and solvents. There are several ways of connecting pieces of this material. In a heat application process the seams are heated to melt the asphalt together and create a seal.				
Reserve History	Year of Acquisition	2006			
	Description	Component has been replaced since original construction.			
Potential Deterioration	Asphalt degradation is a growing concern. UV-rays oxidize the surface of the asphalt and produces a chalk-like residue. As plasticizers leach out of the asphalt, a modified bitumen or "mod bit" roof becomes brittle. Cracking and alligating inevitably follows, allowing water to penetrate the system causing blisters and cracks, potentially causing leaks.

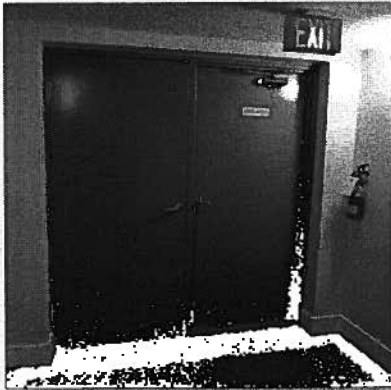
Component Description	This component refers to the common corridors inside the building. Component includes paint on walls and trim, and includes preparation for masking and finish. Interior latex paint is applied on common area walls and ceilings over a seal coat. Interior wood trim is painted with lacquer or gloss paint. Includes common side of doors. Excludes integrated construction unless noted. Excludes damage from repair work. Includes doors, casings, and trims as appropriate.				
Reserve History	Year of Acquisition	2009			
	Description	Component has been repaired / replaced since original construction.			
Potential Deterioration	Interior paint can deteriorate from UV sources, physical damage or water / moisture ingress. Repainting can also be done for aesthetic reasons.				
Condition Analysis	Based upon a visual-inspection, this component appears to be in good condition for its age.

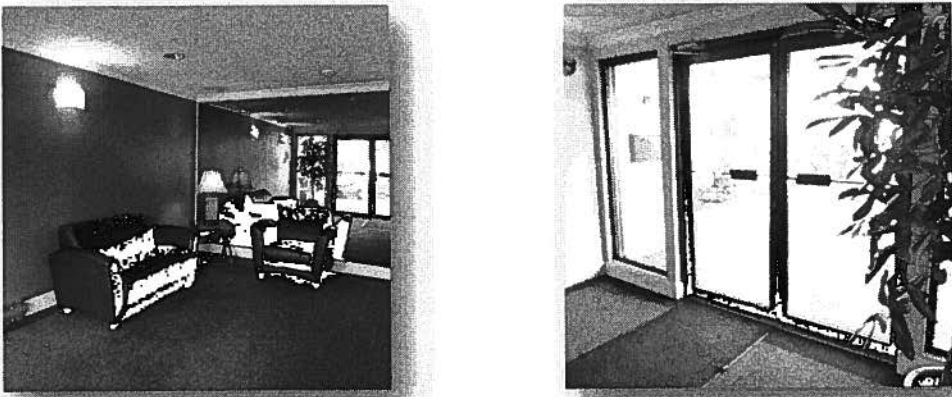
Component Description	This component comprises all of the reserve items and materials of the common lobby area(s), including flooring, wall finish, ceiling finish, fixtures, furnishings, and decorations, including the common mailbox.				
Reserve History	Year of Acquisition	2009			
	Description	Component has been remodelled since original construction.			
Potential Deterioration	This component will typically experience wear and tear from owner and visitor use, which could include marking / damage to the wall surfaces including impact damage, damage to the flooring due to use, obsolescence of fixtures and furnishings due to diminished utility or dated design / aesthetics.				
Condition Analysis	Based upon a visual-inspection, this component appears to be in good condition for its age.				
Life Cycle Analysis	Expected Lifespan	24 years

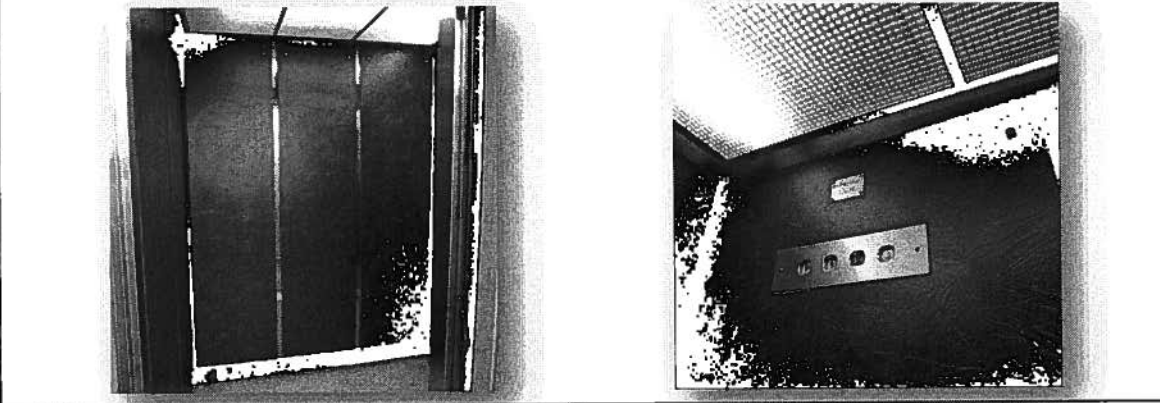
Component Description	This component covers the repair and replacement of the interior of the elevator cabs, including the flooring, wall panels, ceiling panels, ventilation fan, paint, light fixtures, and railings. This component does not include safety features, mechanical or electrical components within the elevator enclosure.				
Reserve History	Year of Acquisition	1985			
	Description	Original to the building construction.			
Potential Deterioration	The elevator cabs are most prone to impact damage caused by moving items in and out. Further damage is caused by wear and tear and vandalism. Most cab interiors are constructed of materials to allow for a certain resistance to deterioration of this type.				
Condition Analysis	Based upon a visual-inspection, this component appears to be in good condition for its age.

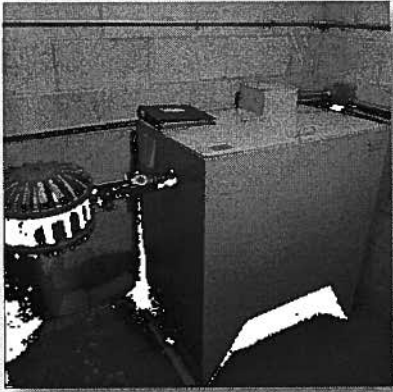
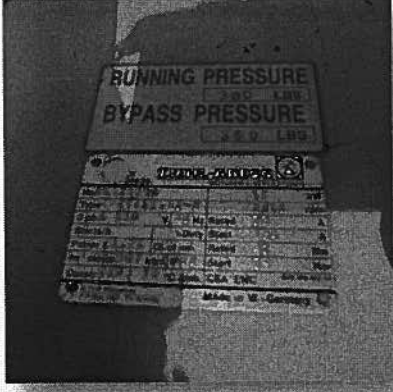
Component Description	Hydraulic elevators use a hydraulic ram system comprising a tank, pump, valve, and a cylinder. Upward movement is created by the electric motor pumping oil into the cylinder causing the piston to lift the elevator cab. To descend, the valve releases the oil from the cylinder back into the oil tank.				
Reserve History	Year of Acquisition	1985			
	Description	Original to the building construction.			
Potential Deterioration	Deterioration could include wear and tear of mechanical components including bearings, gears, valves, and pump. Electrical failures of relays, contactors, motor windings, and processors may occur over time. Leaks from hydraulic connections may also occur, as may door operator failures. Single-bottom cylinders built prior to 1977 risk failure due to cylinder corrosion or electrolytic action. Systems of this type will require retrofit or replacement (B44-2007 safety code).

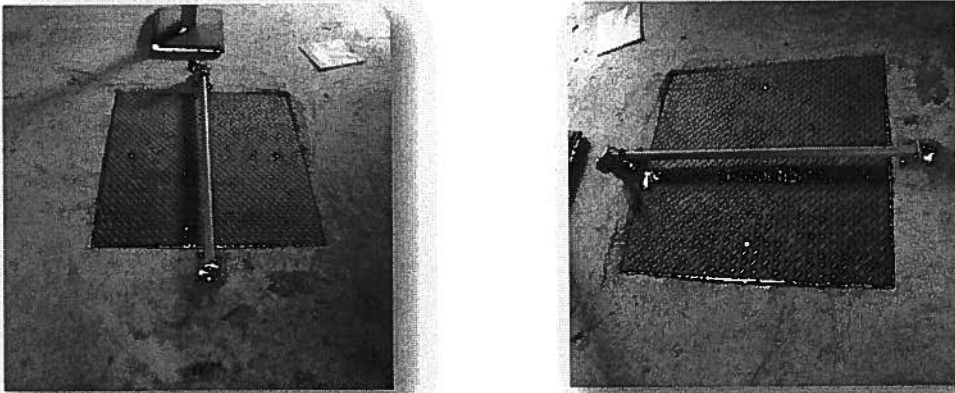
Component Description	The sump pump is located below the parkade grade in a locked pit - access was unavailable.				
Reserve History	Year of Acquisition	2007			
	Description	Component has been replaced since original construction.			
Potential Deterioration	Pump failure may occur over time due to wear and tear. Subject pumps were replaced in approximately 2006/2007.				
Condition Analysis	No visual inspection possible, this component is assumed to be in average condition for its age.				
Life Cycle Analysis	Expected Lifespan	15 years			
	Effective Age	6 years			
	Remaining Lifespan	9 years			
Funding Analysis	Description	Unknown total expenditures have been spent on this component to date.			
	Work	Remove old pump, replace with new unit.			
	Quantity	2 Pumps			
	Job Cost	\$3,908.10			
Deficiency Analysis	No major deficiencies were indicated at the time of property inspection. The life of this component may be prolonged by effective maintenance and repairs as required.
