Strata NW 1505 Lincoln's Gate Depreciation Report

The Owners, Strata NW 1505
Lincoln's Gate
10620 150th Street
Surrey, BC

May 15, 2014

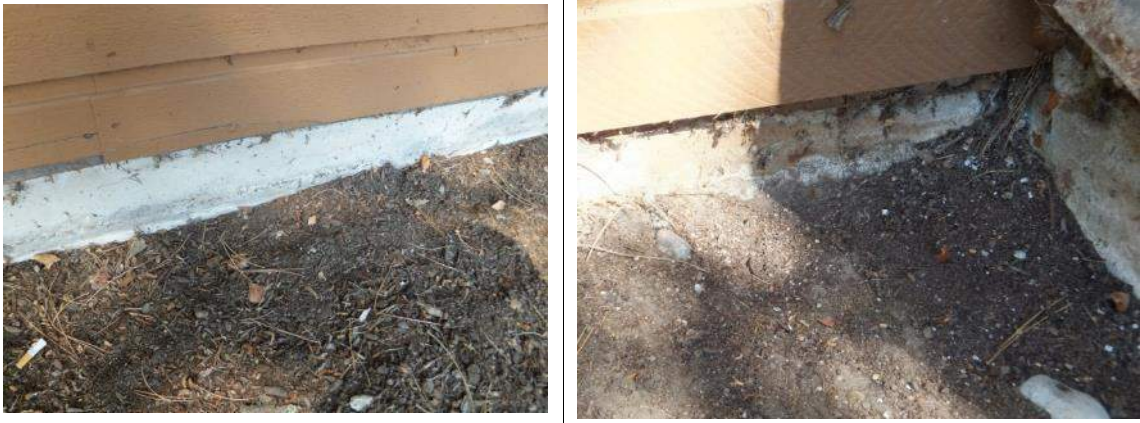
S 1 – Foundation & Structure		
Year Installed	1980	Description: The buildings sit on poured cast-in-place concrete foundations. The main floor of the suites are wood frame construction over concrete slab. The sloped roofs are constructed of engineered wood trusses and rafters and the floors of wood joists that are supported on wood framed exterior and interior load bearing walls.
Expected Life Span	60+	
Observed Condition	33	
Repair or Replace	1

<p>Financial Review: We understand that the foundation is part of the original construction. Over the years there have been relatively small, localized repair jobs on this component, often as part of drain tile replacements.</p>		
<p>Visual Review: Generally most of the structural components of the buildings are concealed by exterior cladding. The framing and foundation out-of-sight is assumed to be in satisfactory condition. There is likely a waterproofing or damp-proofing material installed on the exterior side of the foundation walls. We saw evidence of some foundation cracks and spalling, however the structural components of the buildings where viewed appear to be in decent condition. We did note areas where ground cover and foliage is touching the foundation, a situation which can lead to water ingress</p>

<p>Recommendations: Foundations typically last the life of the building; however periodic repairs will be required during the term of this DR. There are few exposed wood beams and columns on the building, so we do not anticipate any major repairs in this regard.</p> <p>We recommend that the Strata continue to monitor the foundations carefully for any leaks, preferably with the assistance of a professional. The foliage or ground cover that is touching the foundation should be cut back, to reduce the possibility of water ingress.</p> <p>In the plan we have included a repair allowance every 15 years starting in the year 2014. Costs incurred in between these repairs are assumed to be less than the Report threshold and be funded from Operating Funds. The repair project allows for excavation around the walls, concrete repairs and replacement of localized areas of the foundation waterproofing. We assume that the concealed structural components of the buildings will last the life of the structures; therefore we have not allowed for major structural replacement within the Report term.</p>

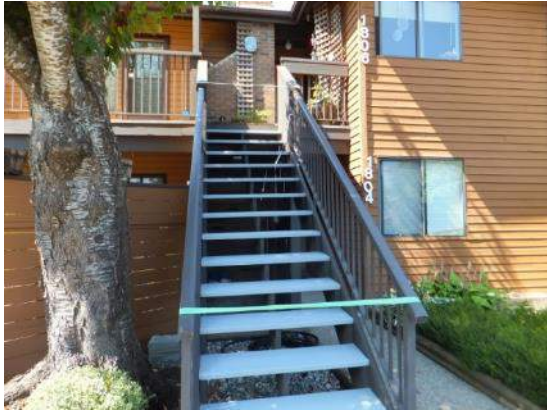
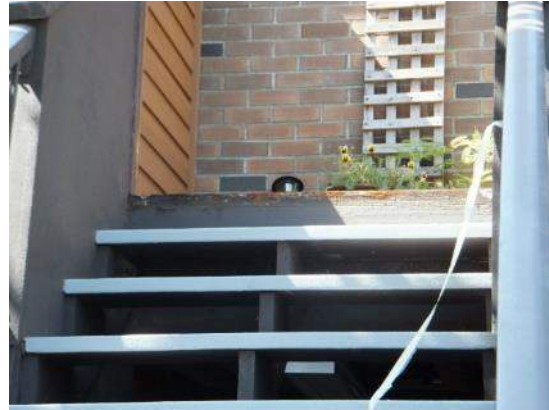
S 2 – Wood Stairs		
Year Installed	1980	Description: Some of the suites have wood framed staircases constructed of painted wood treads and stringers. The stairs, which rest on concrete slabs at the bottom, lead up to balconies and suite entry landings.
Expected Life Span	20-30	
Observed Condition	6	
Repair or Replace	14

Visual Review: As expected, some of the staircases appeared to be new or recently repaired. Many appeared to have been painted in the past few years. We did note some signs of deterioration such as cracks, warping or missing paint, but overall the stairs are in reasonably good condition.

Recommendations: Issues related to wood staircases include UV ray damage, moisture, freeze/thaw cycles, mold, mildew, algae, poor installation, warping, and rot.

Starting in the year 2027 we have reserved for replacement of the stairs, spread over 5 years on 25 year cycles. Only the wooden part of the stairs has been considered for this component, the guards are included in S4 – Balcony & Staircase Guards. To take advantage of economies of scale as well as access considerations, this project has been timed to coincide with the exterior cladding, balcony, and window projects.

For maintenance we would recommend annual cleanings and painting touch-ups where needed. Any loose treads should be repaired immediately. In addition, any ground cover should be cut back to minimize water ingress.

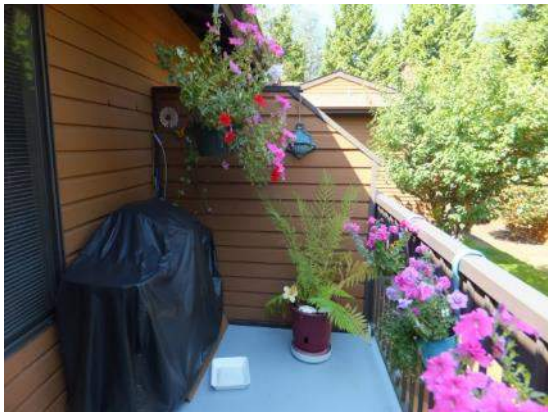
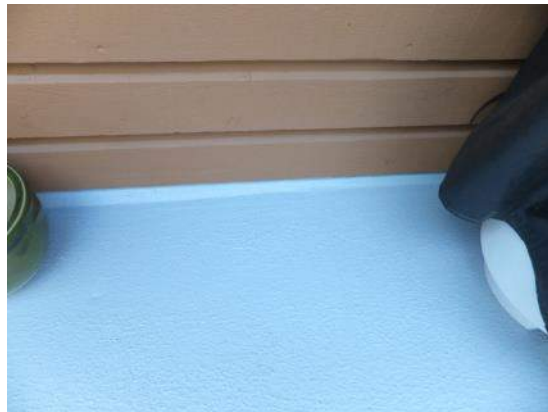
S 3 – Balconies		
Year Installed	Varies	Description: There are wood framed balconies and entrance landings, which are constructed of wood framed flooring that is extended past the second floor walls. The flooring is protected with a liquid applied membrane over single ply substrate. There is metal flashing that extends down over the outer edges at the fascia. Adjacent balconies and landings are separated by painted wood dividers. Drainage is accomplished by sloping of the flooring to the exterior, and some balconies have gutters installed at the fascia
Expected Life Span	20-30	
Observed Condition	6	
Repair or Replace	14

Visual Review: We did not view all balconies, so we assume that the ones we did see are a fair representation of this component. As expected, some of the staircases appeared to be new or recently repaired. We did note some signs of deterioration but considering their age the balconies are in reasonably good condition.

Starting in the year 2027 we have reserved for major repairs to the balconies, spread over 5 years on 25 year cycles. The project includes costs for removal and replacement of the membrane, as well as the fascia and flashing. A percentage is assumed for repairs and replacement of underlying wood and structural components. Only the balconies & landings have been considered for this component, the guards are included in S4 – Balcony & Staircase Guards. To take advantage of economies of scale as well as access considerations, this project has been timed to coincide with the exterior cladding, staircases, and window projects.

For maintenance we would recommend annual cleanings and touch-ups where needed. Any loose or missing flashing/fascia should be repaired as soon as possible.

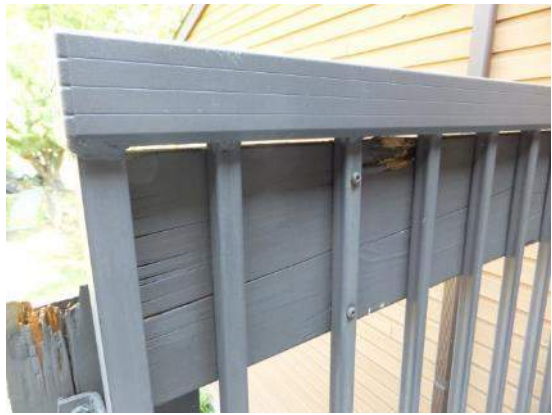
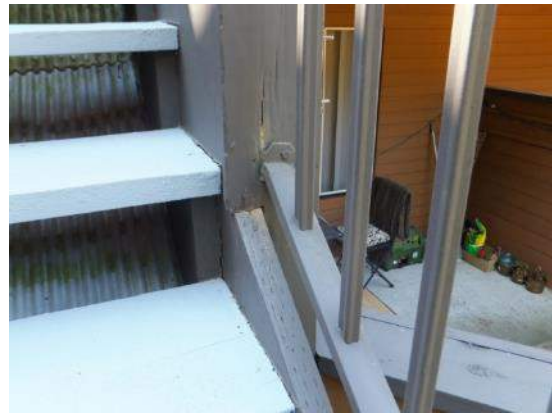
S 4 – Balcony & Staircase Guards

Year Installed	1980	Description: The balcony and staircase guard assemblies consist of aluminum pickets. At their base they are attached to the outer edge of the balconies, and at the sides they connect to the building, posts, or upstand walls. Below the top rail of the balcony guards painted fascia boards are attached. At the top of the staircases and between adjacent balconies painted wood framed and clad upstand walls are mounted.
Expected Life Span	40-50	
Observed Condition	33	
Repair or Replace	14

Visual Review: Our observations from grade and the roof along with review of the drawings led us to assume that all guards are similar. We noted cracks and general deterioration on the attached wood fascia, but most faces were fully painted.

Where checked the aluminum guards appeared to be intact and secured. No cracks or excessive corrosion was noted.

The upstand walls, including the posts showed evidence of cracks, missing paint, and some rot, but overall they appear to have been well maintained over the years.

Recommendations: Aluminum guard assemblies have a typical life expectancy of 40-50 years. We recommend that along with the annual inspection of the balcony assemblies the Strata take note and monitor the condition of the guards as well. Ensure that they are well secured, and no cracks are evident.

Due to their age, the guards are believed to be approaching the end of their typical lifespans. However, considering their satisfactory condition, the guards are planned for replacement at the same time as major balcony repairs to take advantage of economies of scale and other efficiencies.

The plan allows for removal and replacement of the guards to coincide with the balcony repair projects (which also coincides with the cladding project), and spread over 5 years. The first instance of the guard replacement will commence in the year 2027 starting with the guards in the worst condition. We planned for future guard replacements to occur with every other major balcony repair.

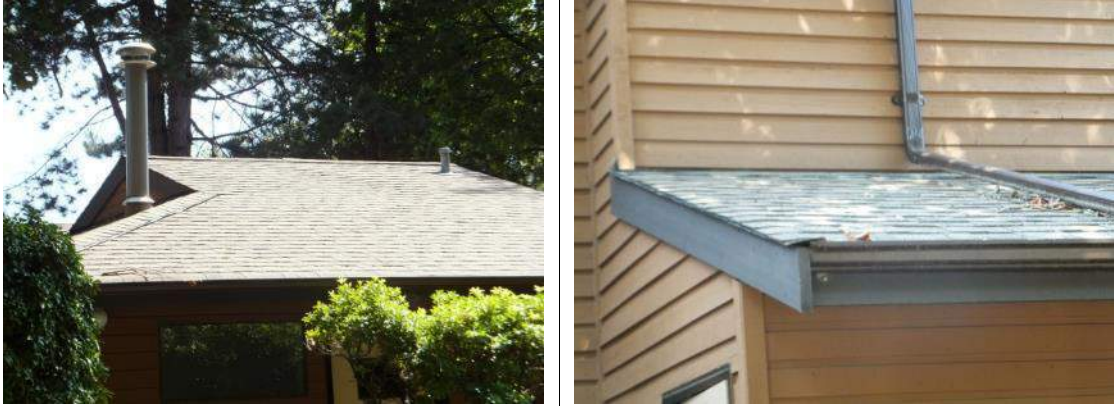
EE 1 – Roofing – Sloped Roofing System		
Year Installed	2008	Description: The sloped roofs are protected with asphalt shingles over underlayment. There are aluminum diverter and vertical penetration flashings.
Expected Life Span	20-25	
Observed Condition	5	
Repair or Replace	19

<p>Financial Review: We were advised by Council that the sloped roof, including gutters, downspouts, and fascia, was replaced approximately 5 years ago by Langley Roofing and was funded through special levies. We did not see the work contract, however, and are not aware of the costs involved.</p>		
<p>Visual Review: The sloped roof areas were viewed from grade and second floor balconies. Where checked, the roofs were generally clear of debris and organic growth. There were a few locations where we noted the edges of some shingles have started to lift, but overall the shingles are consistent with their chronological age.</p>

<p>Recommendations: Asphalt shingles typically last 20-25 years with regular maintenance. Periodic washing and clearing of leaves and other organic growth is the best way to maximize the life of the roofing. The Strata should also ensure that all flashings are installed at proper locations.</p> <p>The plan allows for replacement of the sloped asphalt shingled roof areas to be completed in approximately 19 years. We have split the replacement over 2 years.</p>

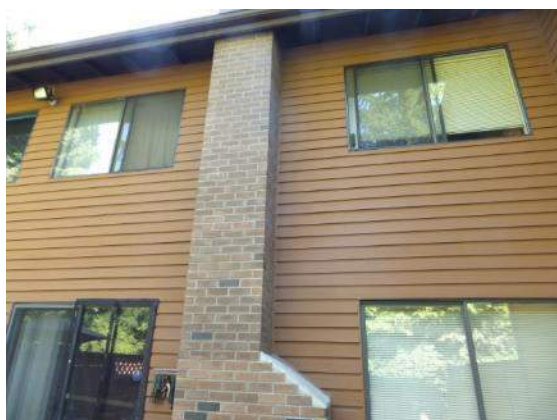
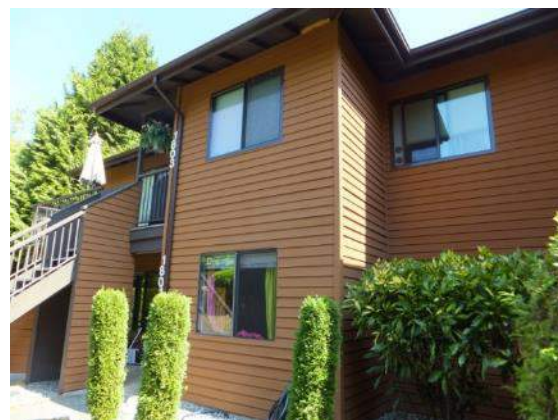
Year Installed	1980	Description: The exterior walls typically consist of wood framed back up walls with assumed batt insulation and vapour barrier. The walls are primarily clad with painted cedar siding. The chimneys are brick. The wood clad siding is designed as a face-sealed system, and does not incorporate a drainage cavity or rainscreen technology.
Expected Life Span	30-40	
Observed Condition	31	
Repair or Replace	7

Visual Review: As expected, some of the cladding appears to be new or recently repaired. We did note some signs of deterioration such as cracks and missing paint but considering its age the cladding appears to be in reasonable shape. The brick chimneys also appear to be in reasonable shape.

It is possible, because the assembly is face-sealed, that there may be concealed deterioration of some components of the cladding (i.e. exterior wood stud wall framing).

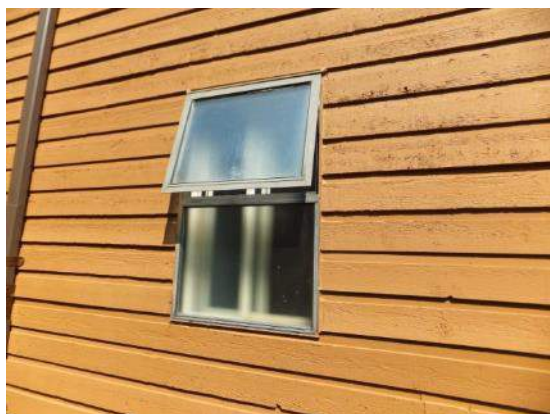
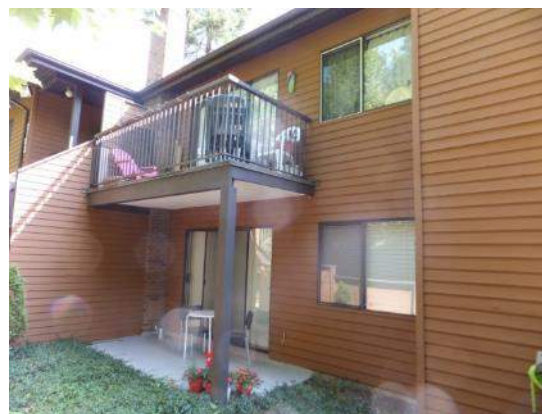
Year Installed	1980	Description: The windows consist of double-glazed units in aluminum frames. There is an assortment of fixed, sliding, and awning style window assemblies. Some of the patios and balconies are accessed by aluminum framed sliding glass door assemblies. Metal flashing is provided at the head of the windows. Weep holes are provided at the base of the windows to allow for drainage.
Expected Life Span	35-45	
Observed Condition	33	
Repair or Replace	7

Visual Review: We are not aware of any reported window issues. From our visual review from grade and the accessed suites we did not observe any major defects such as condensation, or cracks in the panels.

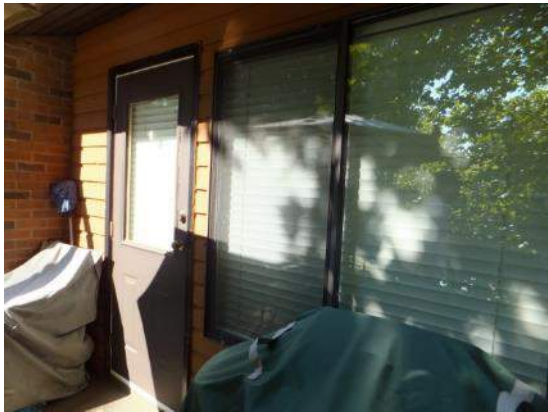
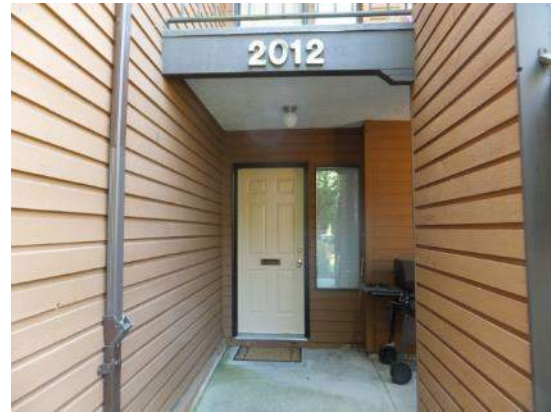
EE 4 – Exterior Doors, Major Repairs		
Year Installed	1980	Description: The exterior swing doors comprise of painted metal skinned units with hollow wood core in wood frames, and having an aluminum threshold. Some of the doors have a glass panel.
Expected Life Span	30-50	
Observed Condition	33	
Repair or Replace	15

Visual Review: We are not aware of any performance issues with the exterior doors.

Recommendations: Exterior doors of these types typically have a life expectancy of 30-50 years. Since the exterior doors at this property are generally sheltered we have assumed that a full replacement during the term of this DR will not be required.

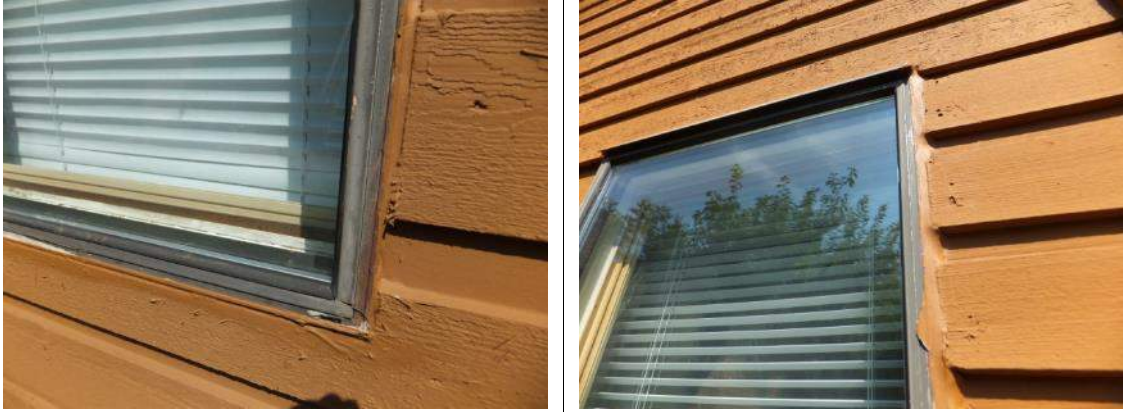
EE 5 – Painting & Caulking		
Year Installed	Varies	Description: Paint is applied to the wood cladding, soffits, fascia, and doors. Sealants are applied at window and door perimeters, as well as at any transition joints between the siding and other building components.
Expected Life Span	10-15	
Observed Condition	3	
Repair or Replace	22

<p>Financial Review: We understand that many painting projects have been completed over the years, the most recent of which was \$6,174 in 2013. Other painting jobs have been completed as part of general maintenance work.</p>		
<p>Visual Review: Although it was not checked at all locations, we assume that sealant is applied at all window and door perimeters. Where checked the sealant is not consistently applied; it is cracked or missing in some places, and excessively applied in other spots.</p> <p>Although not consistently applied everywhere, we found that the painting coverage and quality is good overall. It appears that the Strata has taken a pro-active view of painting for the structures, and this has, in our opinion, extended the life of the painted components.</p>

<p>Recommendations: Regular wall maintenance including cleaning and sealing will generally assist in mitigating premature deterioration and failure of the exterior cladding concrete walls. The paint will assist in mitigating water penetration at the exterior walls. Over time with weathering and aging the coating and sealants will begin to crack and break down requiring eventual replacement.</p> <p>The plan allows for recoating the walls and replacement of the sealants to occur in 22 years on a 15 year cycle. The project is spread over two years. We have not included a painting project during the years 2020 - 2024 because repainting is assumed to be done as part of the recladding project at that time. We suggest annual cleaning and spot repainting to maximize the lifespan of the paint and sealants. We assume that localized repainting or caulking jobs will continue, and will be funded from the operating account.</p> <p>Engineering costs have been included along with associated costs for specification and tendering. The total repair cost also includes a 20% allowance for mobilization and site access (suspended access and ground protection).</p>

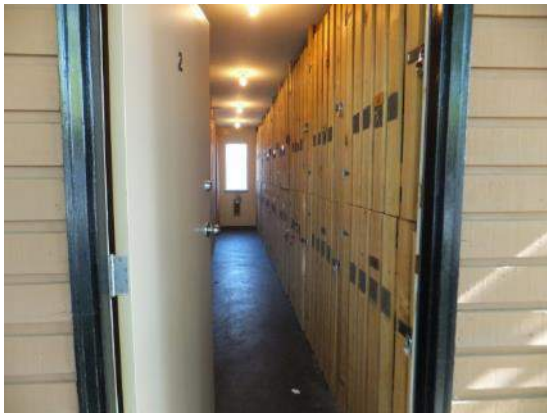
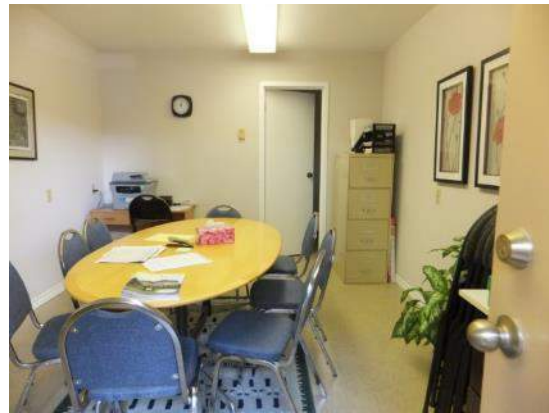
I 1 – Storage Rooms		
Year Installed	1980	Description: The two storage buildings were originally utilized as laundry structures. In their current configuration they comprise storage rooms, a meeting/office room, as well as two 2-piece washrooms. The flooring consists of epoxy and exposed concrete, the walls & ceilings are painted drywall. Heating is provided by electric baseboards, and there is a mix of incandescent and fluorescent light fixtures. Wood storage units are built into the storage rooms, and there are various contents including tables, chairs, office equipment and artwork.
Expected Life Span	30-50	
Observed Condition	33	
Repair or Replace	17

Visual Review: We have only considered the interior finishes, equipment and contents within the buildings; all exterior common assets would have been included in other components. We have assumed that all contents are wholly owned by the Strata and not leased. We did not test any equipment or plumbing fixtures, but assume they are functioning satisfactorily.

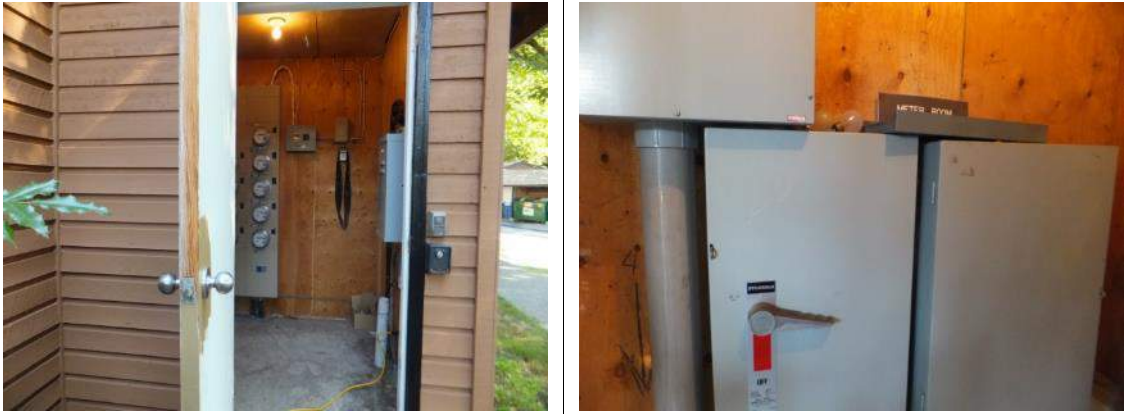
EL 1 – Electrical Systems		
Year Installed	1980	<p>Description: The electrical service is supplied to electrical rooms via buried cables. Based on what we could determine on site and from the plans, there are 5 electrical closets. We assume that the rooms are similar. A typical electrical room has a main switch that is rated 400A, 3-phase, 4 wire. A 70A house panel and meter center is also located in each electrical room.</p> <p>Any telephone and cable equipment is assumed to be the responsibility of the provider. We assume that any meter centres in the electrical closets are the responsibility of B.C. Hydro.</p>
Expected Life Span	50+	
Observed Condition	33	
Repair or Replace	24

<p>Financial Review: We understand that the electrical systems are part of the original construction. We are not aware of any replacements or significant repairs to this component.</p>		
<p>Visual Review: The meters are assumed to be the responsibility of the service provider and have not been considered. Where visible, the equipment appeared to be operating well at the time of our visit. We are unaware of any electrical issues at the building.</p>

<p>Recommendations: Major electrical equipment has an average service life of 50 years or more.</p> <p>Although we do not anticipate replacing all of the electrical closet components at one time, the Strata should plan for the eventual replacement of the main switches, and distribution panels at the end of their expected operable life terms. We have planned for replacement of the main switches, plus an allowance for miscellaneous repairs in the year 2037, and then every 25 years thereafter.</p>

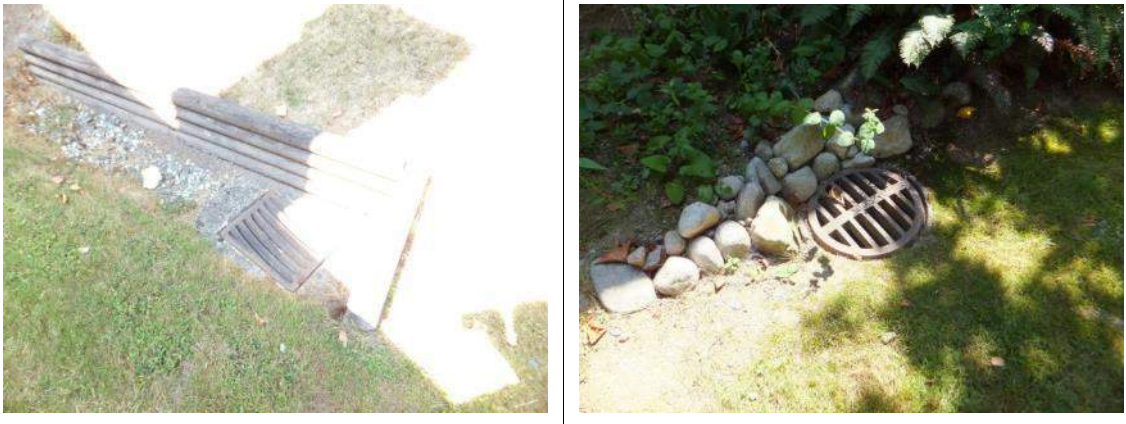
SRV 1 – Buried Site Services		
Year Installed	1980	Description: Site services include domestic cold water, sanitary and storm piping, gas piping, and electrical wiring. They are supplied to the building via buried conduits and piping fed from main municipal lines below the adjacent roads. Site drainage is accomplished with natural sloping of the hard and soft landscaping components to various catch basins throughout the site. Immediate drainage from the buildings is accomplished with buried drain tiles that are located next to the foundations and attached to downspouts. Assumed domestic water, storm and sanitary piping are connected to the buildings. Gas meters are located beside the buildings at grade.
Expected Life Span	60	
Observed Condition	33	
Repair or Replace	N/A

<p>Financial Review: We were advised by Council that two of the water supply lines were replaced in 2008 after an underground leak. However, we cannot confirm the costs involved through a work contract. We also understand that in 2013 drainage work on Buildings 2100, 2200, & 2300 has been done and includes cleaning of drain tiles, new drain tiles, and sump pumps. We are not aware of any other major repairs or replacements to this component.</p>

<p>Visual Review: Buried site services were not visually inspected due to their concealed locations. Review of these systems was done by studying the available information from building plans in combination with the limited amount seen. The sanitary drainage systems within the building, including the risers to the suites, are expected to last beyond the scope of the DR so they have not been included.</p> <p>Where checked, there are some signs of pooling water, and soil erosion especially near catch basin grates. We noted various catch basins throughout the site and they appear to be properly placed to serve the building site.</p>		
<p>Recommendations: We assume that the underground services and drainage have a remaining life that extends beyond the scope of this DR, so full replacements have not yet been considered. Over time it is expected that repairs and localized replacement of sections of the piping will be required due to unplanned damage from occurrences such as natural settlement above and below the buried piping, soil erosion, and seismic activity.</p> <p>Allowances to adjust settled areas around the catch basins and some buried piping are budgeted in the repair projects of the paving section.</p>

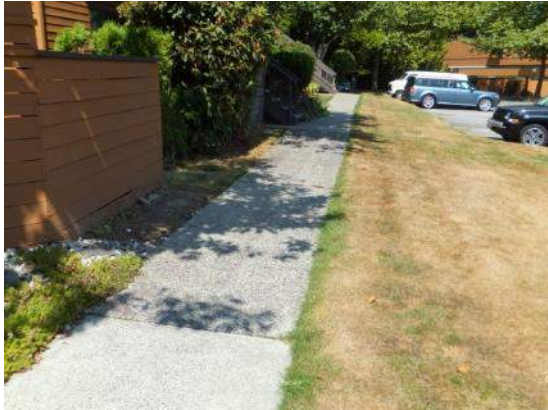
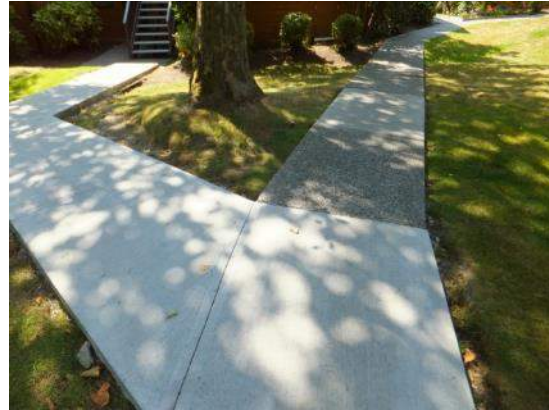
Site 2 – Walkways & Patios		
Year Installed	1980-2013	Description: The walkways consist of cast-in-place concrete slab over compacted fill. The patios are also concrete slab, but some of them are covered with wood decks.
Expected Life Span	30-40	
Observed Condition	33	
Repair or Replace	4

Visual Review: The newer sections of walkways remain in good condition. For the original walkways, we noted cracking, spalling, and some settlement. Taken as a whole the walkways and patios are in fair to good condition.

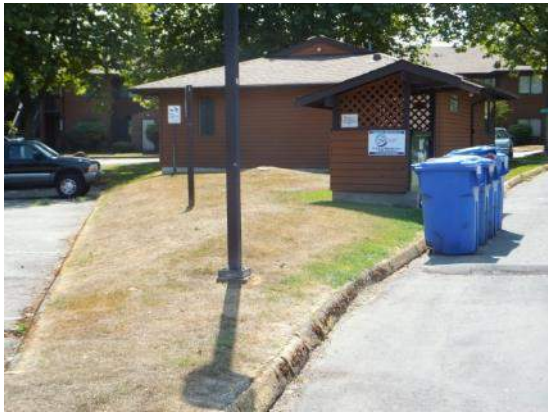
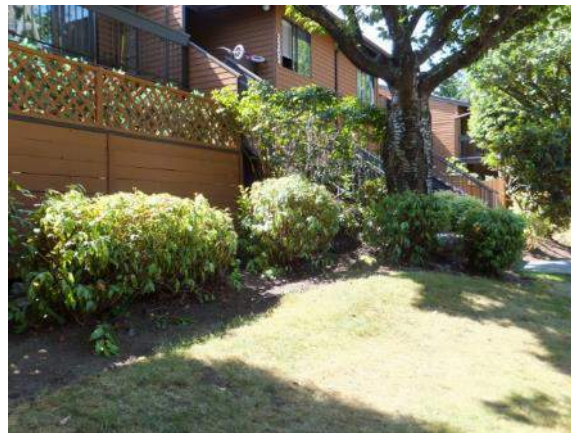
Year Installed	1980	Description: Site landscaping consists of various hard and soft landscaping components. Trees, shrubbery, flowerbeds and sodded areas are incorporated throughout the site. Hard landscaping includes the garbage shelters, signage, street lights, landscaping lights, fire hydrants, and retaining walls.
Expected Life Span	30+	
Observed Condition	25	
Repair or Replace	4

Visual Review: The site landscaping is showing signs of their age. The grass is burned out in many places and sparse in other areas. The lights, although still functioning well are due for some more paint. The garbage structures appear to be in reasonably good condition.
