Winchester

5 Year Warranty Review

21867 50th Avenue
Langley, BC

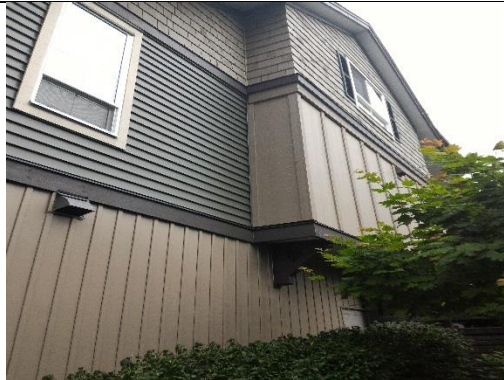
PVC vinyl siding is a lightweight, economical siding material that has been around for a long time and generally performs well in our local climate. The colour of vinyl siding will fade fairly rapidly. PVC is a thermoplastic and cannot tolerate much heat. BBQ's should not be placed near vinyl siding as the heat from the BBQ will distort the vinyl material.

The through wall flashings drain moisture from the weather/moisture barrier underneath and allow any moisture that gets past the face of the claddings to be diverted to the exterior. Flashings installed at each floor level also compartmentalize the exterior walls into sections, which acts to keep the accumulation of moisture in any one section to a minimum. The through wall flashings at level 2 and 3 appeared to be in good condition with adequate slope and coverage.

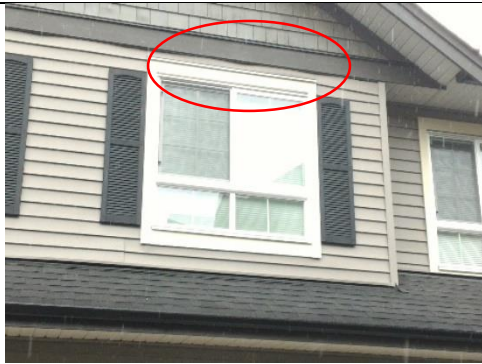
Siding has dislodged at unit 57.

B SHELL		
B20 EXTERIOR VERTICAL ENCLOSURES		
	B2010 Exterior Walls	1. Reset siding at unit 57.
	B2020 Exterior Windows	No warranty items identified.
	B2050 Exterior Doors	No warranty items identified.
	B2070 Exterior Louvers & Vents	No warranty items identified.
	B2080 Exterior Wall Appurtenances	No warranty items identified.
B30 EXTERIOR HORIZONTAL ENCLOSURES		
	B3010 Roofing	No warranty items identified.
	B3020 Roof Appurtenances	No warranty items identified.
	B3040 Traffic Bearing Horizontal Enclosures	1. Move top tread away from building to allow water drainage between the top stair tread and the wood fascia.
	B3080 Overhead Exterior Enclosures	No warranty items identified.

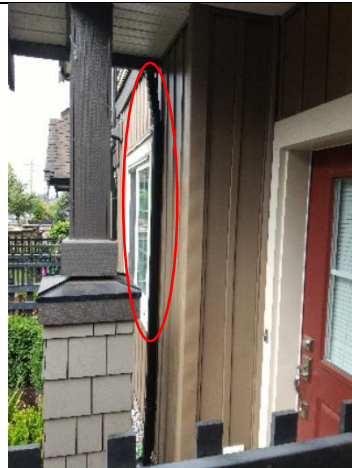
Siding corner trim show uneven surface. This is an aesthetic concern only, the performance of the siding will not be affected.

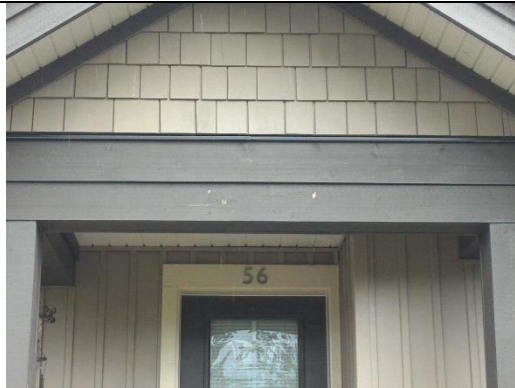
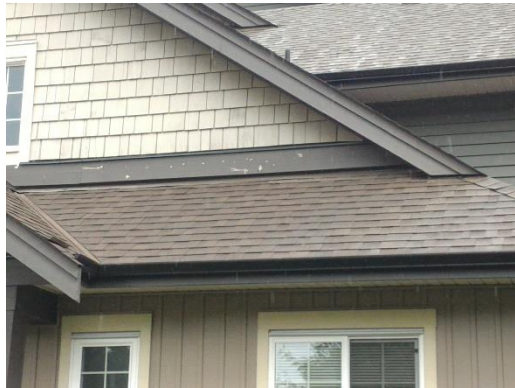
The paint application to the wood trim, including the roof and floor level fascias appears to be showing wear and signs of weathering.

Please note that typically the paint coverage on the wood trim at southerly exposed areas will be the first to show signs of deterioration.

Repainting of the wood trim and composite cement siding is recommended to be completed within approximately the next two years. The repainting works should include renewal of sealants.

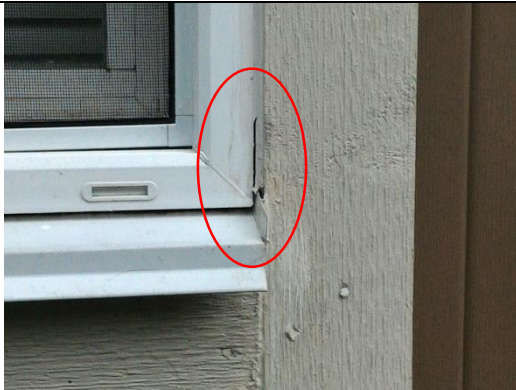
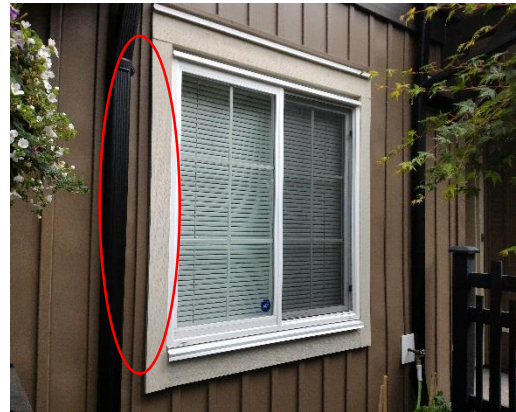
Sealant was observed to be installed between the window frame jamb and wood trim, which is in our opinion, an industry standard.

The sealant is beginning to fail near the lower section of the window jambs and between wood trim intersections. Replacement of the sealants is a normal maintenance procedure and we recommend the sealants be renewed in conjunction with repainting.

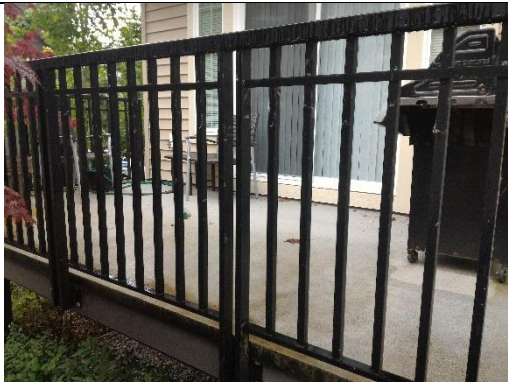
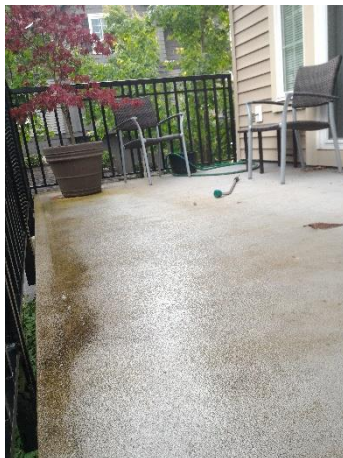
The balcony membrane installed on this project is a liquid applied balcony coating, typically a moisture cured urethane product is used in residential construction. The liquid applied membrane does not have a very long service life, and recoating of the membrane is recommended at approximately ten year intervals.

The balconies appeared to be sloped to drain away from the building, and the membrane observed was well applied, without damage, blistering or delamination.

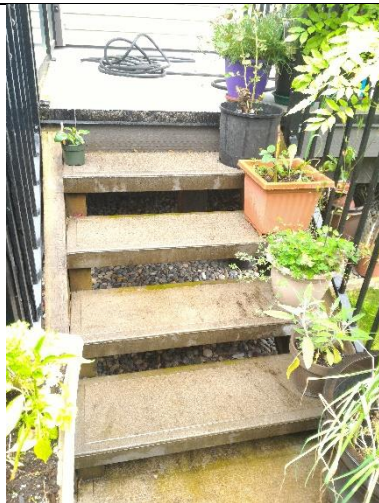
Typical concrete stair entry to balcony.
Top step is tight against the wood fascia.

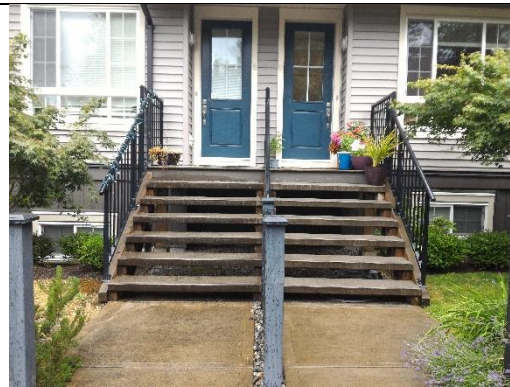
Typical front entry stair, the top step is tight against the landing wood fascia.

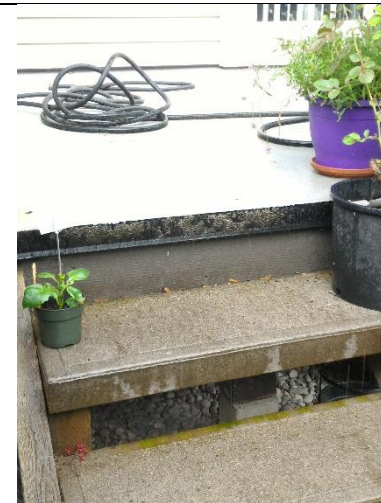
The concrete stair treads placed against the wood fascia boards at entries and decks, in our opinion is retaining water against the building and will lead to premature damage (decay) of the fascia boards. We recommend remedial work take place under warranty.

Top stair tread is tight against the wood fascia. This retains water against the wood fascia, which will lead to premature deterioration of the wood fascia. The tread should allow enough space for water to drain between the fascia and the stair treat.

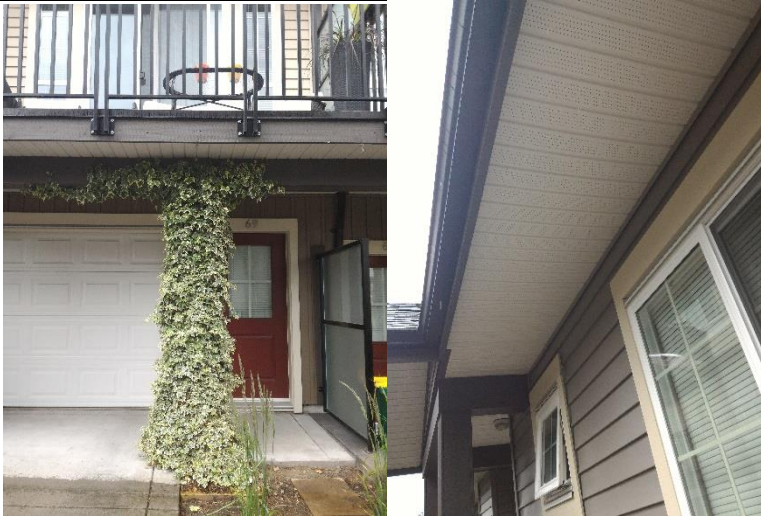
The perforated vinyl soffits below most of the balconies and roof eaves were generally in good condition without systemic signs of staining, damage or loose panels.

The ivy growing on the columns and wood trim at unit 69 can damage the paint and wood surfaces, and should be removed.
