**Visual Property Inspection**

**404 Bruneau Place  
Langley, BC V4W 3K9**

Date: 26-Apr-2017

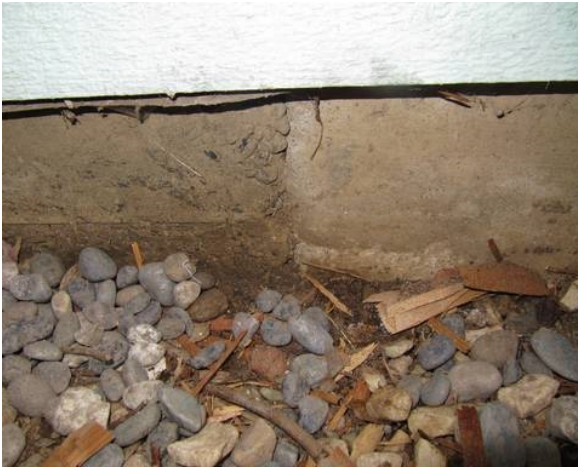
Minor foundation crack.

Fill and seal foundation cracks to reduce potential water penetration and subsequent damages. No moisture detected at the time of inspection.

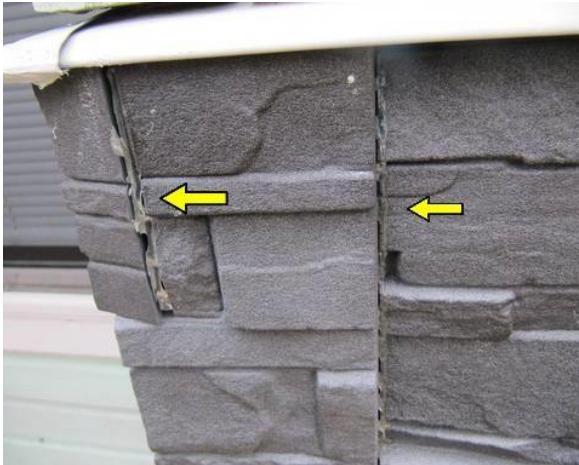
Seal all wall crack to prevent water entry.

Seal any crack/gaps or penetrations in the siding throughout the home including around windows and doors to help reduce moisture entry/damage.

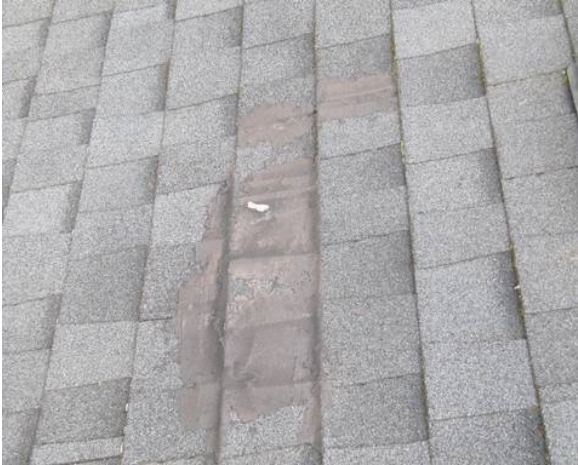
*Previous repairs noted on the main roof, this is above the stains I noted in the attic. Monitor.*

Patch work noted on the main roof above the water staining in the attic.

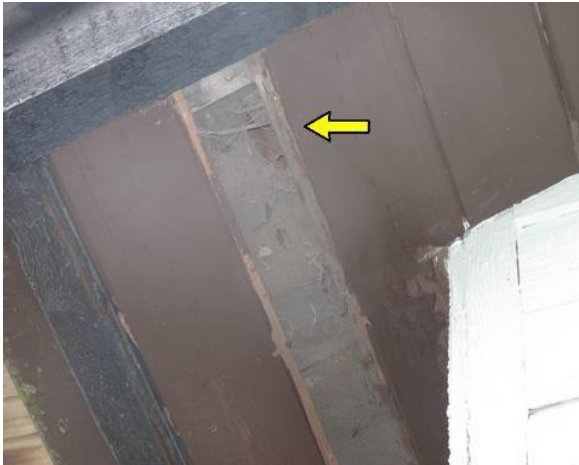
Open gap in some soffit vents. Recommend sealing gap to reduce risk of rodent access and bird nesting. A bird nest was noted at the time of inspection.

Fix holes in soffit vents.

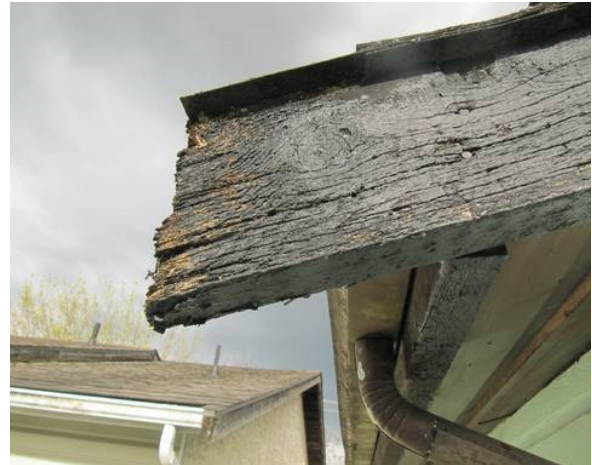
*Fascia deterioration noted on all fascias. Repairs/replacement is to be expected in the future.*

Fascias are deteriorating.

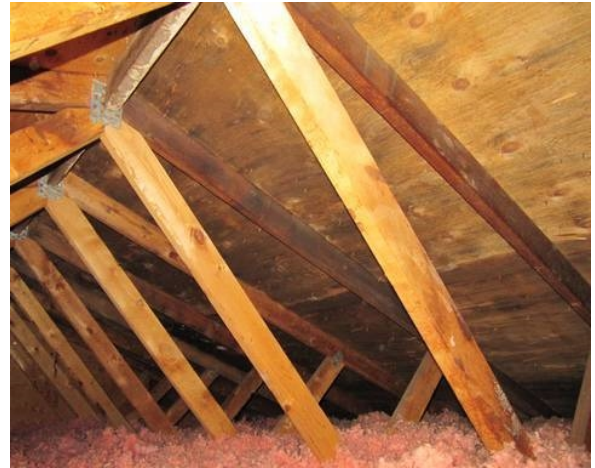
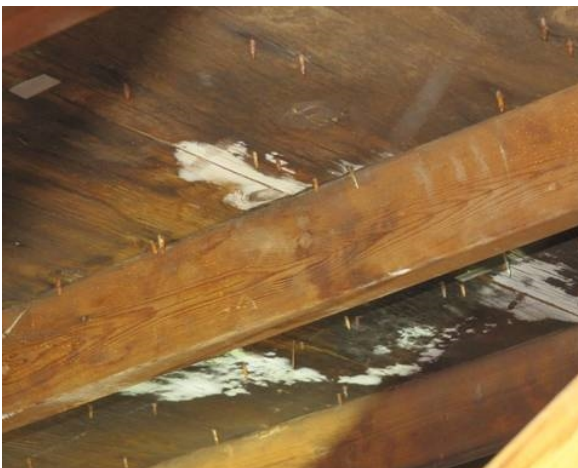
*Some water staining noted in the sheathing. It appears the issue was fixed, monitor and repair as necessary.*

Minor staining noted in the attic.

Water stains noted in the attic.

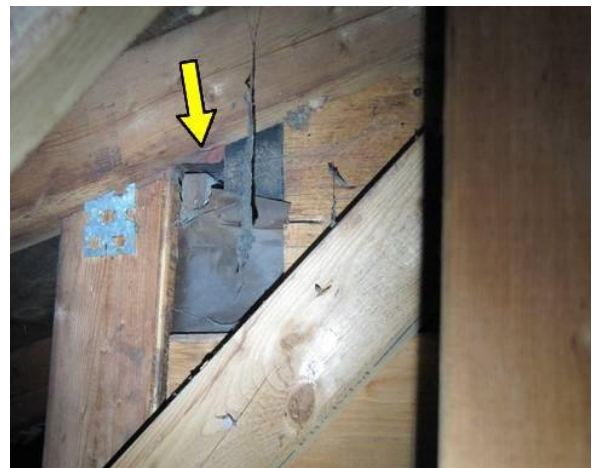
Holes in the attic need to be sealed.

*Consult a qualified roofer to seal all gaps in roofing material/sheathing to reduce water entry and subsequent damages.*

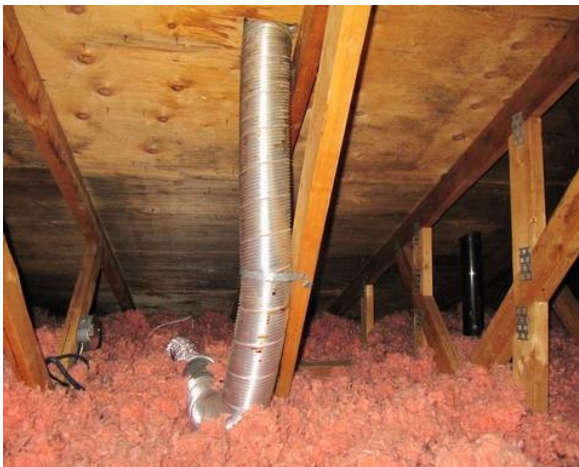
Recommend all vents be insulated.

*Insulate exhaust duct to reduce condensation and potential damages related to moisture runback.*

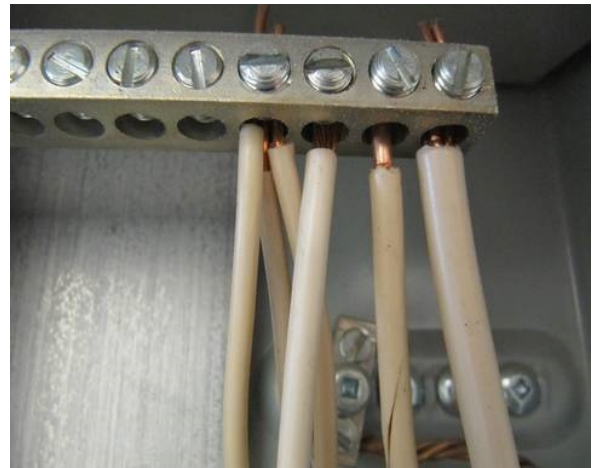
Neutral wires should have their own spot, not 3 in one spot.

Each neutral (white) wire should be secured separately under a setscrew terminal in an electric panel. Recommend an electrician fix this issue.

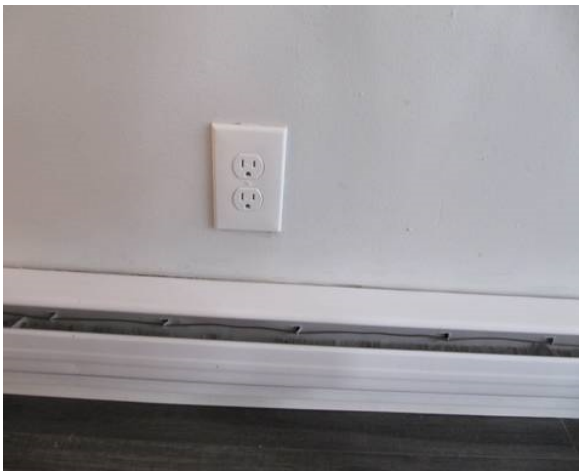
*Receptacles are located over electric baseboard heaters, this is typical of homes this age. Receptacles are now located off to side of heater to reduce risk of and electrical hazard with cords contacting heaters.*

Outlets over baseboards aren't recommended.

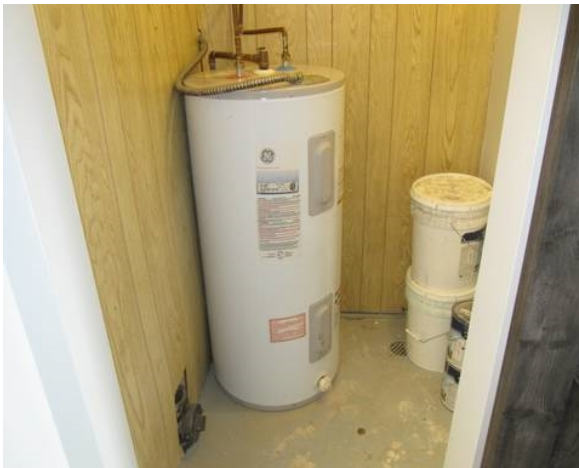
*Water heater is nearing the end of typical life expectancy (8-12 years). Budget to replace.*

*Install water heater strapping/anchoring to promote tank stability.*

Install seismic strapping and drip pan.

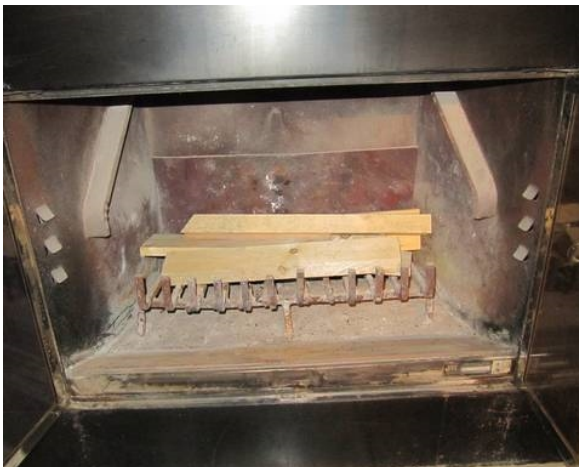
*Wood fireplace flue has some creosote build up. Recommend cleaning and evaluation prior to use to reduce risk of a chimney fire.*

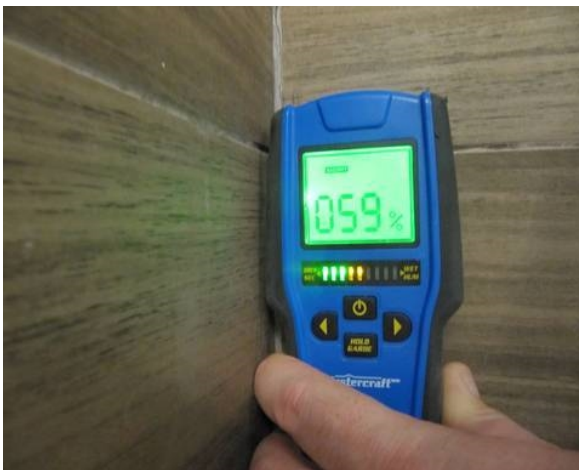
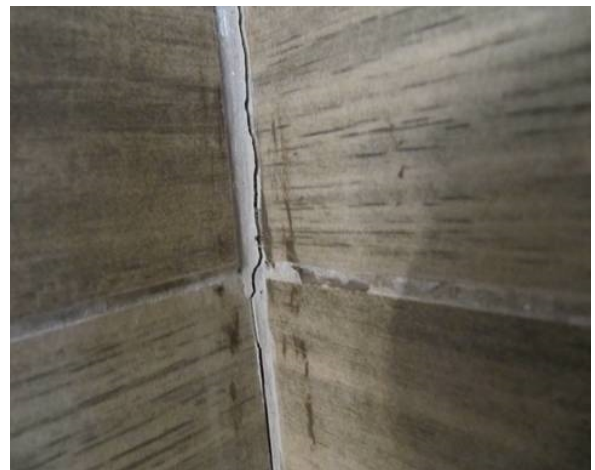
*Slightly elevated moisture but no movement detected behind shower wall ceramic tiles. Recommend required maintenance to reduce risk of further water seepage through grout.*

Elevated moisture noted in the bathroom.

Grout cracks should be repaired.

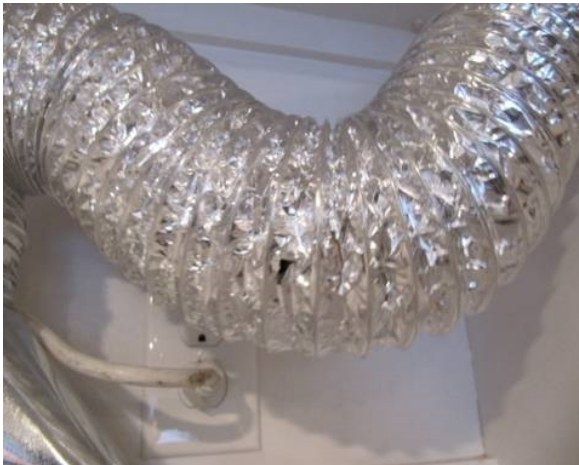
Fix the hole in the range vent.

Recommend repairing the small hole in the range hood vent to prevent smells from entering the house and ruining the inside of the cabinet.

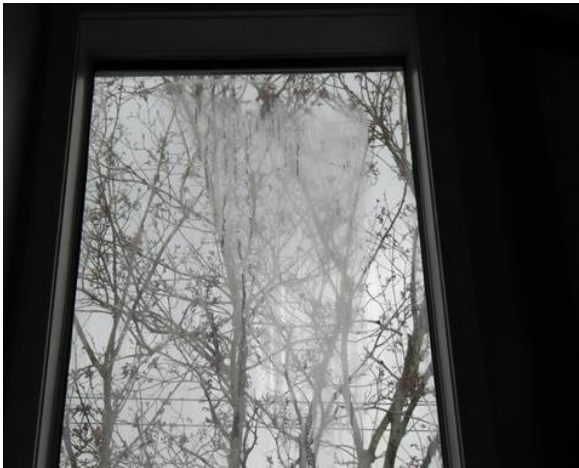
*Failed seal between double panes of glass. Window has fogged. Condition considered cosmetic.*

Failed seal between windows.
