# Depreciation Report - Final

## The Boardwalk Strata Corporation VIS 3899

827 North Park St  
Victoria, BC

**Elevator  
Depreciation Report**

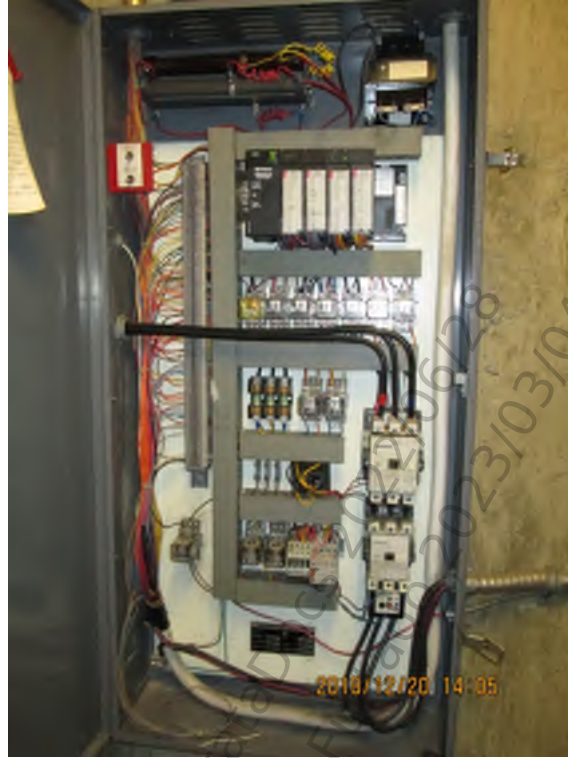
Photo 1 - Elevator controller

**Major Control Modernization** - The typical elevator “full maintenance” contract covers the replacement of major components in addition to the labour and materials necessary for ongoing repairs, adjustment and preventive maintenance work. Despite this, however, over time some components will require modernization. Certain elevator components may eventually no longer be readily available. This will require that the maintenance contractor make arrangements to purchase parts from an external supplier or have parts manufactured and repaired locally. Although this is not the owner's direct concern, it will result in some delays and difficulties in implementing a proper maintenance program. Based on the age and current condition of the equipment, a major control modernization could be anticipated within approximately seven years. The scope of work would include replacement of the present controllers with a newer design of microprocessor-based controller, replacement of the door operator, fixture replacement, possible replacement of the levelling valve and some refurbishing of the hydraulic pump and motor. The cost for this would be in the area of \$65,000.

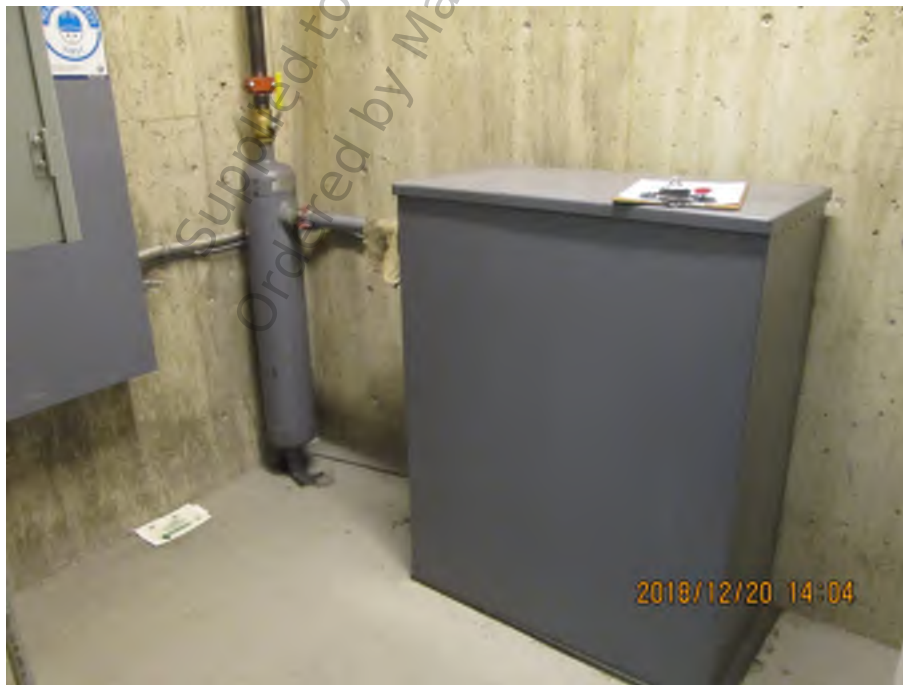
The hydraulic and electrical equipment in the machine room appears to be operating reasonably well with no undue vibrations or unusual noises noted.

Photo 2 - Elevator hydraulic pumping unit

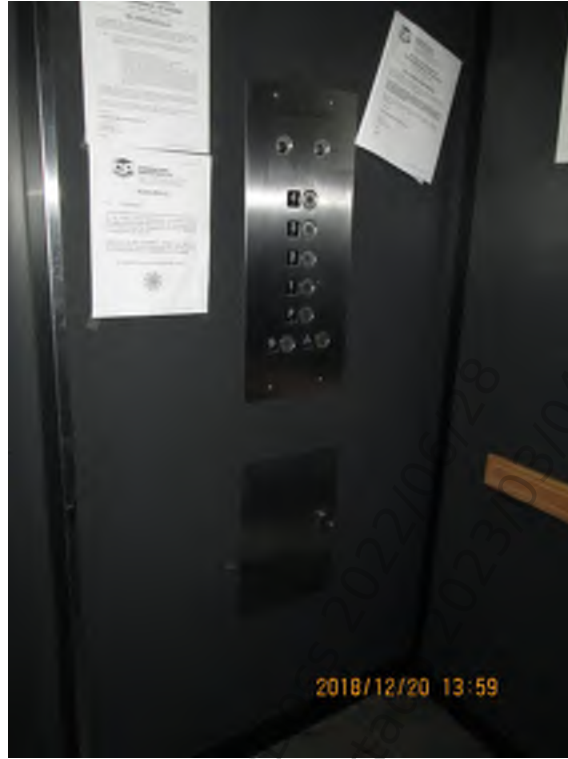
**Photo 3 - Elevator car station**

**Hands-Free Telephone** – Presently the only form of emergency communication inside the elevator is an alarm bell. Should a passenger become entrapped there would be no assured way of directly calling for help. We recommend that a hands-free telephone be installed inside the elevator cab for emergency communication. The cost would be in the area of \$2,500 and should be performed within the next twelve months. An active telephone line to the machine room would be required to be installed by other trades. The cost for this would be negligible if performed in conjunction with a major control modernization.

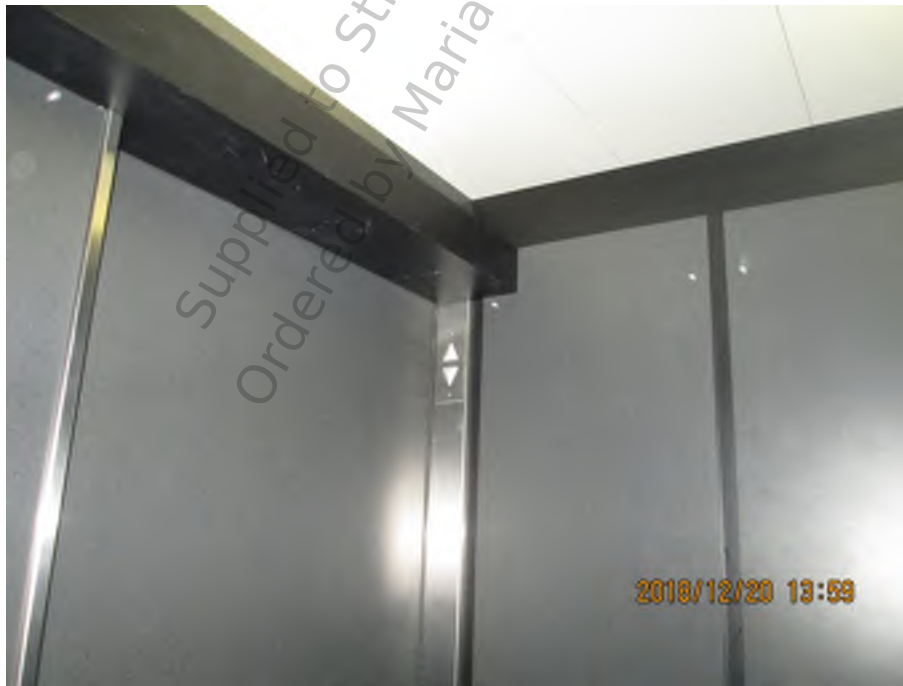
**Photo 4 - Elevator cab finishes**

**New Cab Finishes** - The cost to upgrade the cab finishes could range from \$15,000 to \$25,000, depending on the finishes selected. We recommend using a figure of \$20,000. We suggest the cab upgrades be performed in the next ten years. The cost could be reduced if performed in conjunction with a major control modernization.

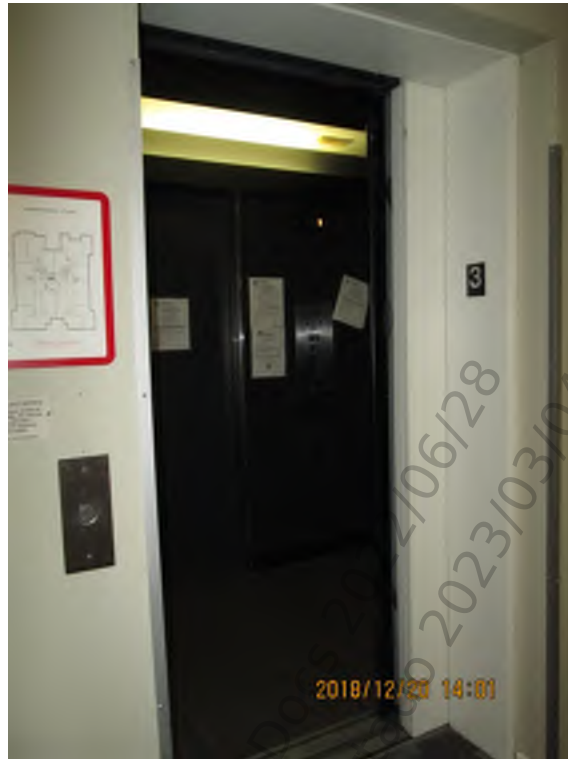
**Photo 5 – Floor 3 lobby view**

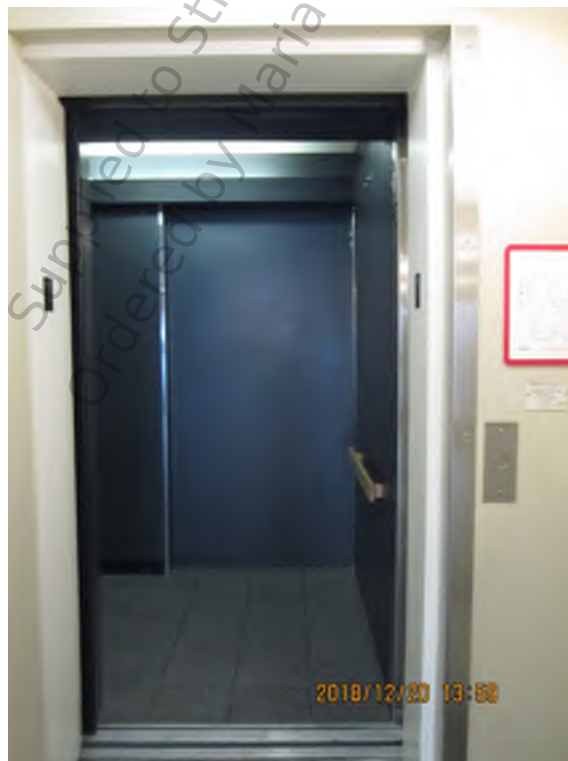
**Photo 6 – Floor 1 lobby view**

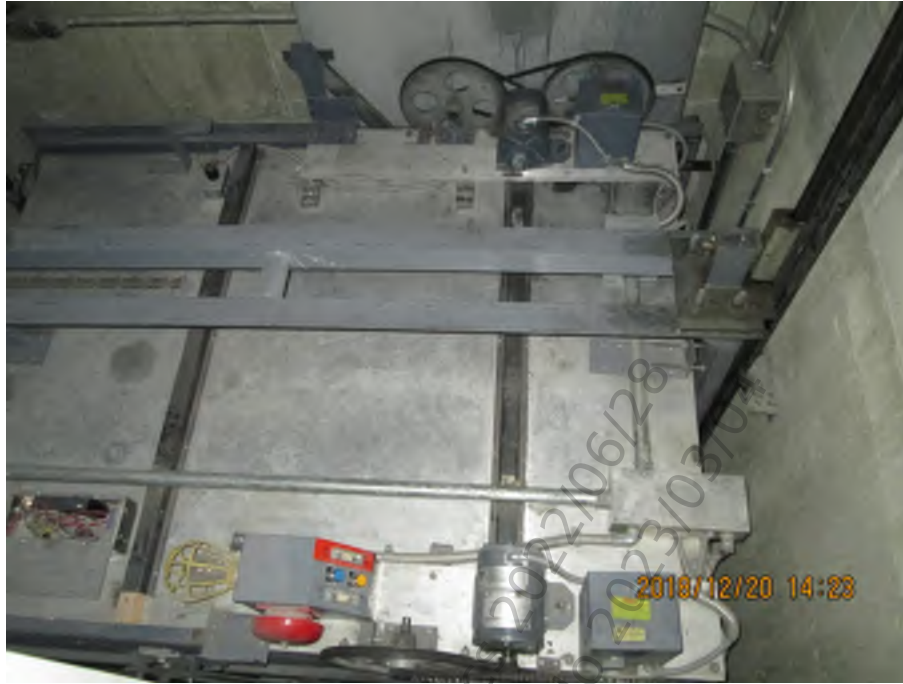
**Photo 7 – Car top**

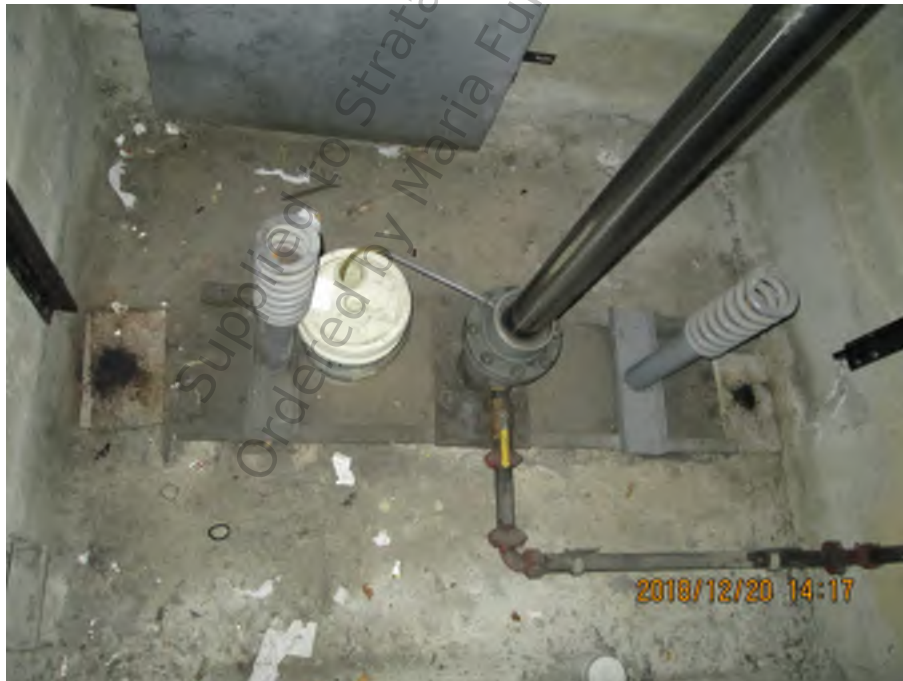
**Hydraulic Cylinder Replacement** - The elevator's hydraulic cylinder is not provided with any form of corrosion protection, such as a cathodic protection system or a PVC liner (now required by code on new hydraulic elevators). The average life expectancy of a buried cylinder is in the range of 25 years but there is a wide variation from one installation to another. We recommend that the cylinder be replaced or the elevator converted to an above-ground design within the next five years.

**Photo 8 – Pit**

Rather than replacing the cylinder we recommend that consideration be given to the replacement of the elevator with a hole-less (above ground) roped hydraulic elevator. Alternatively the elevator could be replaced with a machine-room-less (MRL) design.
