10530.0000
Southpoint Ridge
15-mth & 2-yr Warranty Review

Regarding: **15-mth & 2-yr Warranty Review**

Method Engineering and Building Services Ltd. (METHOD) was retained by Strata Plan EPS 5294 to complete a review related to the 15-month and 2-year warranty at phase 1-3 of the Southpoint Ridge Townhouses in Langford, BC.

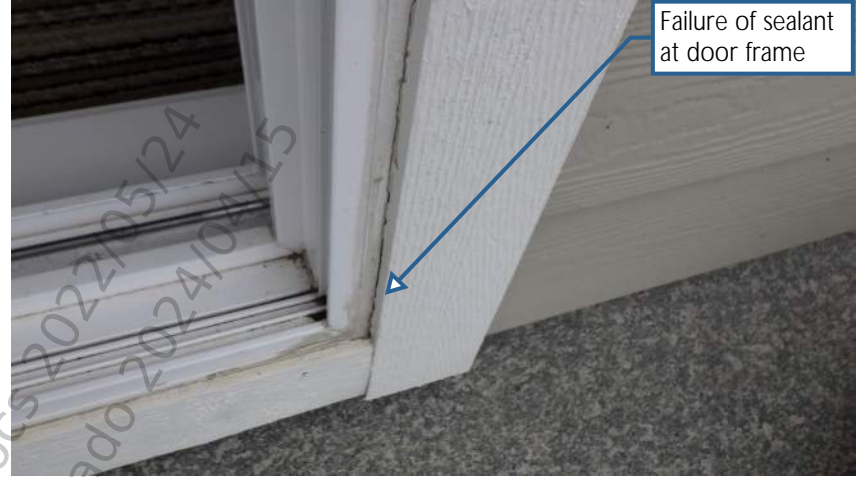
A03 - F	Unit 1216	80267576		
A03 - B	Unit 1237	80250968		
A04 - A	Unit 1223, 1225, 1229	80250933	OBS A04-01 to OBS A04-05	<ul style="list-style-type: none"> Sealant failure at door between door frame and trim. At unit 1241, there is a hole existing in sealant at the balcony door due to a void in the adjacent trim board.
A04 - C	Unit 1239, 1241, 1245	80250963		
A04 - F	Unit 1220	80267576		
A05 - A	Unit 1223, 1225	80250933	OBS A05-01 to OBS A05-08	<ul style="list-style-type: none"> Inconsistent paint finish noted on trim/siding. This is a cosmetic workmanship item and not a performance concern.
A05 - C	Unit 1239, 1241, 1243, 1245	80250963		
A05 - B	Unit 1235	80250968		
A05 - D	Unit 1249, 1251, 1253	80252844		
A05 - E	Unit 1257	80252839		
A06 - A	Unit 1223, 1225, 1229	80250933	OBS A06-01 to OBS A06-06	<ul style="list-style-type: none"> Paint noted on flashing. This is a cosmetic workmanship item and not a performance concern.

Failure of sealant at door frame

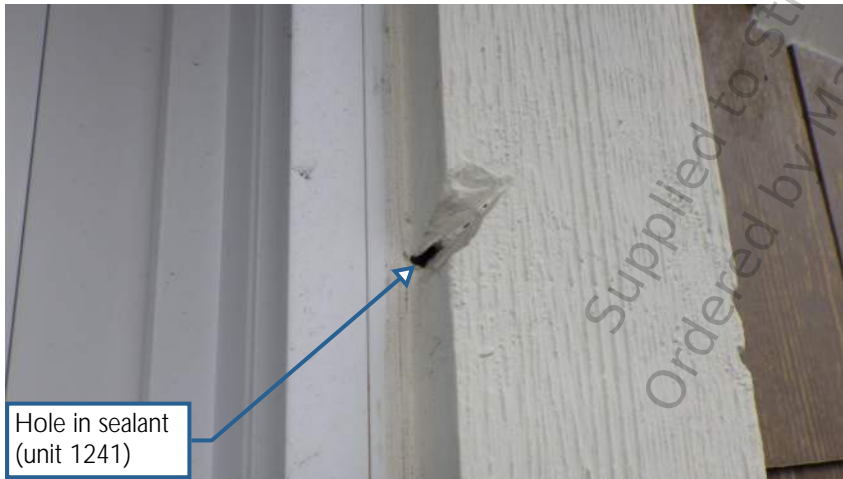
OBS A04-02

Hole in sealant (unit 1241)

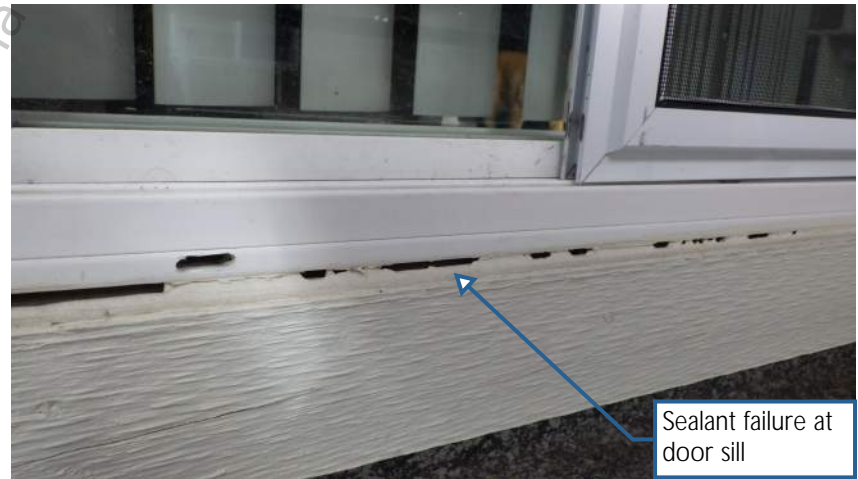
OBS A04-03

Sealant failure at door sill

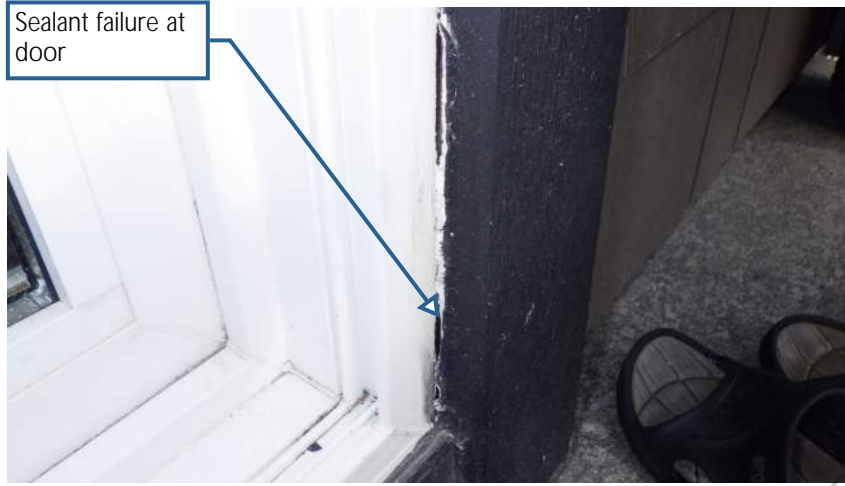
OBS A04-04

Sealant failure at door

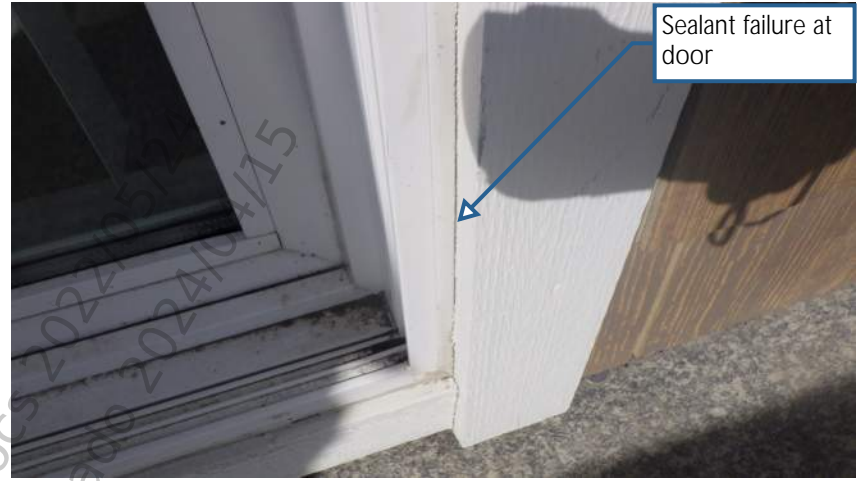
OBS A04-05

Sealant failure at door

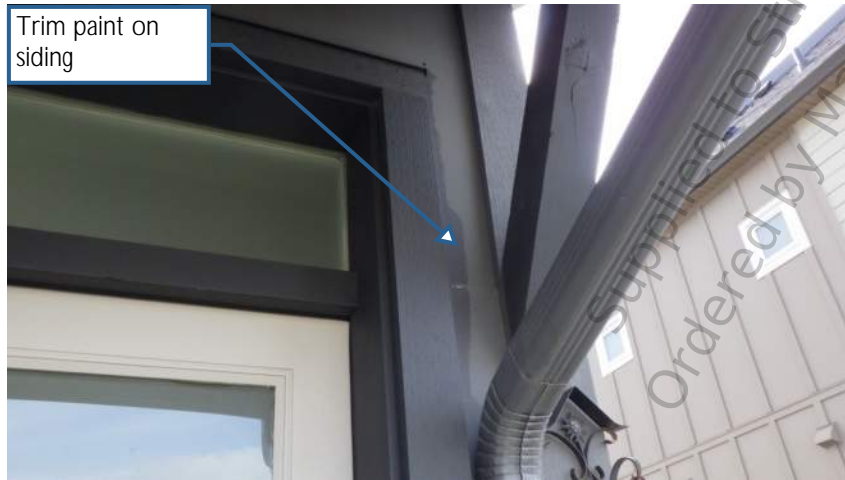
OBS A05-01

Trim paint on siding

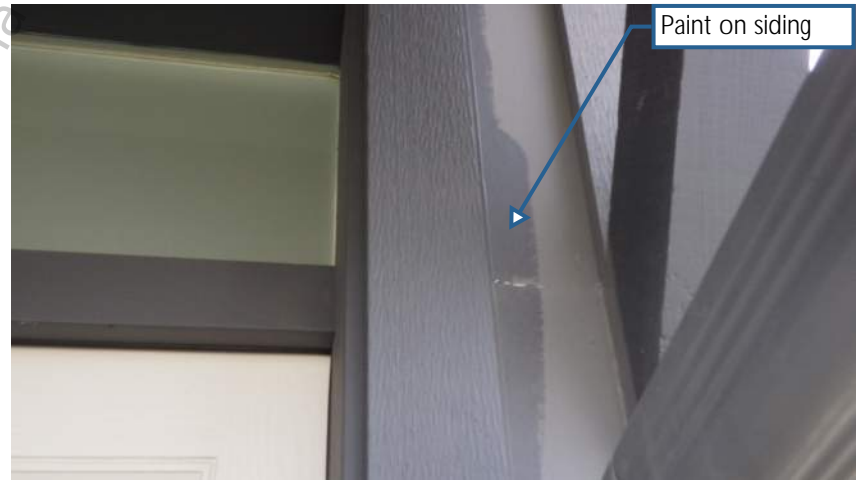
OBS A05-02

Paint on siding

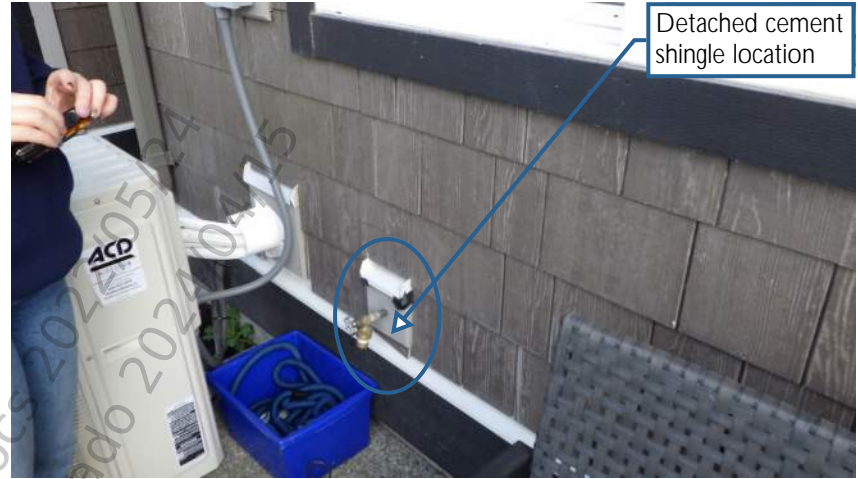
OBS A16-04

Detached cement shingle location

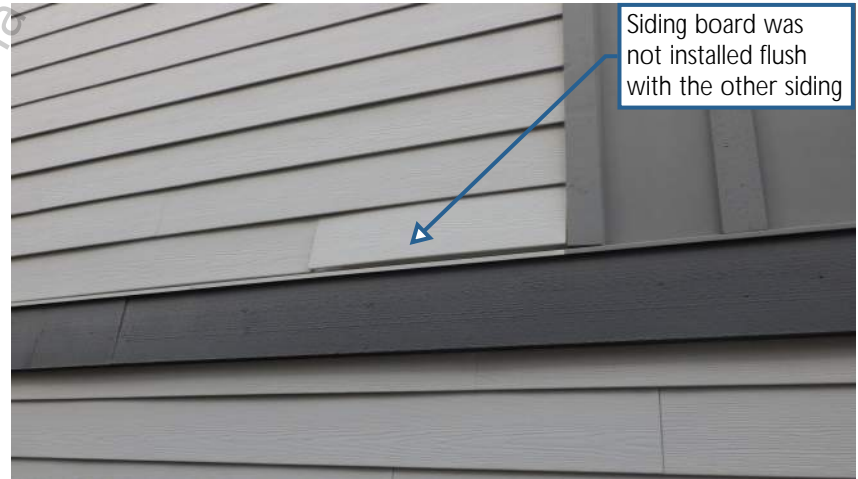
OBS A16-06

Siding board was not installed flush with the other siding

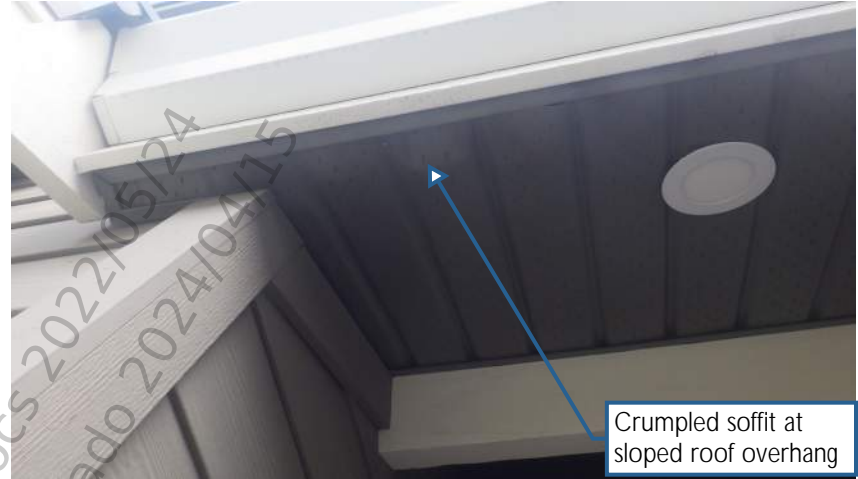
OBS A20-04

Crumpled soffit at sloped roof overhang

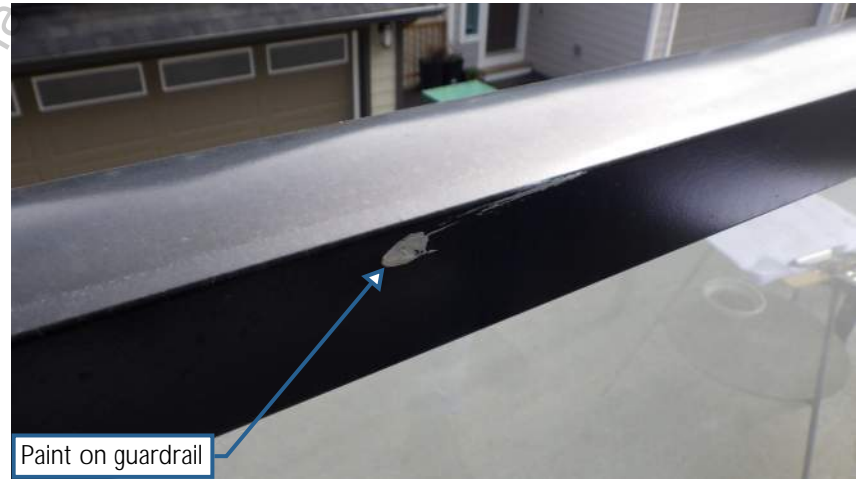
OBS A22-02

A21 -				Item number omitted
A22 - C	Unit 1245, 1243	80250963	OBS A22-01 to OBS A22-03	<ul style="list-style-type: none"> Paint on guardrail. This is a cosmetic workmanship item and not a performance concern.
A23 - D	Unit 1249	80252844	OBS A23-01 to OBS A23-03	<ul style="list-style-type: none"> Cement board shingle siding is damaged at the gas outlet head flashing resulting in a poor aesthetic finish. This is not a performance issue.
A24 - D	Unit 1249	80252844	OBS A24-01	<ul style="list-style-type: none"> Soffit panel is loose.
A25 - D	Unit 1251	80252844	OBS A25-01 to OBS A25-11	<ul style="list-style-type: none"> Exposed sheathing paper and tuck-tape at the base of cladding. This is a cosmetic/workmanship issue and not related to building performance.
A25 - F	Unit 1220, 1216, 1224, 1228	80267576		
A25 - E	Unit 1261	80252839		
A26 - D	Unit 1253	80252844	OBS A26-01 to OBS A26-02	<ul style="list-style-type: none"> Paint on door. This is a cosmetic workmanship item and not a performance concern.

Paint on guardrail

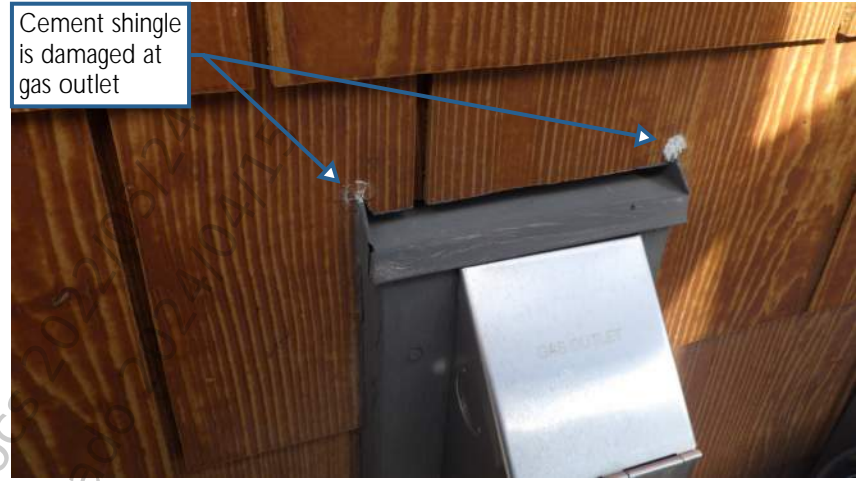
OBS A23-01

Cement shingle is damaged at gas outlet

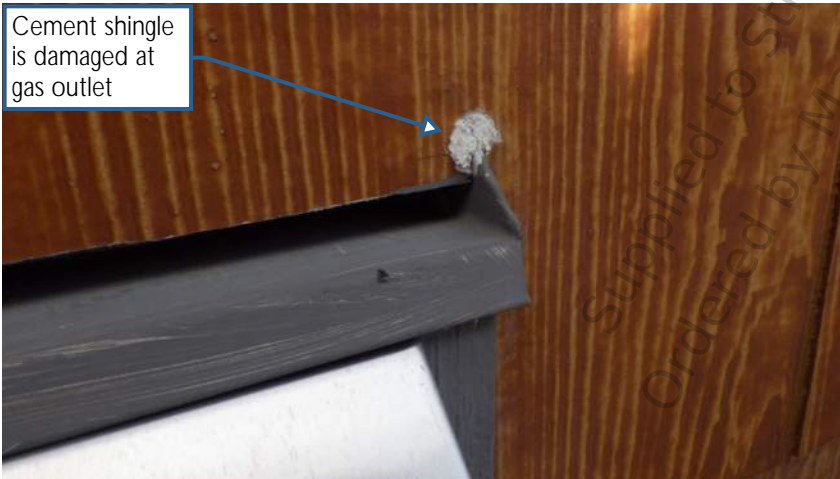
OBS A23-02

Cement shingle is damaged at gas outlet

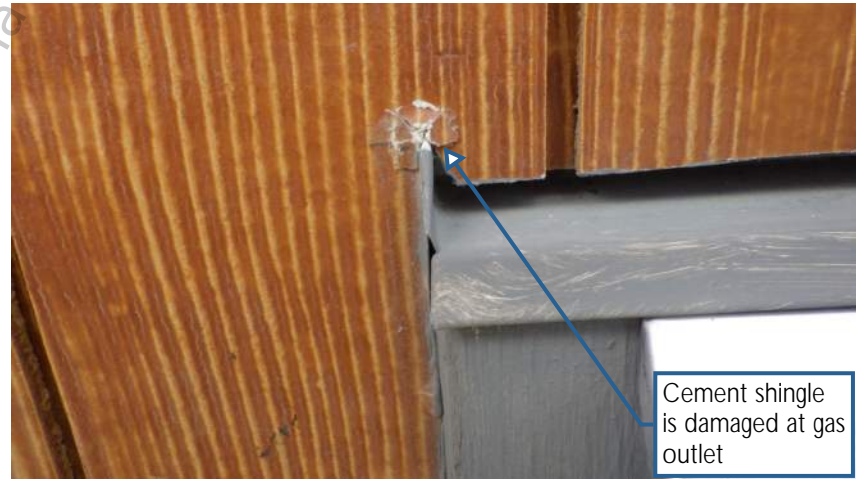
OBS A23-03

Cement shingle is damaged at gas outlet

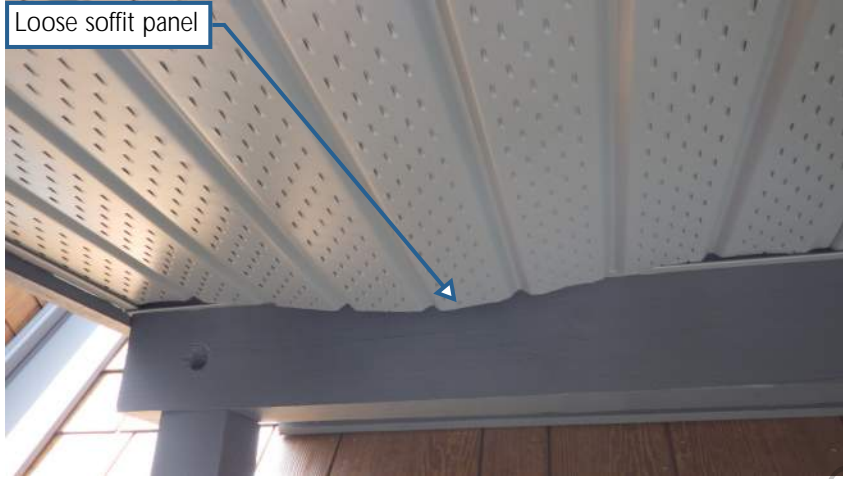
OBS A24-01

Loose soffit panel

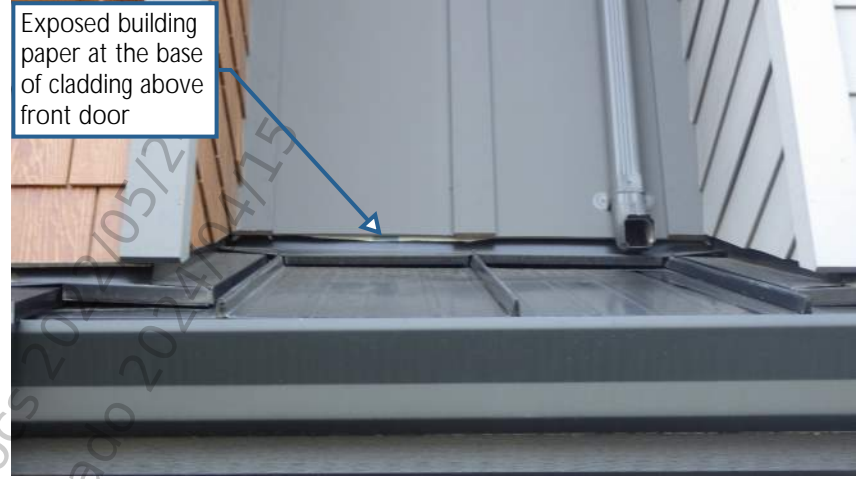
OBS A25-01

Exposed building paper at the base of cladding above front door

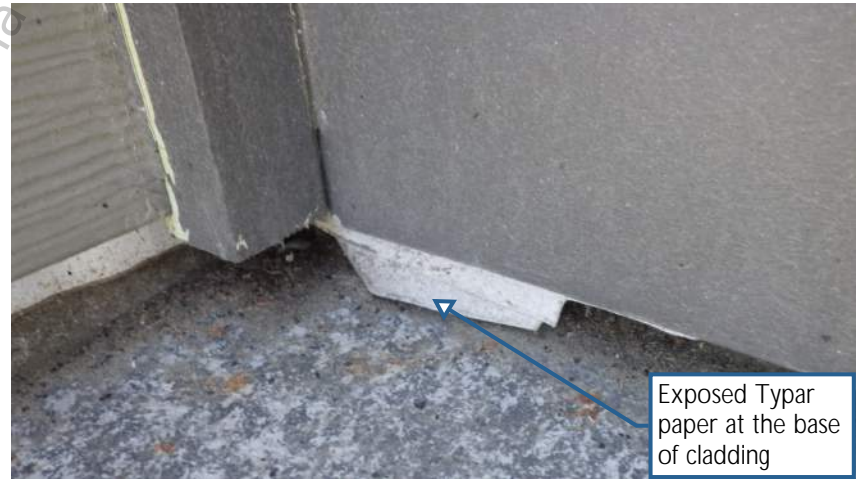
OBS A25-03

Exposed Tybar paper at the base of cladding

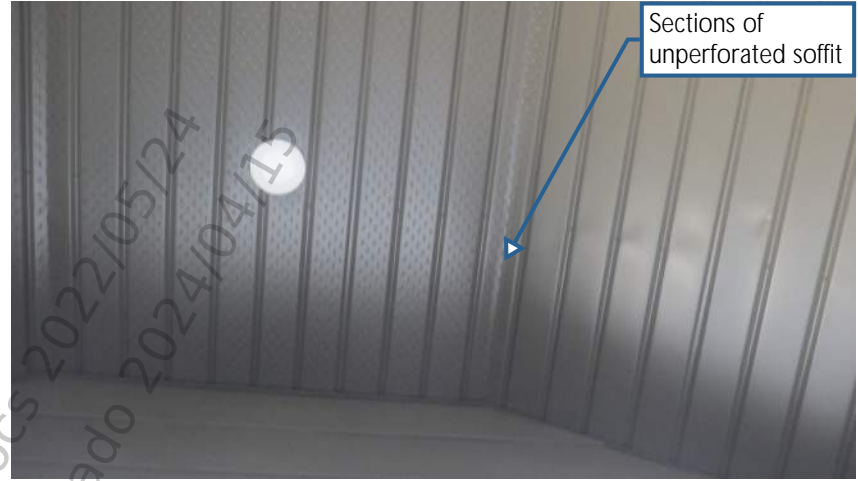
OBS A30-03

Sections of unperforated soffit

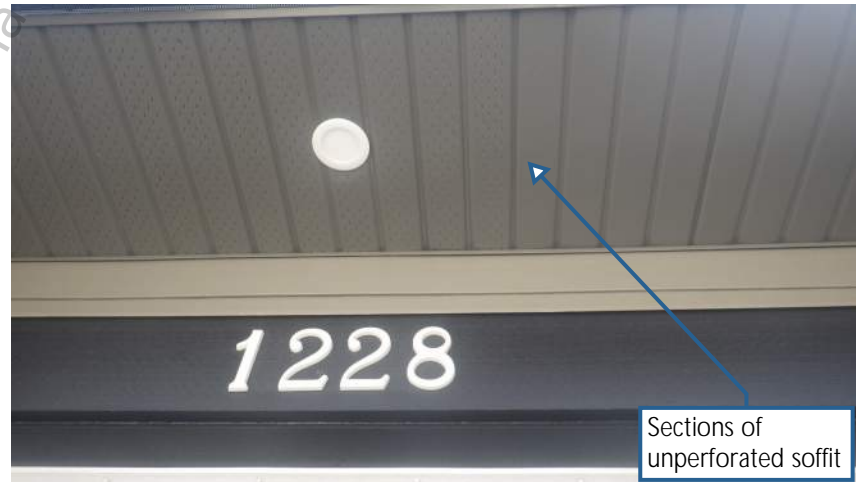
OBS A30-05

Sections of unperforated soffit

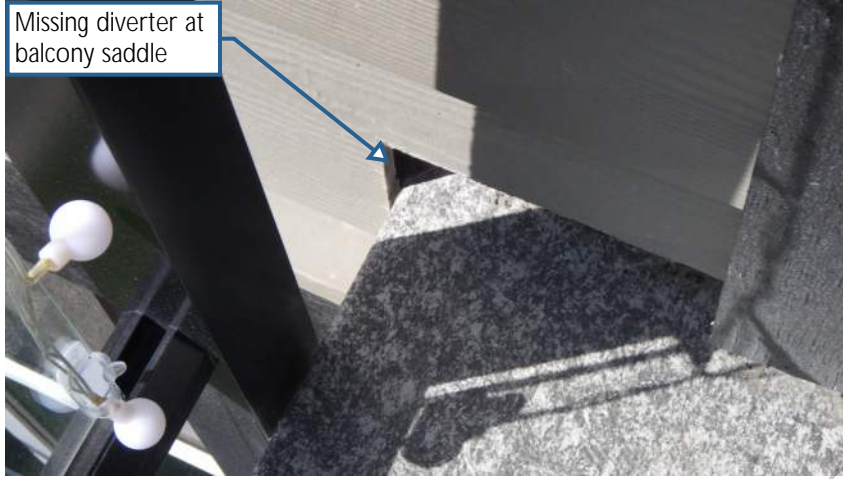
OBS A31-05

Missing diverter at balcony saddle

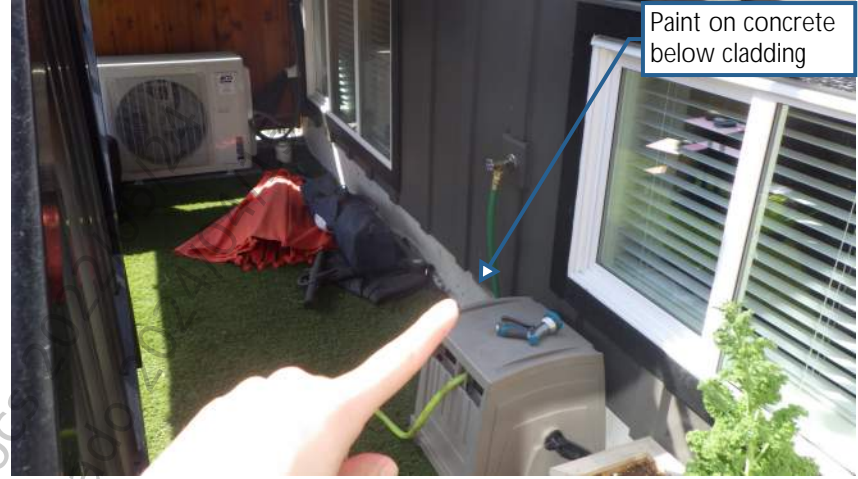
A32 - F	Unit 1224	80267576	OBS A32-01 to OBS A32-02	<ul style="list-style-type: none"> Paint on concrete below cladding. This is a cosmetic workmanship item and not a performance concern.
A33 - F	Unit 1224, 1228	80267576	OBS A33-01 to OBS A33-05	<ul style="list-style-type: none"> Dent noted in soffit panel. This is a cosmetic/workmansip issue and not related to building performance.
A34 - F	Unit 1224, 1228	80267576	OBS A34-01 to OBS A34-04	<ul style="list-style-type: none"> Efflorescence along base of concrete wall
A35 - F	Unit 1228, 1224	80267576	OBS A35-01	<ul style="list-style-type: none"> Construction debris noted on balcony fascia of unit 1228 Construction debris noted on the cladding of units 1224, 1228, and on the window at unit 1247 This is a housekeeping issue from the original construction work that was not addressed.
A35 - D	Unit 1247	80252844		
A36 -				Item Omitted
A37 - F	Unit 1220	80267576	OBS A37-01 to OBS A37-03	<ul style="list-style-type: none"> Corrosion staining noted on vinyl membrane. Occupant reported staining was present at first occupancy.

Paint on concrete below cladding

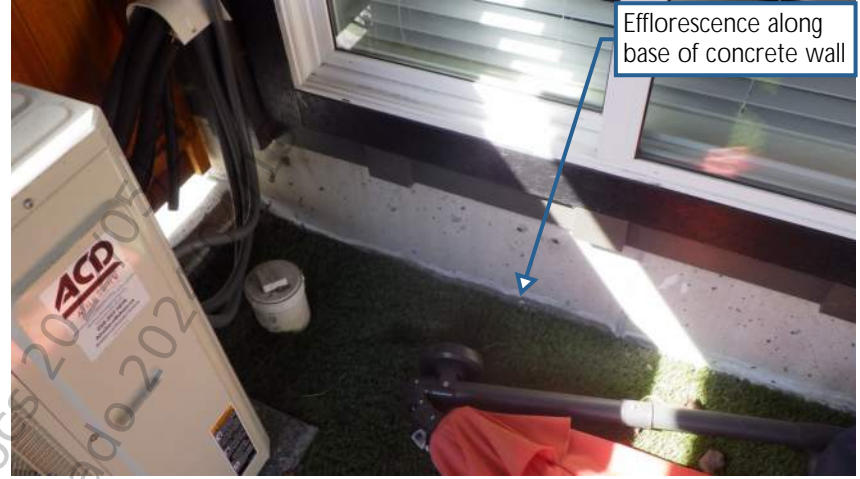
OBS A34-02

Efflorescence along base of concrete wall

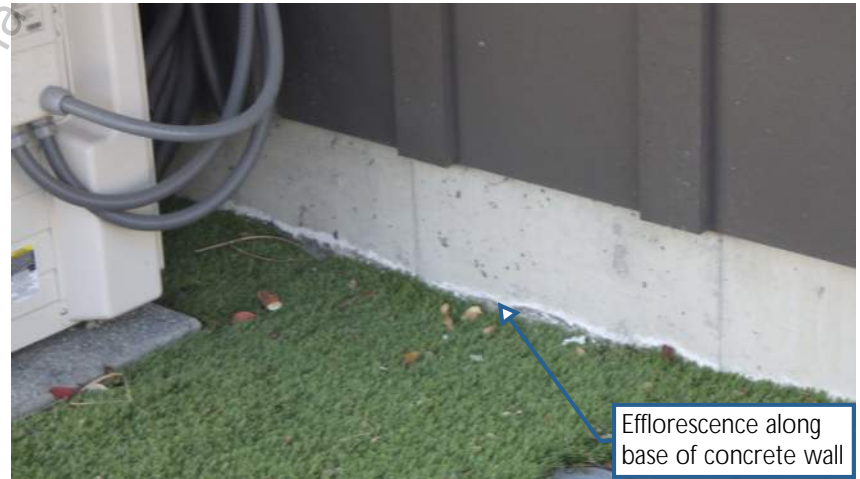
OBS A34-04

Efflorescence along base of concrete wall

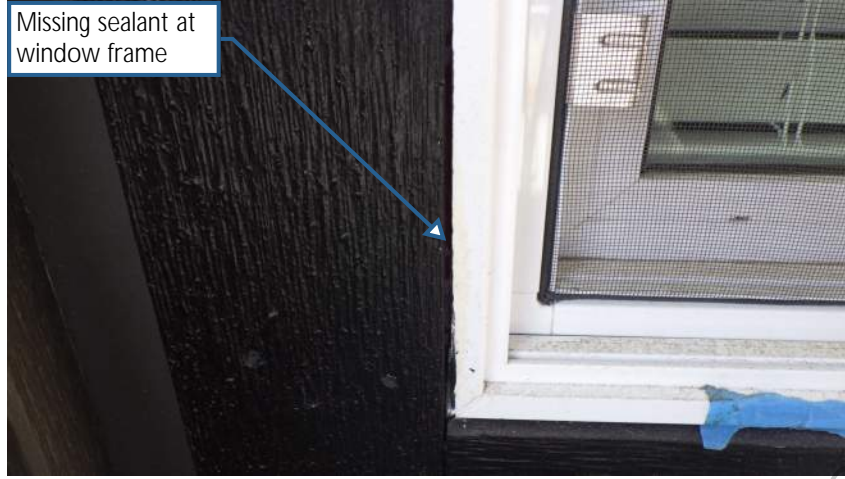
OBS A40-02

A38 -				Item Omitted
A39 -				Item Omitted
A40 - F	Unit 1220, 1216, 1228	80267576	OBS A40-01 to OBS A40-04	<ul style="list-style-type: none"> Missing sealant between window frame and trim at window jambs.
A40 - B	Unit 1237	80250968

Missing sealant at window frame

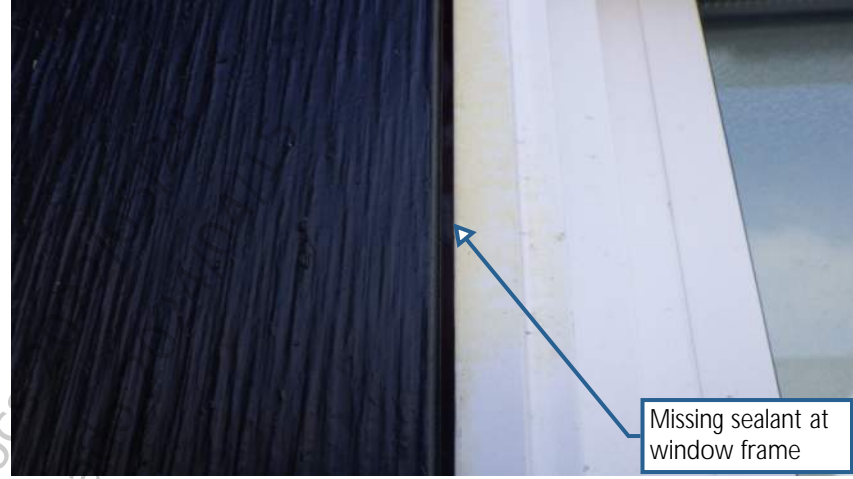
OBS A40-03

Missing sealant at window frame

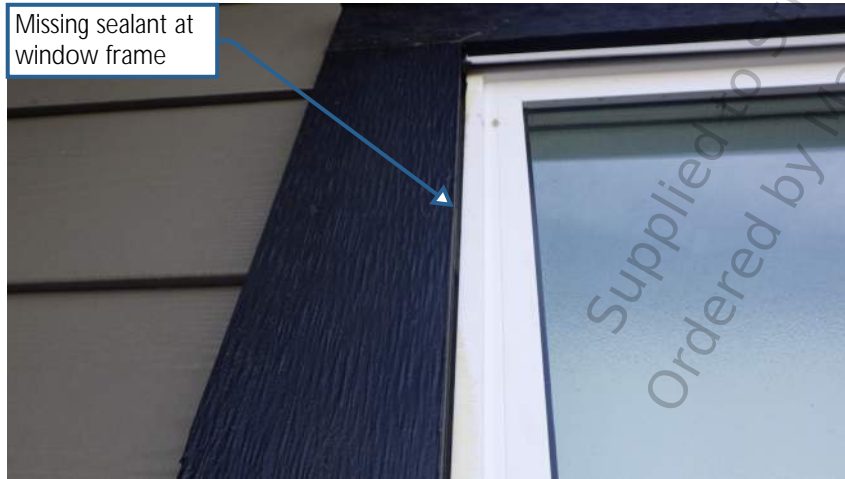
OBS A40-04

Missing sealant at window frame

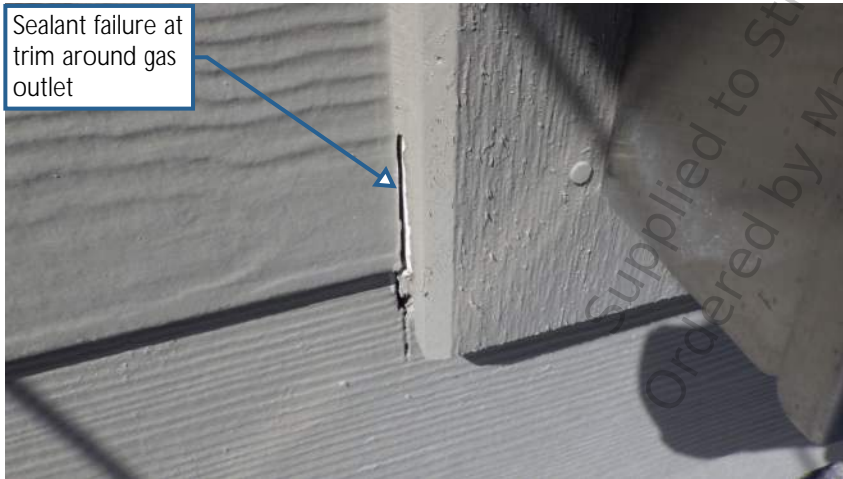
OBS A42-01

Sealant failure at trim around gas outlet

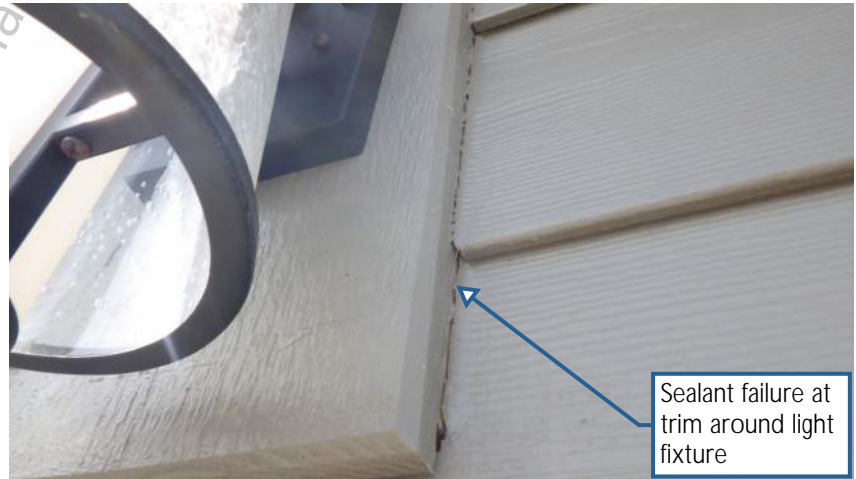
OBS A42-02

Sealant failure at trim around light fixture

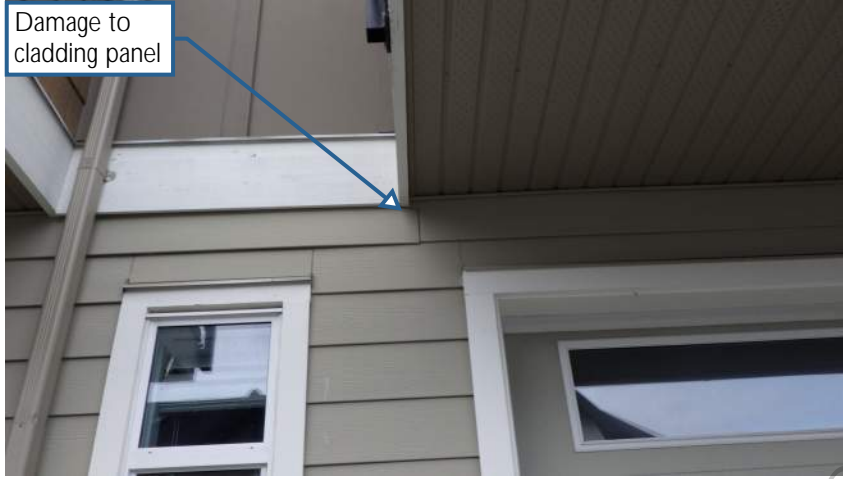
OBS A43-03

Damage to cladding panel

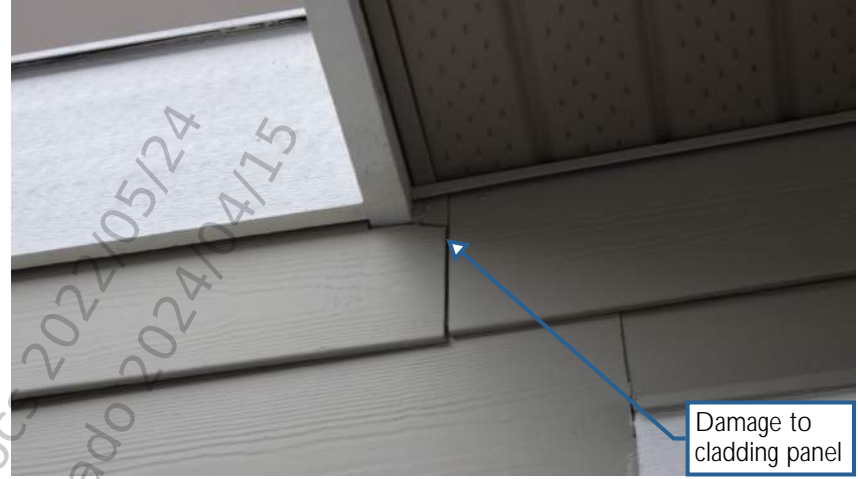
OBS A43-04

Damage to cladding panel

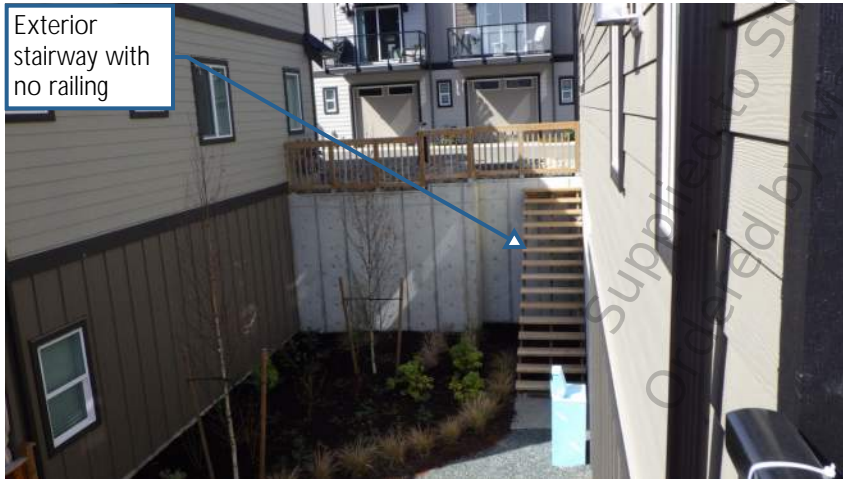
OBS A44-01

Exterior stairway with no railing

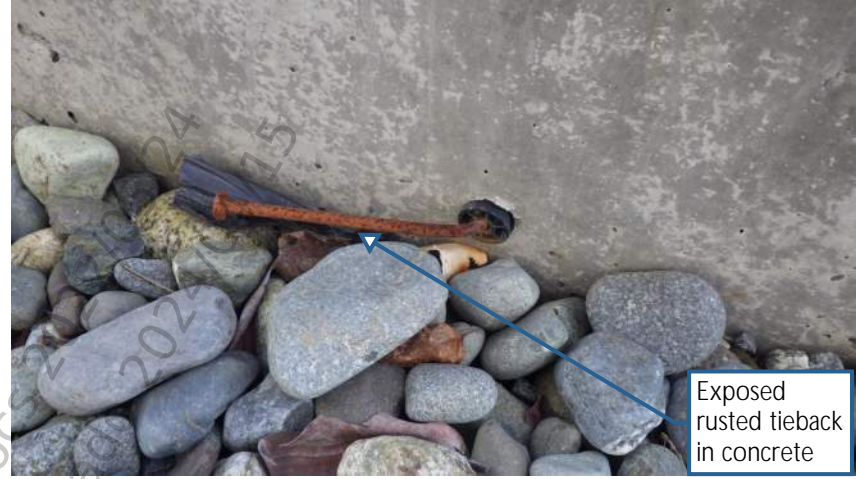
OBS A47-02

Exposed rusted tieback in concrete

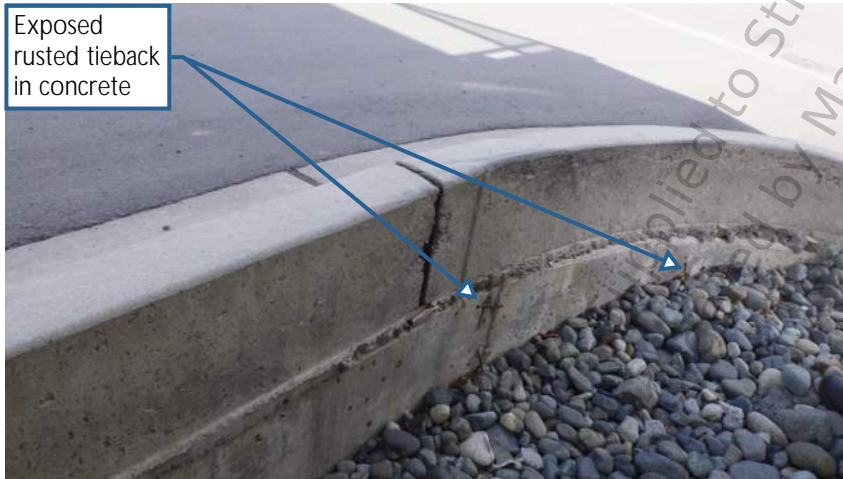
OBS A47-03

Exposed rusted tieback in concrete

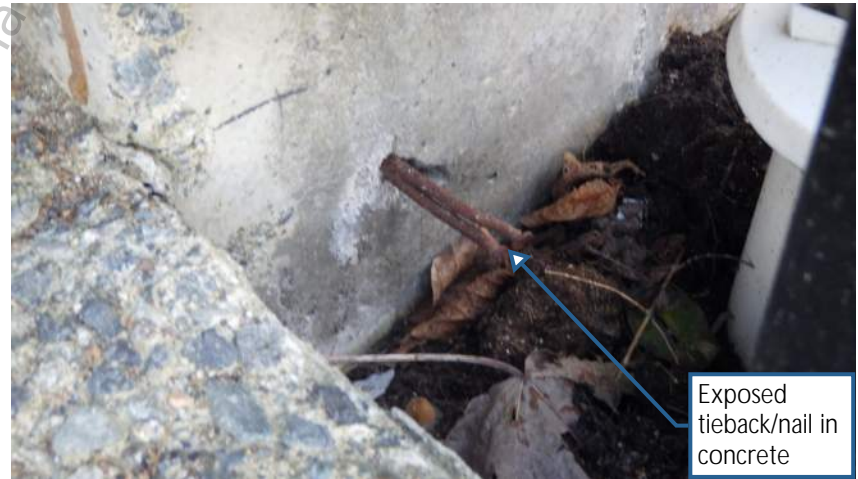
OBS A47-04

Exposed tieback/nail in concrete

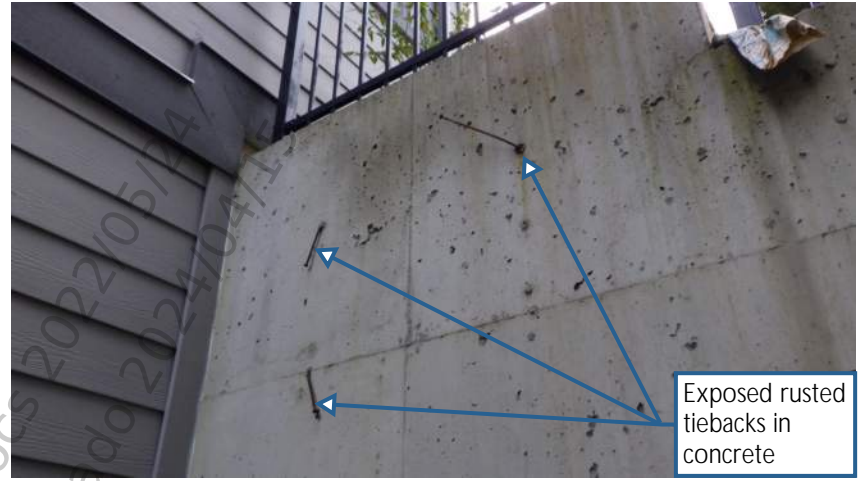
OBS A47-06

Exposed rusted tiebacks in concrete

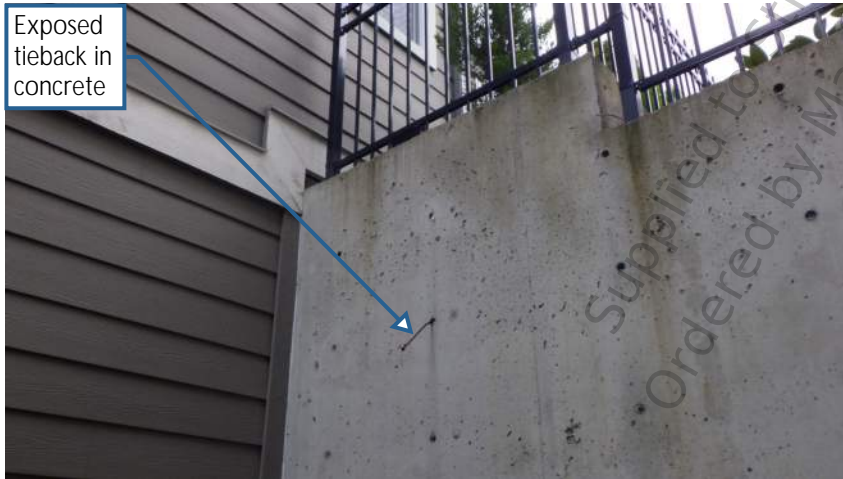
OBS A47-07

Exposed tieback in concrete
