# Depreciation Report – Final

## The Westfield Strata Corporation VIS 365

1024 Fairfield Road  
Victoria, BC

November 29, 2022

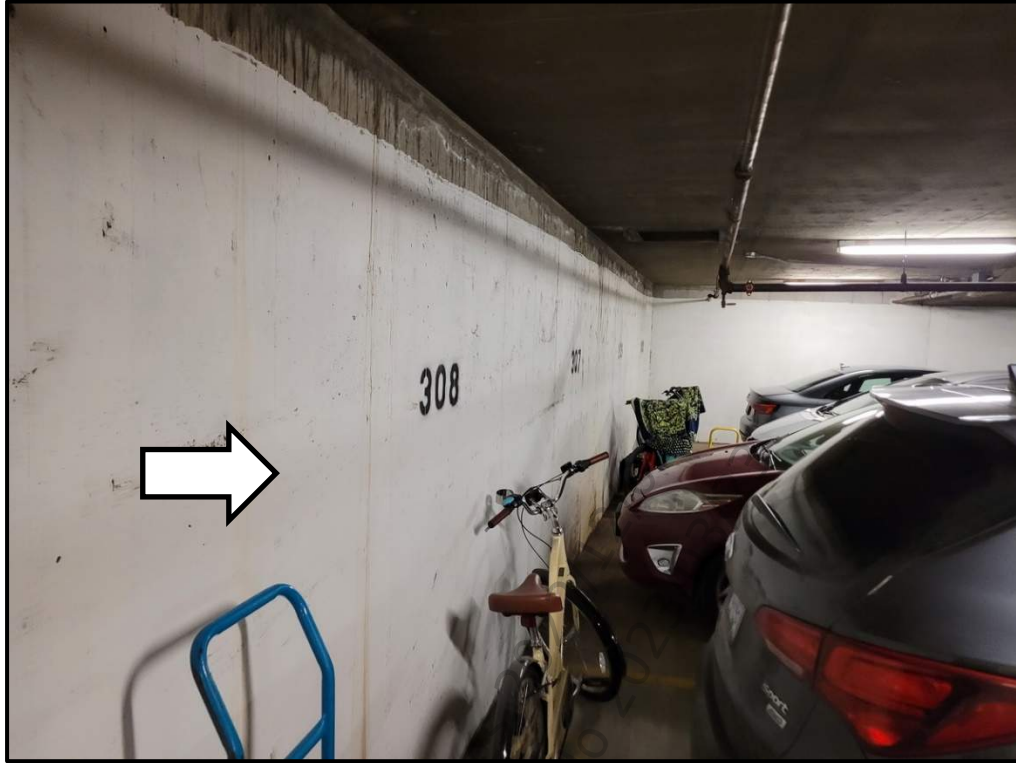
Photo 1 (A10 00 00) - Foundation Wall Viewed From Within Parkade

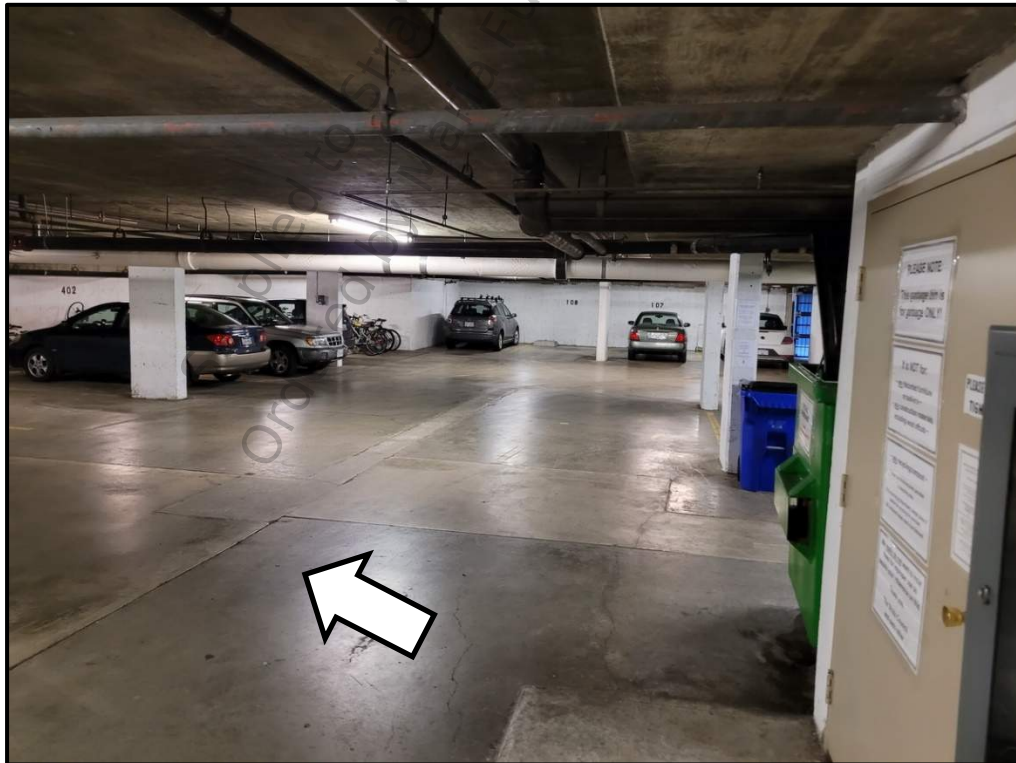
Photo 2 (A10 30 00) - Slab-on-Grade

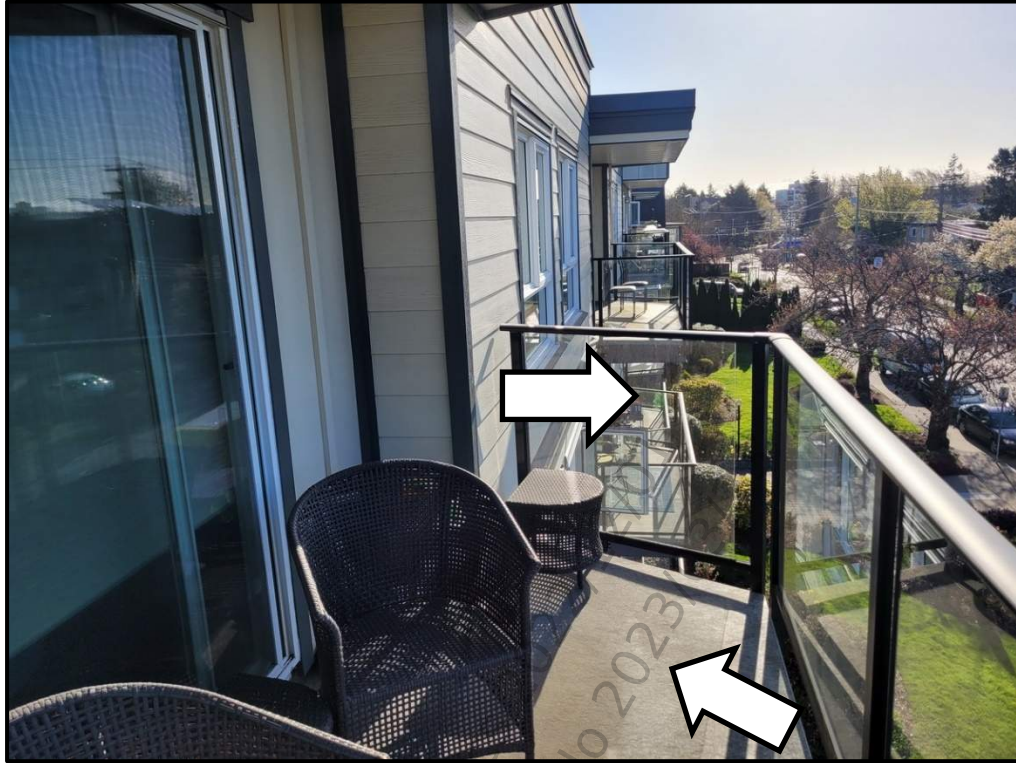
Photo 3 (B10 10 04) - Balconies, Showing Vinyl Waterproofing Membrane and Railings

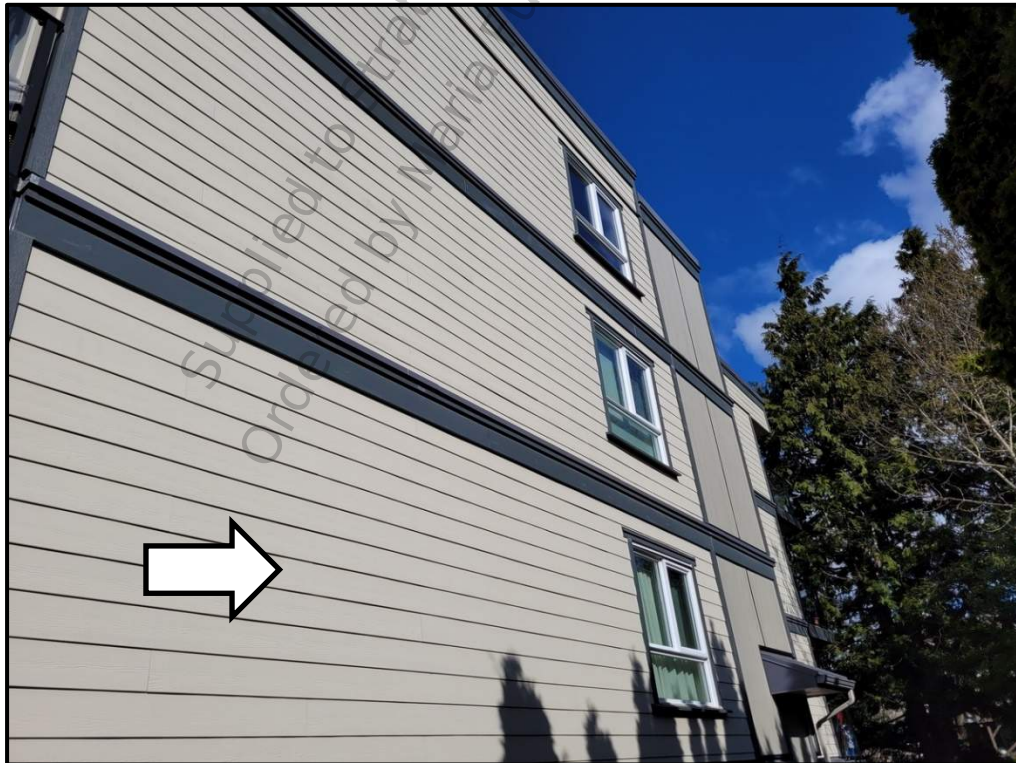
Photo 4 (B20 10 00.01) - Fibre Cement Cladding

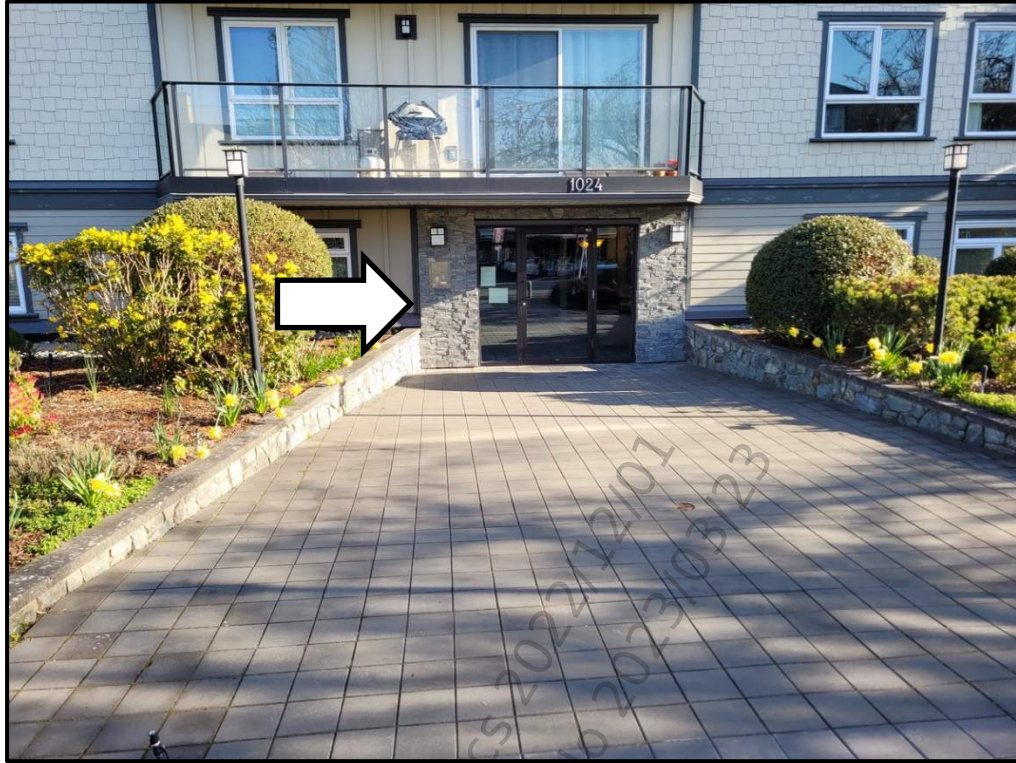
Photo 5 (B20 10 00.03) - Stone Veneer Cladding around Front Entrance

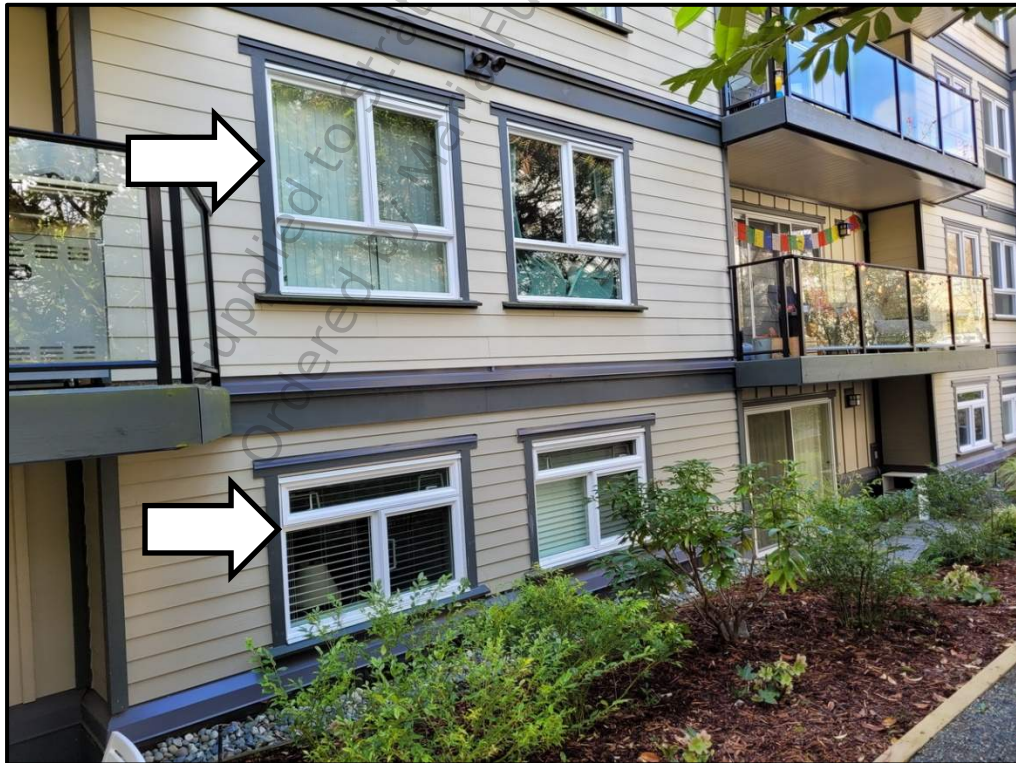
Photo 6 (B20 20 00.01) - Vinyl-Framed Windows

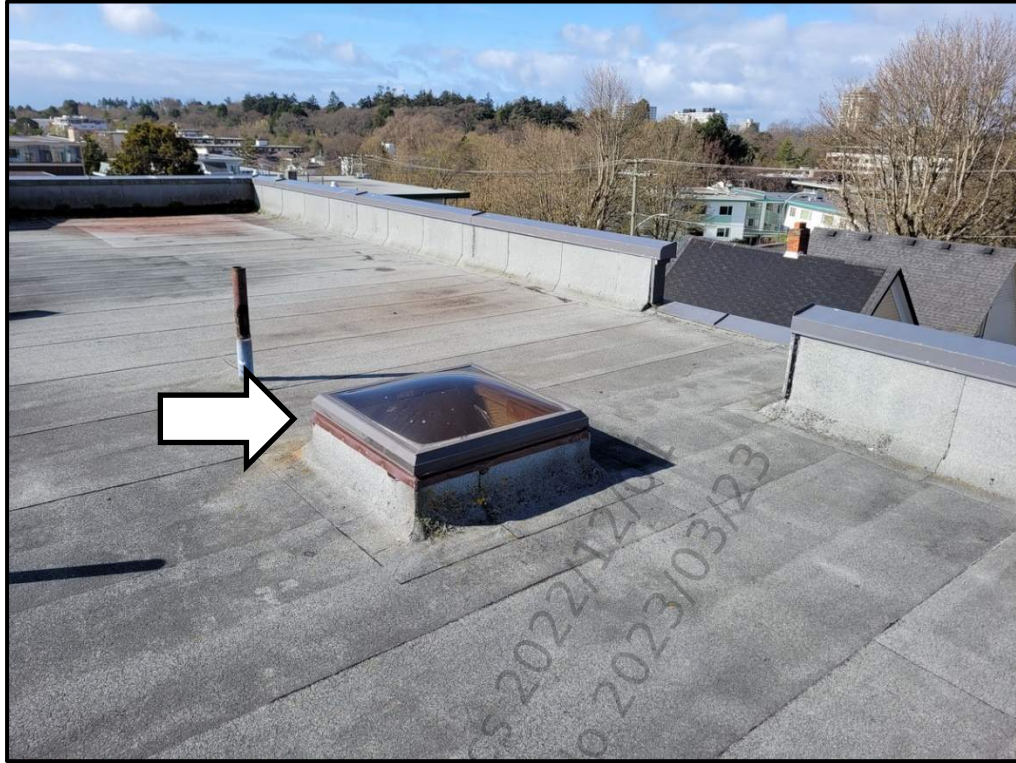
Photo 7 (B20 20 99) - Skylight Roof Hatch Cover

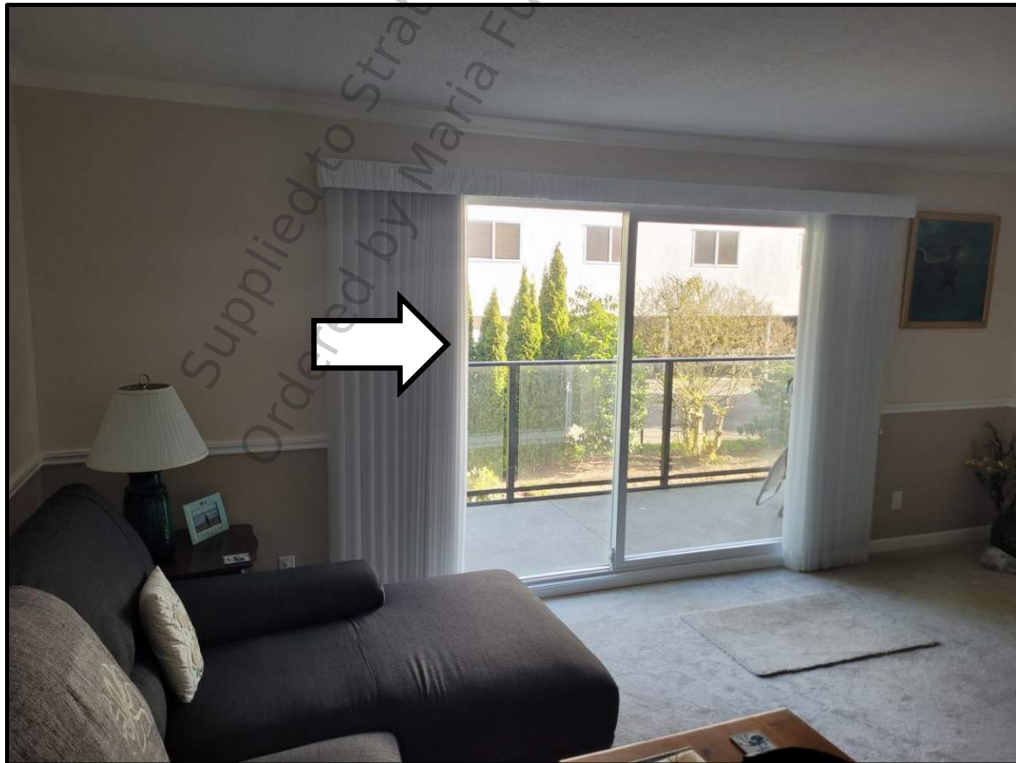
Photo 8 (B20 30 02.01) - Sliding Door at Balcony

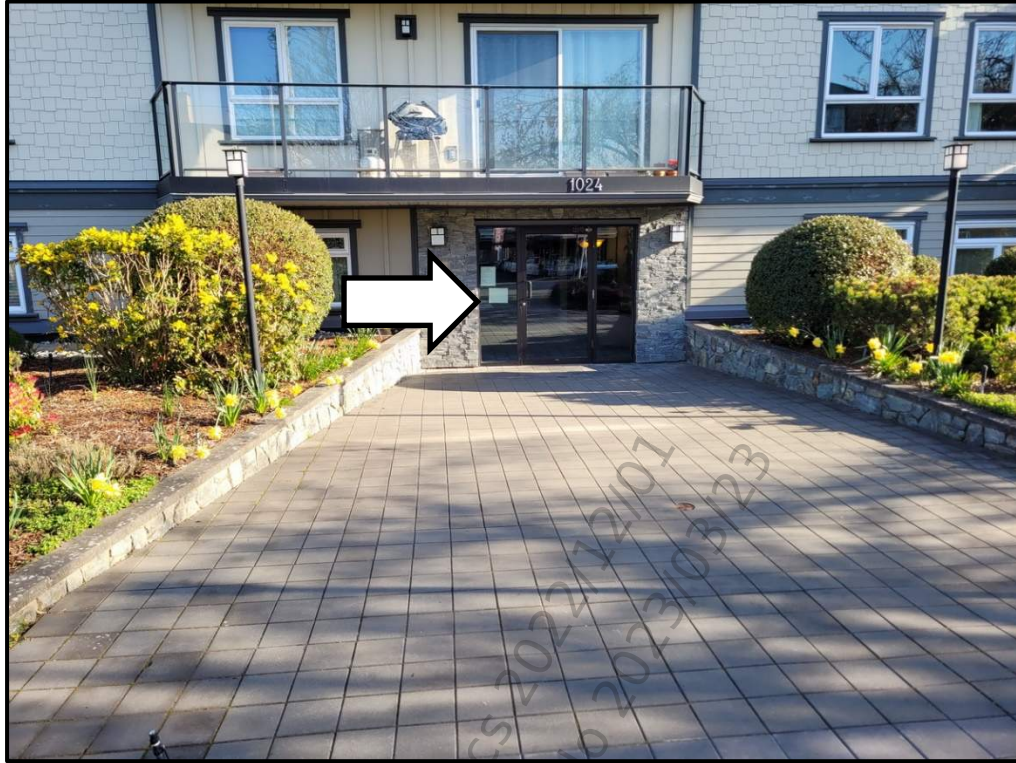
Photo 9 (B20 30 02.03) - Front Entrance Doors

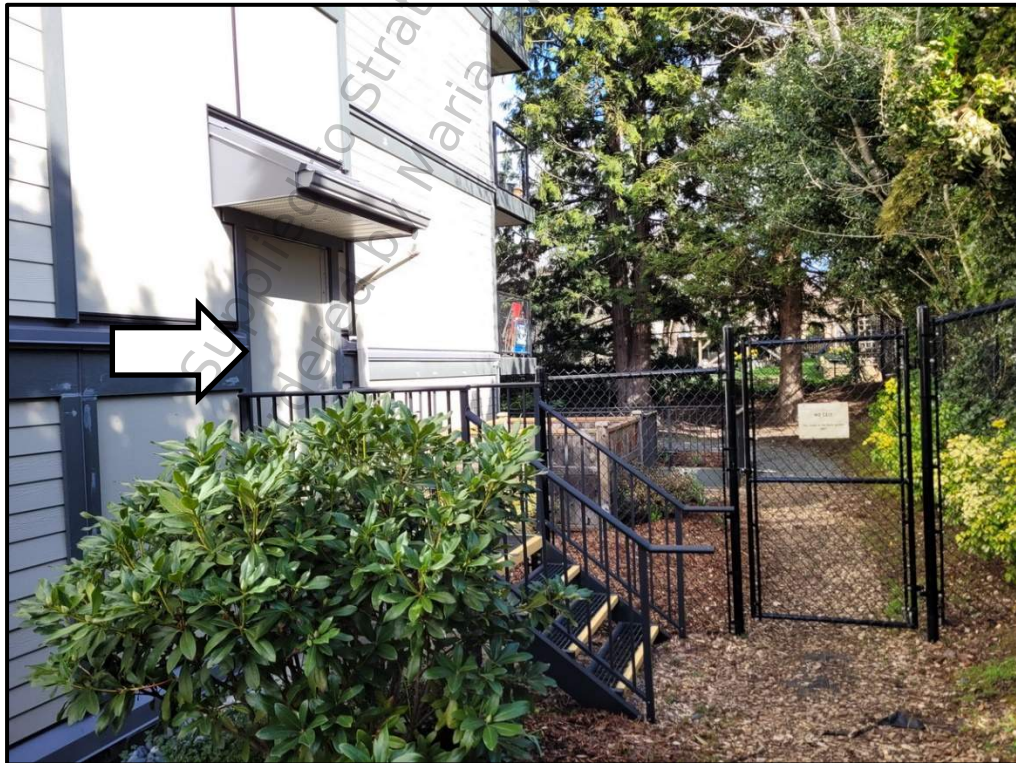
Photo 10 (B20 30 02.04) - Side Entrance Door

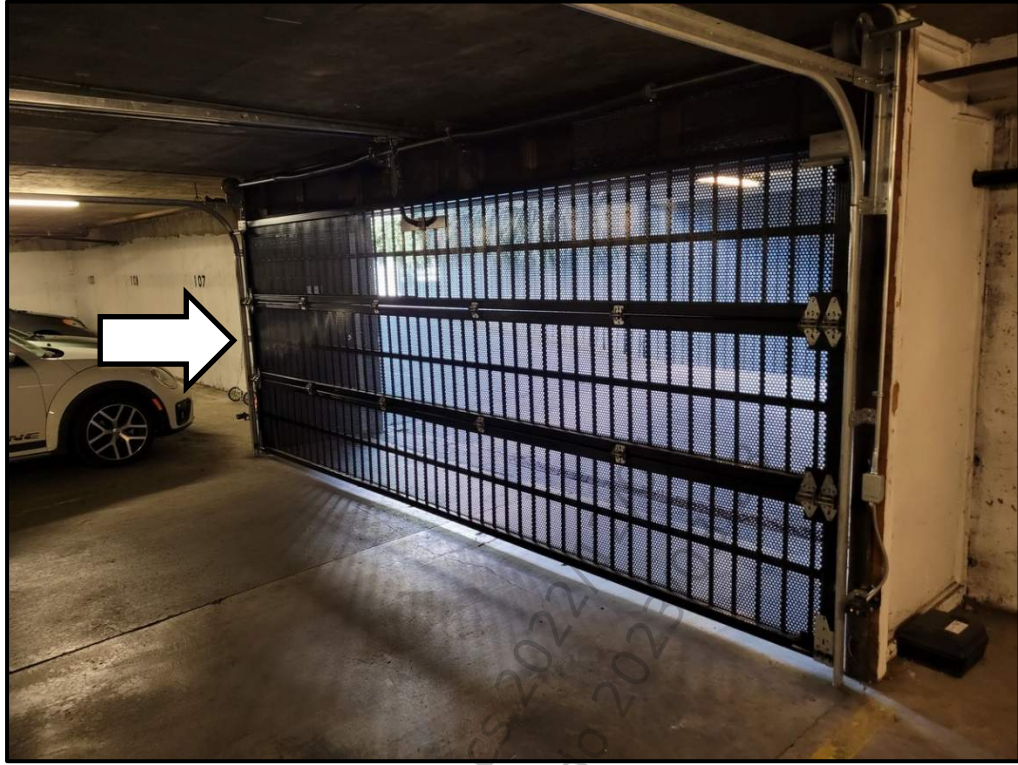
Photo 11 (B20 30 02.05) - Overhead Parkade Gate

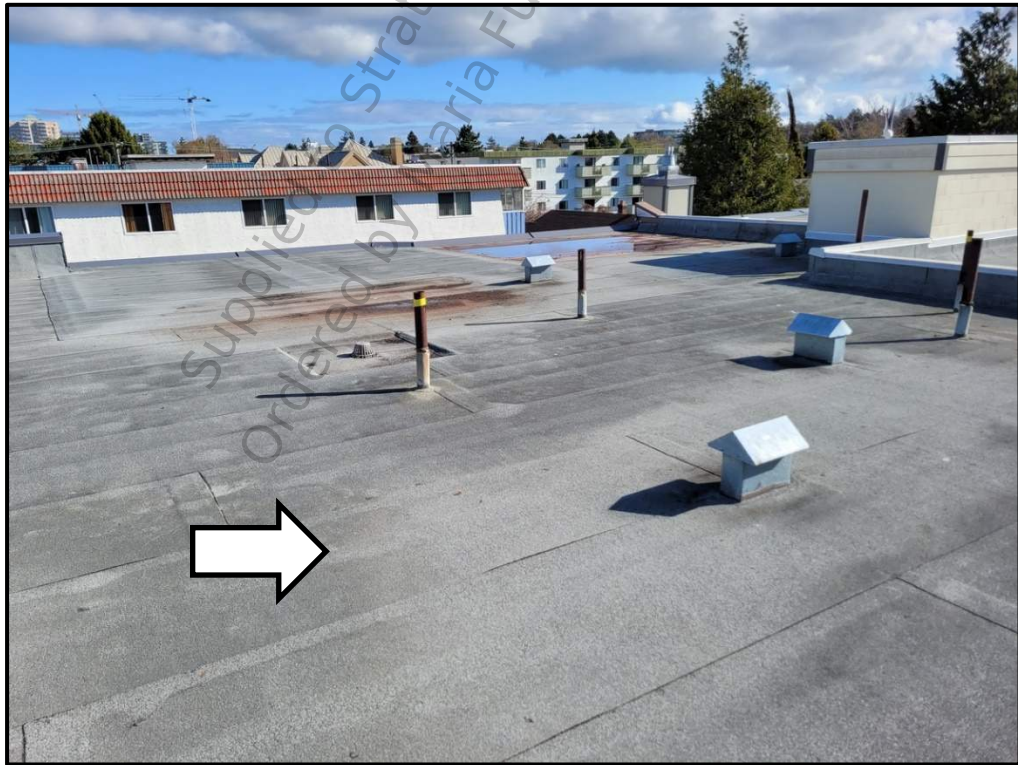
Photo 12 (B30 10 02.01) - SBS-Modified Bitumen Membrane at Main Roof

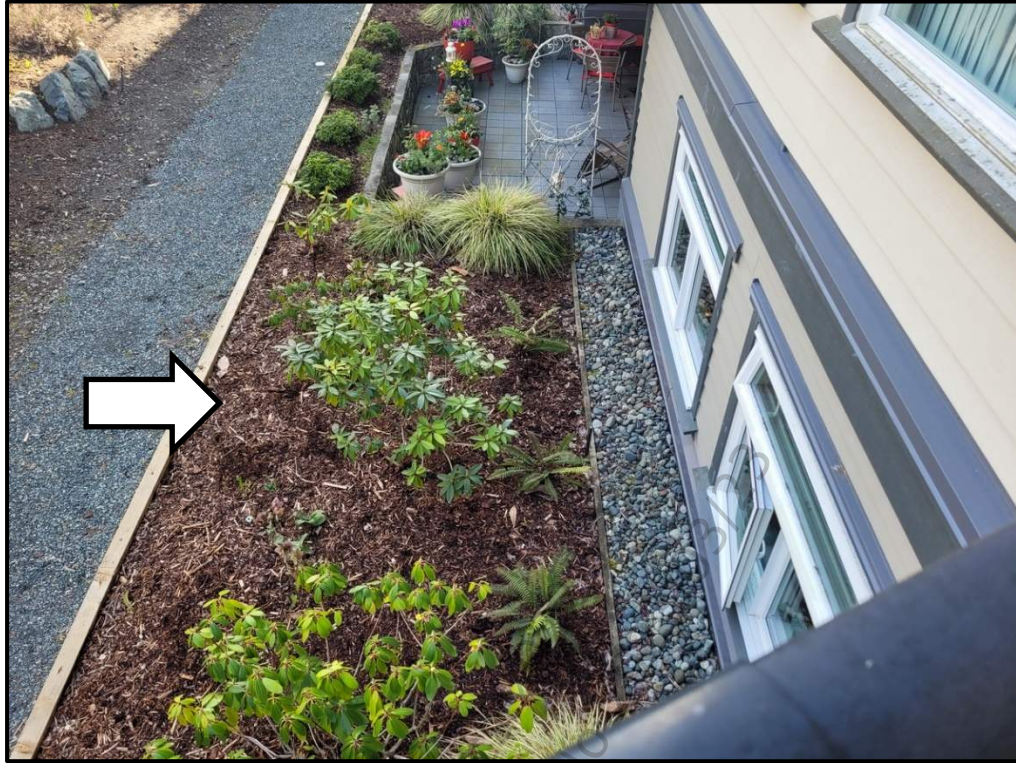
Photo 13 (B30 10 02.02) - Overburden above Podium Deck Waterproofing

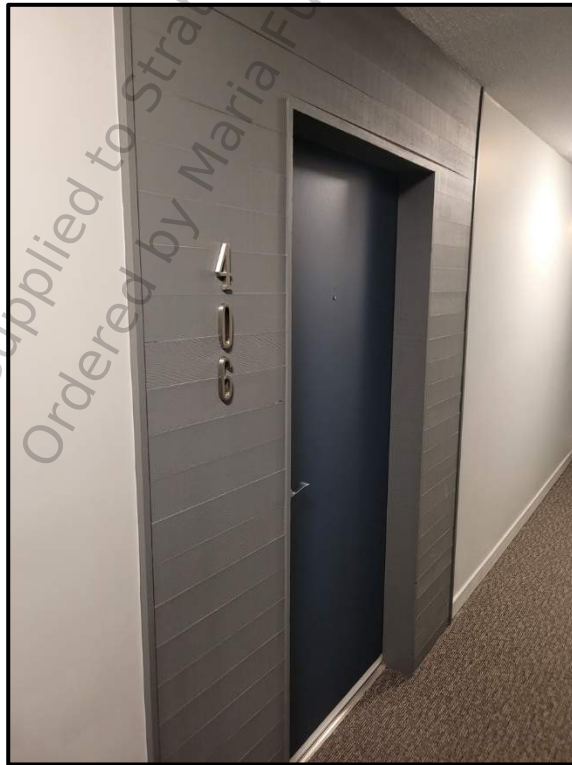
Photo 14 (C10 20 03) - Interior Unit Door

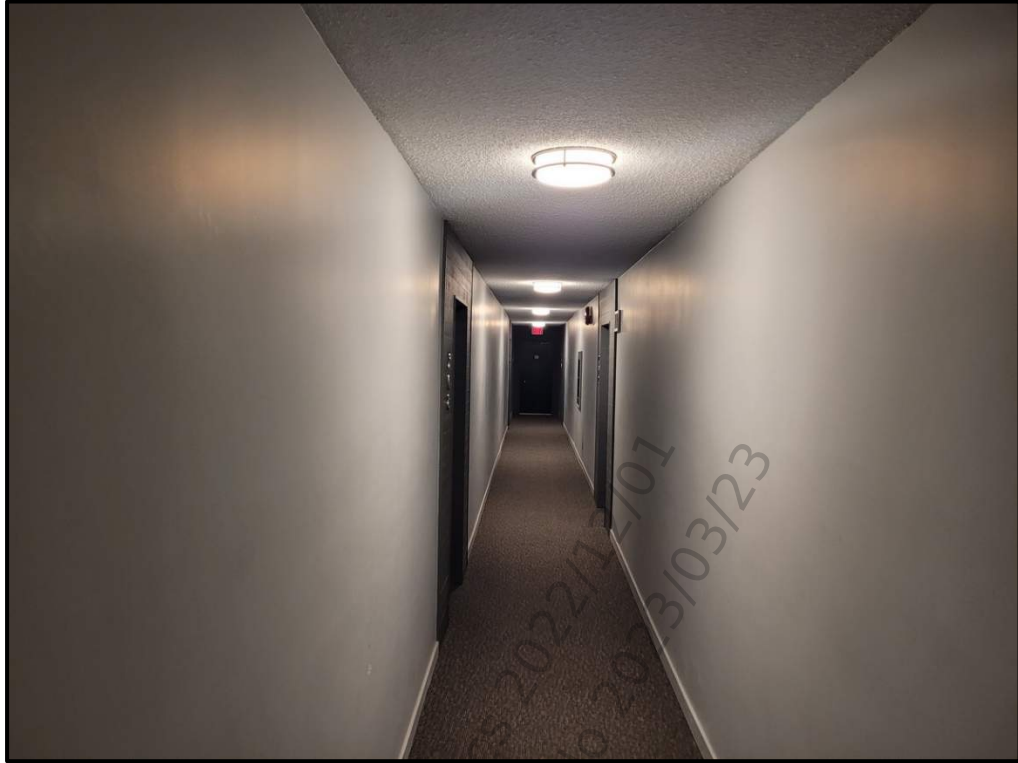
Photo 15 (C30 00 00.01) - Interior Finishes in Hallway

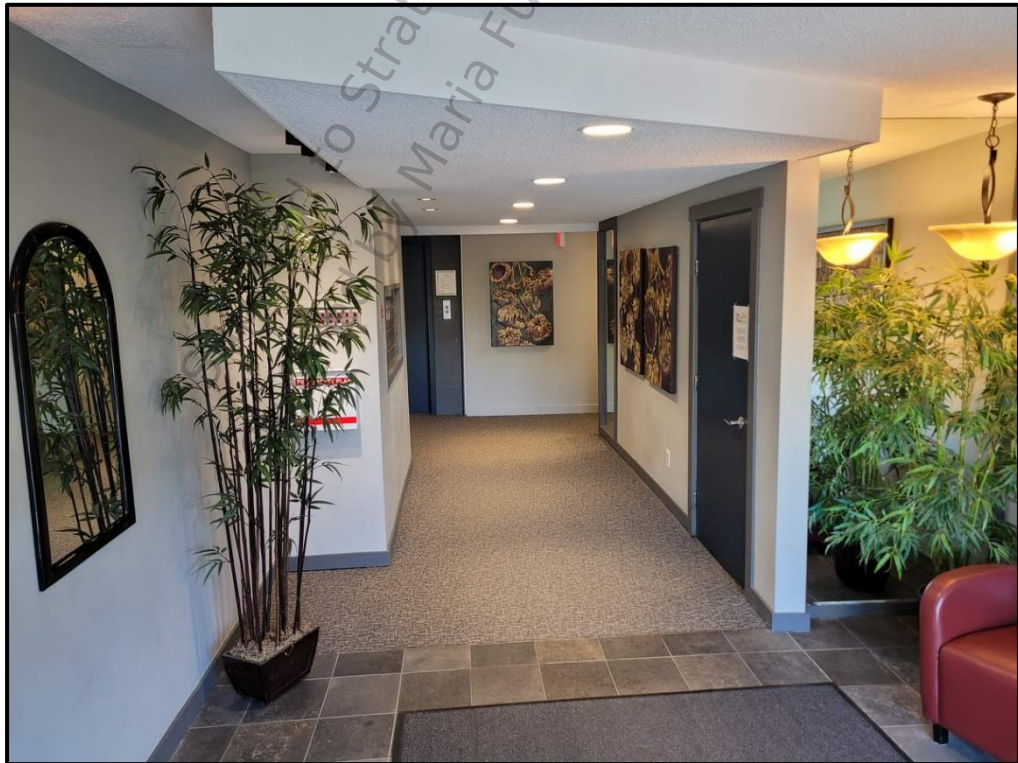
Photo 16 (C30 00 00.02) - Interior Finishes in Front Lobby

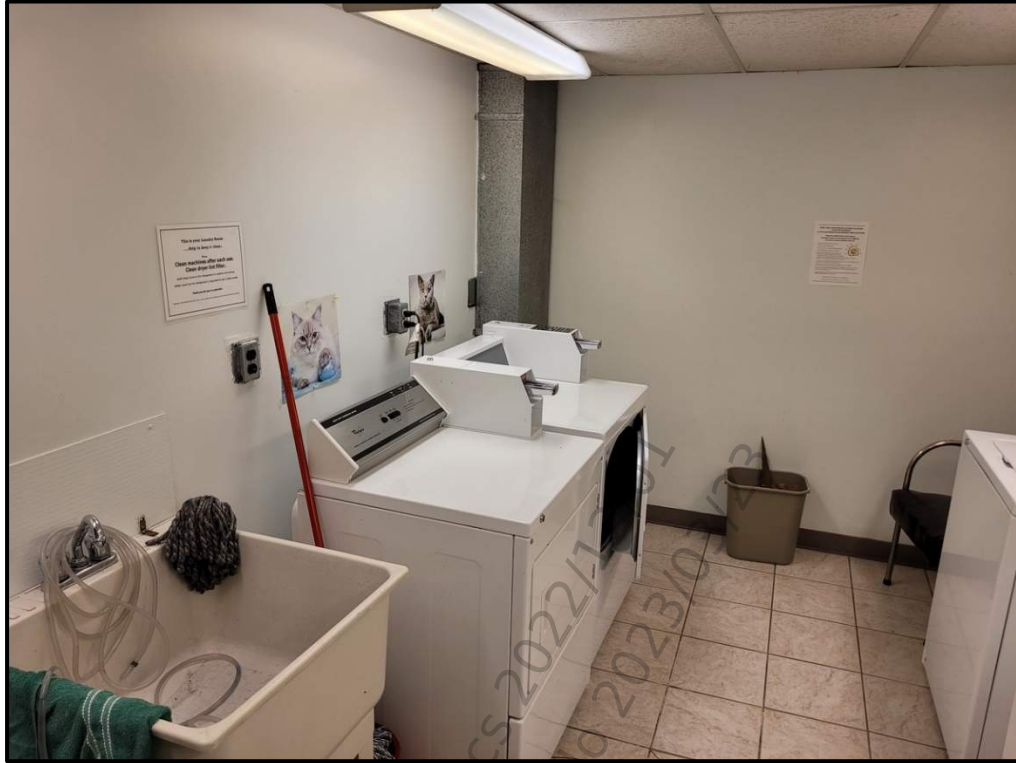
Photo 17 (C30 00 00.03) - Interior Finishes in the Laundry Room

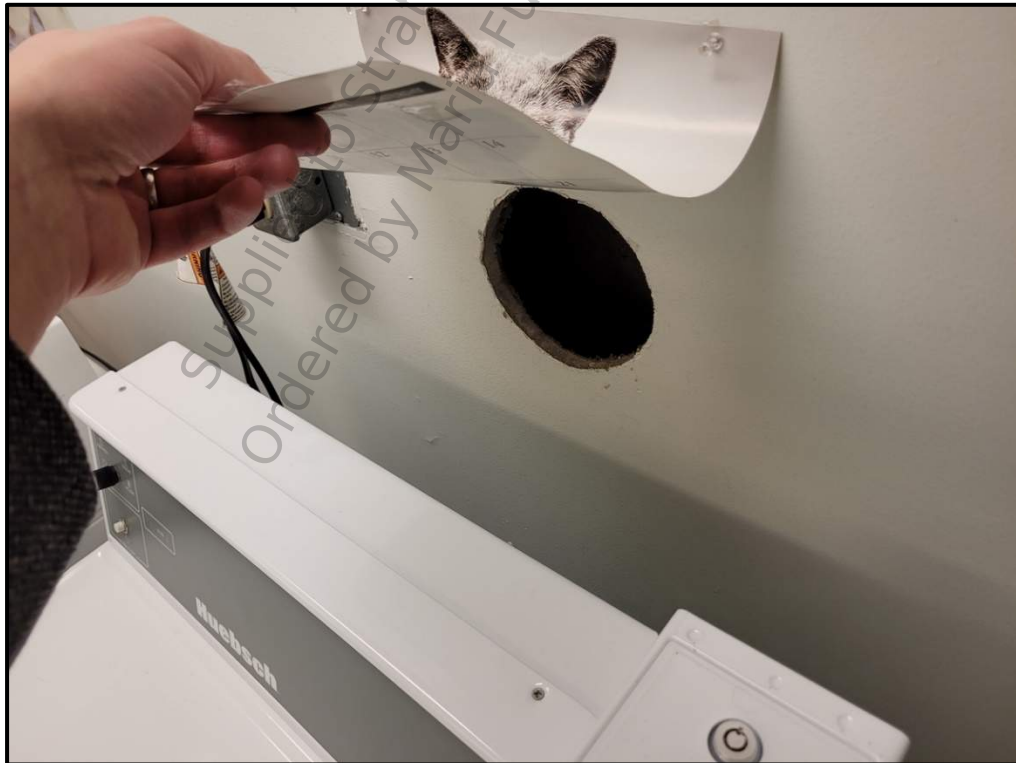
Photo 18 (C30 00 00.04) - Unsealed Opening in the Wall Adjacent to the Mechanical Room

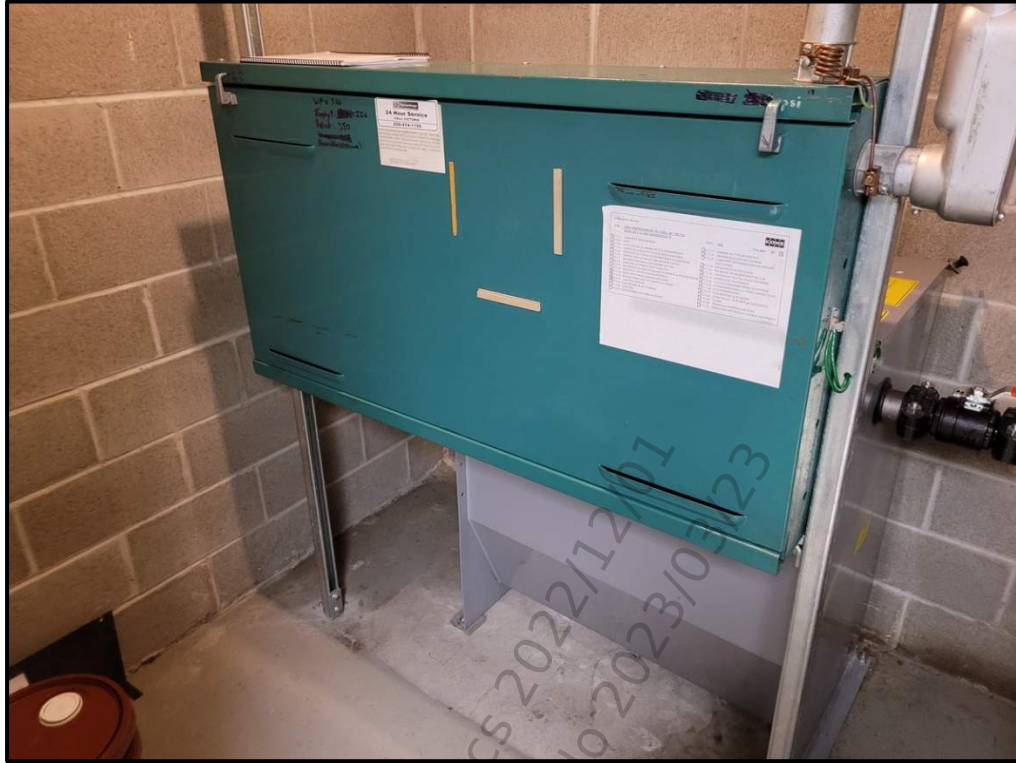
Photo 19 (D10 10 02) - Elevator Machine Room

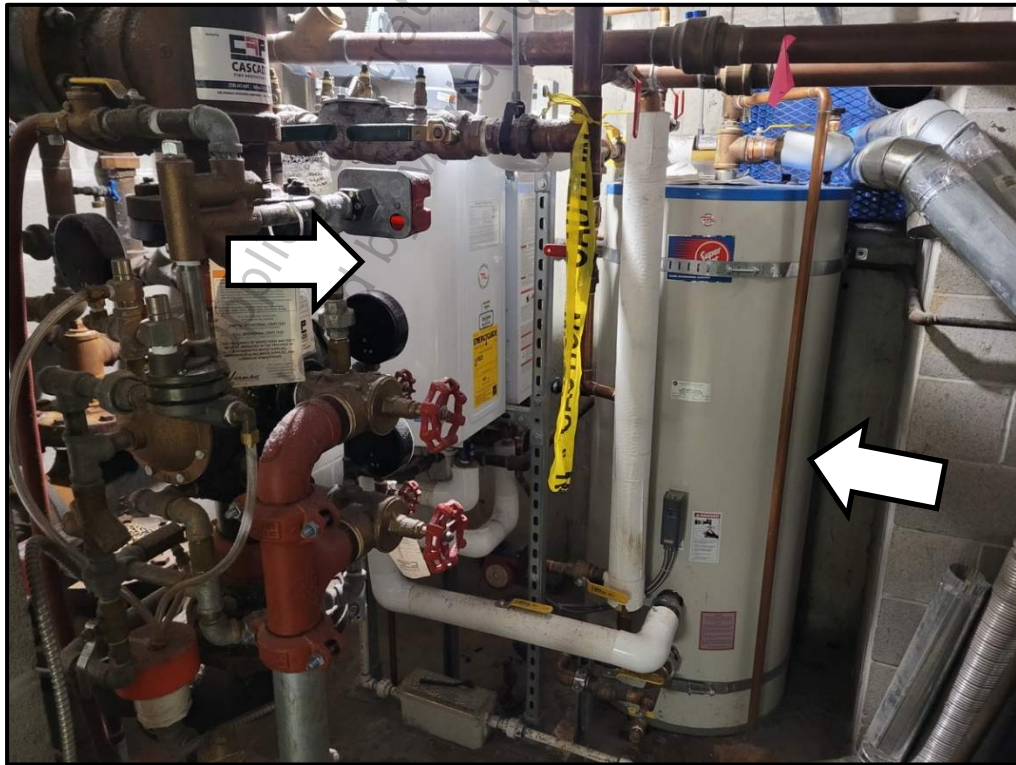
Photo 20 (D20 20 03.01) - Water Heaters and Storage Tank

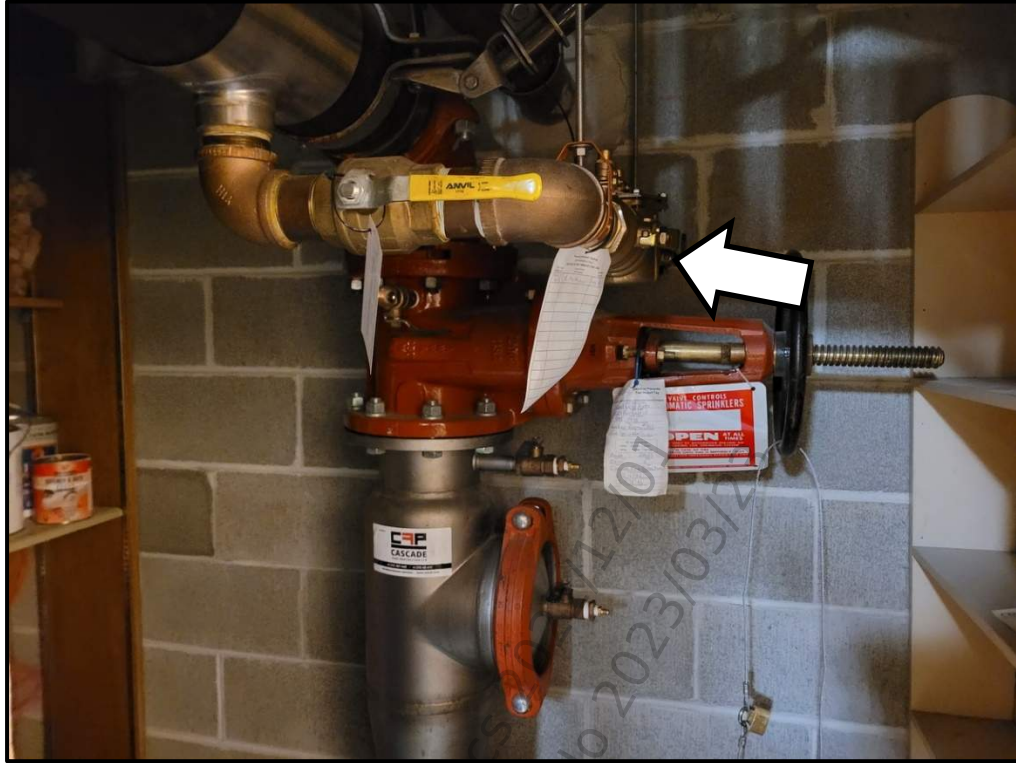
Photo 21 (D20 20 03.02) - Backflow Preventer on the Water Supply Line

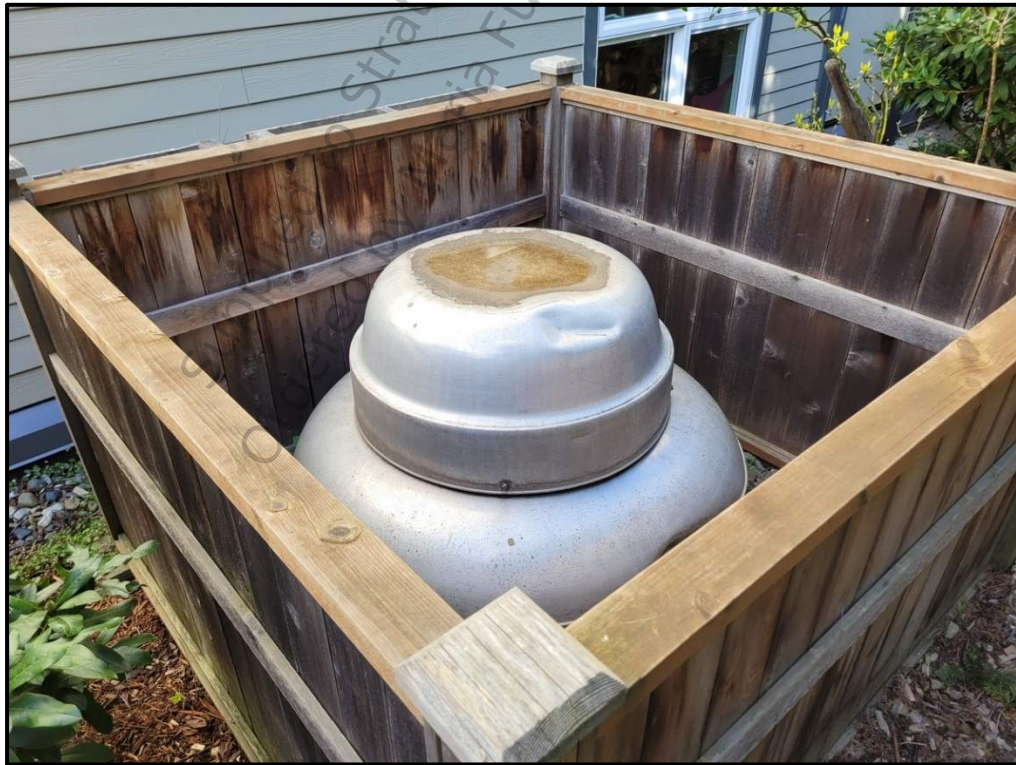
Photo 22 (D30 40 07.01) - Parkade Exhaust Fan at Grade

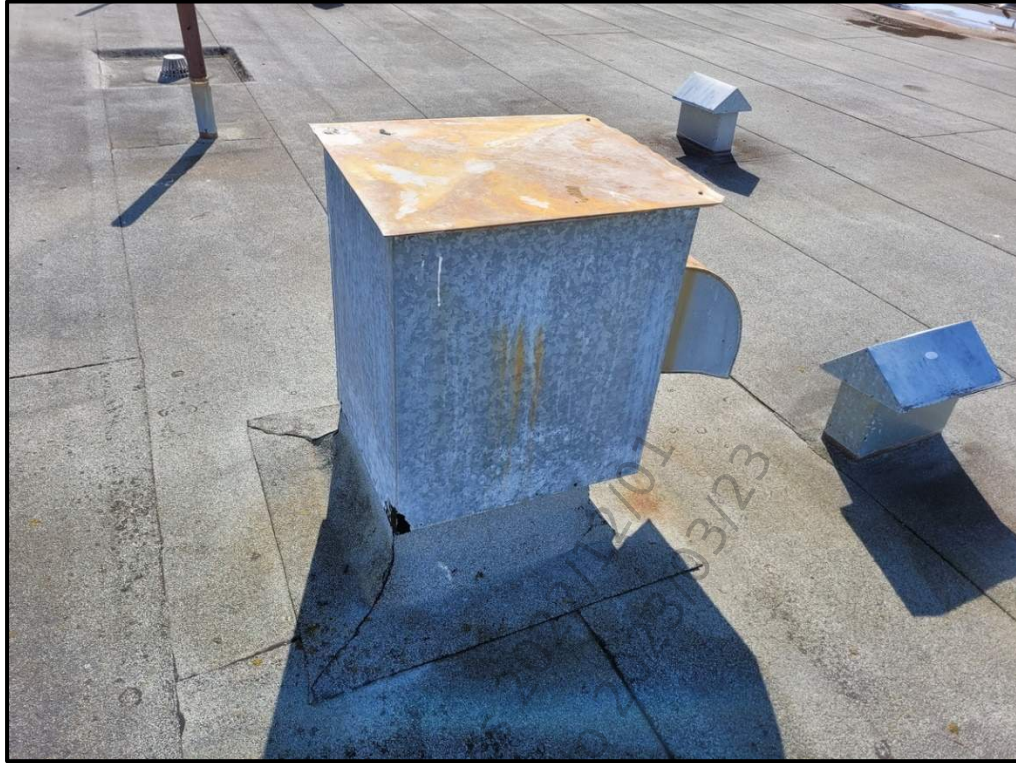
Photo 23 (D30 40 08) - Rooftop Air Handling Unit

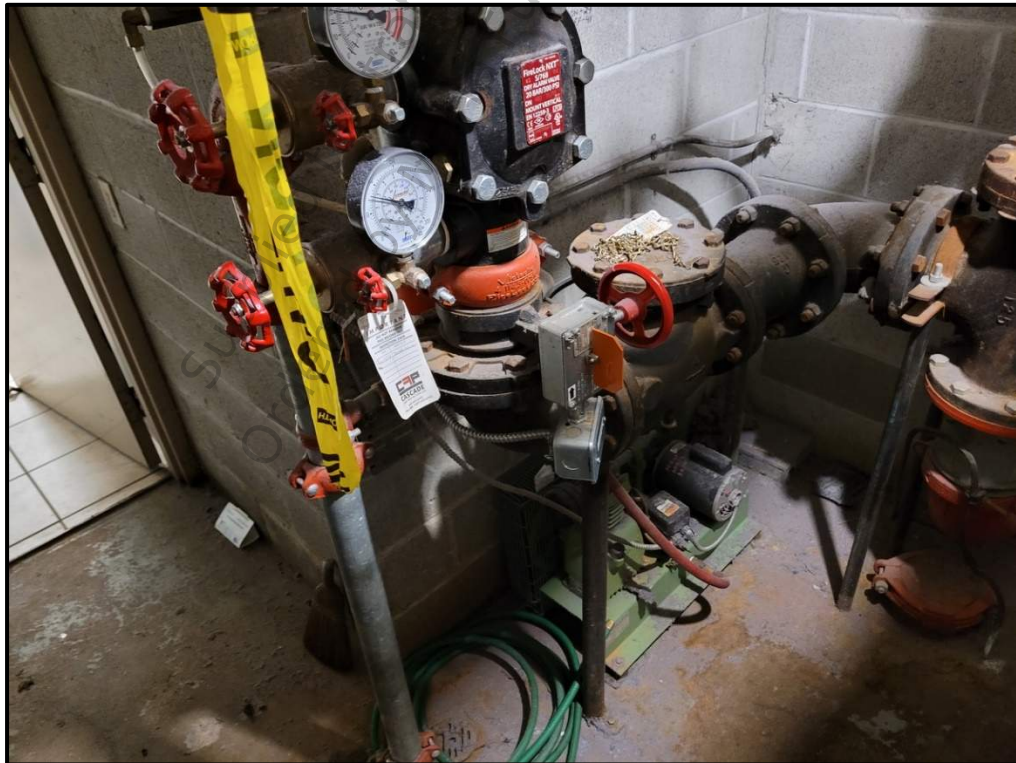
Photo 24 (D40 00 00) - Sprinkler Tree and Air Compressor

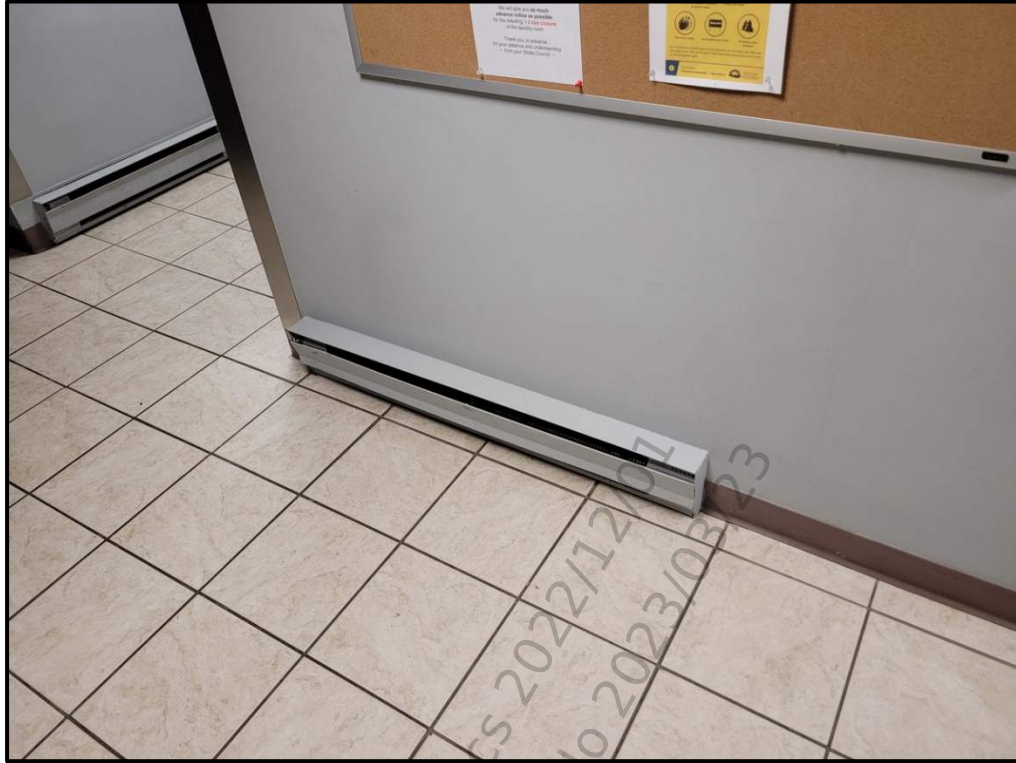
Photo 25 (D30 50 05) - Baseboard Heater

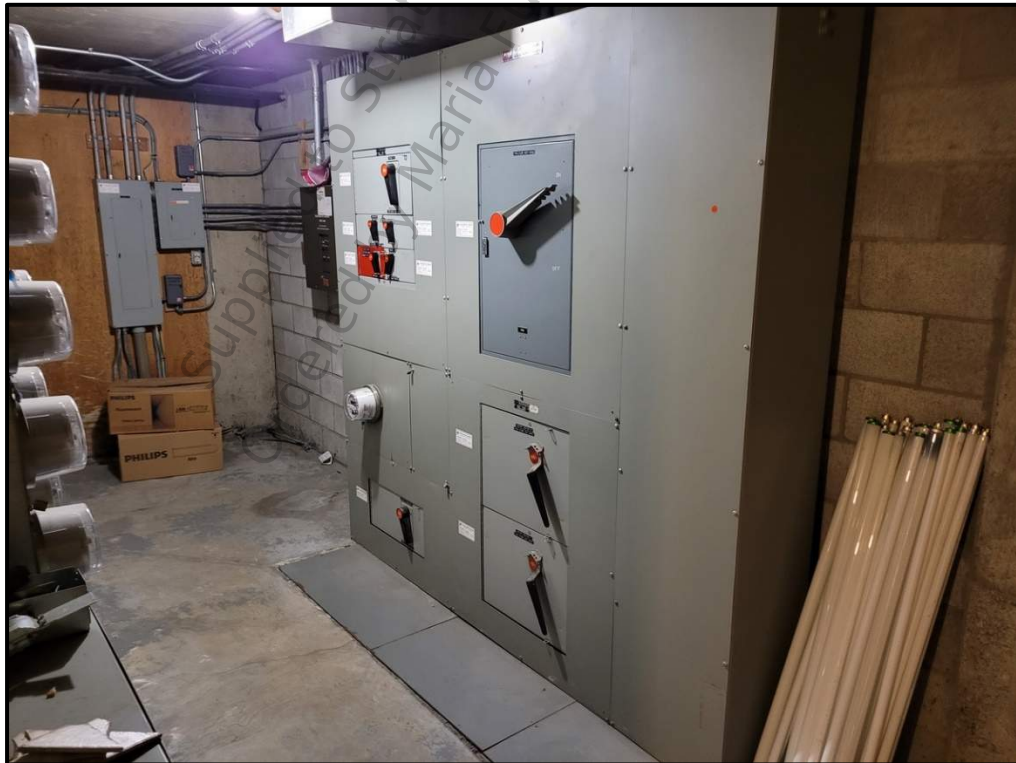
Photo 26 (D50 10 03) - Main Electrical Disconnect Switches

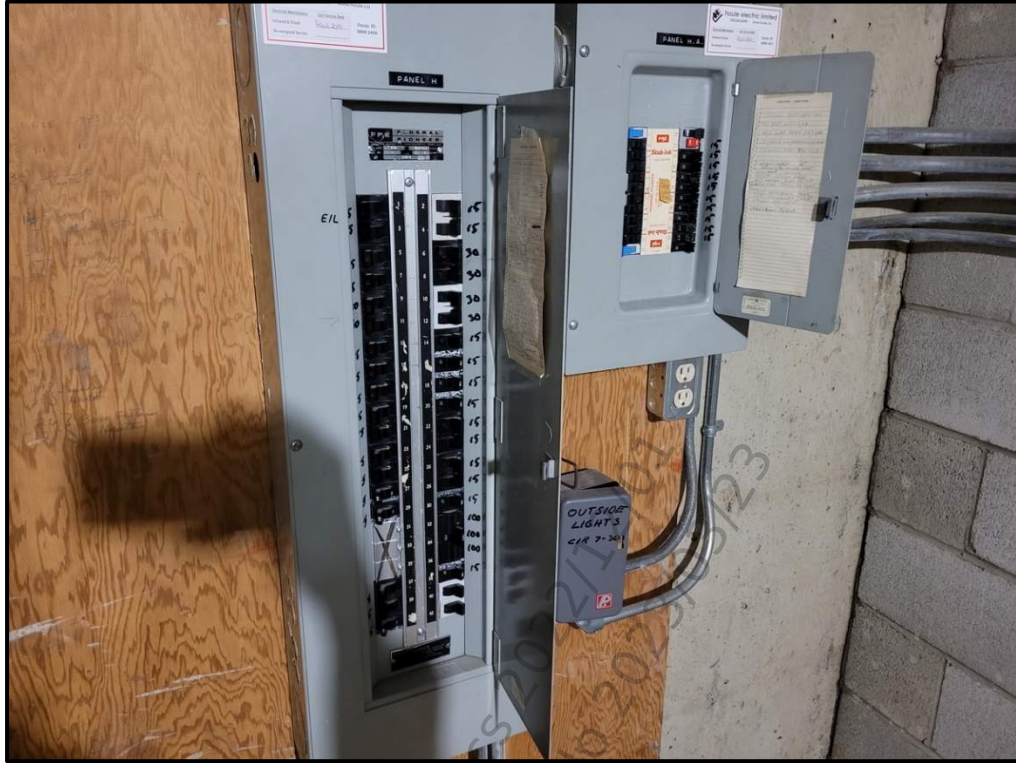
Photo 27 (D50 10 05) - Electrical Branch Circuit Distribution Panels

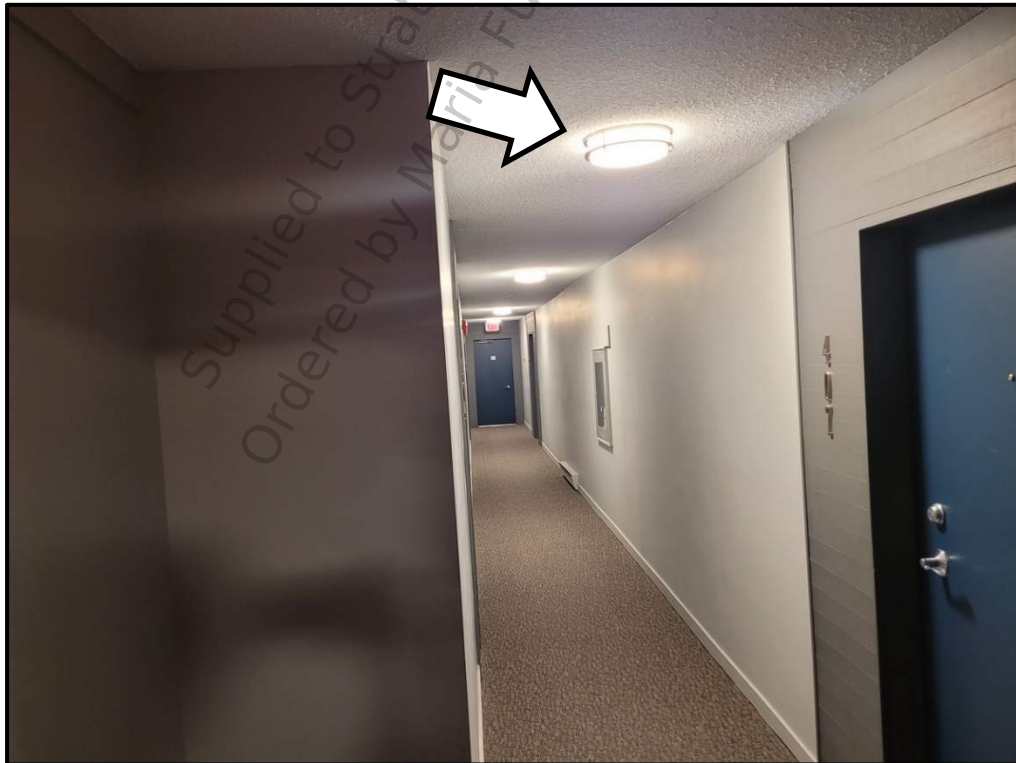
Photo 28 (D50 20 02.01) - Interior Light Fixtures in Hallway

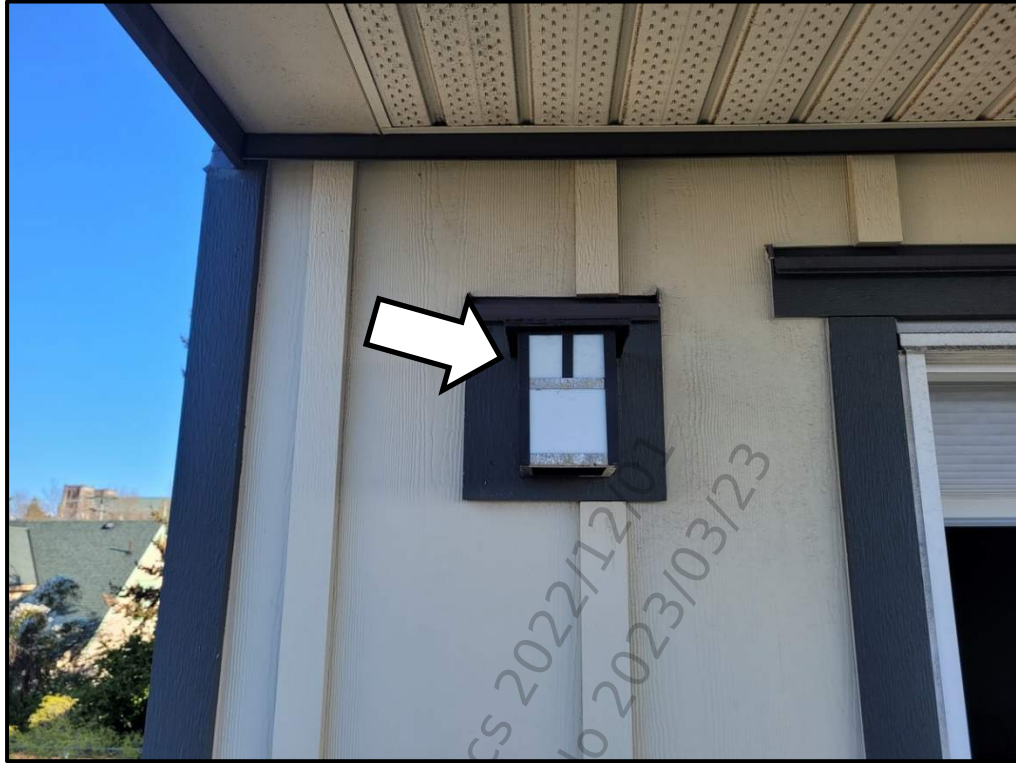
Photo 29 (D50 20 02.03) - Wall-Mounted Exterior Light Fixture
