# Depreciation Report – Final

## The Westfield Strata Corporation VIS 365

1024 Fairfield Road  
Victoria, BC

November 29, 2022

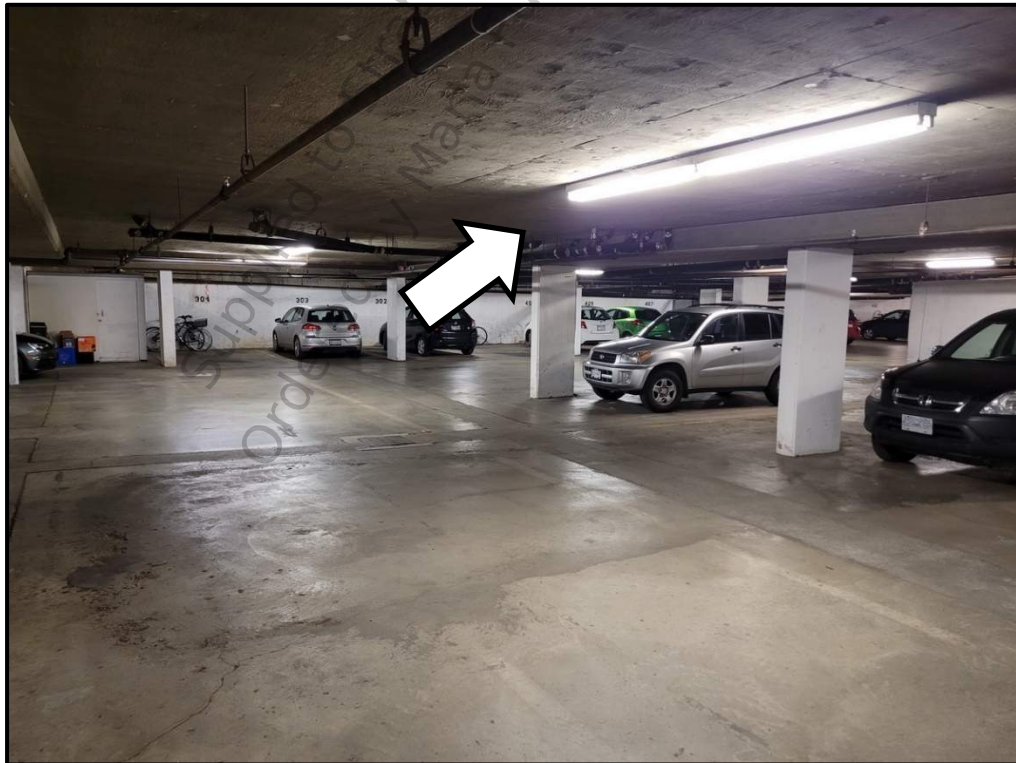
Photo 30 (D50 20 02.04) - Soffit-Mounted Light Fixtures in Parkade

SHORT TERM (WITHIN THREE YEARS)	MIDDLE TERM (YEARS FOUR TO SIX)
Projects	Projects
<ul style="list-style-type: none"> <li>• Replace the light fixtures in the parkade. Consideration for improved energy efficient fixtures (i.e., LED) may be given at the time of replacement. <i>Item 48 (D50 20 02.04) - \$10,000*</i></li> <li>• Replace/Upgrade the fire alarm panel and devices. <i>Item 50 (D50 30 01) - \$43,000*</i></li> <li>• Replace the Access System at the main entrance. <i>Item 51 (D50 30 08) - \$8,000*</i></li> <li>• Replace the emergency generator system; the type of replacement will depend on the findings of the investigation related to the feasible options. <i>Item 52 (D50 90 01) - \$23,000*</i></li> </ul>	<ul style="list-style-type: none"> <li>• Complete localized crack injection, repair waterproofing, and recoat exterior concrete at foundations/foundation walls as needed. <i>Item 2 (A10 00 00.02) - \$6,000*</i></li> <li>• Repaint/Repair the fibre cement cladding, trim, metal flashings, and soffits, as necessary, and replace joint sealant. <i>Item 9 &amp; 11 (B20 10 00.02 &amp; B20 10 11) - \$105,000*</i></li> <li>• Replace the skylights; timed to coincide with main roof replacement. <i>Item 14 (B20 20 99) - \$4,000*</i></li> <li>• Replace the SBS-modified bitumen roof assembly and accessories (including metal flashing and drains) at the main low-sloped roof area. <i>Item 20 (B30 10 02.01) - \$353,000*</i></li> <li>• Perform required/recommended elevator work to meet required Code upgrades and/or repairs related to vandalism/wear/tear. <i>Item 28 (D10 10 02.02) - \$5,000*</i></li> <li>• Refurbish/Replace the parkade exhaust fans. <i>Item 36 (D30 40 07.01) - \$6,000*</i></li> <li>• Refurbish/Replace the rooftop air handling units. <i>Item 38 (D30 40 08) - \$6,000*</i></li> <li>• Replace the interior light fixtures throughout the storage/utility rooms. <i>Item 46 (D50 20 02.02) - \$4,000*</i></li> <li>• Replace the laundry equipment (washing machines, dryers, and sink). <i>Item 54 (E10 10 04) - \$8,000*</i></li> <li>• Repair/Patch concrete pavement at parkade ramp and exterior stairs as needed. <i>Item 56 (G20 10 00.02) - \$11,000*</i></li> <li>• Carry an allowance to perform larger soft landscaping work (i.e., mature tree removal) and irrigation repairs as needed. <i>Item 61 (G20 50 00) - \$5,000*</i></li> </ul>

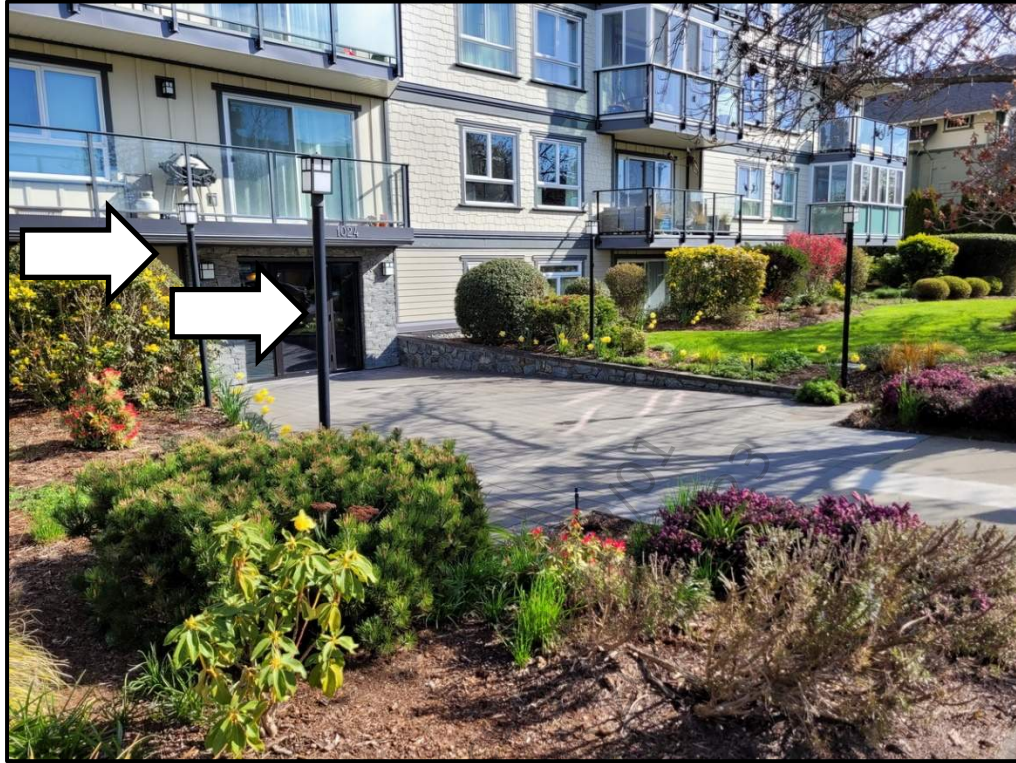
Photo 31 (D50 20 02.05) - Exterior Pole-Mounted Light Fixtures

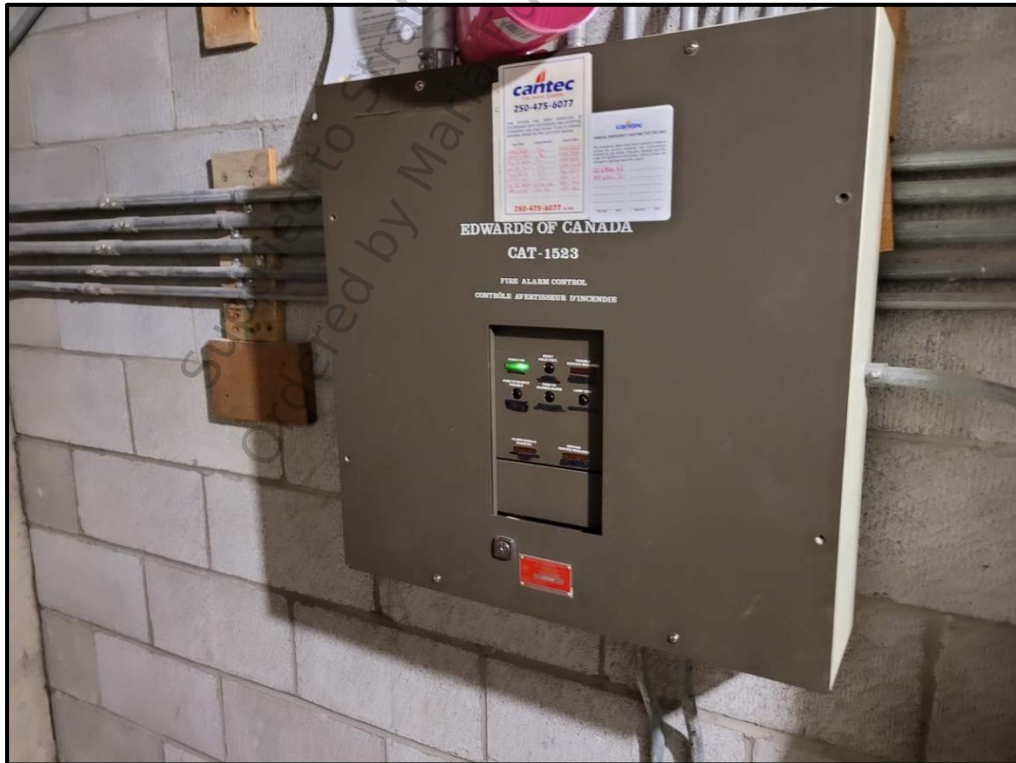
Photo 32 (D50 30 01) - Fire Alarm Panel

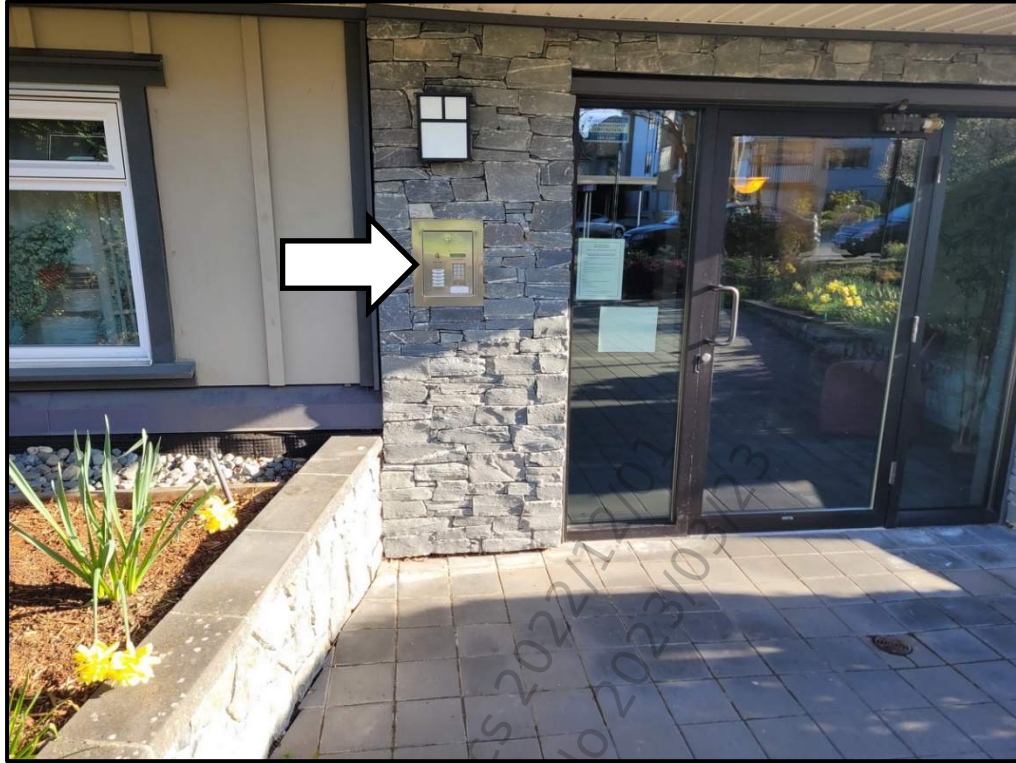
Photo 33 (D50 30 08) - Access System Keypad at Front Entrance

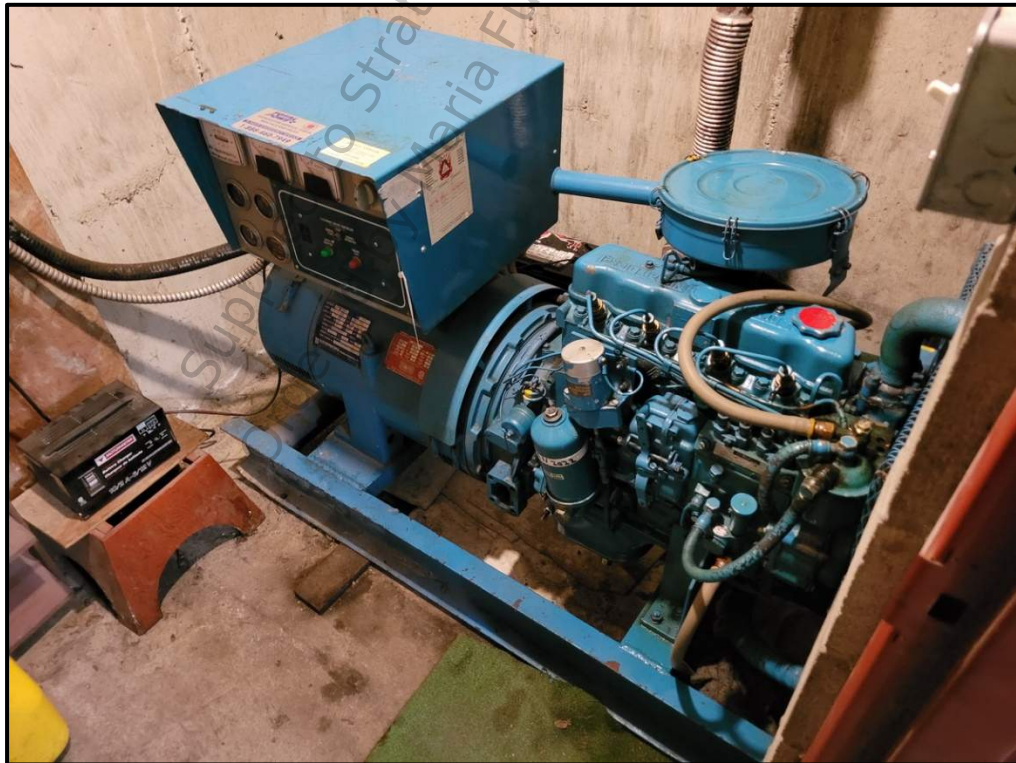
Photo 34 (D50 90 01) - Emergency Generator

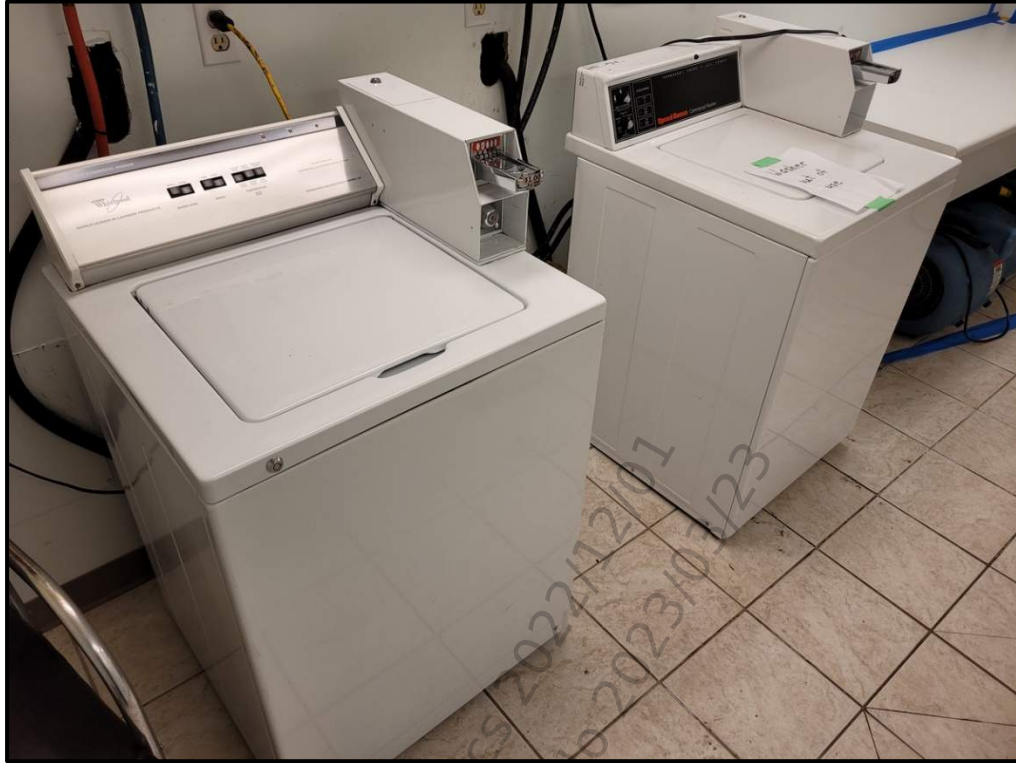
Photo 35 (E10 10 04) - Laundry Equipment

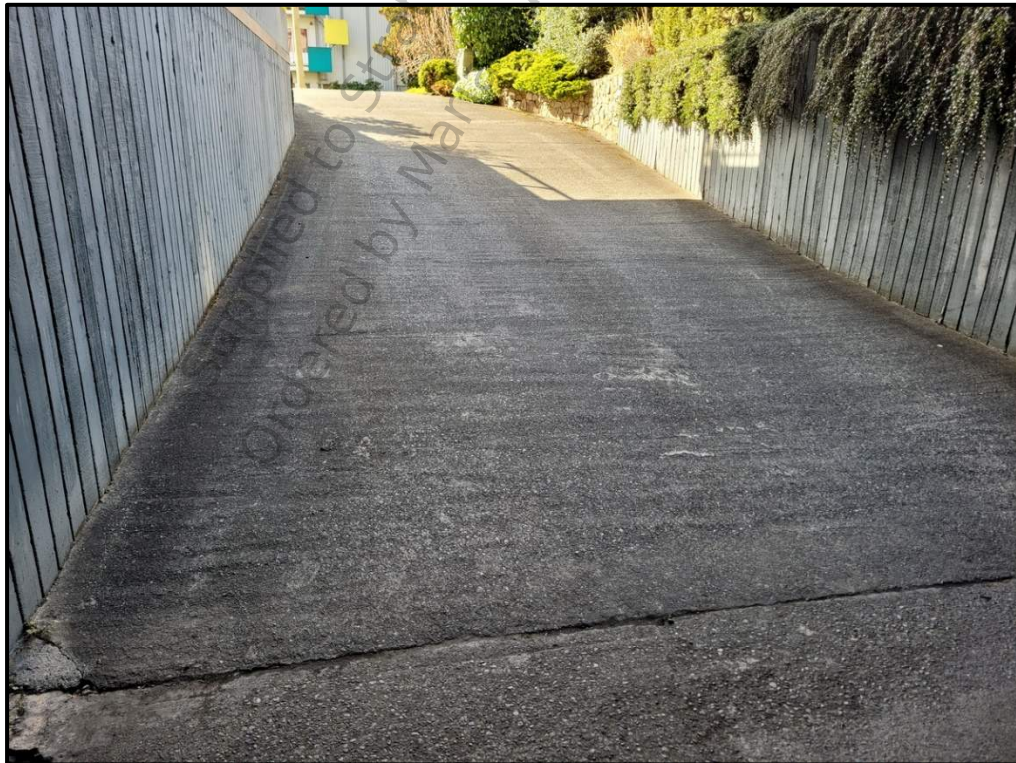
Photo 36 (G20 10 00) - Concrete Pavement at Parkade Ramp

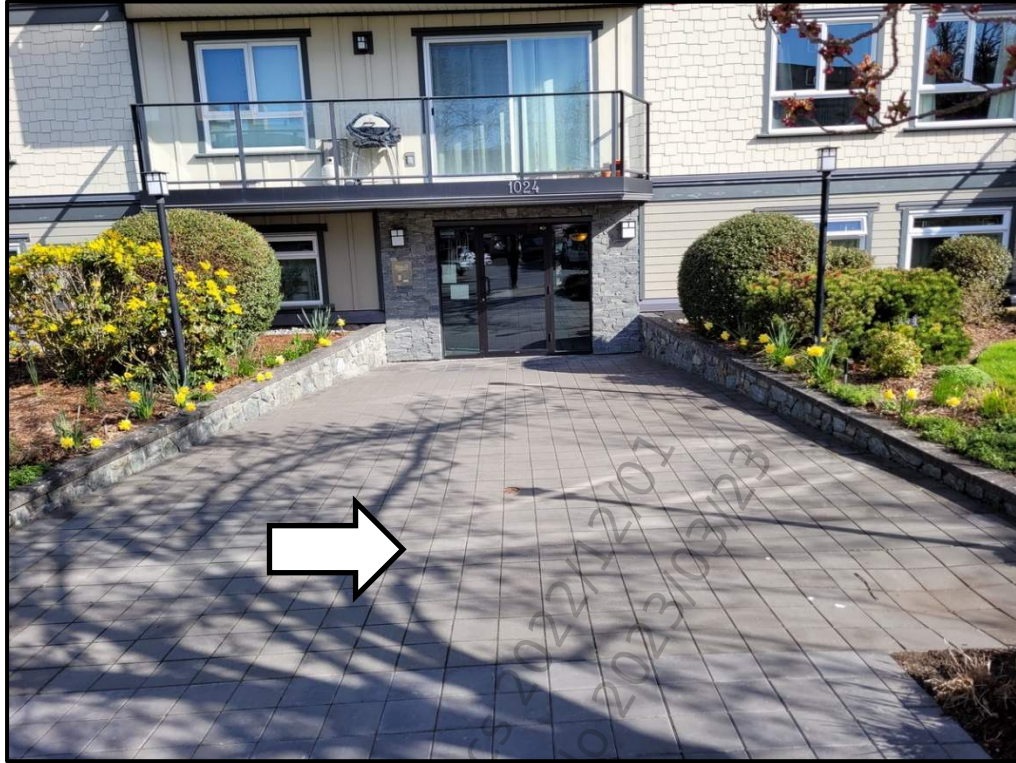
Photo 37 (G20 30 00) - Concrete Unit Pavers at Front Entrance Walkway

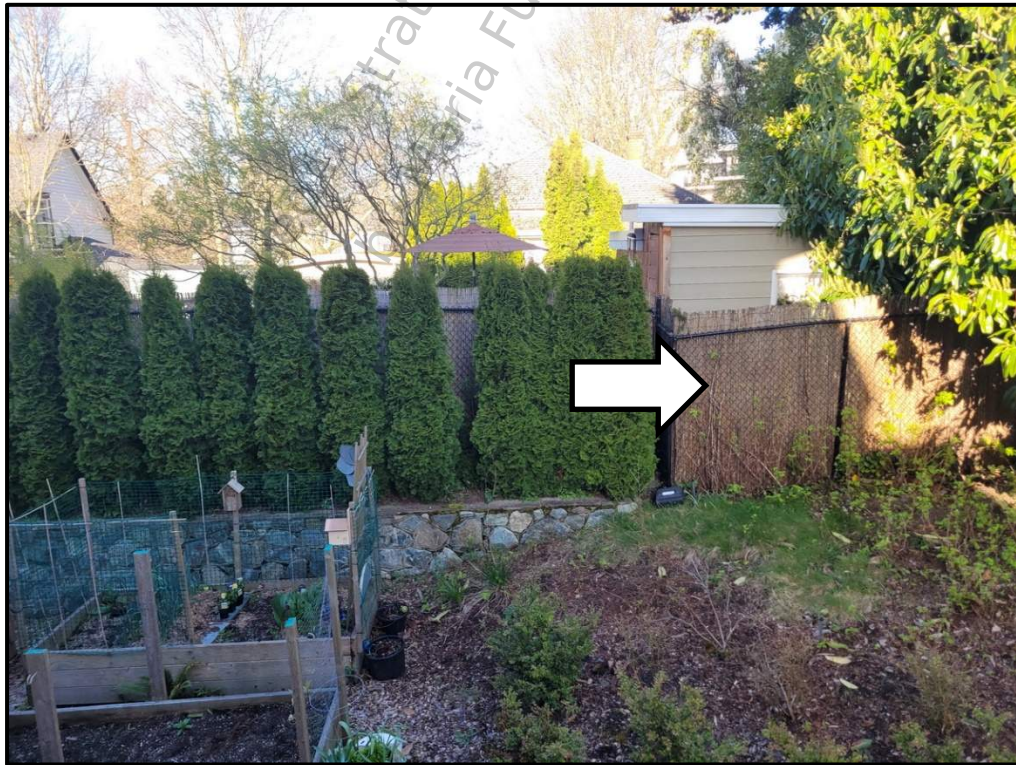
Photo 38 (G20 40 01.01) - Chainlink Fence at Property Line

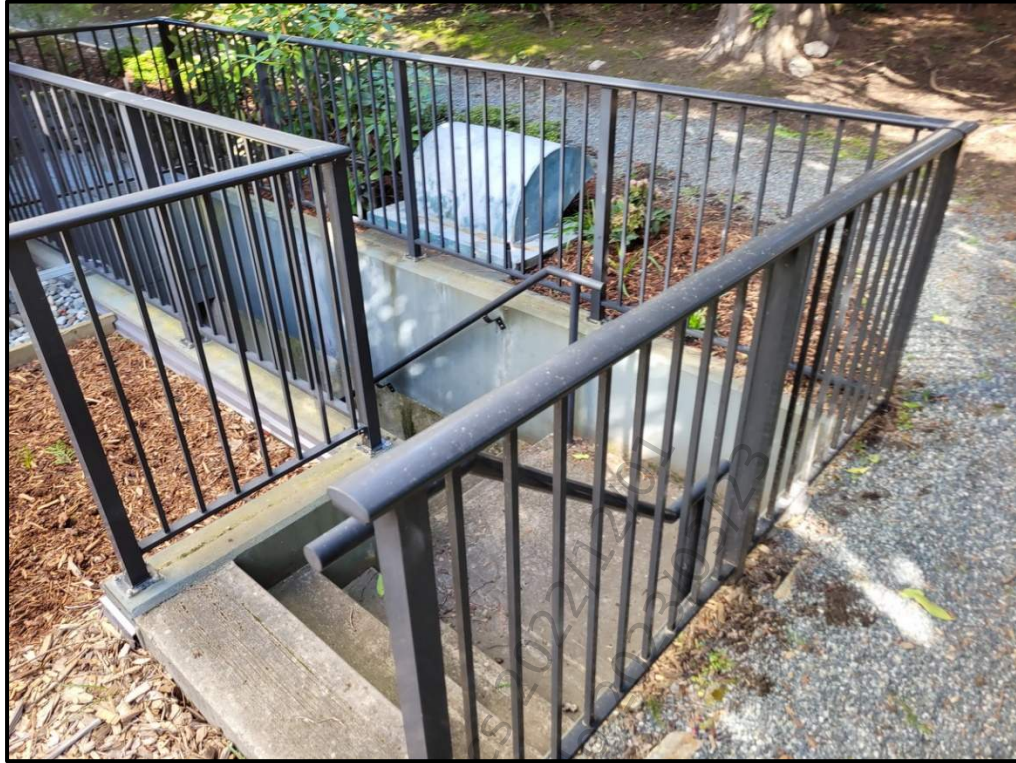
Photo 39 (G20 40 01.02) - Metal Railing around Parkade Stairs

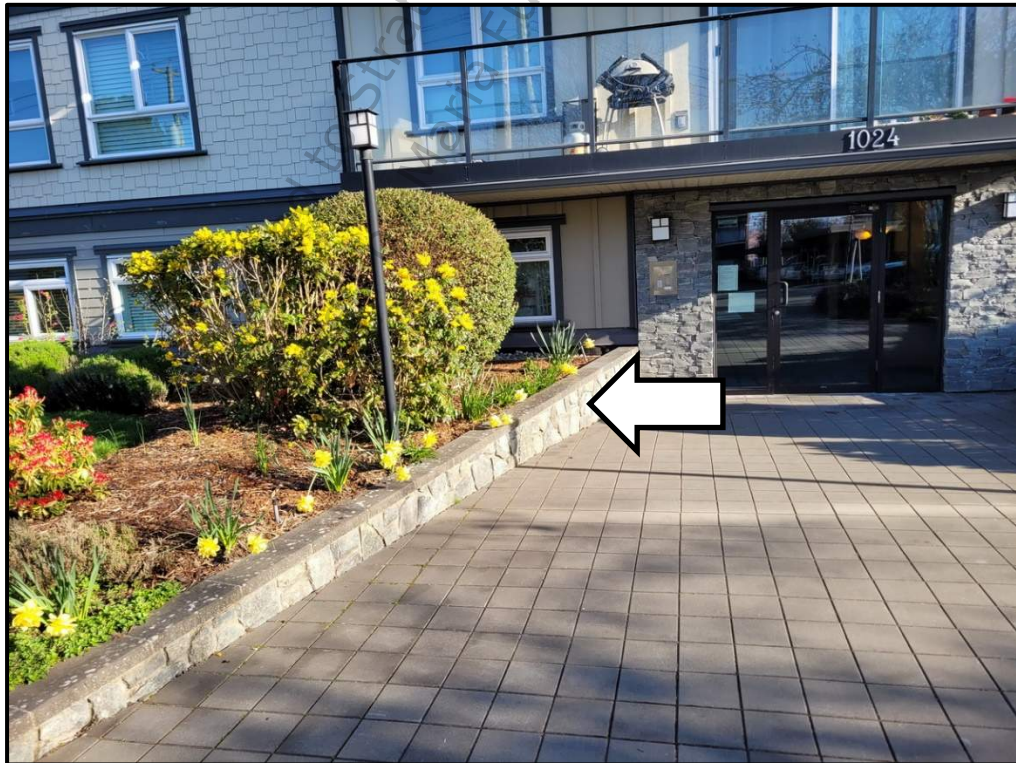
Photo 40 (G20 40 01.03) - Stone Masonry Retaining Walls Leading to Front Entrance

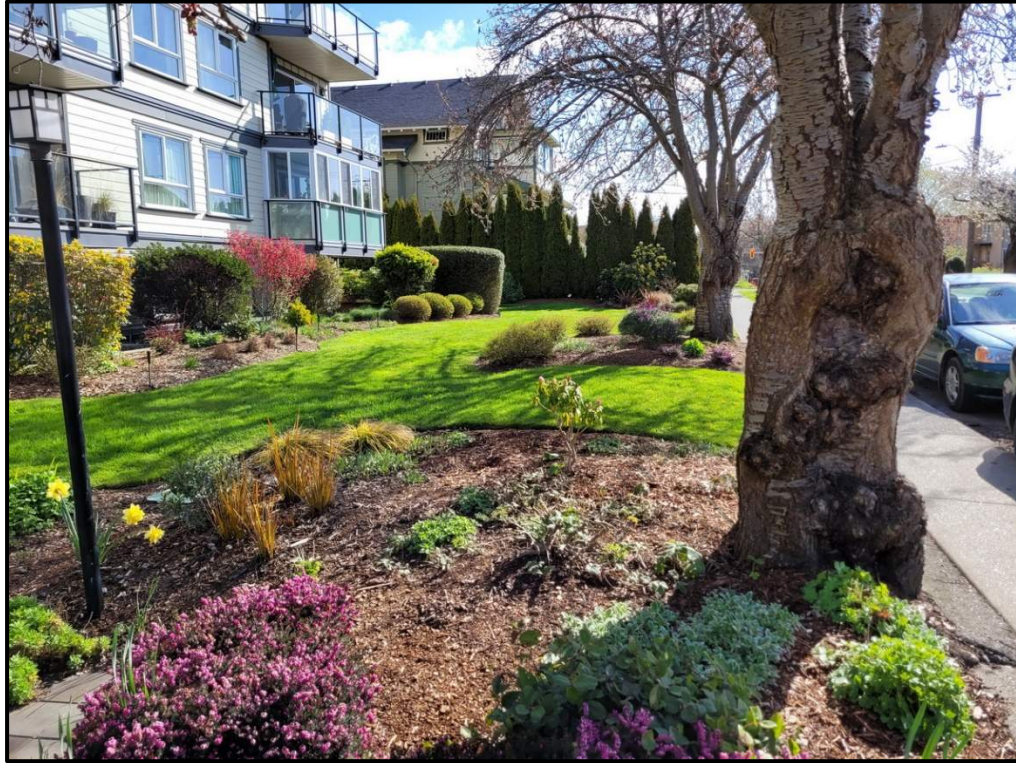
Photo 41 (G20 50 00) - Soft Landscaping

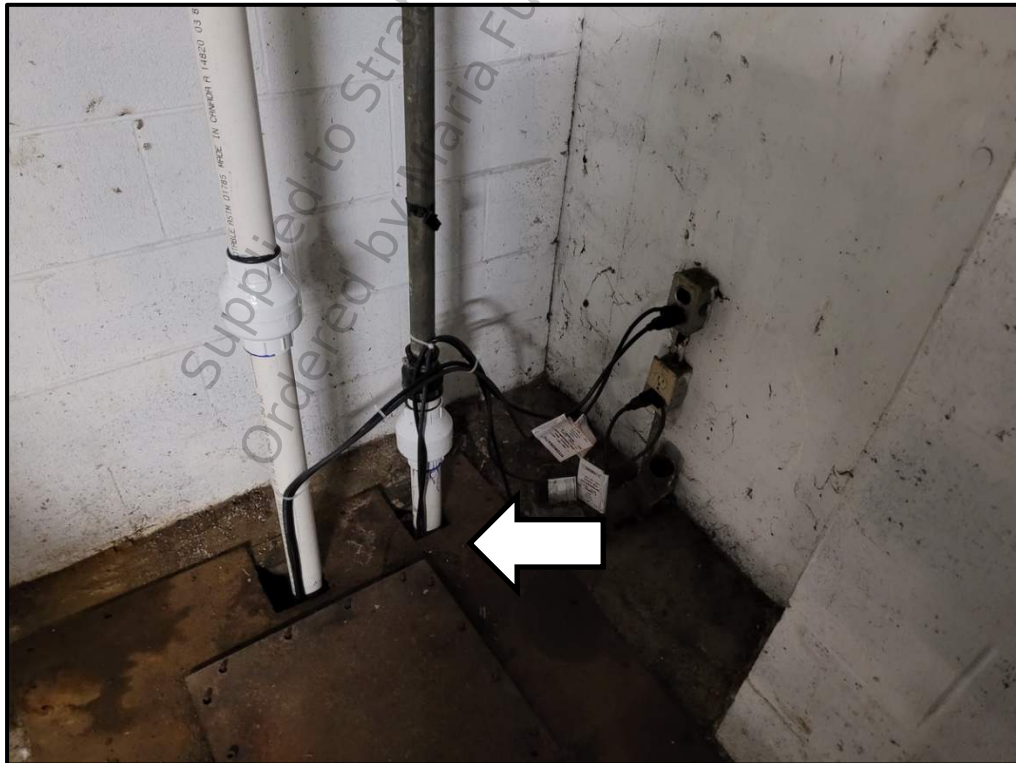
Photo 42 (G30 30 00) - Sump Pump within Parkade
