Southpoint Ridge

Depreciation Report

1223 – 1261 Flint Ave; 1103 – 1228 Moonstone Loop, Langford, BC

RJC Engineers
1515 Douglas Street, Suite 330
Victoria BC V8W 2G4

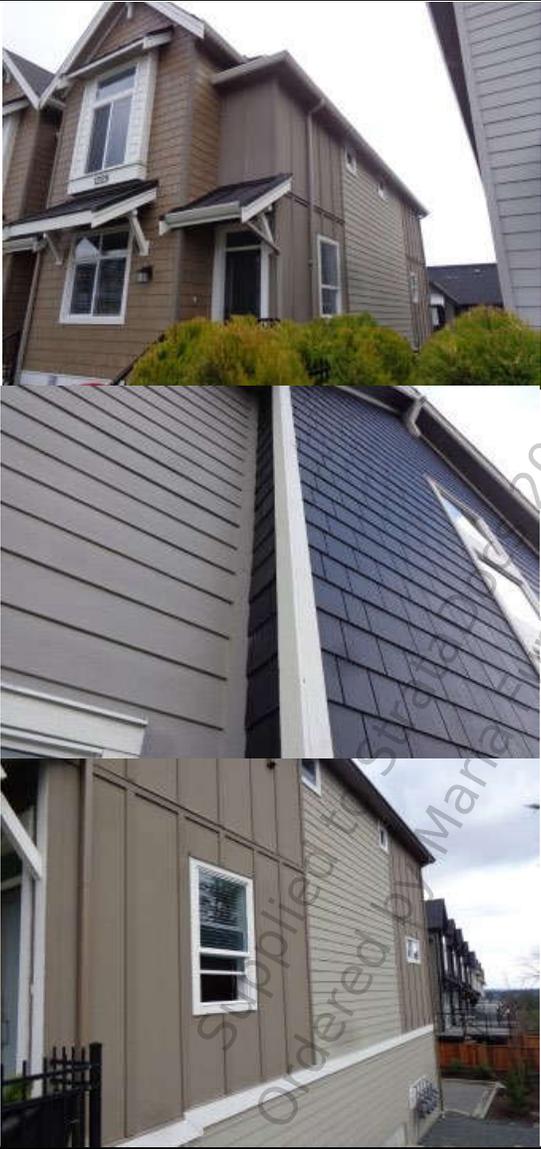
<p>Description Fibre cement horizontal siding, shingles, and board and batten panels.</p> <p>Assessment The finish on the wall cladding appeared to be generally in good condition. Expected Service Life is 8 to 10 years depending on exposure, quality of paint, workmanship, etc. The Strata documents indicate that the wall shingles were prefinished whereas the remainder of the cladding was painted on site. The prefinished shingles are not included in the paint renewal schedule below as the finish is expected to last significantly longer.</p> <p>Priority 4 Building Functionality; cost effective and/or marketability upgrades.</p>
	<p>Expected Service Life 9 Years Present Equivalent Age 3, 1, 0 Years Estimated Remaining Life 6, 8, 9 Years</p>	<p>Note: Phase 1: Year 7: 26 Units: \$125,000 Phase 2: Year 9: 20 Units: \$100,000 Phase 3: Year 10: 22 Units: \$110,000 The Estimated Budget includes wood trim Items A1.03, A1.04.</p> <p style="text-align: right;">Estimated Budget See Above</p>

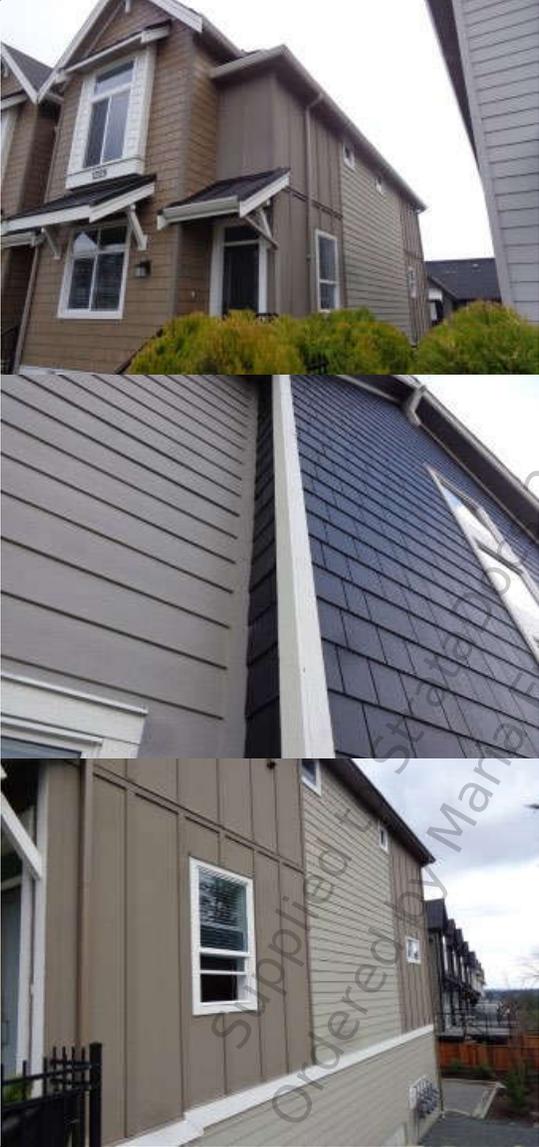
Item	Component	Description / Assessment / Priority
A1.0 Building Exterior		
1.02	Wall Cladding - Replacement

<p>Description Fibre cement horizontal siding, shingles and board and batten panels.</p> <p>Assessment The fibre cement cladding appeared to be generally in good condition commensurate with its age.</p> <p>Priority 4 Building Functionality; cost effective and/or marketability upgrades.</p>
	<p>Expected Service Life 50 Years</p> <p>Present Equivalent Age 5, 3, 2 Years</p> <p>Estimated Remaining Life 45, 47, 48 Years</p>	<p>Note: The Remaining Service Life exceeds the 30 year time frame of this report.</p> <p style="text-align: right;">Estimated Budget NA</p>

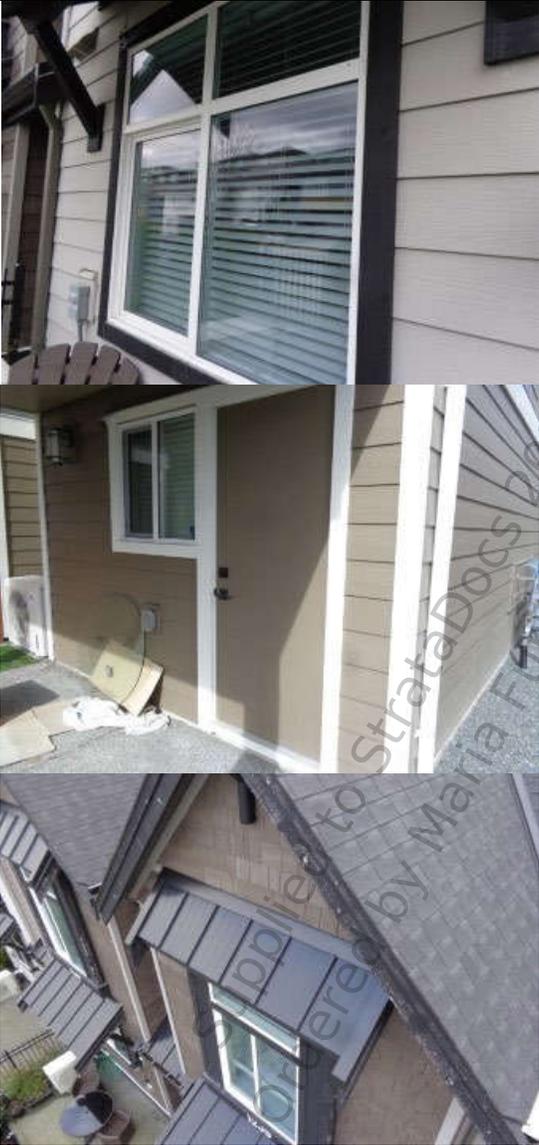
<p>Description Painted wood trim at windows, doors, roof gables, etc.</p> <p>Assessment The paint finish appeared to be generally in good condition except at Units 31 to 50 where the paint finish is deteriorating. Expected Service Life is 8 to 10 years depending on exposure.</p> <p>Priority 4 Building Functionality; cost effective and/or marketability upgrades.</p>
	<p>Expected Service Life 9 Years</p> <p>Present Equivalent Age Varies Years</p> <p>Estimated Remaining Life Varies Years</p>	<p>Note: Phase 1: Year 1: Units 31 to 50: \$5,000 Phase 2: going forward the trim would be painted with the cladding and the Estimated Budget is included with the wall cladding Item A1.01.</p> <p style="text-align: right;">Estimated Budget See Above</p>

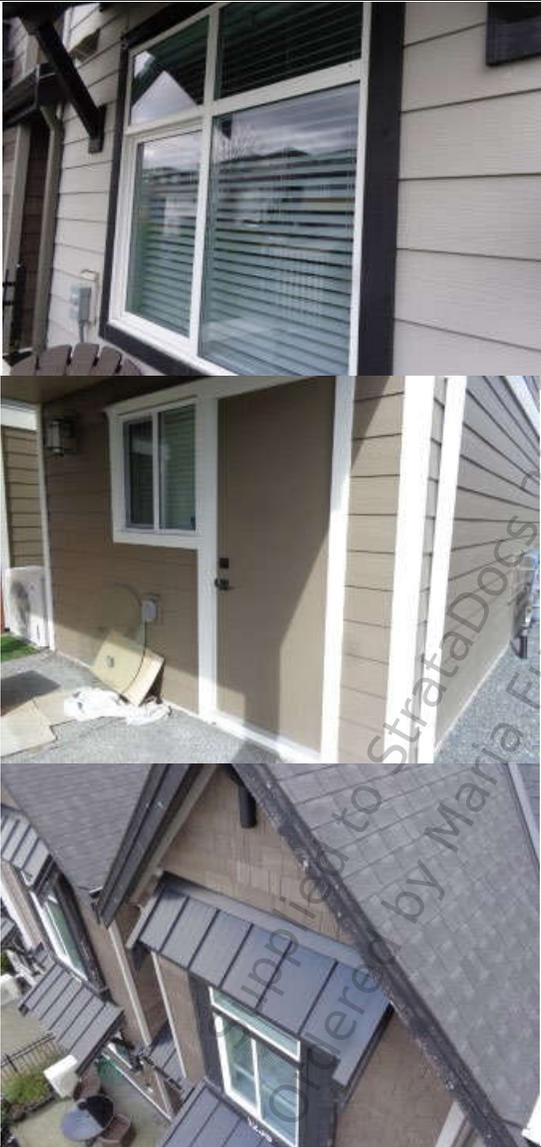
Item	Component	Description / Assessment / Priority
A1.0 Building Exterior		
1.04	Wood Trim - Replacement

<p>Description Painted wood trim at windows, doors, roof gables, etc.</p> <p>Assessment The trim appeared to be generally in good condition commensurate with its age.</p> <p>Priority 4 Building Functionality; cost effective and/or marketability upgrades.</p>
<p>Expected Service Life 30 Years Present Equivalent Age Varies Years Estimated Remaining Life Varies Years</p>		<p>Note: The trim could be replaced on an as-required basis during painting. The Estimated Budget is included in Item A1.01.</p>
		<p style="text-align: right;">Estimated Budget See Above</p>

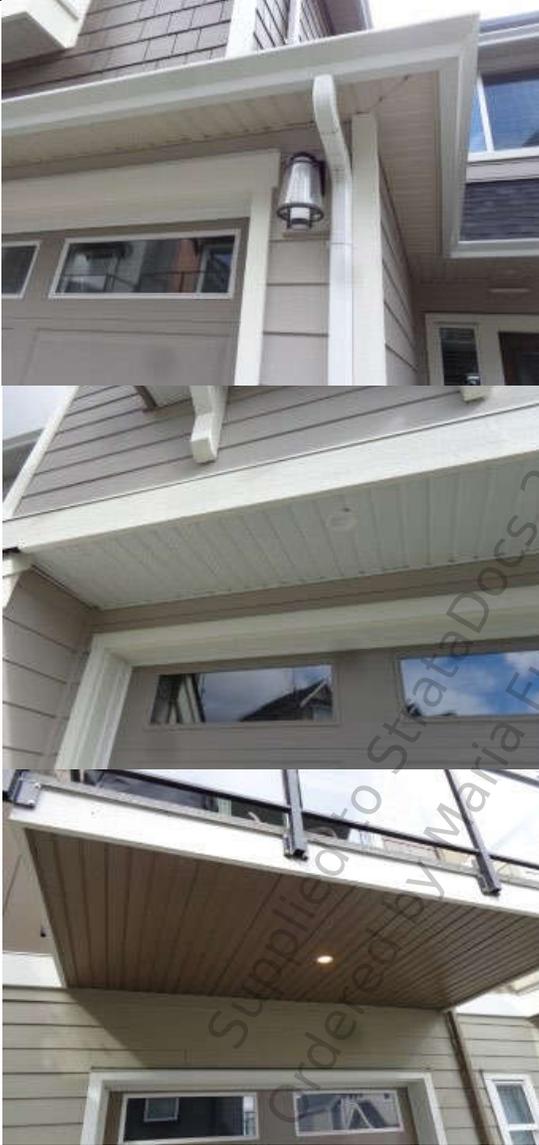
Item	Component	Description / Assessment / Priority
A1.0 Building Exterior		
1.05	Soffits - Replacement

<p>Description Perforated aluminum soffits at roof overhangs, wall overhangs, and balconies.</p> <p>Assessment The soffits appeared to be generally in good condition commensurate with its age.</p> <p>Priority 4 Building Functionality; cost effective and/or marketability upgrades.</p>
<p>Expected Service Life 50 Years Present Equivalent Age 5, 3, 2 Years Estimated Remaining Life 45, 47, 48 Years</p>		<p>Note: The Remaining Service Life exceeds the 30 year time frame of this report.</p>
		<p style="text-align: right;">Estimated Budget NA</p>

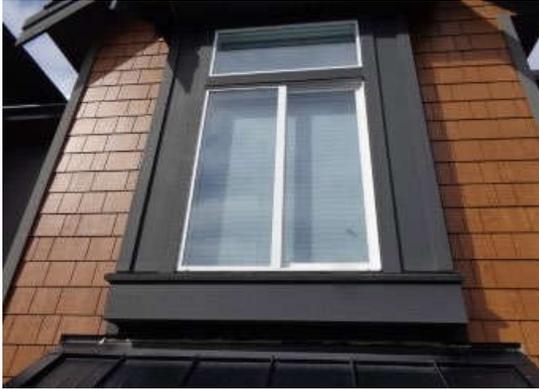
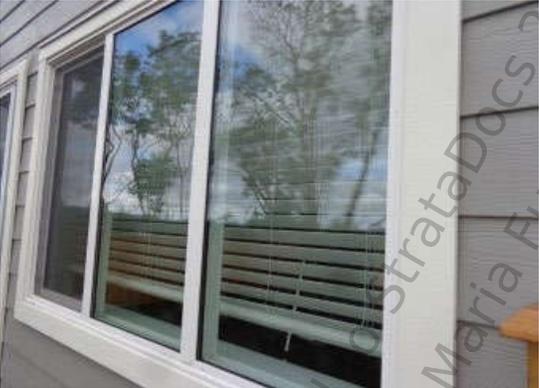
<p>Description Double-glazed vinyl-framed windows.</p> <p>Assessment Renewals would typically include the replacement of the IGUs which can be expected to fail at random after about 10 to 15 years. No failed IGU's were noted.</p> <p>Priority 4 Building Functionality; cost effective and/or marketability upgrades.</p>
	<p>Expected Service Life 3 Years</p> <p>Present Equivalent Age -6 Years</p> <p>Estimated Remaining Life 9 Years</p>	<p>Note: An allowance of \$5,000 every 3 years (beginning in Year 10) is suggested for replacement of failed IGUs. Estimated Budget includes the glazed swing A1.08 and sliding doors A1.10. The Expected Service Life is set to reflect the 3 year cycle.</p> <p style="text-align: right;">Estimated Budget \$ 5,000</p>

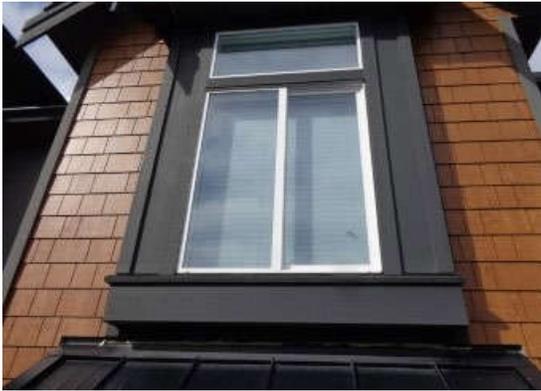
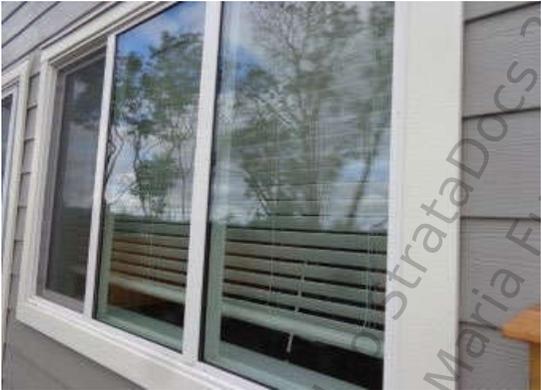
Item	Component	Description / Assessment / Priority
A1.0 Building Exterior		
1.07	Windows - Replacement

<p>Description Double-glazed vinyl-framed windows.</p> <p>Assessment The windows appeared to be generally in good condition commensurate with their age.</p> <p>Priority 4 Building Functionality; cost effective and/or marketability upgrades.</p>
	<p>Expected Service Life 45 Years</p> <p>Present Equivalent Age 5, 3, 2 Years</p> <p>Estimated Remaining Life 40, 42, 43 Years</p>	<p>Note: The Remaining Service Life exceeds the 30 year time frame of this report.</p> <p style="text-align: right;">Estimated Budget NA</p>

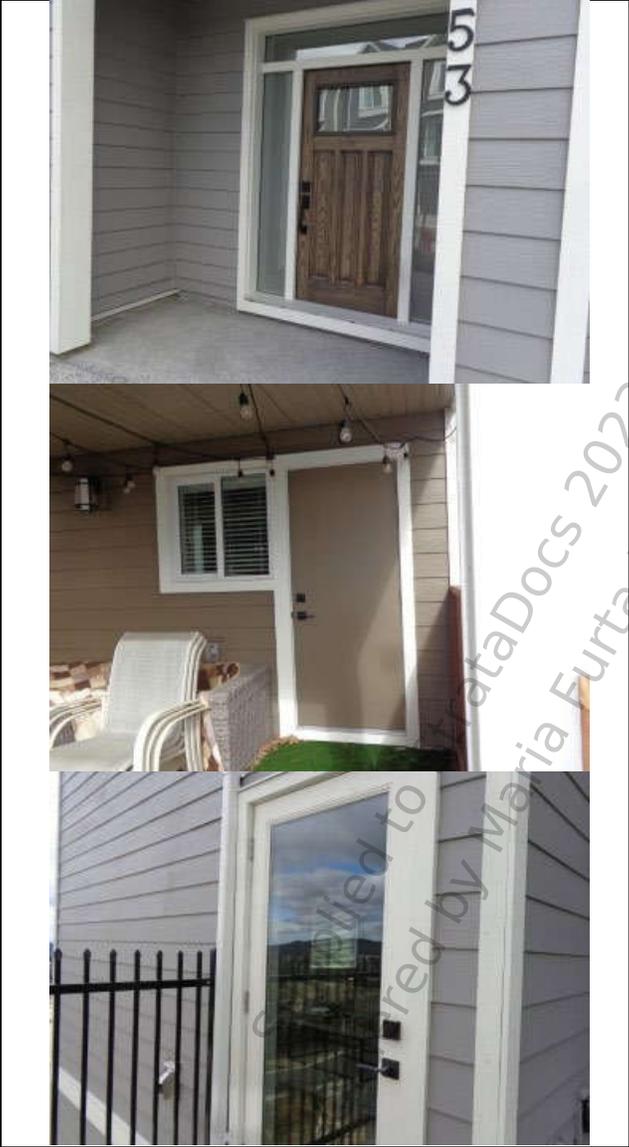
<p>Description Wood and composite doors; solid or with insulated glass units (IGU). Includes front entry doors and swing patio doors.</p> <p>Assessment The finish on the doors appeared to be generally in good condition. No failed IGU's were noted.</p> <p>Priority 4 Building Functionality; cost effective and/or marketability upgrades.</p>
	<p>Expected Service Life Varies Years Present Equivalent Age Varies Years Estimated Remaining Life Varies Years</p>	<p>Note: Renewals would include refinish and replacement of failed IGU's. Refinish is included with the cladding Item A1.01 and the failed IGU's with Item A1.06.</p> <p style="text-align: right;">Estimated Budget NA</p>

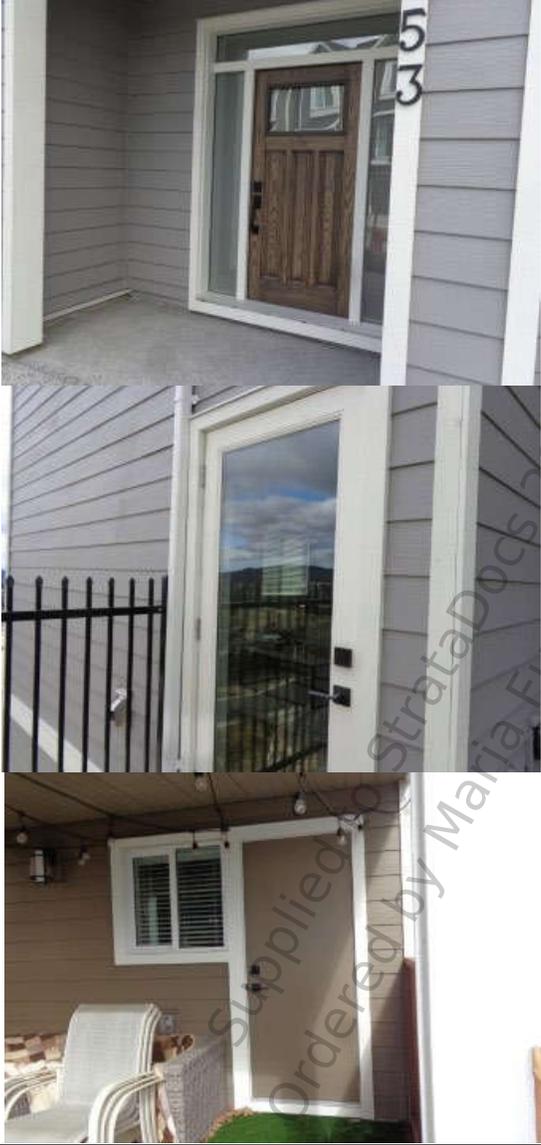
Item	Component	Description / Assessment / Priority
A1.0 Building Exterior		
1.09	Doors - Swing Entry/Exit - Replacement

<p>Description Wood and composite doors; solid or with insulated glass units (IGU). Includes front entry doors and swing patio doors.</p> <p>Assessment The doors appeared to be generally in good condition commensurate with their age.</p> <p>Priority 4 Building Functionality; cost effective and/or marketability upgrades.</p>
<p>Expected Service Life 40 Years</p>		<p>Note:</p>
<p>Present Equivalent Age 5, 3, 2 Years</p>		<p>The Remaining Service Life exceeds the 30 year time frame of this report.</p>
<p>Estimated Remaining Life 35, 37, 38 Years</p>		
		<p style="text-align: right;">Estimated Budget NA</p>

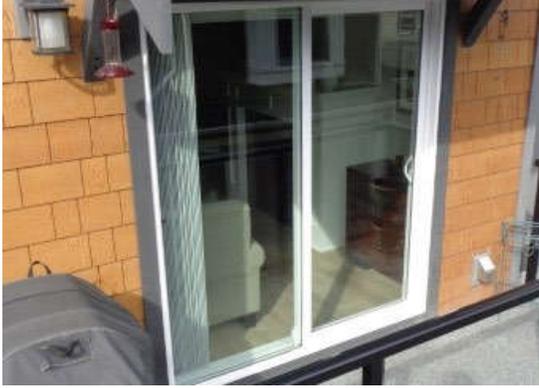
<p>Description Double-glazed vinyl-framed doors.</p> <p>Assessment Similar to the widows, renewals would typically include the replacement of the IGUs which can be expected to fail at random after about 10 to 15 years. No failed IGU's were noted.</p> <p>Priority 4 Building Functionality; cost effective and/or marketability upgrades.</p>
	<p>Expected Service Life 10 to 15 Years</p> <p>Present Equivalent Age Varies Years</p> <p>Estimated Remaining Life Varies Years</p>	<p>Note: The Estimated Budget for replacement of failed IGU's is included with Item A1.06.</p> <p style="text-align: right;">Estimated Budget NA</p>

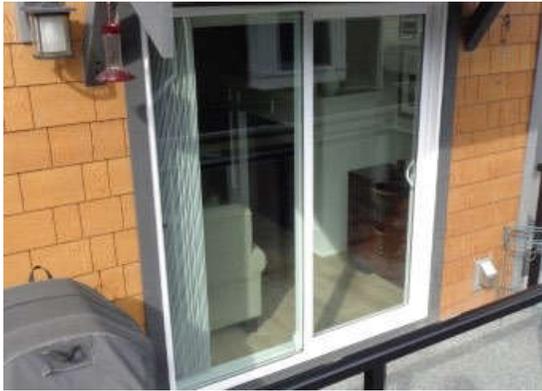
<p>Description Double-glazed vinyl-framed doors.</p> <p>Assessment The doors appeared to be generally in good condition commensurate with their age.</p> <p>Priority 4 Building Functionality; cost effective and/or marketability upgrades.</p>
	<p>Expected Service Life 40 Years</p> <p>Present Equivalent Age 5, 3, 2 Years</p> <p>Estimated Remaining Life 35, 37, 38 Years</p>	<p>Note: The Remaining Service Life exceeds the 30 year time frame of this report.</p> <p style="text-align: right;">Estimated Budget NA</p>

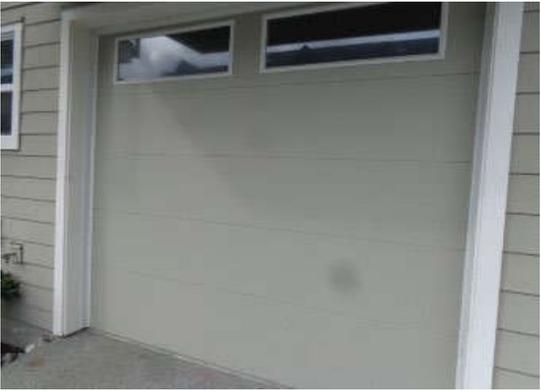
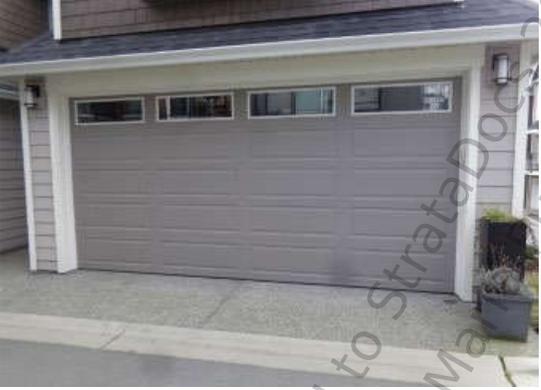
<p>Description Single and double prefinished garage overhead doors.</p> <p>Assessment The finish on the doors appeared to be generally in good condition. On site refinishing is not typically required.</p> <p>Priority 4 Building Functionality; cost effective and/or marketability upgrades.</p>
	<p>Expected Service Life 3 Years</p> <p>Present Equivalent Age 0 Years</p> <p>Estimated Remaining Life 3 Years</p>	<p>Note: An allowance of \$3,000 every 3 years is suggested for replacement of miscellaneous hardware. The Expected Service Life is set to reflect the 3 year cycle.</p> <p style="text-align: right;">Estimated Budget \$ 3,000</p>

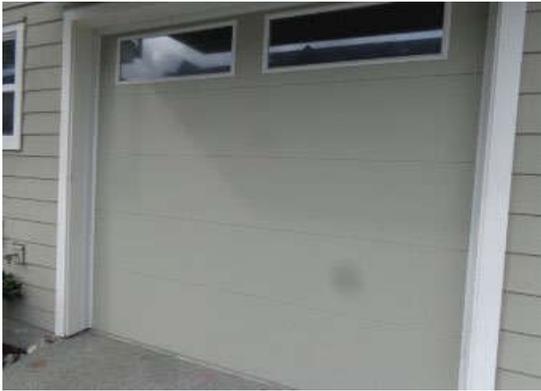
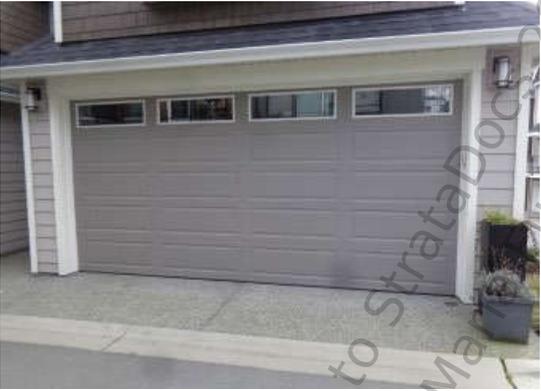
<p>Description Single and double prefinished garage overhead doors.</p> <p>Assessment The doors appeared to be generally in good condition commensurate with their age.</p> <p>The replacement of the electric motor operators is the responsibility of the individual Owner.</p> <p>Priority 4 Building Functionality; cost effective and/or marketability upgrades.</p>
	<p>Expected Service Life 25 Years</p> <p>Present Equivalent Age 5, 3, 2 Years</p> <p>Estimated Remaining Life 20, 22, 23 Years</p>	<p>Note: Phase 1: Year 21: 20 single/6 double: \$97,000 Phase 2: Year 23: 20 single: \$70,000 Phase 3: Year 24: 22 single: \$77,000</p> <p style="text-align: right;">Estimated Budget See Above</p>

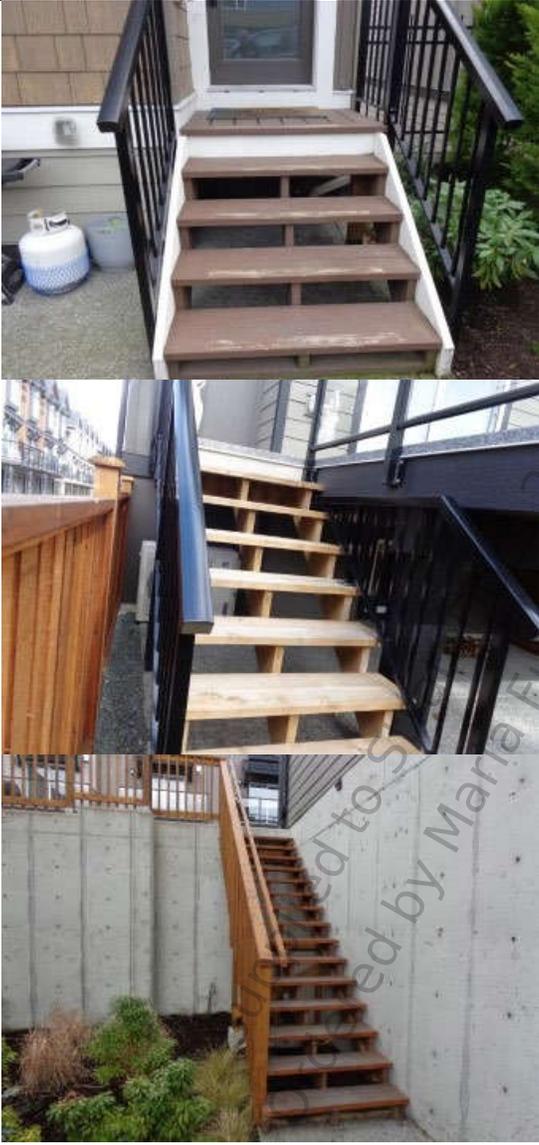
<p>Description Wood steps at some front entrances.</p> <p>Wood stairs to some balconies and between Units 61 - 64 and Units 65 - 68.</p> <p>The steps are generally painted and the stairs are generally unfinished.</p> <p>Assessment The finish on the steps appeared to be generally in good to fair condition.</p> <p>Renewals would include refinishing as required.</p> <p>Priority 4 Building Functionality; cost effective and/or marketability upgrades.</p>
<p>Expected Service Life 3 Years</p> <p>Present Equivalent Age 2 Years</p> <p>Estimated Remaining Life 1 Years</p>		<p>Note:</p>
		<p style="text-align: right;">Estimated Budget \$ 1,500</p>

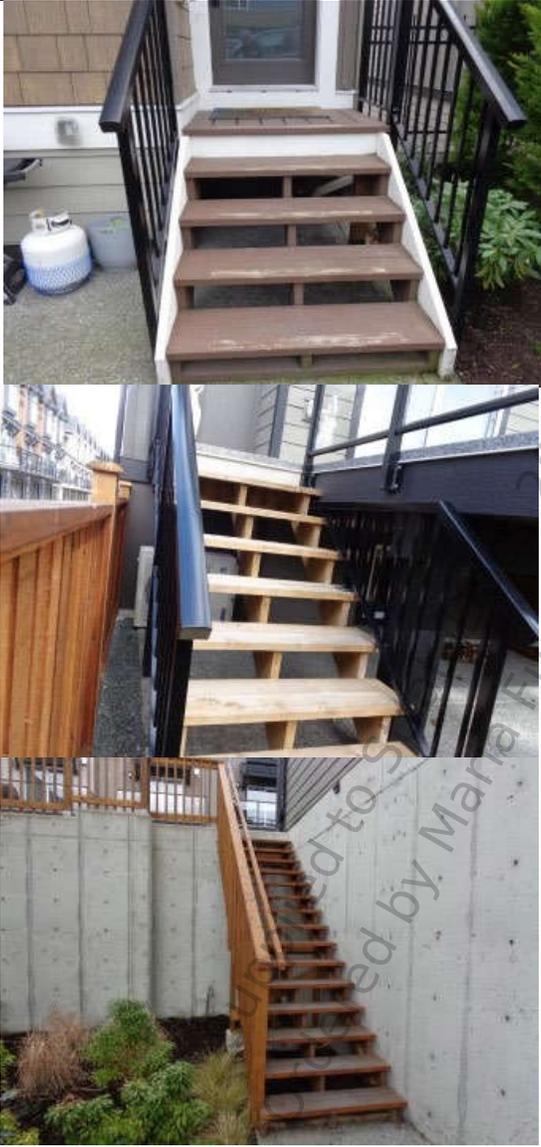
<p>Description</p> <p>Wood steps at some front entrances.</p> <p>Wood stairs to some balconies and between Units 61 - 64 and Units 65 - 68.</p> <p>The steps are generally painted and the stairs are generally unfinished.</p> <p>Assessment</p> <p>The steps and the stairs appeared to be generally in good condition commensurate with their age.</p> <p>Priority</p> <p>4 Building Functionality; cost effective and/or marketability upgrades.</p>
<p>Expected Service Life 25 Years</p> <p>Present Equivalent Age 3 Years</p> <p>Estimated Remaining Life 22 Years</p>		<p>Note:</p>
		<p style="text-align: right;">Estimated Budget \$ 20,000</p>

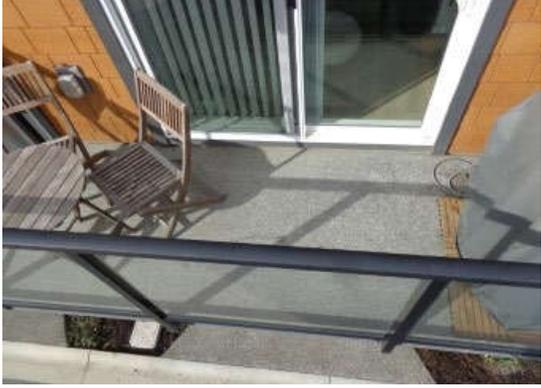
<p>Description PVC waterproofing membrane on the balconies.</p> <p>Assessment The membrane appeared to be generally in good condition commensurate with its age.</p> <p>A well maintained PVC membrane can typically last 15 to 20 years.</p> <p>Priority 4 Building Functionality; cost effective and/or marketability upgrades.</p>
	<p>Expected Service Life 18 Years</p> <p>Present Equivalent Age 5, 3, 2 Years</p> <p>Estimated Remaining Life 13, 15, 16 Years</p>	<p>Note: Phase 1: Year 14: \$22,000 Phase 2: Year 16: \$32,000 Phase 3: Year 17: \$3,500</p> <p style="text-align: right;">Estimated Budget See Above</p>

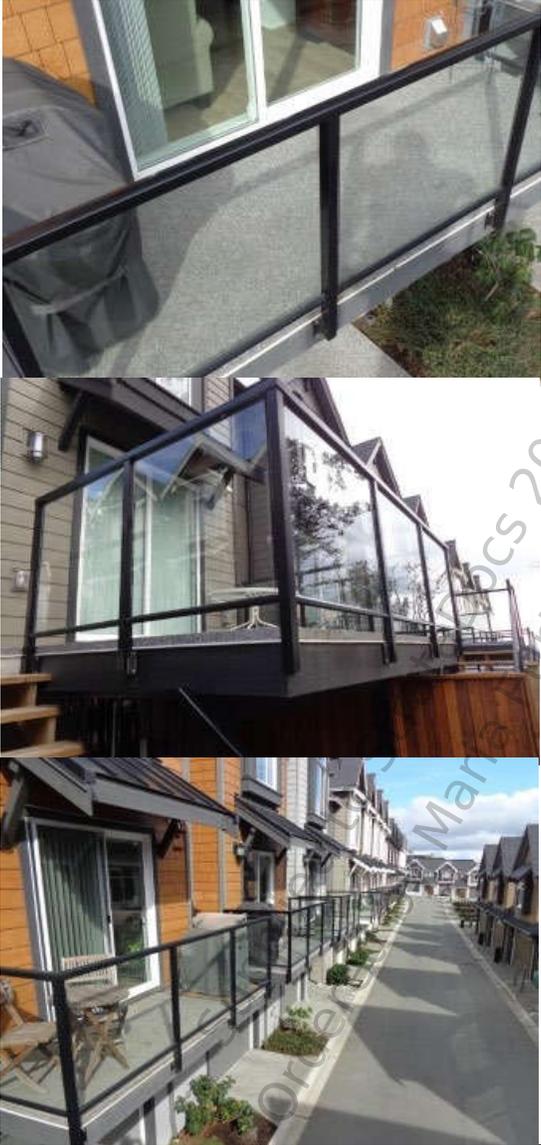
<p>Description Prefinished aluminum frame with glass infill panels.</p> <p>Assessment The guardrails appeared to be generally in good condition commensurate with their age. On site refinishing is not typically required.</p> <p>Priority 1 Health and Safety</p>
<p>Expected Service Life 45 Years Present Equivalent Age 5, 3, 2 Years Estimated Remaining Life 40, 42, 43 Years</p>		<p>Note: The Remaining Service Life exceeds the 30 year time frame of this report.</p>
		<p style="text-align: right;">Estimated Budget NA</p>

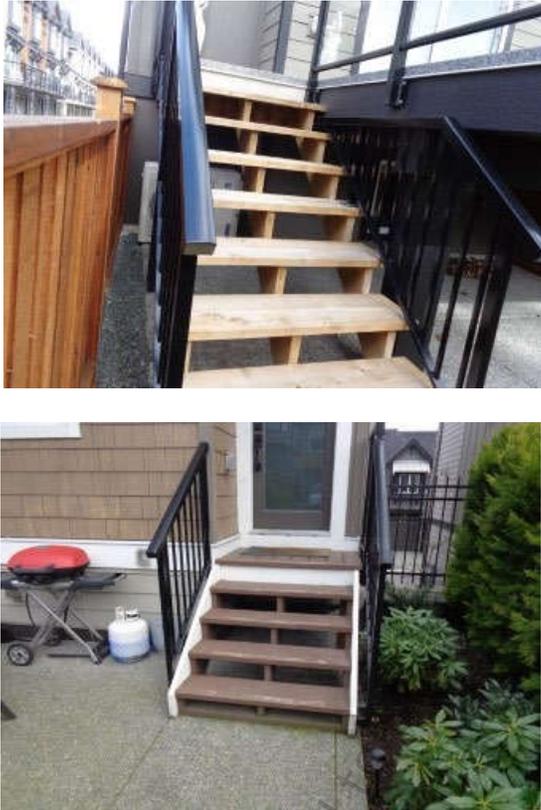
<p>Description Prefinished aluminum frame with infill pickets at several stairs to balconies and patios.</p> <p>Assessment The guardrails/handrails appeared to be generally in good condition commensurate with their age. On site refinishing is not typically required.</p> <p>Priority 1 Health and Safety</p>

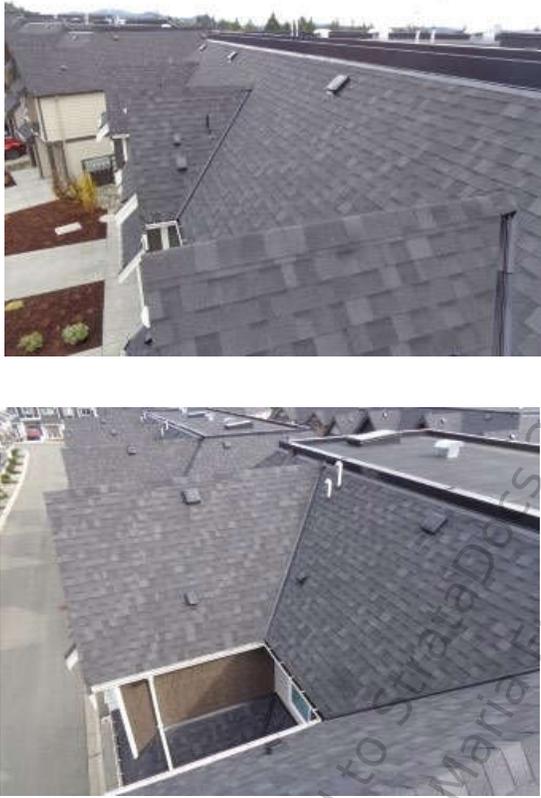
<p>Description Sloped asphalt shingle roofs.</p> <p>Assessment The shingles appeared to be generally in good condition commensurate with their age.</p> <p>This type of roofing product would be expected to last 20 to 30 years and is highly dependent upon quality of shingles, location, and maintenance.</p> <p>Priority 4 Building Functionality; cost effective and/or marketability upgrades.</p>
	<p>Expected Service Life 25 Years</p> <p>Present Equivalent Age 5, 3, 2 Years</p> <p>Estimated Remaining Life 20, 22, 23 Years</p>	<p>Note: Phase 1 - Year 21: \$240,000; Phase 2 - Year 23: \$175,000 Phase 3 - Year 24: \$310,000 Budgets include Gutters/Downspouts Item A2.04 and Skylights Item A2.05</p> <p style="text-align: right;">Estimated Budget See Above</p>

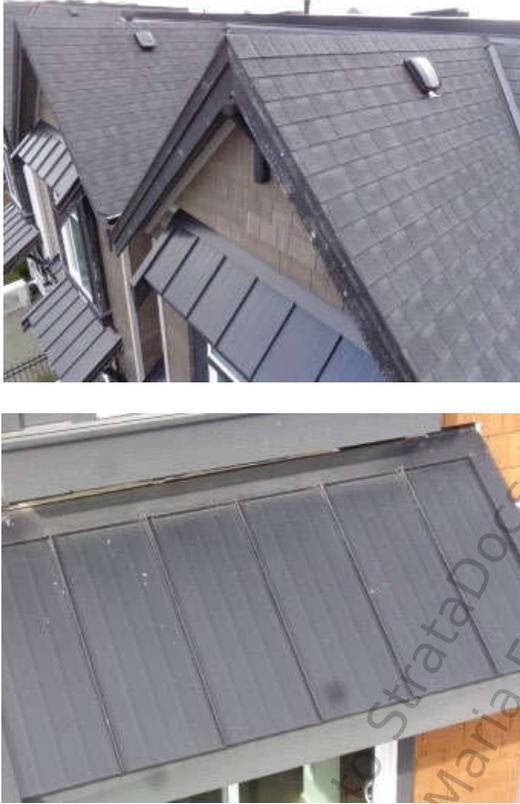
<p>Description Sloped standing seam metal roofs.</p> <p>Assessment The metal roofing appeared to be generally in good condition commensurate with its age. This type of roofing product would be expected to last 35 to 45 years and is highly dependent upon quality of metal, location, and maintenance.</p> <p>Priority 4 Building Functionality; cost effective and/or marketability upgrades.</p>
	<p>Expected Service Life 40 Years</p> <p>Present Equivalent Age 5 Years</p> <p>Estimated Remaining Life 35 Years</p>	<p>Note: The Remaining Service Life exceeds the 30 year time frame of this report.</p> <p style="text-align: right;">Estimated Budget NA</p>

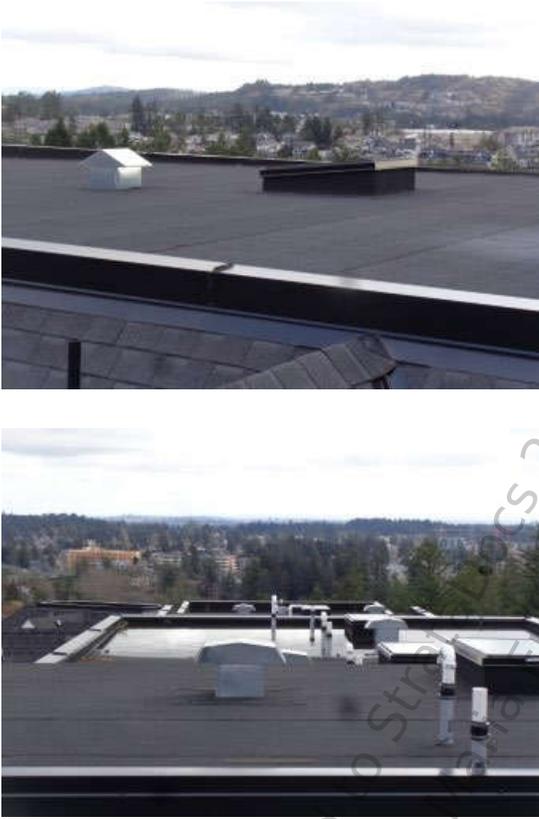
<p>Description Conventional two ply modified bitumen roofing.</p> <p>Assessment The roofing appeared to be generally in good condition commensurate with its age.</p> <p>However the roof was flooded at Units 61 - 64; there may be a plugged scupper drain or insufficient slope. The Strata has been notified in separate correspondence.</p> <p>This type of roofing product would be expected to last 20 to 30 years and is highly dependent upon quality of material, location, and maintenance. It may outlast the sloped asphalt shingles however consideration should be given to replacing both types of roofs concurrently on each building to reduce the amount and cost of rework if they are done at separate times.</p> <p>The Expected Service Life has been set assuming the sloped and low slope roofs will be done concurrently.</p> <p>Priority 4 Building Functionality; cost effective and/or marketability upgrades.</p>

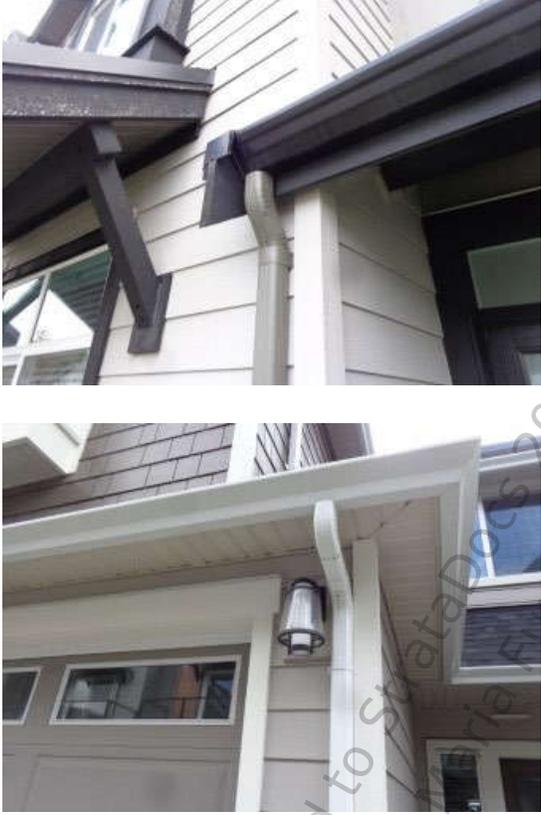
<p>Description Prefinished aluminum gutters and downspouts</p> <p>Assessment The gutters and downspouts appeared to be generally in good condition commensurate with their age.</p> <p>These would typically be replaced when replacing the roofing and the budget for replacement has been included in Item A2.01.</p> <p>Priority 4 Building Functionality; cost effective and/or marketability upgrades.</p>
	<p>Expected Service Life 25 Years</p> <p>Present Equivalent Age 5, 3, 2 Years</p> <p>Estimated Remaining Life 20, 22, 23 Years</p>	<p>Note: Estimated Budgets included in Item A2.01.</p> <p style="text-align: right;">Estimated Budget NA</p>

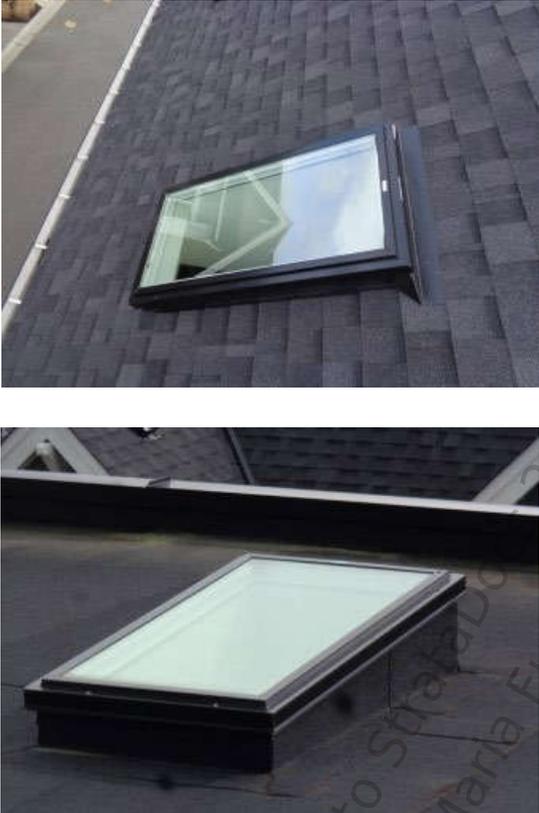
<p>Description Aluminum framed skylights in the sloped and low slope roofs.</p> <p>Assessment The skylights appeared to be generally in good condition commensurate with their age. It is assumed that these units would be replaced during the replacement of the roofing. The service life would be expected to be 20 to 30 years.</p> <p>Priority 4 Building Functionality; cost effective and/or marketability upgrades.</p>
	<p>Expected Service Life 25 Years Present Equivalent Age 5, 3, 2 Years Estimated Remaining Life 20, 22, 23 Years</p>	<p>Note: Estimated Budgets included in Items A2.01 and A2.03.</p> <p style="text-align: right;">Estimated Budget See Above</p>

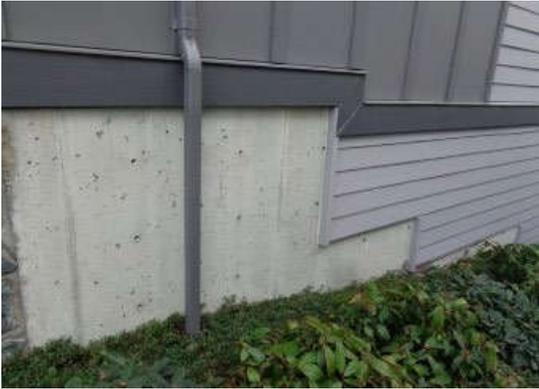
<p>Description Conventional wood frame construction atop cast-in-place concrete foundations.</p> <p>Assessment The base building structures were not assessed during the review as invasive investigation was not included. However no visual evidence of distress was noted and it is assumed that the structures are in good condition commensurate with their age.</p> <p>Priority 2 Structural Integrity</p>
	<p>Expected Service Life 75+ Years Present Equivalent Age 5, 3, 2 Years Estimated Remaining Life 70, 72, 73 Years</p>	<p>Note: The Remaining Service Life exceeds the 30 year time frame of this report.</p> <p style="text-align: right;">Estimated Budget NA</p>

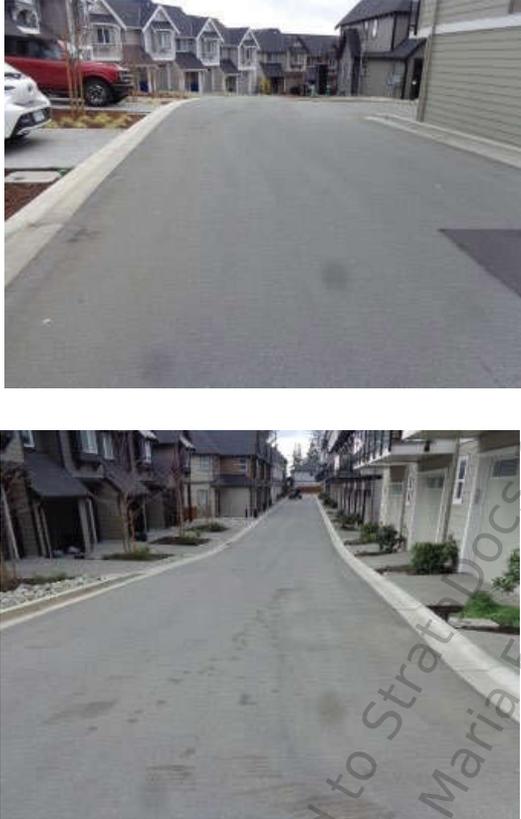
<p>Description Asphalt roadway (Moonstone Loop) and concrete curbs within the complex.</p> <p>Assessment The asphalt pavement and the concrete curbs appeared to be generally in good condition commensurate with their age.</p> <p>Priority 4 Building Functionality; cost effective and/or marketability upgrades.</p>
	<p>Expected Service Life 45 Years</p> <p>Present Equivalent Age 5 Years</p> <p>Estimated Remaining Life 40 Years</p>	<p>Note: The Remaining Service Life exceeds the 30 year time frame of this report.</p> <p style="text-align: right;">Estimated Budget NA</p>

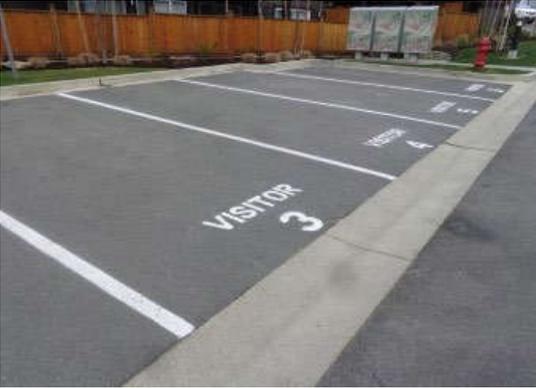
<p>Description Line painting at the visitor parking area.</p> <p>Assessment The line painting appeared to be generally in good condition.</p> <p>Priority 4 Building Functionality; cost effective and/or marketability upgrades.</p>
	<p>Expected Service Life 5 Years</p> <p>Present Equivalent Age 2 Years</p> <p>Estimated Remaining Life 3 Years</p>	<p>Note:</p> <p style="text-align: right;">Estimated Budget \$ 1,500</p>

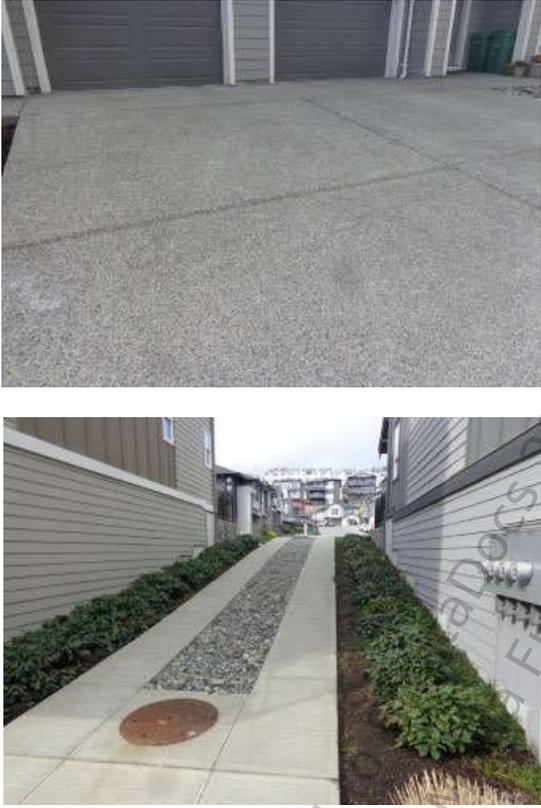
<p>Description Cast in place concrete driveways and walkways.</p> <p>Assessment The concrete driveways and walkways appeared to generally in good condition commensurate with their age.</p> <p>Priority 4 Building Functionality; cost effective and/or marketability upgrades.</p>
<p>Expected Service Life 45 Years Present Equivalent Age 5, 3, 2 Years Estimated Remaining Life 40, 42, 43 Years</p>		<p>Note: The Remaining Service Life exceeds the 30 year time frame of this report.</p>
		<p style="text-align: right;">Estimated Budget NA</p>

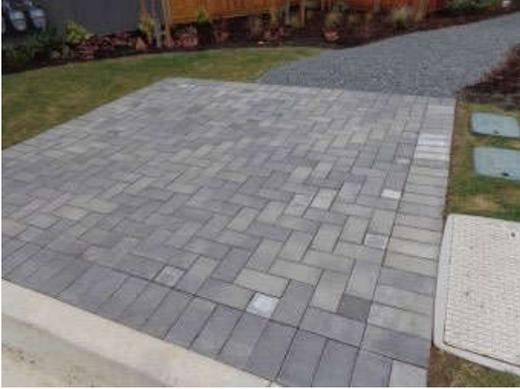
<p>Description Concrete pavers adjacent to the visitor parking area.</p> <p>Assessment The pavers appeared to be generally in good condition commensurate with their age.</p> <p>Priority 4 Building Functionality; cost effective and/or marketability upgrades.</p>
	<p>Expected Service Life 45 Years Present Equivalent Age 3 Years Estimated Remaining Life 42 Years</p>	<p>Note: The Remaining Service Life exceeds the 30 year time frame of this report.</p> <p style="text-align: right;">Estimated Budget NA</p>

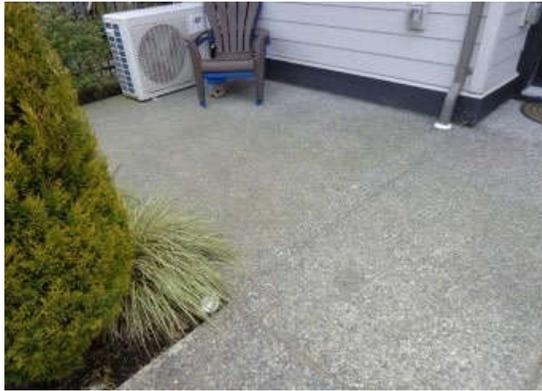
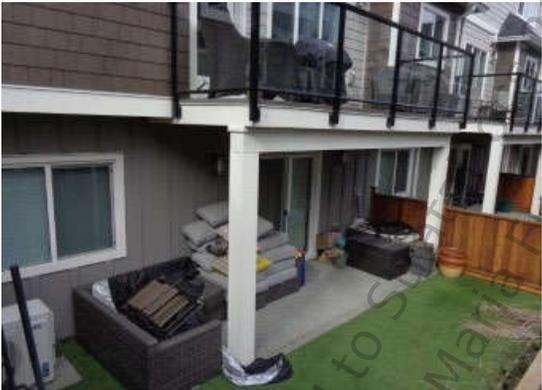
<p>Description Cast in place concrete patios; some at front of building and others at back.</p> <p>Assessment The concrete patios appeared to be generally in good condition commensurate with their age.</p> <p>Priority 4 Building Functionality; cost effective and/or marketability upgrades.</p>
	<p>Expected Service Life 45 Years</p> <p>Present Equivalent Age 5, 3, 2 Years</p> <p>Estimated Remaining Life 40, 42, 43 Years</p>	<p>Note: The Remaining Service Life exceeds the 30 year time frame of this report.</p> <p style="text-align: right;">Estimated Budget NA</p>

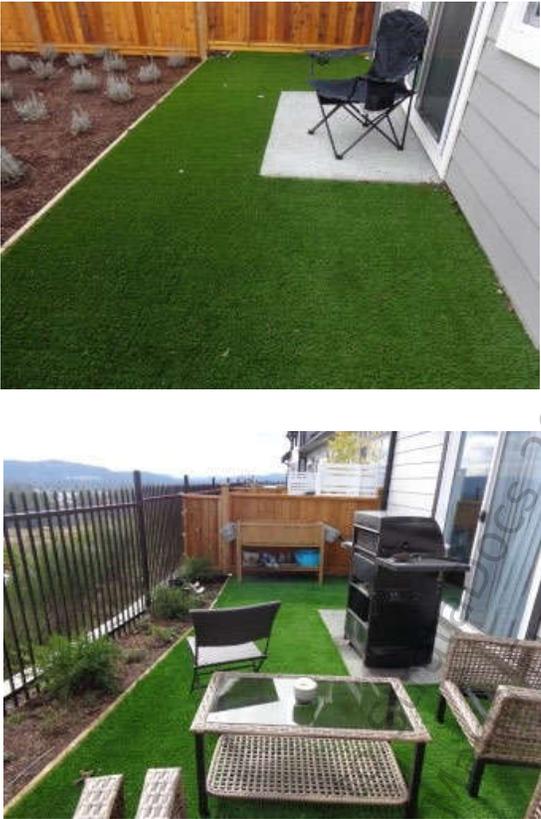
<p>Description Artificial turf installed in patio areas of Buildings comprised of Units 1 - 26 and 55 - 68.</p> <p>Assessment The turf appeared to be generally in good condition commensurate with its age.</p> <p>Priority 4 Building Functionality; cost effective and/or marketability upgrades.</p>
	<p>Expected Service Life 15 Years</p> <p>Present Equivalent Age 5, 3, 2 Years</p> <p>Estimated Remaining Life 10, 12, 13 Years</p>	<p>Note: Phase 1: Year 11: \$8,000 Phase 2: Year 13: \$9,000 Phase 3: Year 14: \$13,000</p> <p style="text-align: right;">Estimated Budget See Above</p>

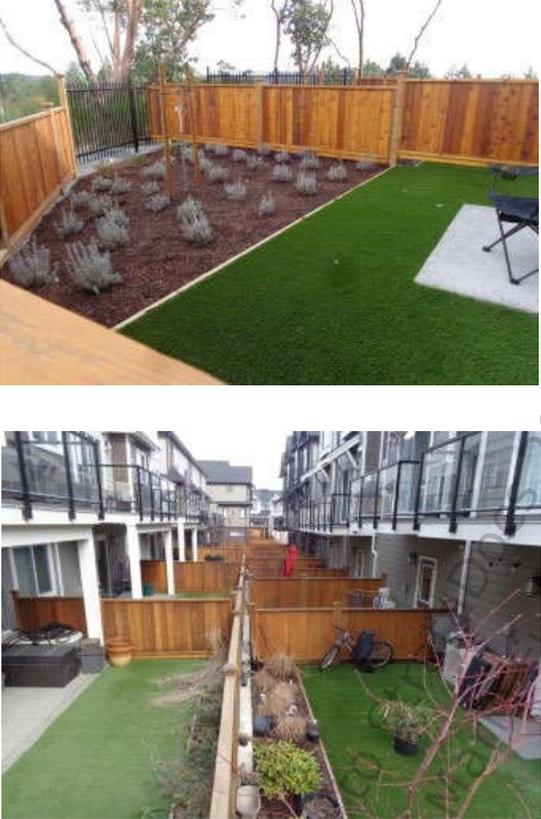
<p>Description Wood fencing at various locations for privacy.</p> <p>Assessment The stain on the fencing appeared to be generally in good condition. Renewals includes the staining. Rather than phase the work it would be more efficient to stain all the fencing at the same time.</p> <p>Priority 4 Building Functionality; cost effective and/or marketability upgrades.</p>
<p>Expected Service Life 10 Years Present Equivalent Age 2 Years Estimated Remaining Life 8 Years</p>		<p>Note:</p> <p style="text-align: right;">Estimated Budget \$ 25,000</p>

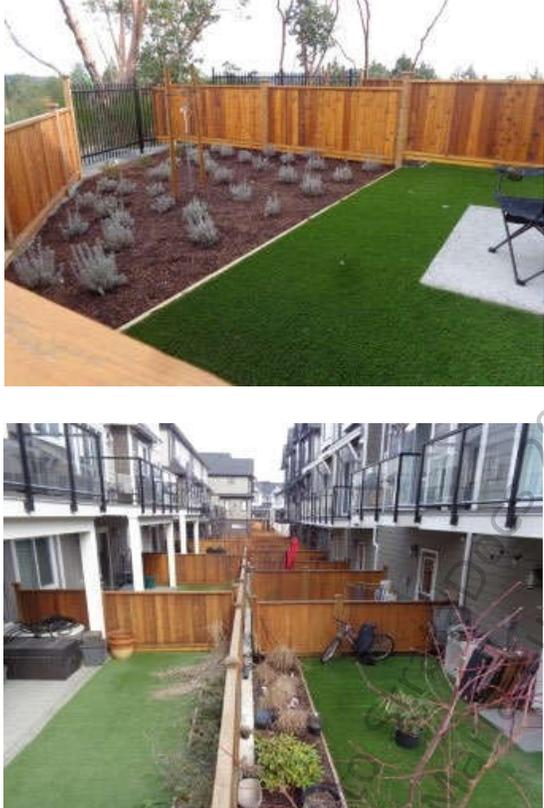
<p>Description Wood fencing at various locations for privacy.</p> <p>Assessment The fencing appeared to be generally in good condition commensurate with its age.</p> <p>Priority 4 Building Functionality; cost effective and/or marketability upgrades.</p>
<p>Expected Service Life 25 Years</p>		<p>Note:</p>
<p>Present Equivalent Age 5, 3, 2 Years</p>		<p>Phase 1: Year 21: \$7,000</p>
<p>Estimated Remaining Life 20, 22, 23 Years</p>		<p>Phase 2: Year 23: \$9,000</p>
		<p>Phase 3: Year 24: \$20,000</p> <p style="text-align: right;">Estimated Budget See Above</p>

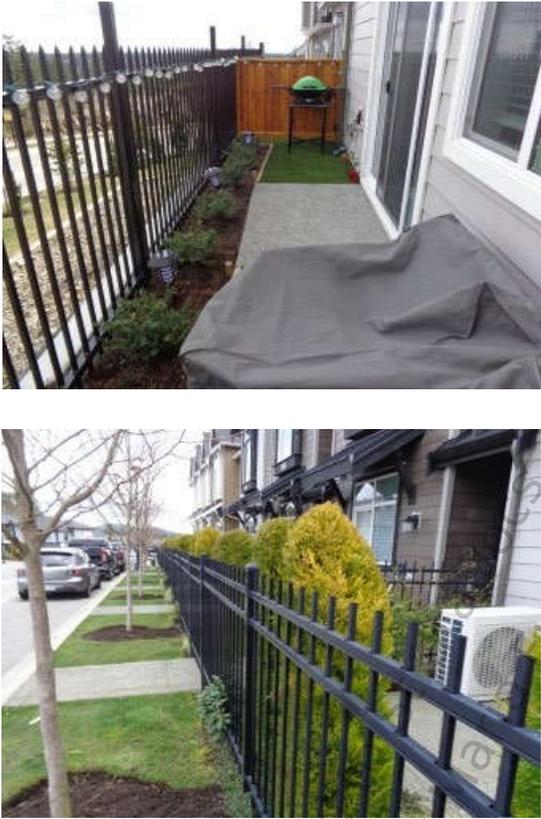
<p>Description Prefinished metal picket fencing along Bear Mountain Parkway and Flint Avenue.</p> <p>Assessment The fencing appeared to be generally in good condition commensurate with its age. On site refinishing is not typically required.</p> <p>Priority 4 Building Functionality; cost effective and/or marketability upgrades.</p>
	<p>Expected Service Life 40 Years Present Equivalent Age 5, 2 Years Estimated Remaining Life 35, 38 Years</p>	<p>Note: The Remaining Service Life exceeds the 30 year time frame of this report.</p> <p style="text-align: right;">Estimated Budget NA</p>

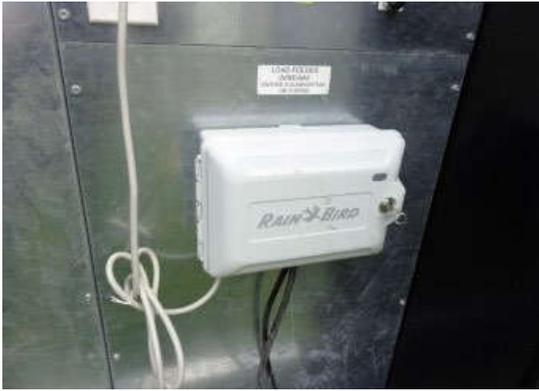
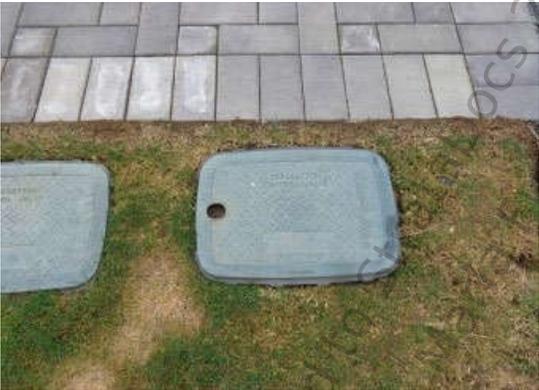
<p>Description Automatic underground irrigation system.</p> <p>Assessment Underground system is not visible and is presumed to be in a condition commensurate with its age.</p> <p>The complete system would typically not be replaced; rather components that fail are replaced on an as required basis.</p> <p>Priority 4 Building Functionality; cost effective and/or marketability upgrades.</p>
	<p>Expected Service Life 4 Years</p> <p>Present Equivalent Age 2 Years</p> <p>Estimated Remaining Life 2 Years</p>	<p>Note: A Budget of \$3,000 is suggested every 4 years to replace failed components. The Expected Life is set at 4 years to reflect the replacement schedule.</p> <p style="text-align: right;">Estimated Budget \$ 3,000</p>

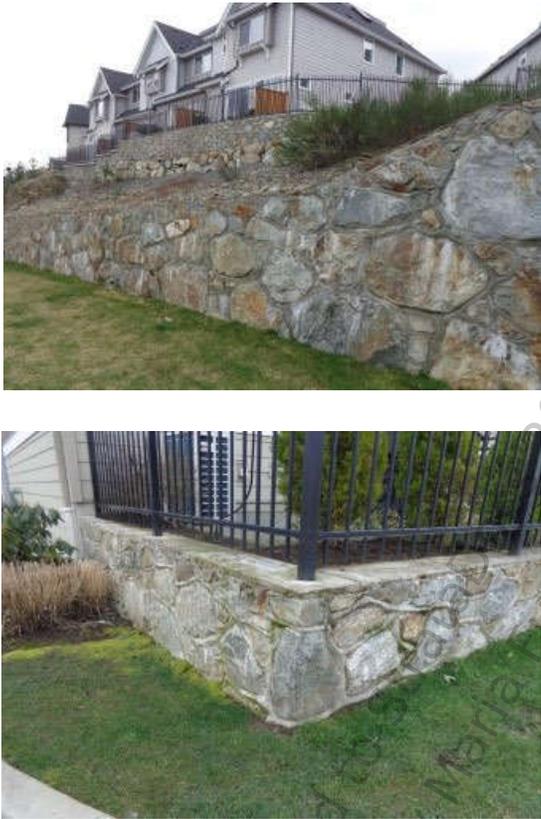
<p>Description Stacked rock retaining walls with mortar joints along Bear Mountain Parkway with shorter walls along Flint Avenue.</p> <p>Assessment The mortar joints in the retaining walls appeared to be generally in good condition. Renewals would include repointing and resetting of loose or dislodged rock as required.</p> <p>Priority 2 Structural Integrity</p>
	<p>Expected Service Life 15 Years Present Equivalent Age 0 Years Estimated Remaining Life 15 Years</p>	<p>Note: The Estimated Budget is for repointing every 15 years beginning in Year 16.</p> <p style="text-align: right;">Estimated Budget \$ 5,000</p>

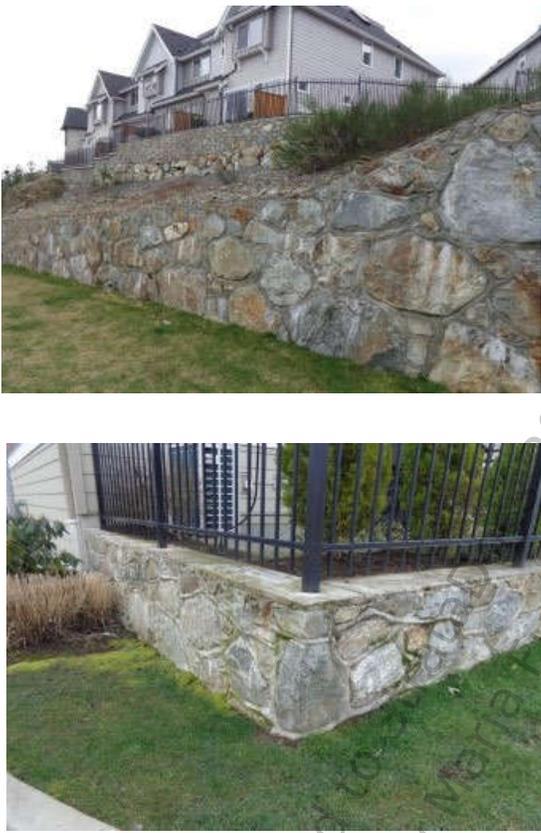
<p>Description Stacked rock retaining walls with mortar joints along Bear Mountain Parkway with shorter walls along Flint Avenue.</p> <p>Assessment The retaining walls appeared to be generally in good condition with no significant visible evidence of structural distress. With ongoing maintenance, complete replacement of the retaining walls would not be expected within the next 30 years.</p> <p>Priority 2 Structural Integrity</p>
	<p>Expected Service Life 65+ Years Present Equivalent Age 5 Years Estimated Remaining Life 60+ Years</p>	<p>Note: The Remaining Service Life exceeds the 30 year time frame of this report.</p> <p style="text-align: right;">Estimated Budget NA</p>
