Southpoint Ridge

Depreciation Report

1223 – 1261 Flint Ave; 1103 – 1228 Moonstone Loop, Langford, BC

RJC Engineers
1515 Douglas Street, Suite 330
Victoria BC V8W 2G4

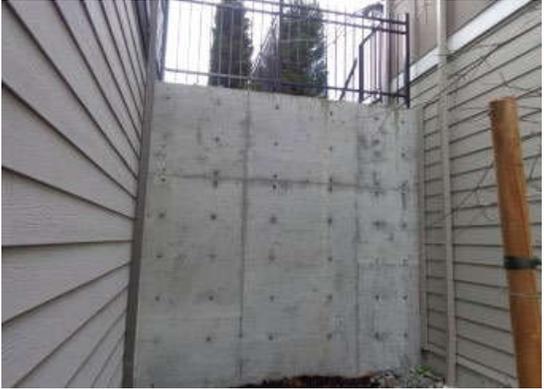
<p>Description Cast-in-place concrete retaining walls.</p> <p>Assessment Similar to the rock walls, the concrete retaining walls appeared to be generally in good condition with no significant visible evidence of structural distress</p> <p>Priority 2 Structural Integrity</p>
	<p>Expected Service Life 75+ Years</p> <p>Present Equivalent Age 2 Years</p> <p>Estimated Remaining Life 73+ Years</p>	<p>Note: The Remaining Service Life exceeds the 30 year time frame of this report.</p> <p style="text-align: right;">Estimated Budget NA</p>

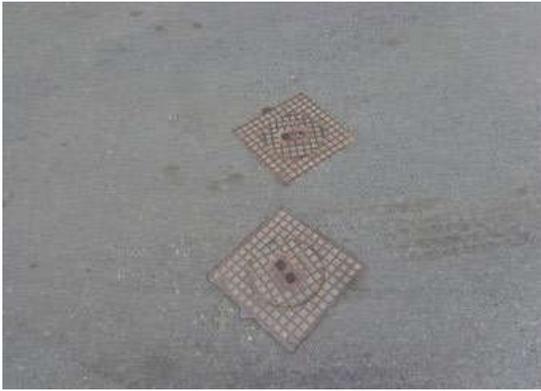
<p>Description</p> <p>Underground water mains supply the buildings and fire hydrants throughout the property. Piping is installed below hard surfaces and landscaped areas.</p> <p>The type of material is unknown and presumed to be plastic.</p> <p>Assessment</p> <p>Piping is underground and not visible for review. There was no indication from the Strata regarding any problems; therefore the system is estimated to be in good condition commensurate with its age.</p> <p>Priority</p> <p>4 Building Functionality; cost effective and/or marketability upgrades.</p>
	<p>Expected Service Life 60 Years</p> <p>Present Equivalent Age 5 Years</p> <p>Estimated Remaining Life 55 Years</p>	<p>Note:</p> <p>The Remaining Service Life exceeds the 30 year time frame of this report.</p> <p style="text-align: right;">Estimated Budget NA</p>

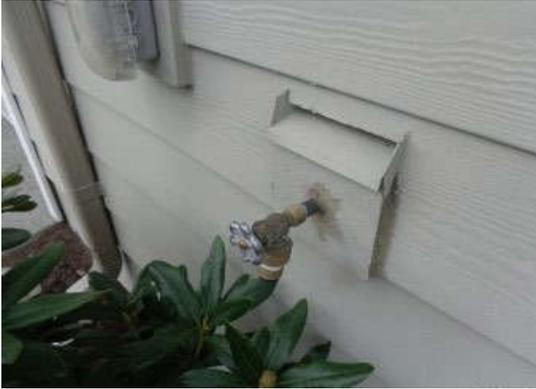
<p>Description Distribution lines run from the main to the various units where cold and hot water lines distribute water to the plumbing fixtures.</p> <p>Assessment The Strata has not reported a history of major problems. Therefore, the system is estimated to be in good condition.</p> <p>The layout of the distribution lines is unknown but is presumed to be a Strata responsibility.</p> <p>Priority 4 Building Functionality; cost effective and/or marketability upgrades.</p>
	<p>Expected Service Life 60 Years Present Equivalent Age 5, 3, 2 Years Estimated Remaining Life 55, 57, 58 Years</p>	<p>Note: The Remaining Service Life exceeds the 30 year time frame of this report.</p> <p style="text-align: right;">Estimated Budget See Above</p>

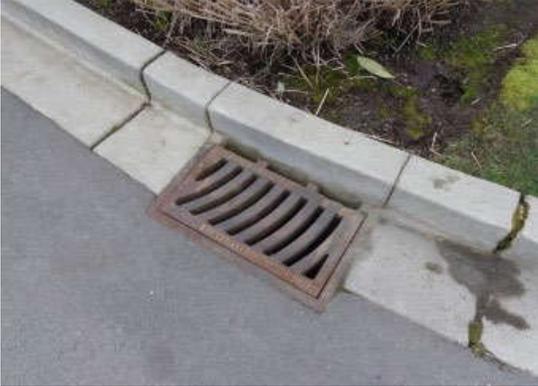
<p>Description Underground storm drains including perimeter drains at the buildings. Storm sewers collect storm water and discharge into the municipal system.</p> <p>Assessment Piping is underground and not visible for review. There was no indication from the Strata regarding any problems; therefore the system is estimated to be in good condition commensurate with its age.</p> <p>Video scoping of this system is recommended to provide an ongoing accurate assessment of its condition.</p> <p>Priority 4 Building Functionality; cost effective and/or marketability upgrades.</p>
	<p>Expected Service Life 65 Years Present Equivalent Age 5 Years Estimated Remaining Life 60 Years</p>	<p>Note: The Remaining Service Life exceeds the 30 year time frame of this report. Video scoping \$1,000 every 5 years beginning in Year 10. This would include the sanitary sewers Item M1.04.</p> <p style="text-align: right;">Estimated Budget NA</p>

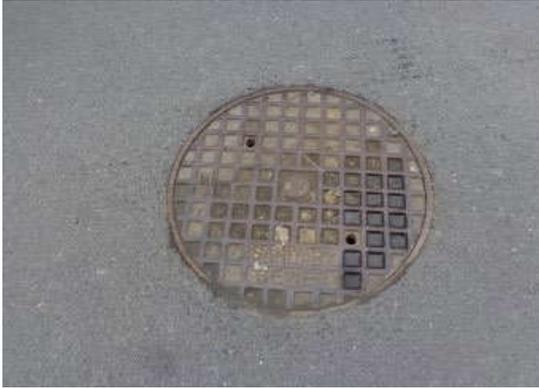
<p>Description Underground sanitary sewers collect wastewater from the buildings and discharge into the municipal system.</p> <p>Assessment Piping is underground and not visible for review. There was no indication from the Strata regarding any problems; therefore the system is estimated to be in good condition commensurate with its age.</p> <p>Similar to the storm drainage video scoping of this system is recommended to provide an ongoing accurate assessment of its condition.</p> <p>Priority 4 Building Functionality; cost effective and/or marketability upgrades.</p>
	<p>Expected Service Life 65 Years</p> <p>Present Equivalent Age 5 Years</p> <p>Estimated Remaining Life 60 Years</p>	<p>Note: The Remaining Service Life exceeds the 30 year time frame of this report. Video scoping included with Item M1.03.</p> <p style="text-align: right;">Estimated Budget NA</p>

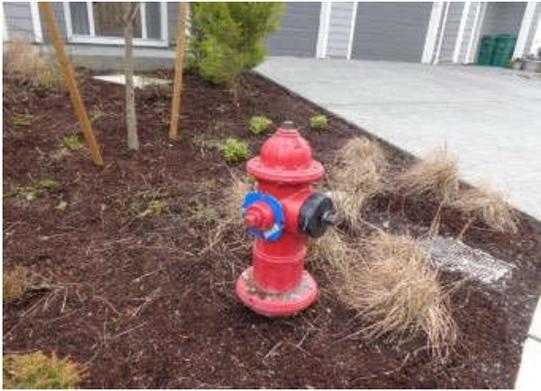
<p>Description Hydrants are fed from a separate water line from the street.</p> <p>Assessment The fire hydrant is presumed to be in good condition commensurate with its age.</p> <p>Priority 4 Building Functionality; cost effective and/or marketability upgrades.</p>
	<p>Expected Service Life 60 Years</p> <p>Present Equivalent Age 5 Years</p> <p>Estimated Remaining Life 55 Years</p>	<p>Note: The Remaining Service Life exceeds the 30 year time frame of this report.</p> <p style="text-align: right;">Estimated Budget NA</p>

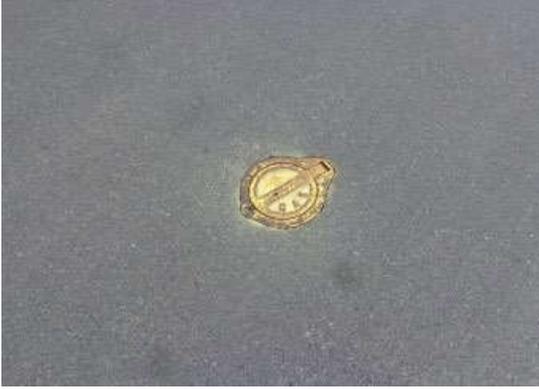
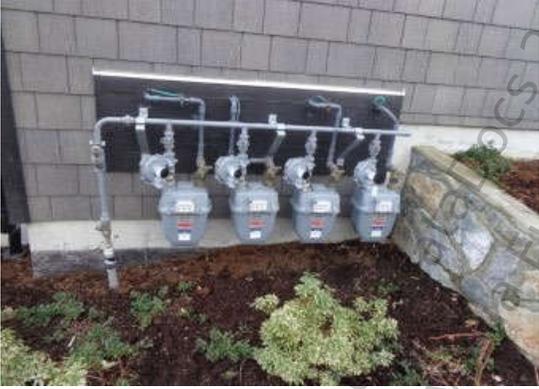
<p>Description Gas piping and meters.</p> <p>Assessment These components are typically the property of the utility.</p> <p>Priority 4 Building Functionality; cost effective and/or marketability upgrades.</p>
	<p>Expected Service Life NA Years</p> <p>Present Equivalent Age NA Years</p> <p>Estimated Remaining Life NA Years</p>	<p>Note:</p> <p style="text-align: right;">Estimated Budget NA</p>

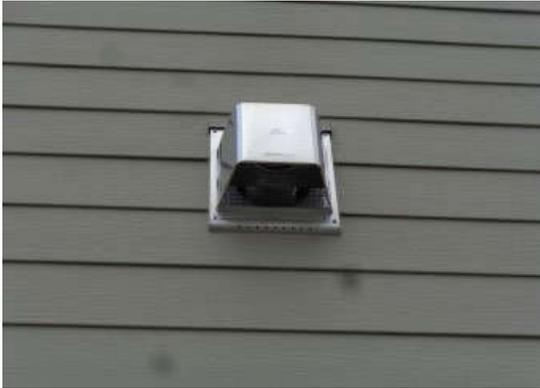
<p>Description Wall mounted direct vents for the fireplaces.</p> <p>Assessment The vents appeared to be generally in good condition commensurate with heir age. The vents should be inspected annually to ensure safe operation.</p> <p>Priority 4 Building Functionality; cost effective and/or marketability upgrades.</p>
	<p>Expected Service Life 30 Years Present Equivalent Age 5, 3, 2 Years Estimated Remaining Life 25, 27, 28 Years</p>	<p>Note: Phase 1 - Year 26: \$20,000 Phase 2 - Year 28: \$15,000 Phase 3 - Year 29: \$17,000</p> <p style="text-align: right;">Estimated Budget See Above</p>

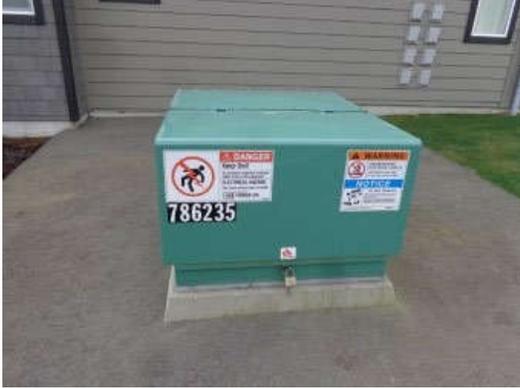
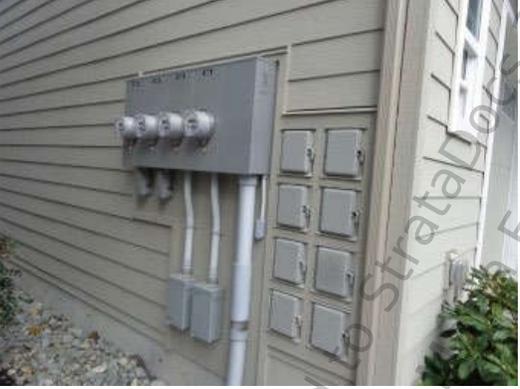
<p>Description</p> <p>There is no central electrical room. There are transformers on the property along with wall mounted meters for individual units.</p> <p>The house meter is located in the metal enclosure.</p> <p>Assessment</p> <p>The transformers and meters are owned and maintained by BC Hydro.</p> <p>Priority</p> <p>4 Building Functionality; cost effective and/or marketability upgrades.</p>
	<p>Expected Service Life NA Years</p> <p>Present Equivalent Age NA Years</p> <p>Estimated Remaining Life NA Years</p>	<p>Note:</p> <p style="text-align: right;">Estimated Budget NA</p>

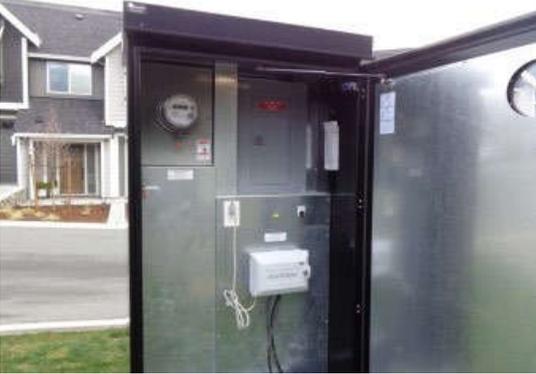
<p>Description 120/240 volt house panel is located in the metal enclosure.</p> <p>Assessment The metal enclosure appeared to be generally in good condition commensurate with its age. The house panel is presumed to be in good condition commensurate with its age.</p> <p>Priority 4 Building Functionality; cost effective and/or marketability upgrades.</p>
	<p>Expected Service Life 45 Years Present Equivalent Age 5 Years Estimated Remaining Life 40 Years</p>	<p>Note: The Remaining Service Life exceeds the 30 year time frame of this report.</p> <p style="text-align: right;">Estimated Budget NA</p>

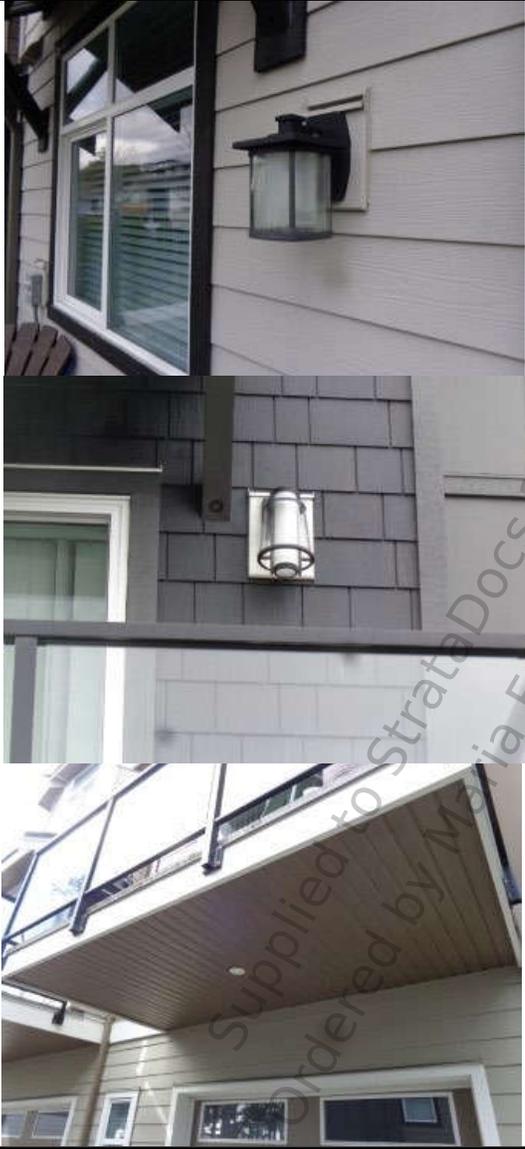
<p>Description Wall and soffit mounted fixtures.</p> <p>Assessment The light fixtures appeared to be generally in good condition commensurate with their age.</p> <p>Priority 4 Building Functionality; cost effective and/or marketability upgrades.</p>
	<p>Expected Service Life 25 Years</p> <p>Present Equivalent Age 5, 3, 2 Years</p> <p>Estimated Remaining Life 20, 22, 23 Years</p>	<p>Note: Phase 1 - Year 21: \$39,000 Phase 2 - Year 23: \$30,000 Phase 3 - Year 24: \$33,000</p> <p style="text-align: right;">Estimated Budget See Above</p>

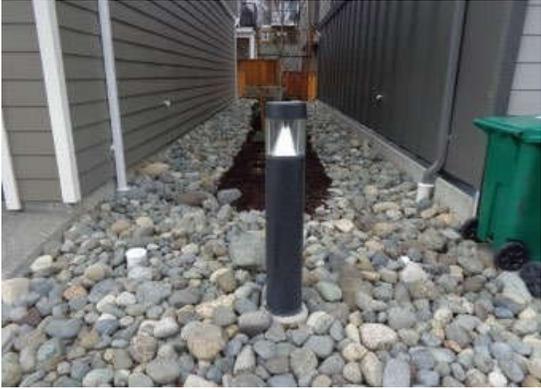
<p>Description Short bollard style landscape fixtures.</p> <p>Assessment The light fixtures appeared to be generally in good condition commensurate with their age.</p> <p>Priority 4 Building Functionality; cost effective and/or marketability upgrades.</p>
	<p>Expected Service Life 20 Years</p> <p>Present Equivalent Age 5 Years</p> <p>Estimated Remaining Life 15 Years</p>	<p>Note:</p> <p style="text-align: right;">Estimated Budget \$ 6,000</p>
