Depreciation & Reserve Fund Study Consultation Appraisal Report

Strata Plan VIS 1166

3215 / 3225 Alder Street
Victoria BC, V8X 1P3

as of fiscal year start date: January 1, 2020

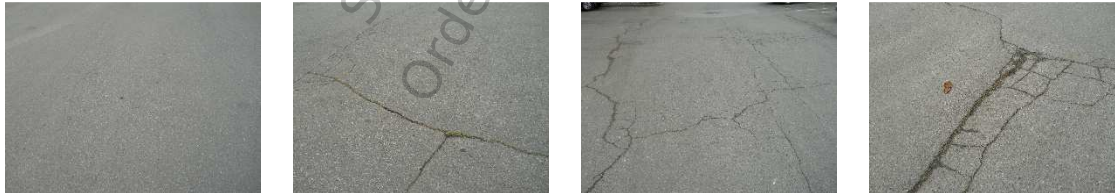
Asphalt paving shows to be in generally average condition however some cracks were noted in locations. These should be filled / repaired to prevent further deterioration.

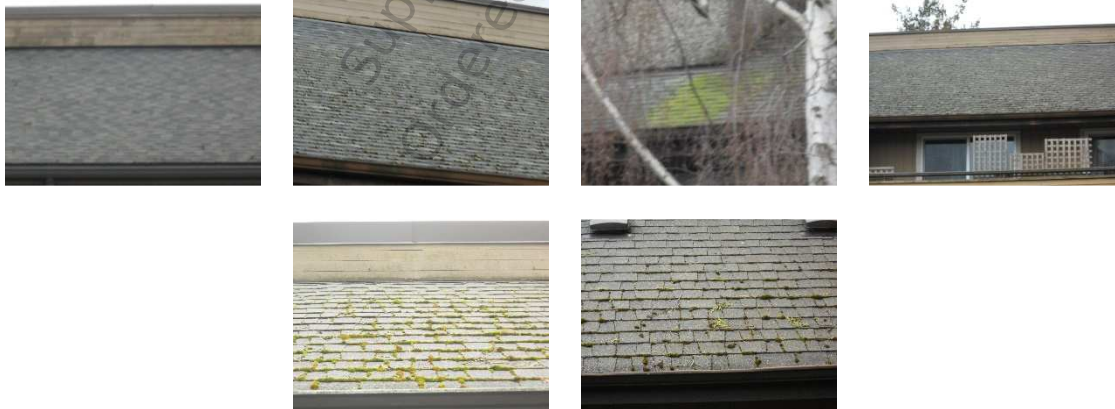
None visually noted at the time of inspection or advised of by the strata corporation however sections of the roof require de-mossing. Please note that both torch-on membrane roofing and composite shingle roofing have been estimated / timed for replacement at the same time on both buildings in order to achieve economies of scale.

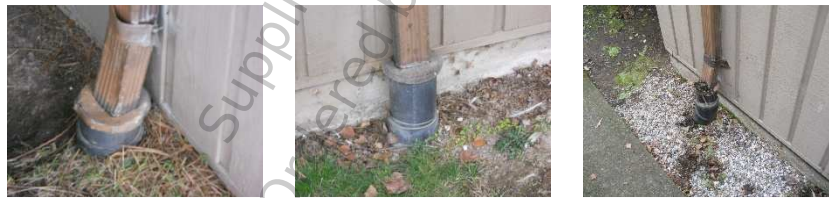
None visually noted at the time of inspection or advised of by the strata corporation. If not done recently, the perimeter drain system should be inspected with a camera system and then every 5 – 10 years to ensure the lines are not damaged or obstructed.

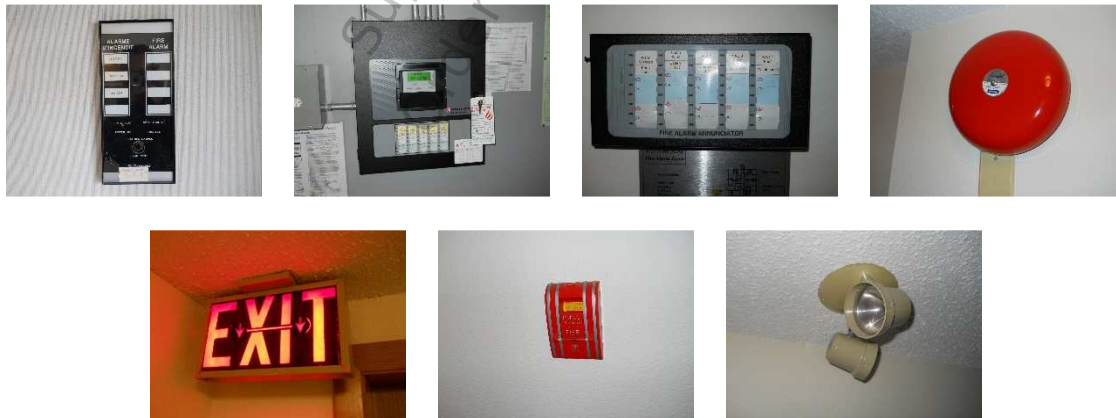
None visually noted at the time of inspection or advised of by the strata corporation however the 3-zone system may require updating within a few years.
