# Inch by Inch inspections inc Home Inspection Report

703 Annette St, Toronto, Ontario

> Date of Inspection: 9/22/2021 Age of Home: 100+ Size: 1500 Weather: Raining

Inspector: Tony Muscat Certified Master Inspector

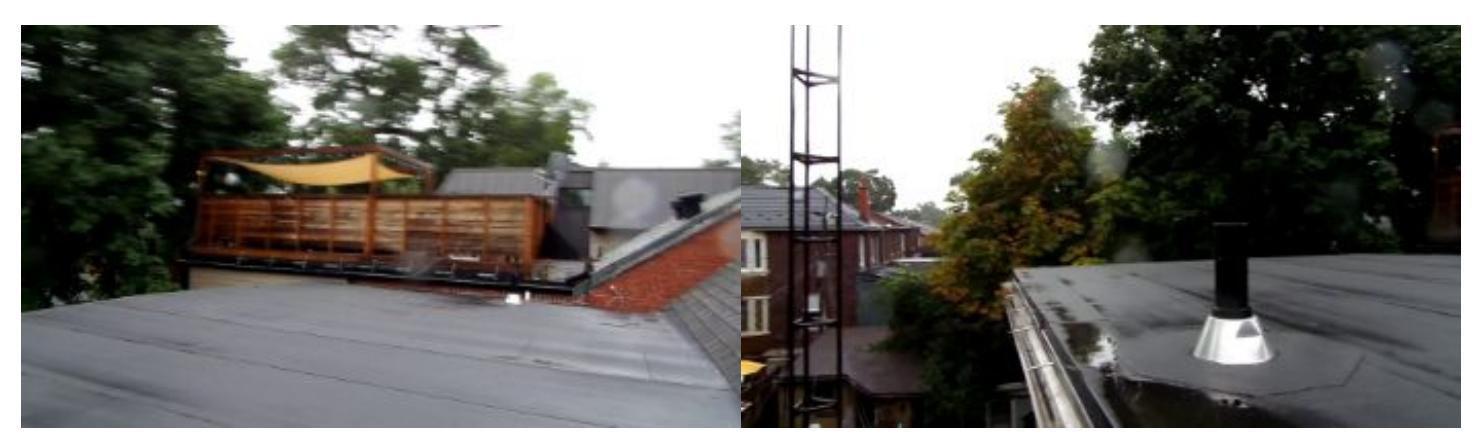
()Good at time of inspection in visible areas only. ()Good at time of inspection in visible areas only.

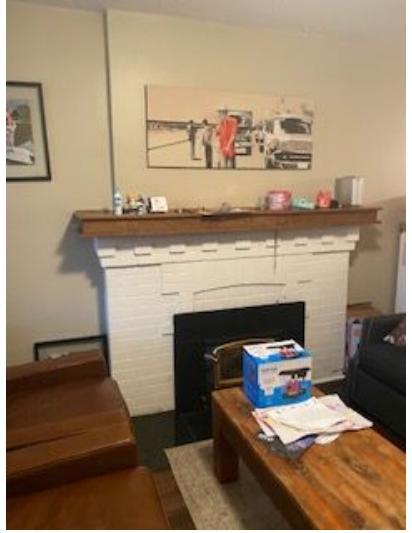
Observations: • ()WETT,A wood- burning fireplace or wood stove is noted in this home. Please be advised that this item may only be lawfully inspected by a WETT certified contractor and then, only after a thorough cleaning. It is strongly suggested that this fireplace and chimney be cleaned and inspected before close or use. Consult a qualified contractor for current standards.

()WETT,A wood- burning fireplace or wood stove is noted in this home. Please be advised that this item may only be lawfully inspected by a WETT certified contractor and then, only after a thorough cleaning. It is strongly suggested that this fireplace and chimney be cleaned and inspected before close or use. Consult a qualified contractor for current standards.

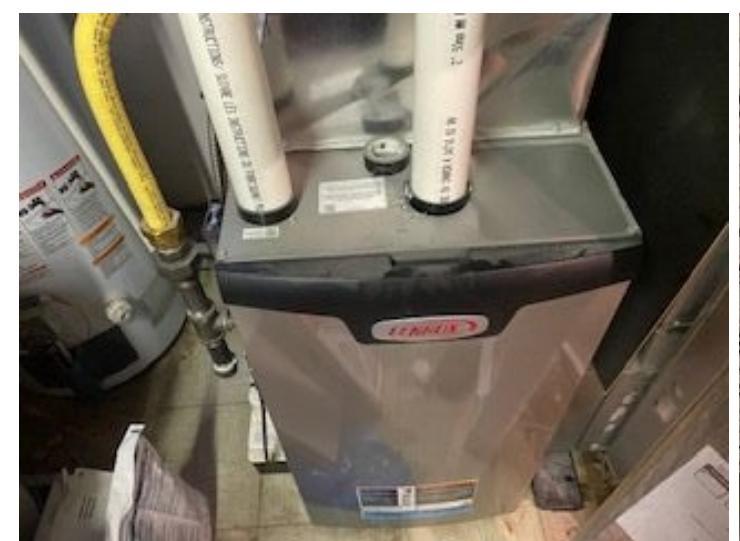
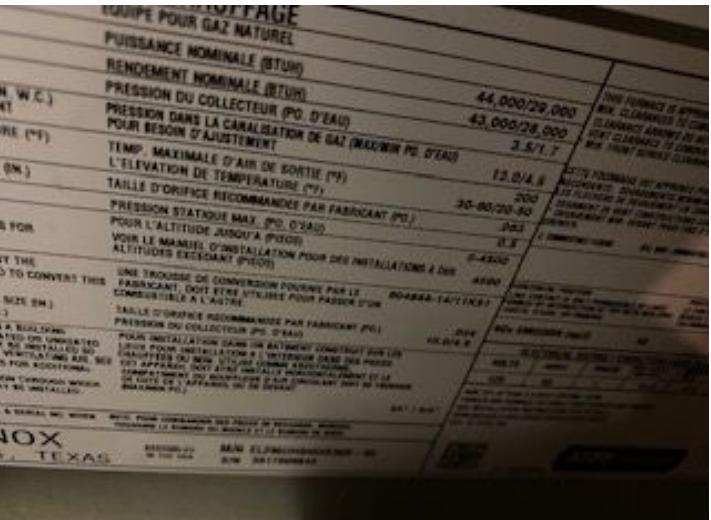
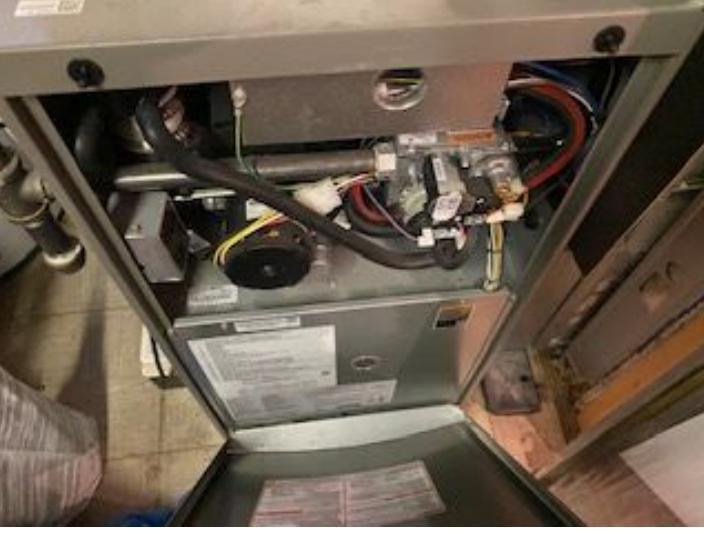
- 2. Burner Chamber Comments
  - NI Rev None Observations:

• ()Annual preventive maintenance is recommended.

()Annual preventive maintenance is recommended.

# ()Annual preventive maintenance is recommended.

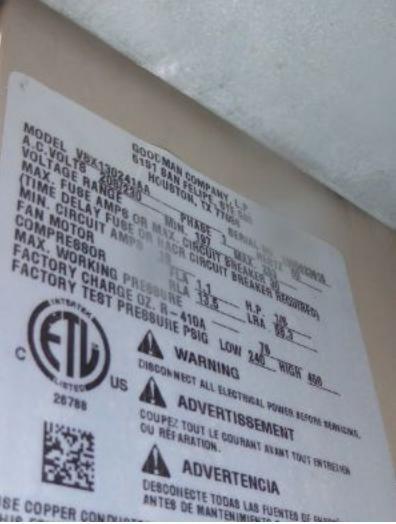
1. Air	Conditioning	Comments
	•

• ()Air condition is working at time of inspection unless noted.

()Air condition is working at time of inspection unless noted.

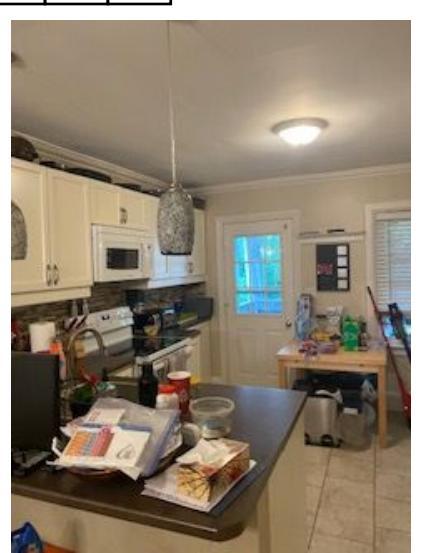
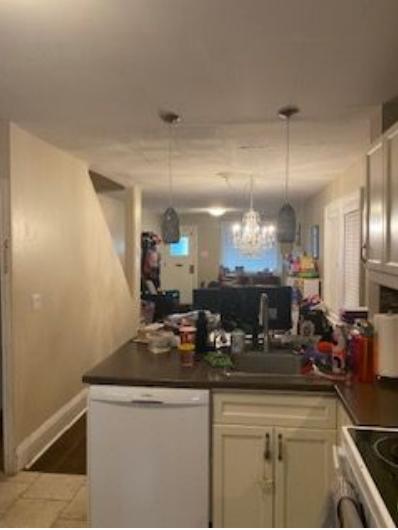
# 3. Ceiling Conditions

• ()Dry at the time of the inspection in visible areas only unless noted.

()Dry at the time of the inspection in visible areas ()Dry at the time of the inspection in visible areas only unless noted.
