Project No. 5150336.00  
**FINAL REVISED** Report

## 551/555 Chatham Street Depreciation Report

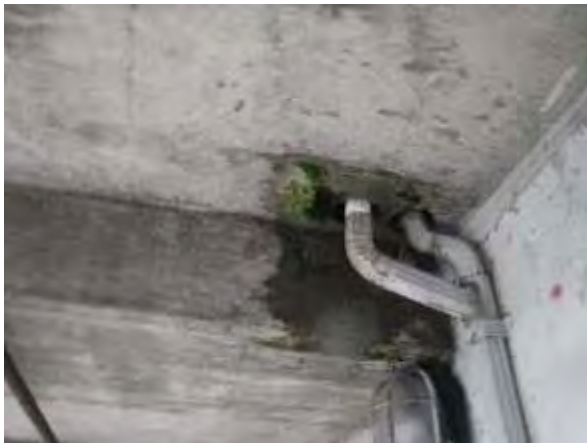
5 – Water leaking over light fixture

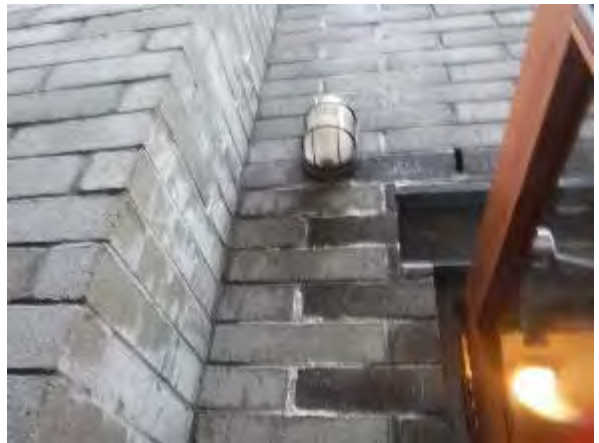
6 – Brick Cladding - Efflorescence

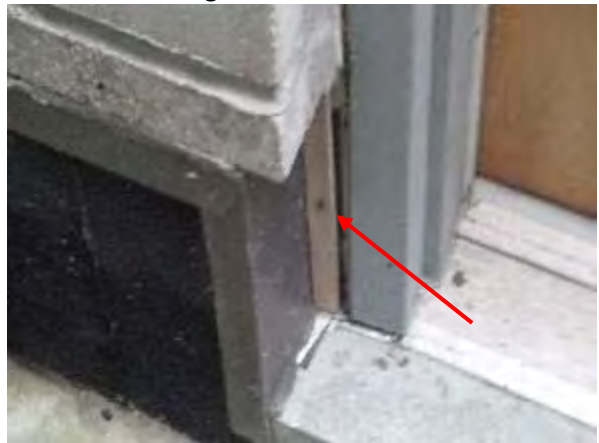
6 – Brick Cladding – Cladding missing at base of wall.

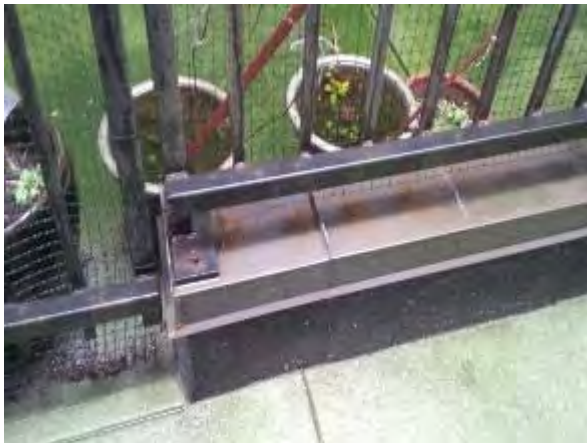
8– Railing repainting- rust noted on rails.

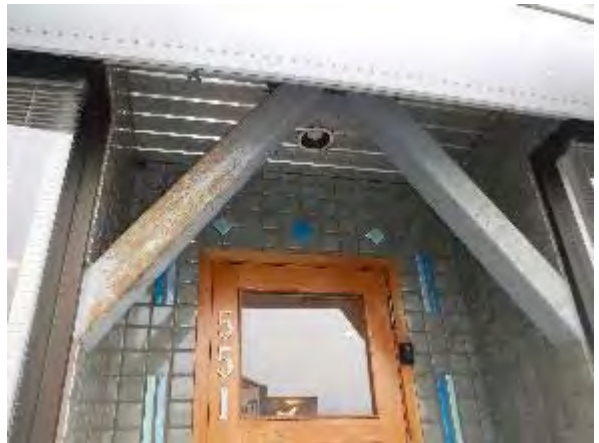
12–Exterior Coatings- metal structural supports

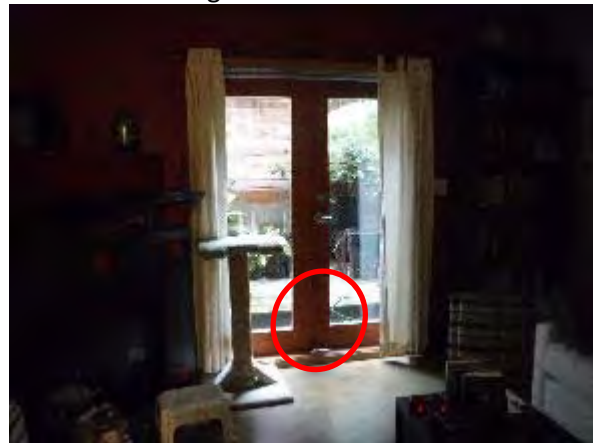
17-Gap noted under door from interior of unit 103

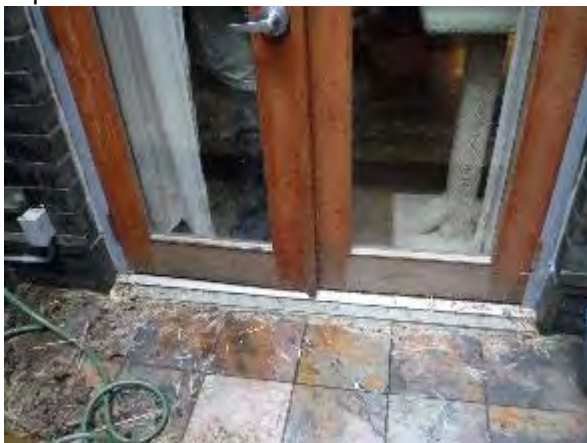
18- Wood finishes on double swing doors

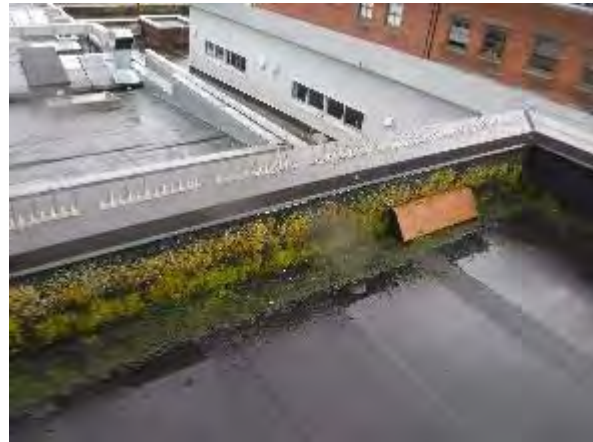
25-Areas of moss growth on SBS membrane at roof. Loose objects on roof.

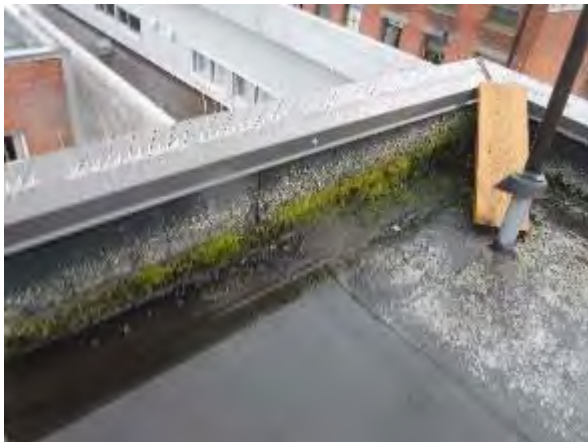
25-Areas of moss and lichen growth on SBS membrane at roof. Loose objects on roof.

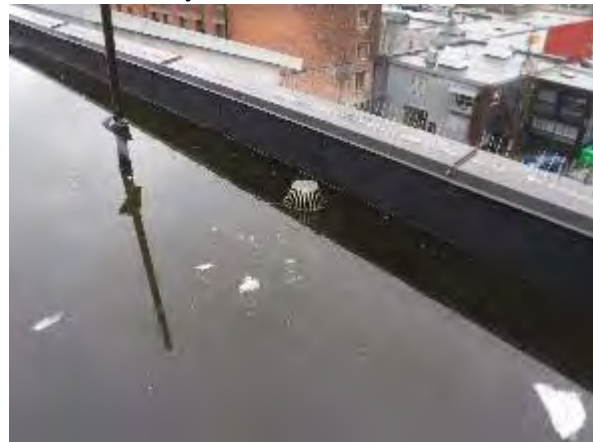
25- Pooling on roof due to blocked drain.

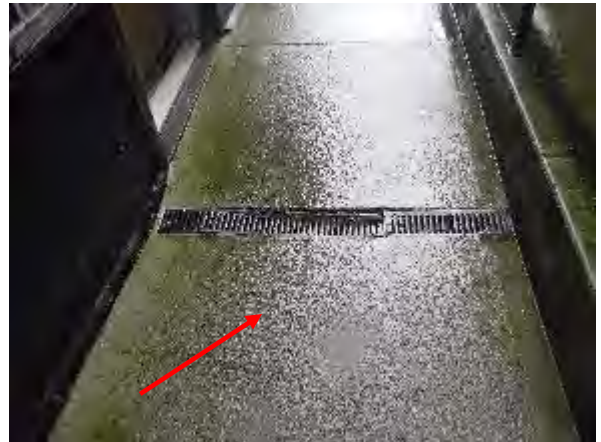
53 – California grate requiring repair

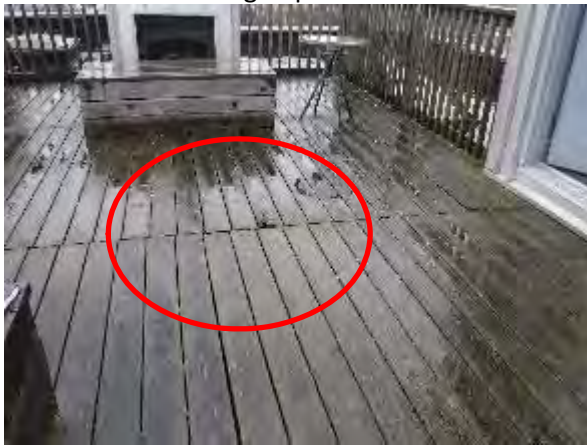
57 – Exterior wood decks -repair
