# Inspection Report

**Property Address:**  
456 Settlers Ridge  
Peterborough

**Paul Galvin Residential Home Inspections**

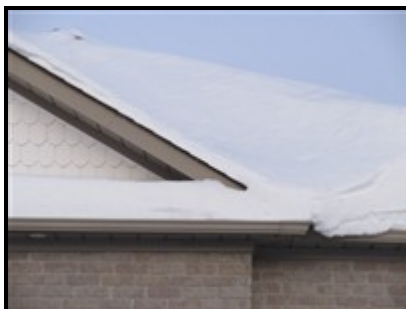
1.0 Picture 1

The entire roof surface appears to be asphalt shingles. The roof was snow covered at the time of the inspection. Therefore no exact comment can be made on it's condition or life expectancy.

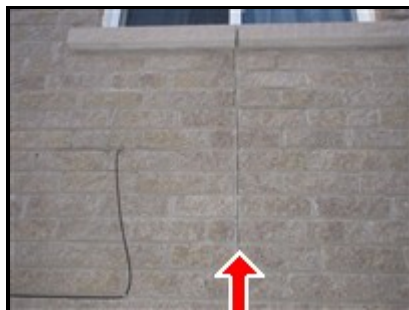
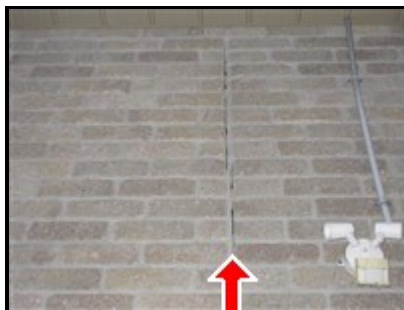
2.0 Picture 1

(1) The entire wall surfaces are brick. The brick is in good overall condition for the age and installed well. There were no signs of any unusual damage or wear.

(2) There is a vertical expansion joint half way down both side walls. This joint was installed when the brick was installed during construction. This is not a structural concern. It would be a good idea to seal these joints with some caulking.

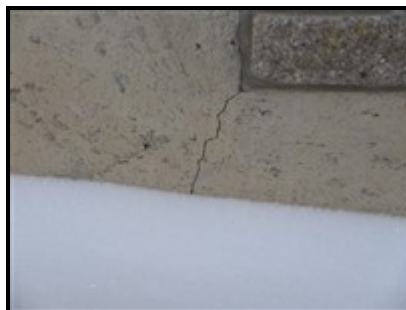
2.1 Picture 1

There are a couple very minor exterior foundation cracks. These are quite typical and not a structural concern.

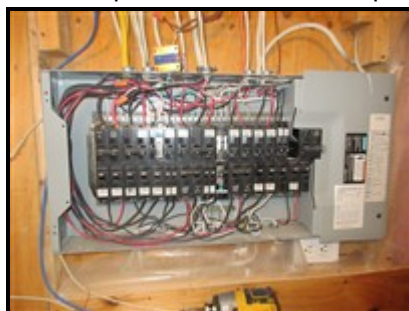
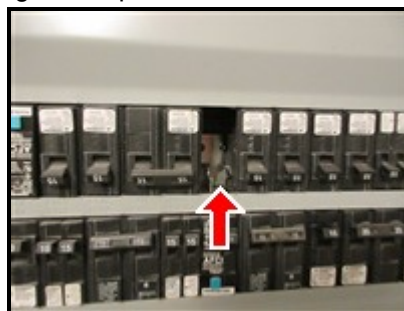
5.2 Picture 1

The main electrical panel was inspected and found to be installed properly and wired correctly. All of the proper sized breakers were present. There is an opening on the panel cover which should be covered.

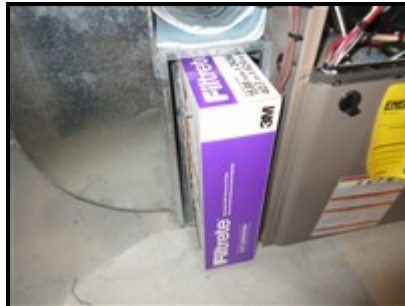
6.0 Picture 1

(1) The furnace was tested and inspected and found to be installed properly and working well. All the necessary safety features were present.

(2) The furnace filter should be changed on a regular basis.

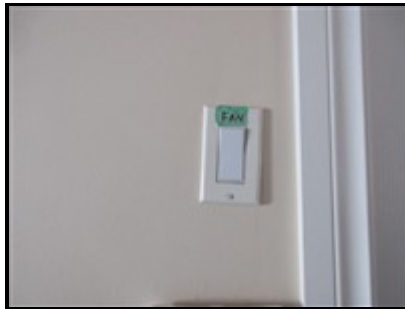
6.10 Picture 1

(1) The heat recovery ventilator located in the basement is a mechanical device that exchanges stale indoor air with fresh outdoor air. Heat is transferred from the outgoing air to incoming fresh air by passing the two air streams through a heat exchange core. Stale air is removed from the bathrooms and kitchen and then fresh air is delivered into the cold air return which then circulates through the house. This device controls air quality and condensation levels in a well sealed house. This is controlled by switches in the hallway, bathrooms and kitchen.

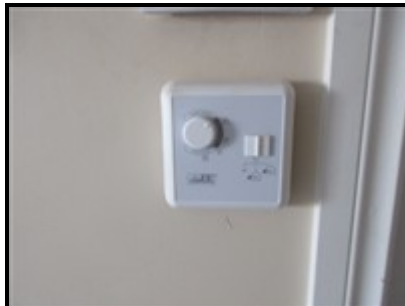
6.10 Picture 2

(2) There is a humidistat in the hallway by the thermostat. This would typically be installed to control the heat recovery ventilator. However this did not appear to be controlling the HRV. This can be checked at your next heating service and wired in if desired.

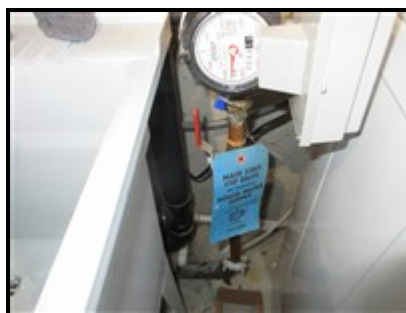
7.4 Picture 1

Basement beside the laundry.

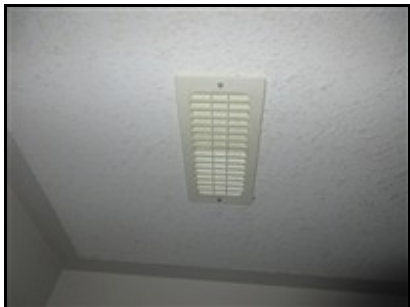
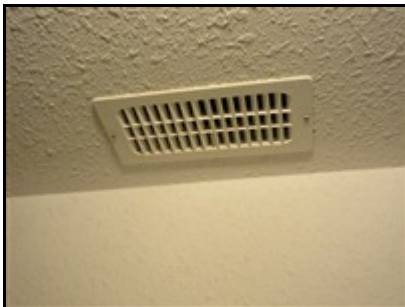
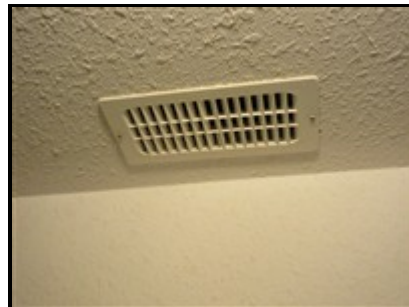
7.11 Picture 1

The outside taps should be shut off and drained before winter. These are located above plastic heating type vents in the basement ceiling.

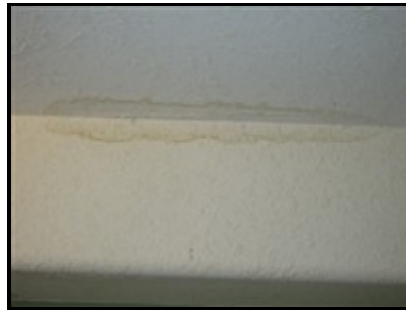
8.1 Picture 1

There is a slight older water stain on the basement ceiling. This is likely from a past plumbing leak from the bathroom above. This did not appear to be a recent concern.

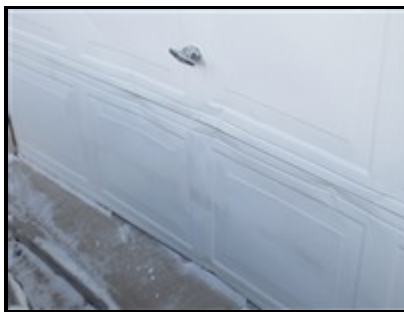
9.4 Picture 1

The left garage door is damaged / dented.

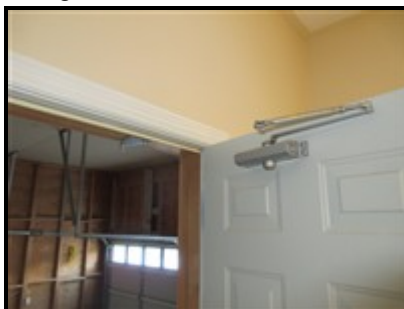
9.5 Picture 1

The self closing device on the door from the garage to the house has been disconnected. This should be reconnected to ensure proper gas proofing.
