Inspection Report

Property Address:
628 Heritage Trail
Peterborough

Paul Galvin Residential Home Inspections

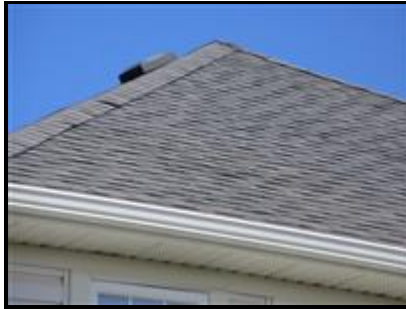
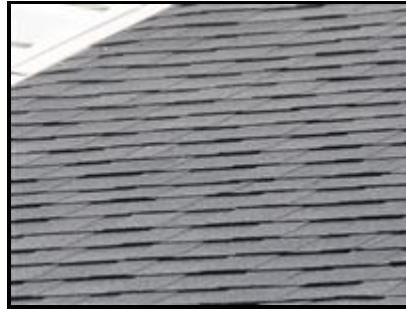
1.0 Picture 1

The entire roof surface is asphalt shingles. The shingles appear to be in good overall condition. They are installed well with all of the necessary caps and flashings.

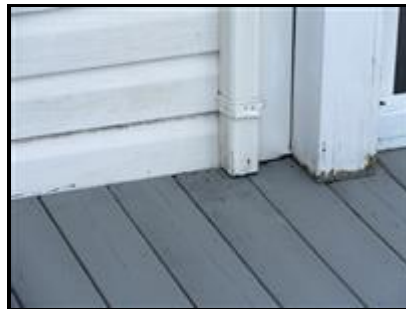
1.3 Picture 1

The downspout at the back of the house by the back door is draining right against the deck. I would recommend adding an extension here to drain well away from the house.

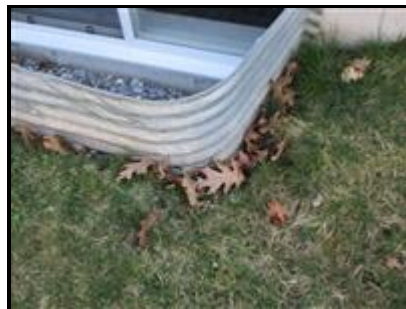
2.5 Picture 1

The grading is a little low at a basement window well. I would recommend raising the grade to ensure a positive slope away.

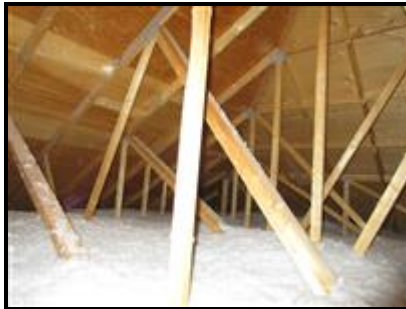
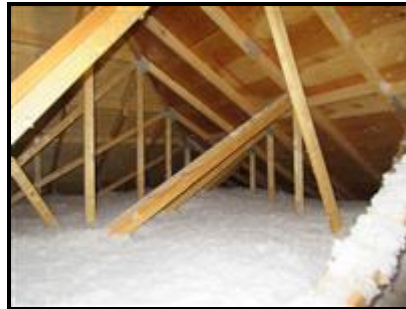
4.0 Picture 1

The attic contains blown in fiberglass insulation. This insulation appears to be well placed and installed in adequate amounts.

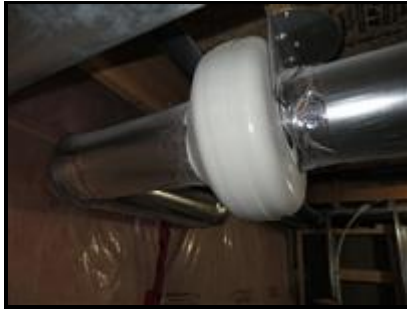
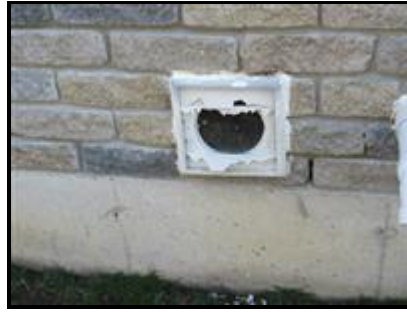
4.5 Picture 1

There is an exhaust fan in the basement which draws from each of the bathrooms and kitchen to vent moisture and odors outside. This is controlled by a switch in each of these rooms as well as a master switch in the hallway above the thermostat. The outside vent cover for this fan is deteriorated. This should be replaced.

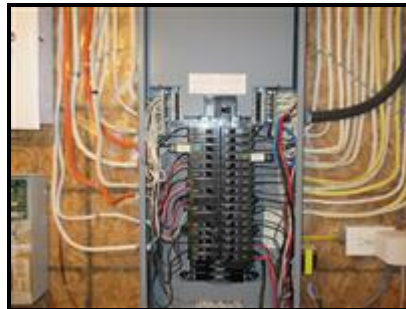
5.2 Picture 1

The main electrical panel was inspected and found to be installed properly and wired correctly. All of the proper sized breakers were present.

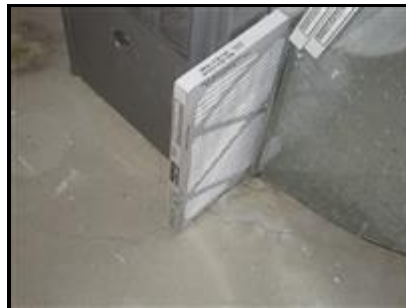
6.0 Picture 1

(1) The furnace was tested and inspected and found to be installed properly and working well. All the necessary safety features were present.

(2) The furnace filter should be changed on a regular basis.

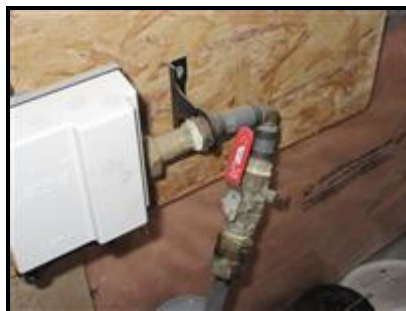
7.4 Picture 1

Front wall of basement.

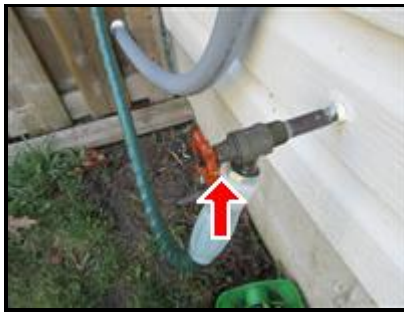
7.12 Picture 3

(2) The outside tap at the left side was leaking at the handle. A new seal / gasket will be needed.

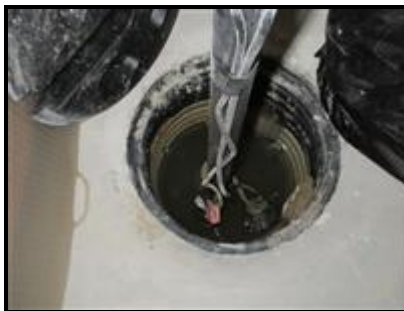
7.13 Picture 1

The sump pump should be tested on a regular basis to ensure its proper operation.

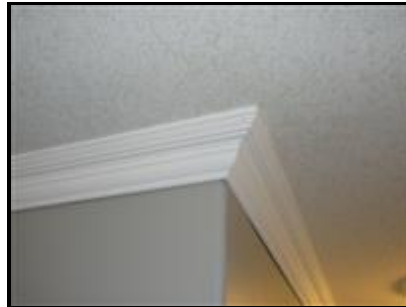
8.1 Picture 1

I understand from the present owner that there has been some slight truss uplift in the master bedroom. This is quite common where the ceiling lifts slightly one season and drops back down in the opposite season. This is quite common and not a structural concern. The present owner has installed some crown moulding and only nailed it to the ceiling. This can then slide up and down very slightly to cover the cracked drywall tape.

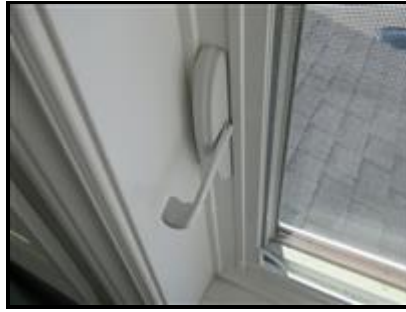
8.7 Picture 1

(1) One of the locks on a front bedroom window would not latch all the way.

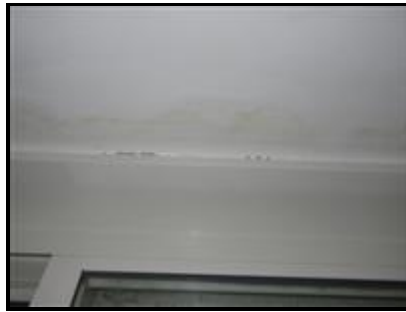
8.7 Picture 2

(2) There appears to have been some slight past seepage above a back basement window. I understand that the caulking outside had failed. The present owner has since recaulked. This should be monitored and kept well caulked.
