Inspection Report

Property Address:
96 Village Cres.
Peterborough

Paul Galvin Residential Home Inspections

Date: 2025-06-10	Time:	Report ID:
Property: 96 Village Cres. Peterborough	Customer: Tom Sangster	Real Estate Professional: Tom Sangster Royal LePage

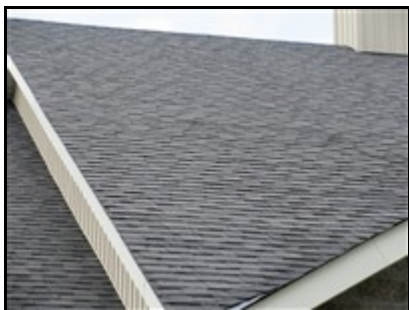
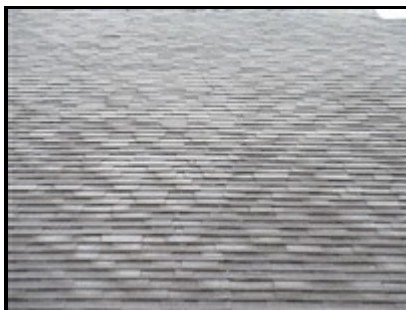
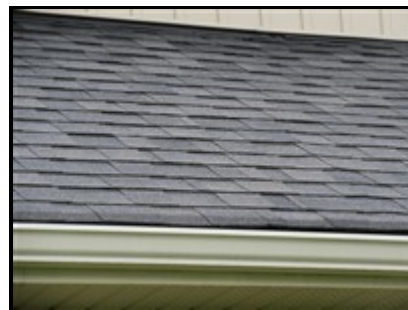
1.0 Picture 1

The entire roof surface is asphalt shingles. The shingles appear to be in good overall condition. They are installed well with all of the necessary caps and flashings.

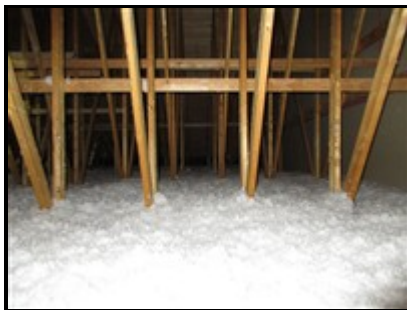
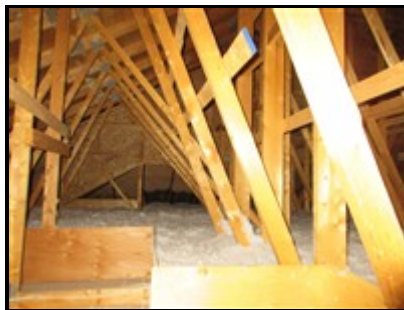
4.0 Picture 1

The attic contains blown in fiberglass insulation. This insulation appears to be well placed and installed in adequate amounts.

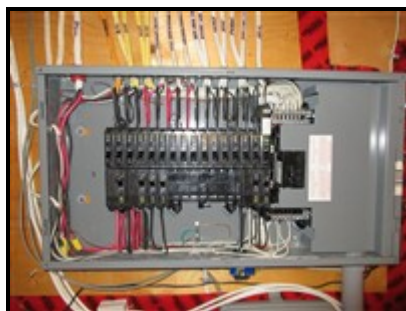
5.2 Picture 1

The main electrical panel was inspected and found to be installed properly and wired correctly. All of the proper sized breakers were present.

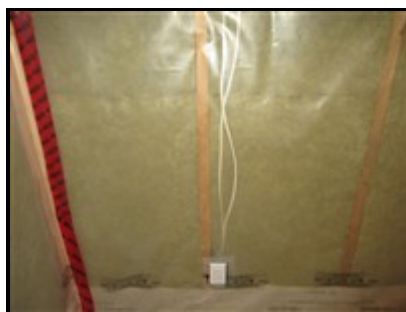
5.3 Picture 1

The wiring in the basement exterior walls to the receptacles are loose in the walls. These should be stapled to the studs.

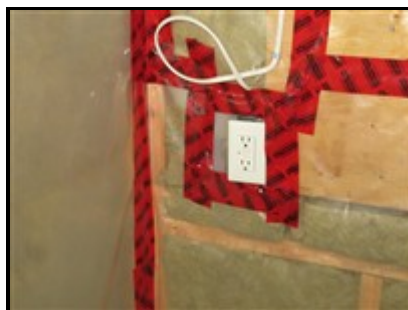
5.6 Picture 1

(2) The receptacle outside at the front of the house is protected by the GFCI receptacle in the basement beside the main panel.

(1) The GFCI receptacles should be tested on a regular basis (monthly).

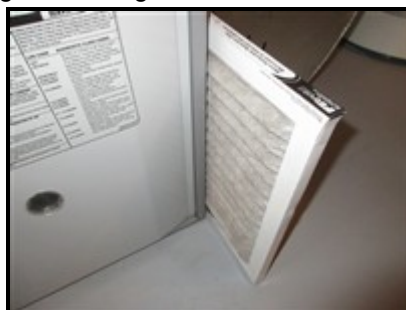
6.0 Picture 1

(1) The furnace was tested and inspected and found to be installed properly and working well. All the necessary safety features were present.

(2) The furnace filter should be changed on a regular basis.

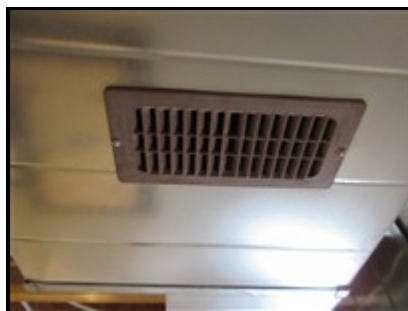
6.4 Picture 1

The cold air return in the basement is installed at the ceiling level. If / when finishing the basement, this should be installed at the floor level.

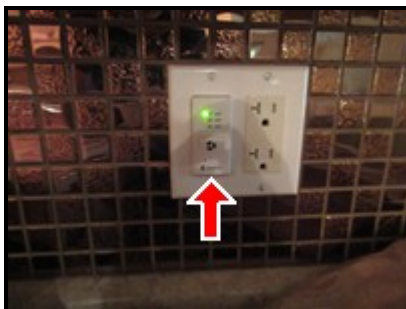
6.11 Picture 1

(1) The heat recovery ventilator located in the basement is a mechanical device that exchanges stale indoor air with fresh outdoor air. Heat is transferred from the outgoing air to incoming air by passing the two air streams through a heat exchange core. Stale air is removed from the bathrooms and kitchen and then fresh air from outside is delivered to the cold air return which then circulates through the house. This device controls air quality and condensation levels in a well sealed house. This is controlled by a humidistat located beside the thermostat.

(2) There are timer buttons in the bathrooms and the kitchen which will turn on the HRV for typically 20 minutes to help clear the air.

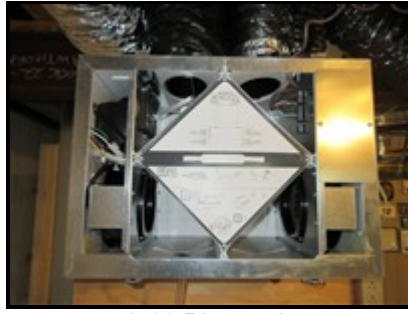
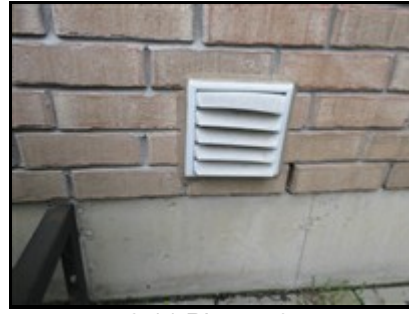
6.11 Picture 2

(3) The heat recovery ventilator filters including the outside fresh air intake screen will require cleaning on a regular basis (see manufacturers recommendations).

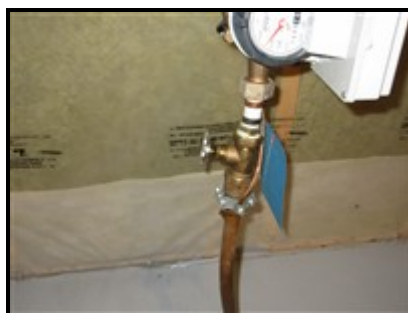
7.4 Picture 1

Front wall of basement.
