Inspection Report

Property Address:
179 Barnardo Ave.
Peterborough

Paul Galvin Residential Home Inspections

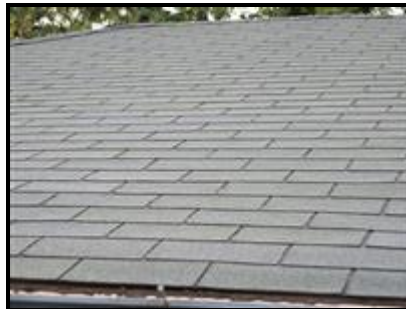
1.0 Picture 1

(1) The entire main roof surface is asphalt shingles. The shingles on the front are basic three tab shingles. These appear to be in good overall condition. They are installed well with all of the necessary caps and flashings.

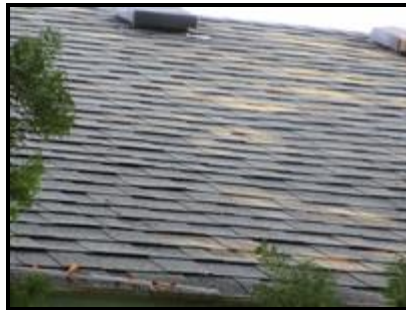
1.0 Picture 2

(2) The shingles on the sides and back are the longer lasting architectural shingles. These shingles are in good condition and installed well.

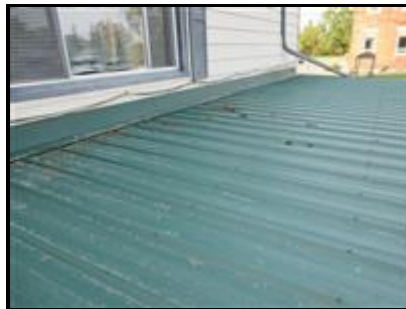
1.0 Picture 3

(3) The lower low slope roof surface is metal. This surface is in good condition and installed well.

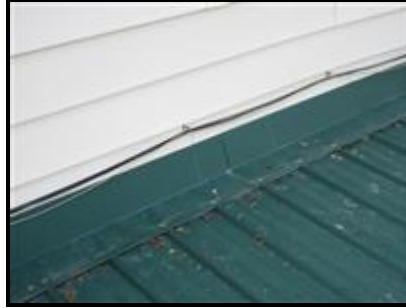
1.1 Picture 1

The flashing where the metal roof meets the vinyl siding should extend up behind the siding. This appears to just be sealed to the siding. This should be kept well sealed over time.

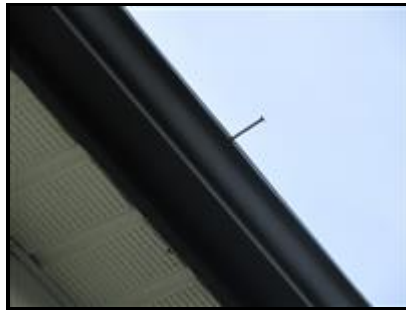
1.3 Picture 1

(2) The eavestrough nails are pulling out in areas. The nails should be resecured so the eavestroughs are resecured and sloped properly.

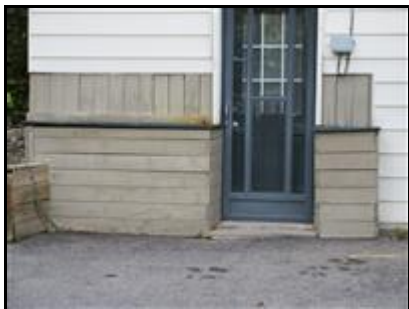
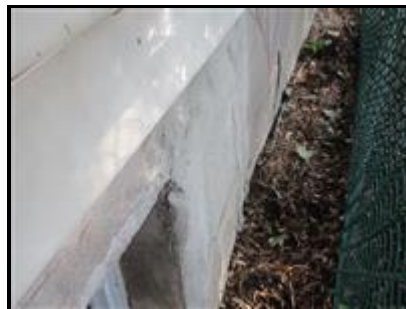
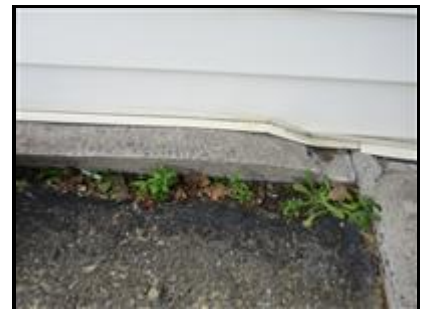
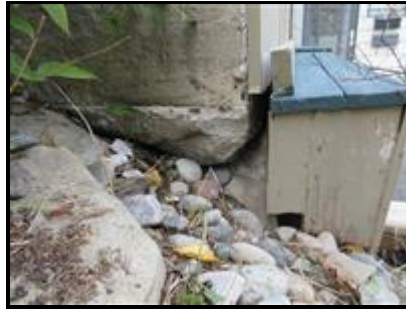
(1) There appears to be some erosion in the foundation at the corner of the driveway. These areas have been covered by some wood framing so no exact comment can be made on it's condition. There does appear to be some rough concrete at the corner and some concrete repairs by the lower entrance door as well as at the back of the house. This does not appear to be causing a structural concern but eventually you may consider removing the wood framing to ascertain if any repairs are necessary.

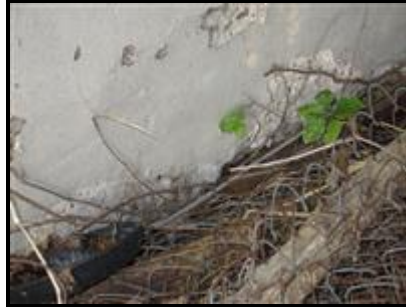
2.1 Picture 5

(2) The exterior concrete foundation could use some reparging in areas.

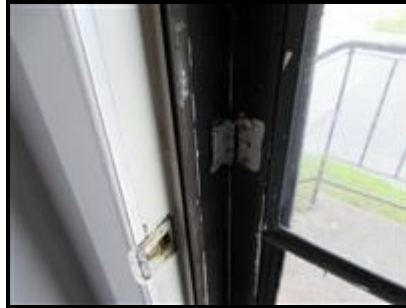
2.2 Picture 1

The upper unit storm door is missing the handle / latch.

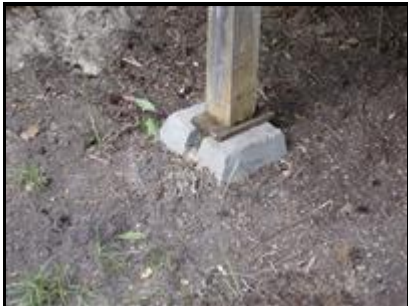
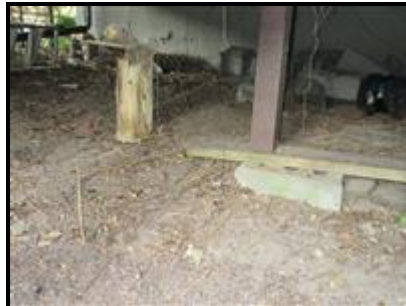
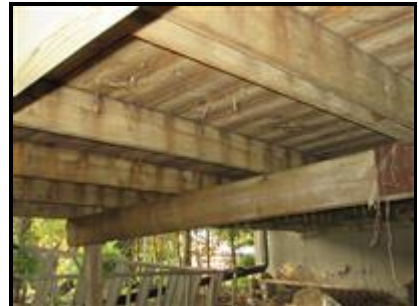
(1) The deck support posts are sitting on deck blocks (floating) although the deck is secured to the house. Technically these posts should extend four feet into the ground. This deck is also minimally framed.

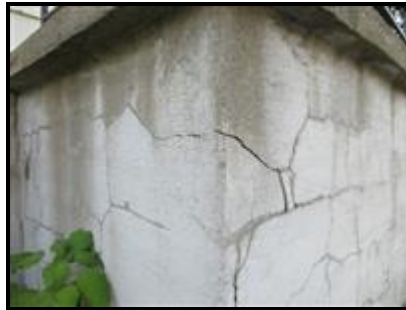
2.4 Picture 5

(3) There is some cracking in the concrete porch. Although not an immediate concern, some concrete repairs will eventually be needed.

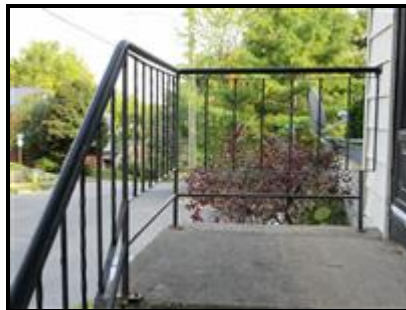
2.4 Picture 6

(4) The concrete porch railing does not meet the present code for safety. This could pose a safety / fall hazard. Care should be taken particularly with children or a proper railing should be installed.

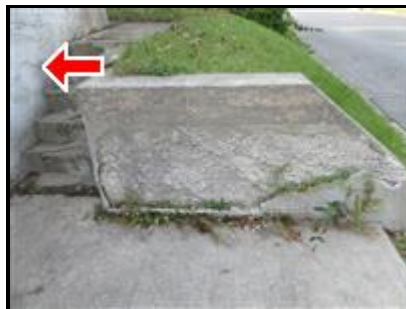
2.4 Picture 7

(5) A handrail should be installed on the exterior stairs where missing.

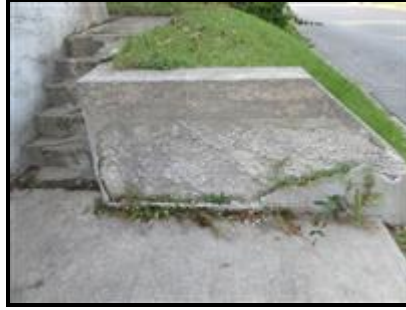
2.5 Picture 1

(2) The concrete retaining wall by the driveway could use some reparging.

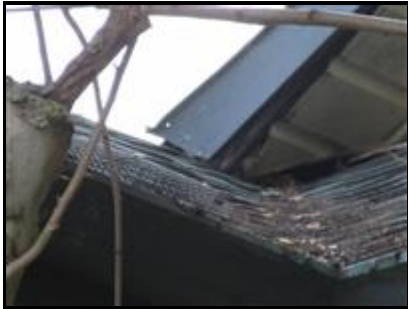
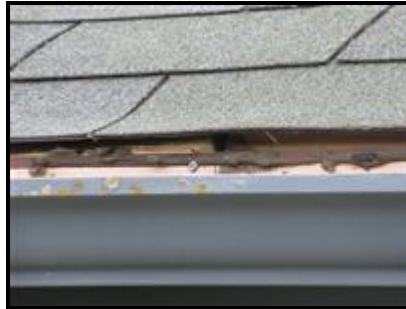
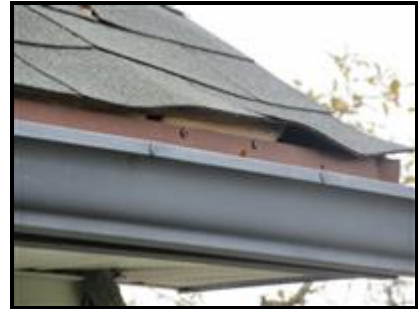
The aluminum fascia will require repair / finishing in areas.

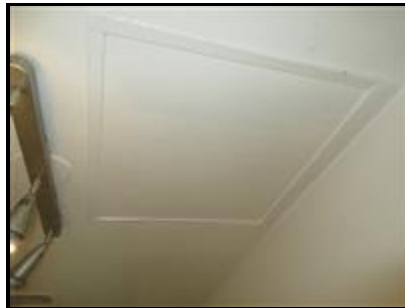
4.0 Picture 1

There was no access to any unfinished attic space as the attic hatch was sealed shut. Therefore no exact comment can be made on attic insulation or ventilation.

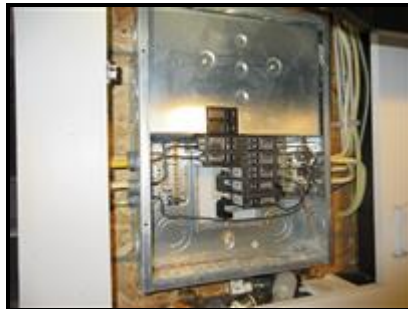
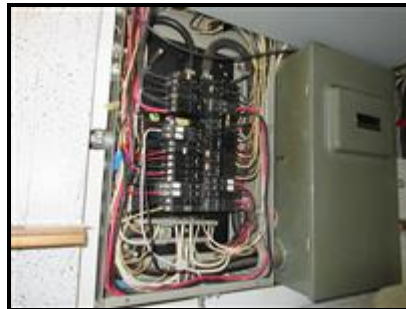
The main electrical panels were inspected and found to be installed properly and wired correctly. All of the proper sized breakers were present.

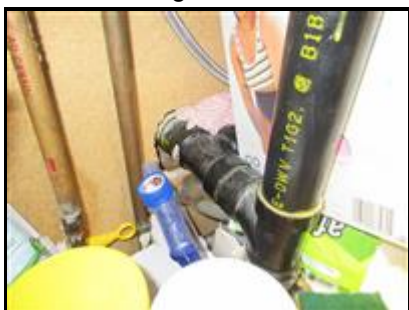
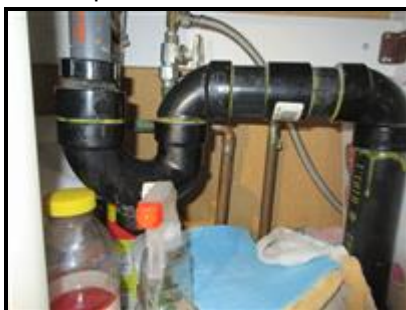
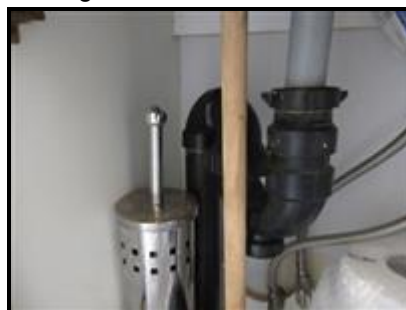
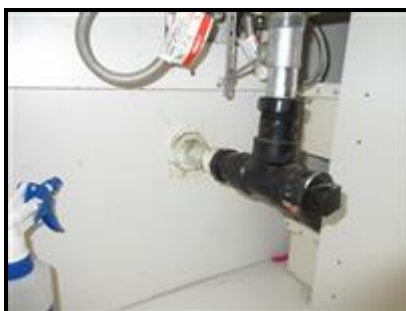
All visible aspects of plumbing system were tested and inspected and found to be working okay although not all of the fixtures/drains were installed or vented properly. (bathroom sinks not vented and one did not have a trap, upper laundry drain not installed properly) Some modifications would be a good idea which could include installing air admittance valves. A trap should be installed where missing.

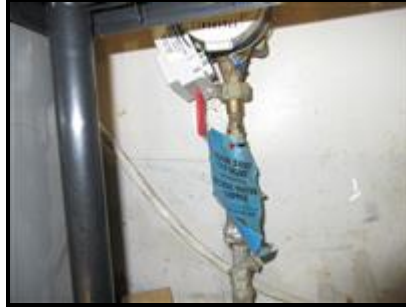
7.4 Picture 1

Basement kitchen closet.

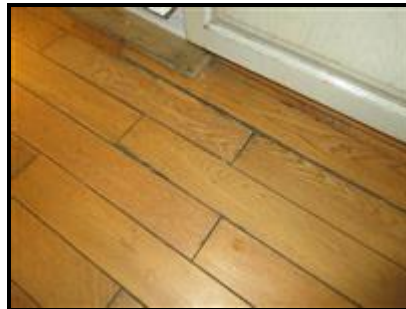
8.3 Picture 1

The hardwood floors in front of the upper kitchen sink is damaged due to some past leaks at sink and / or dishwasher.

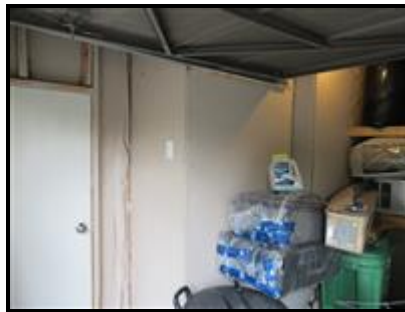
9.2 Picture 1

Technically any wall between the garage and the house should be sealed with drywall with one coat of drywall tape and compound. (for proper gas proofing)
