Inspection Report

Property Address:
4053 County Rd. 36
Buckhorn

Paul Galvin Residential Home Inspections

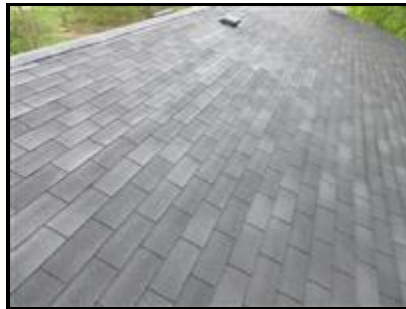
1.0 Picture 1

(1) The entire roof surface is asphalt shingles. The shingles on the back of the roof are basic three tab shingles. These shingles appear to be in good overall condition and installed reasonably well.

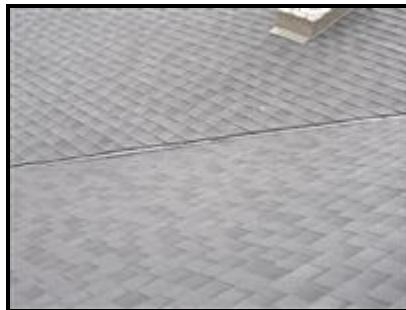
1.0 Picture 2

(2) The shingles on the remainder of the roof are newer, longer lasting architectural shingles. These shingles are in very good condition and installed well. All of the necessary caps and flashing are present.

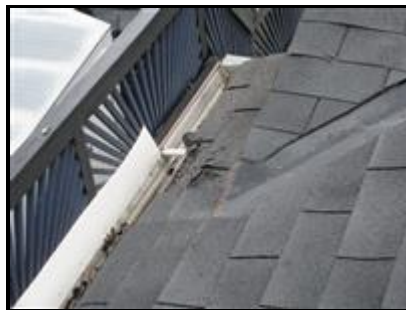
1.0 Picture 3

(3) There is a very small section of shingles at the back which are very worn. This small section was likely not resingled when the rest was. This small section should be resingled.

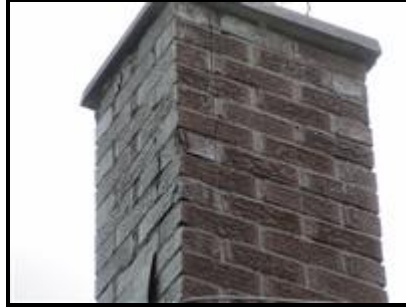
1.2 Picture 1

There is some slight cracking in the brick chimney at the left end of the house. This chimney is no longer in use.

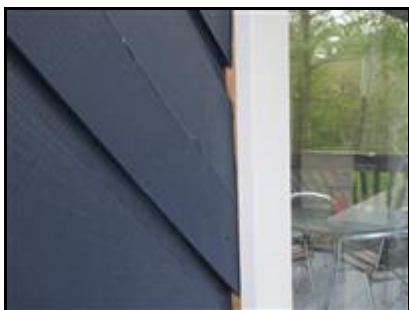
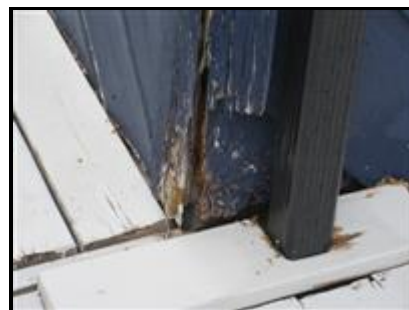
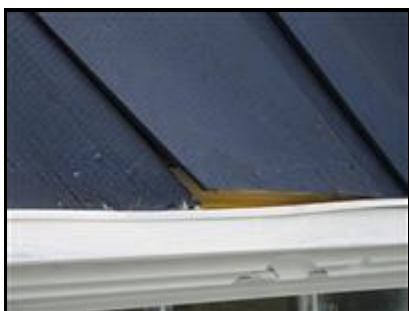
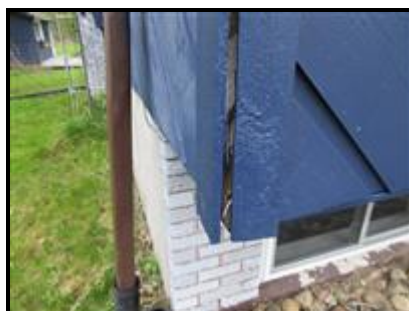
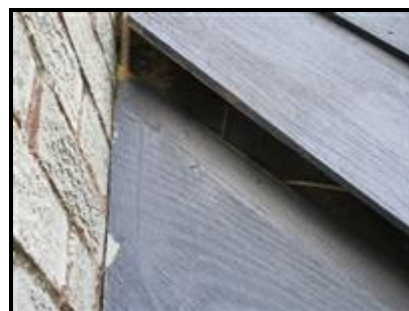
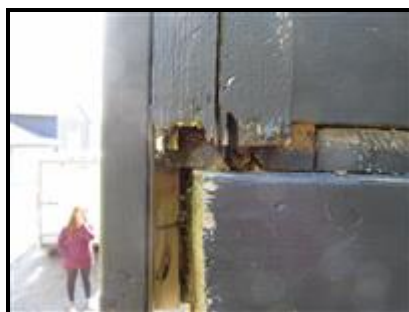
(1) The entire wall surfaces are wood siding. These wall surfaces are in pretty good overall condition for the age. However there are quite a few areas where the siding is buckled, damaged and not finished properly. The siding around the windows and doors are not flashed properly. Repairs and finishing will be needed around much of the house.

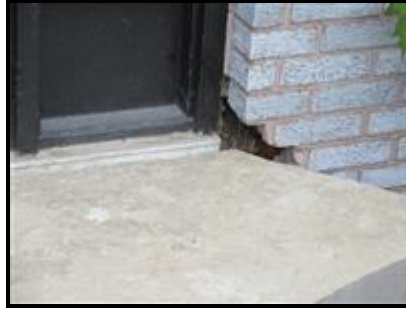
2.0 Picture 8

(2) There is some missing brick at either side of the front door. Although not an immediate concern, these areas should be filled in.

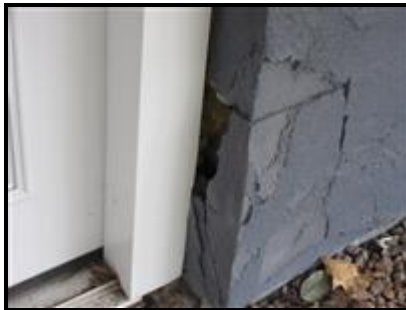
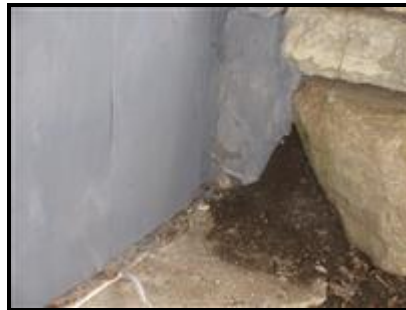
There are a couple areas at the block foundation which are not finished at the sides of the doors. These areas should be filled in.

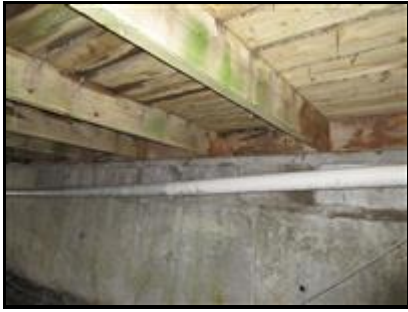
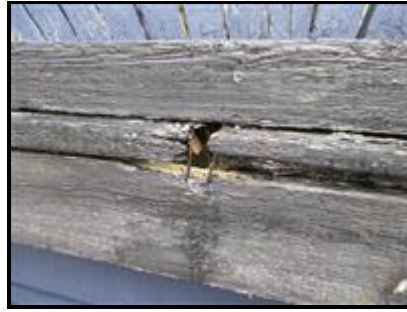
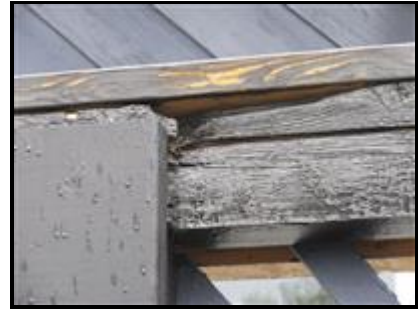
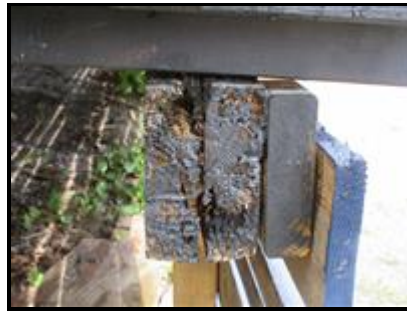
(1) The lower back deck and side deck are older and are minimally built with signs of rot in the outer edge and in the railing. Although not an immediate concern, the deck will require repair or replacement. The deck railing is weak as a result.

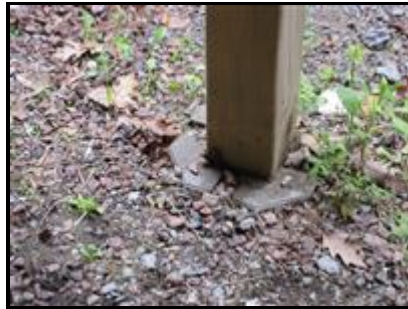
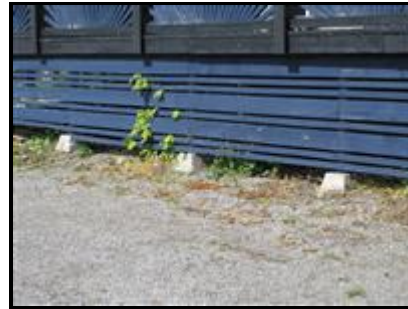
(2) The deck support posts are sitting on deck blocks (floating) although the deck is secured to the house. Technically these posts should extend four feet into the ground. (or to bedrock)

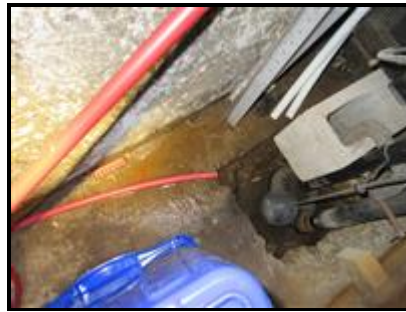
3.0 Picture 1

- (1) Structurally the house appears to be in good overall condition. All visible framing members appear to be adequately sized and free from damage or wear. There were no signs of any unusual settlement or shifting.
- (2) There were no signs of any recent moisture entry into the basement. I would not anticipate any real concerns under normal conditions but I cannot offer any guarantee of a dry basement. Attention must always be paid to grading, downspouts and the exterior flow of water.
- (3) There is some water on the floor beside the sump pit. This is from the dehumidifier from the pool area draining onto the floor.

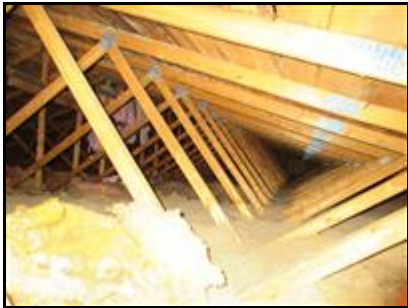
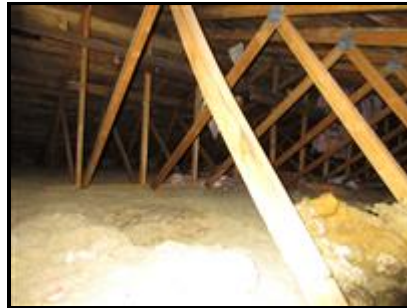
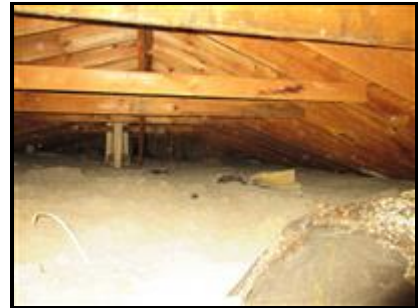
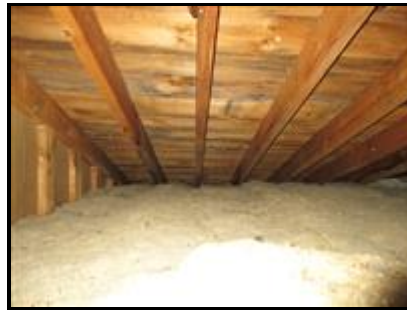
The attic contains a combination of fiberglass batt and blown in cellulose insulation. This insulation appears to be well placed and installed in adequate amounts.

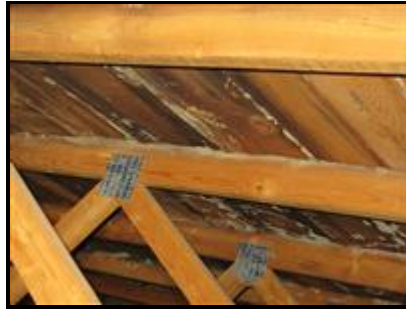
4.2 Picture 1

(2) There is some slight mould type staining on the roof sheathing above the pool area. This may have been due to a couple past roof leaks. This can be cleaned off if desired.

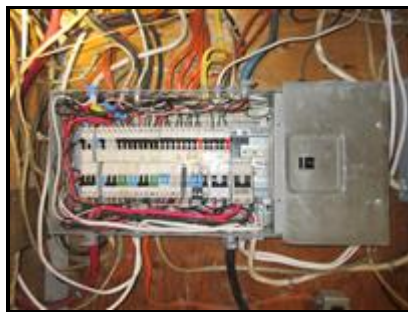
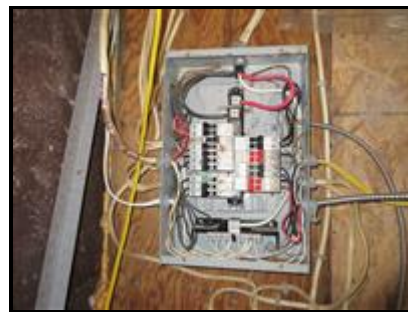
The main and auxiliary electrical panels were inspected and found to be installed properly and wired correctly. All of the proper sized breakers were present. There are openings on the panel covers which should be covered.

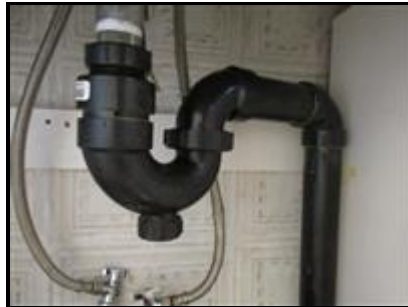
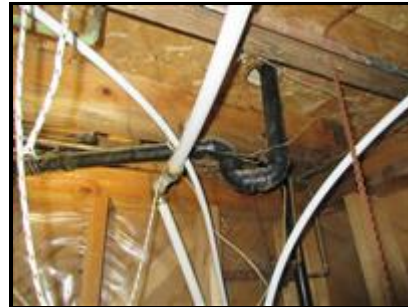
All visible aspects of plumbing system were tested and inspected and found to be installed reasonably well and working okay although not all of the fixtures/drains were installed or vented properly. (main bathroom sink, laundry standpipe and addition bathroom) Some modifications would be a good idea which could include installing air admittance valves.

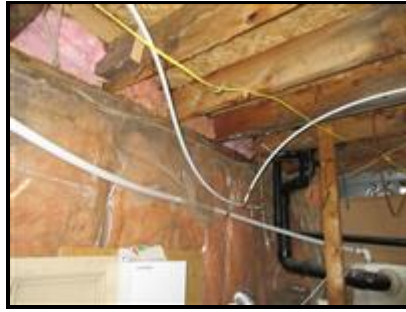
7.2 Picture 1

Some of the pex distribution piping is hanging loose. Some clamping in place would be a good idea.

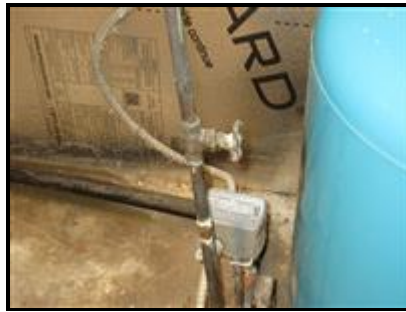
7.4 Picture 1

At pressure tank.

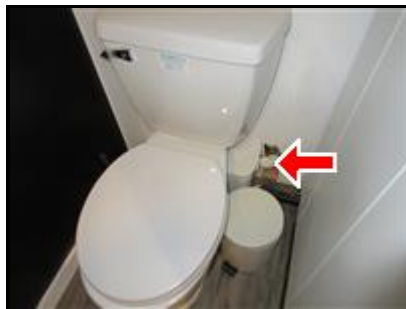
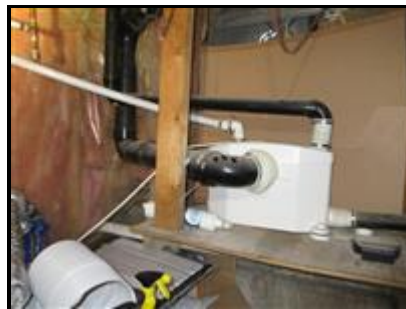
The toilet in the basement has a pumping reservoir behind it. This collects the grey water and sewage from the lower bathroom and kitchen and pumps it up to the septic outlet. There is a similar pumping reservoir below the addition bathroom which collects the sewage and grey water from this bathroom and the pool area sink and pumps it to the septic outlet.

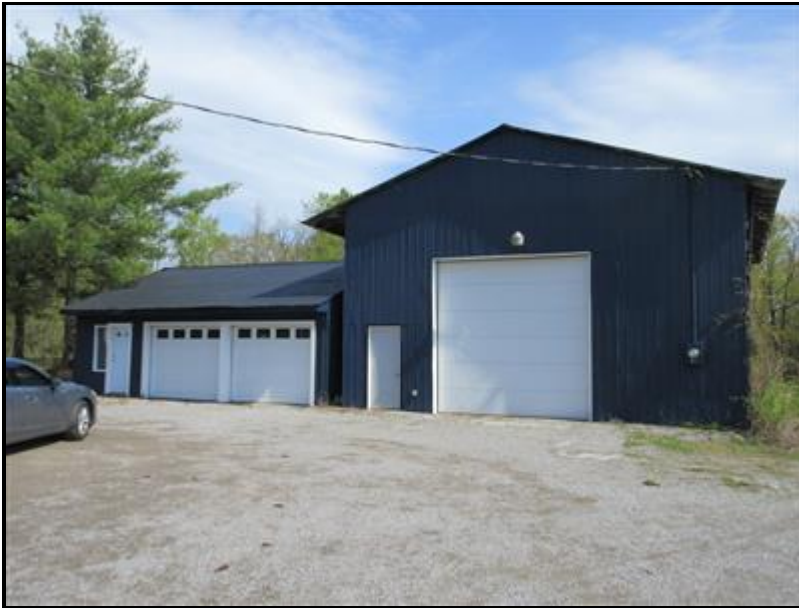
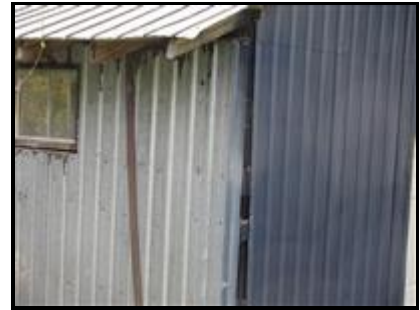
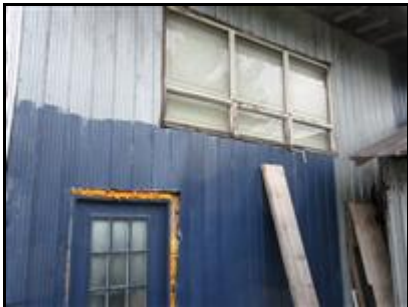
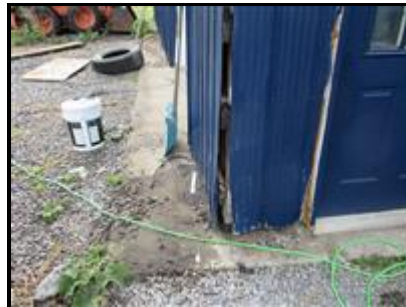
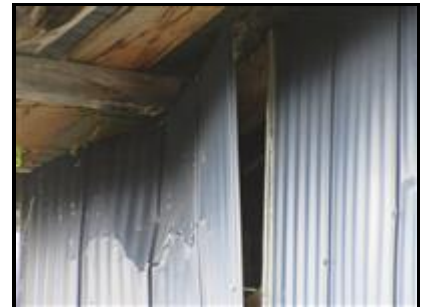
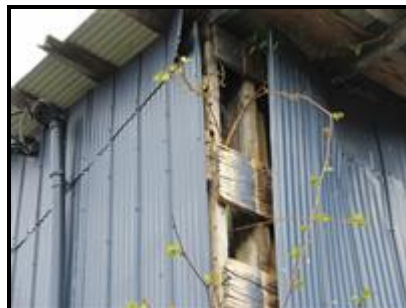
(1) The garage / shop are older but are in pretty good overall condition. However the exterior especially the shop is in rough condition. Considerable repairs / residing will be needed.

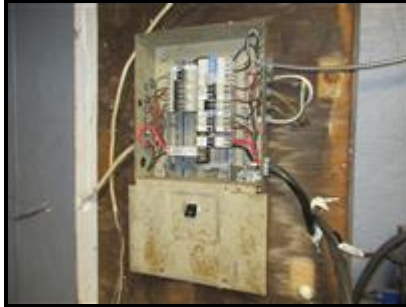
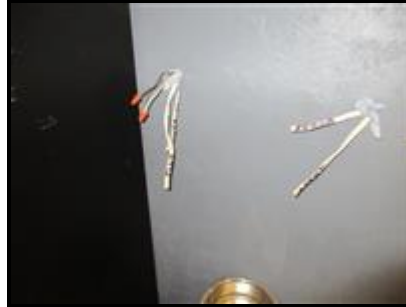
Some wiring clean up / finishing will be needed in the shop.

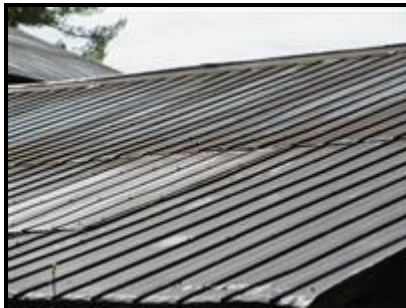
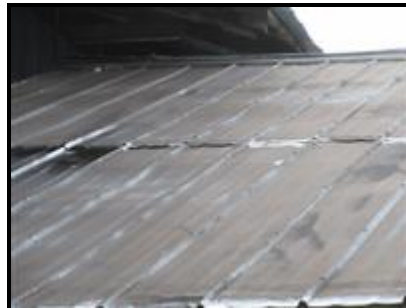
The roof surfaces on the garage is metal. The metal is older but in reasonable condition. However most of the metal has been secured down with nails with lead washers. It would be a good idea to someday replace the nails with screws with rubber washers.
