6322.002
Manhattan Skye
Window Review

REGARDING **Window Review**

As requested by The Owners, Strata Plan BCS2401 (Owners), RDH Building Science Inc. (RDH) is pleased to provide this report of a window review for the townhouse complex known as Manhattan Skye, located at 19551 66th Avenue, Surrey, BC.

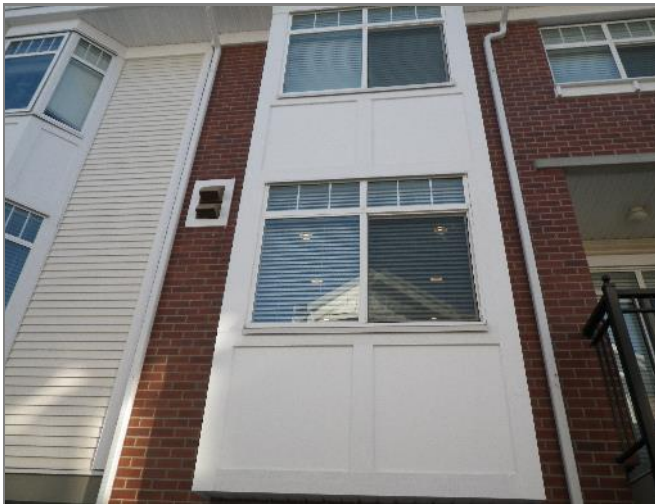
Bay: Rectangular shape, typically one window installed at the widest face of the projection (Figure 2.1).

*Figure 2.1
Photo of a typical bay at
Manhattan Skye.*

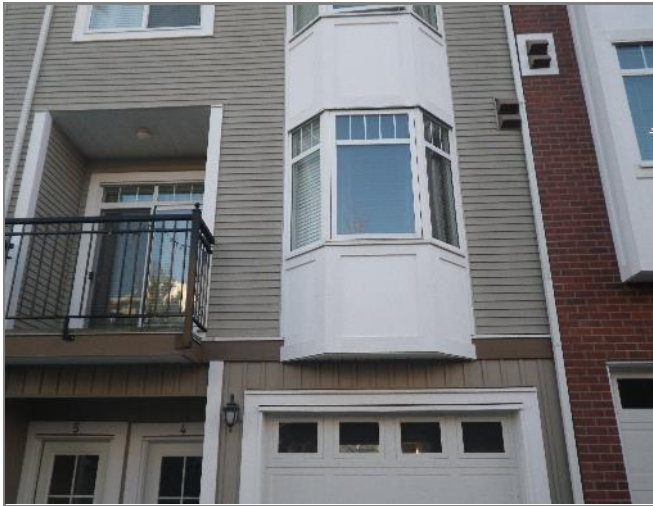
Figure 2.2

Bay Window: Faceted shape, typically 1 larger window installed at the outermost projection with 2 smaller windows installed at each side adjacent to the larger window (one at each side, Figure 2.2). The larger fixed windows appear to be connected with a coupler at the transition from the large casement vent.

Photo of a typical bay window at Manhattan Skye.

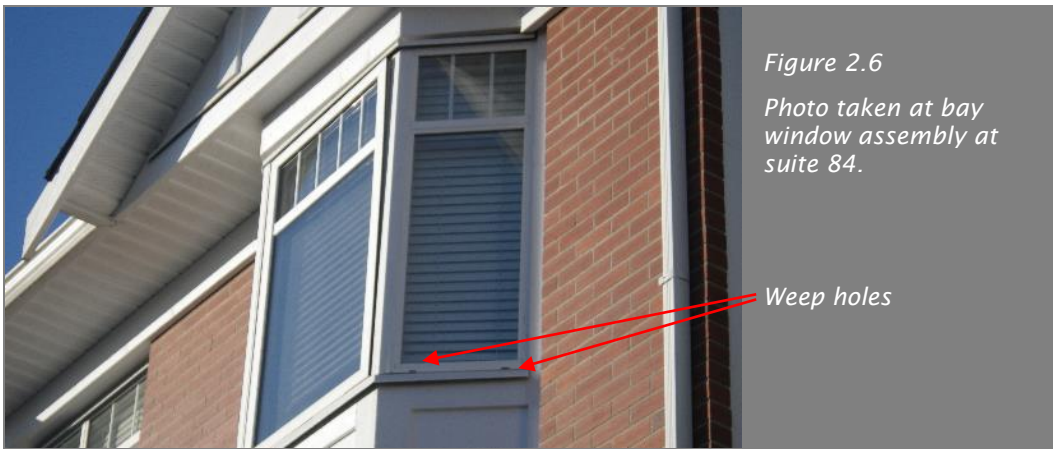
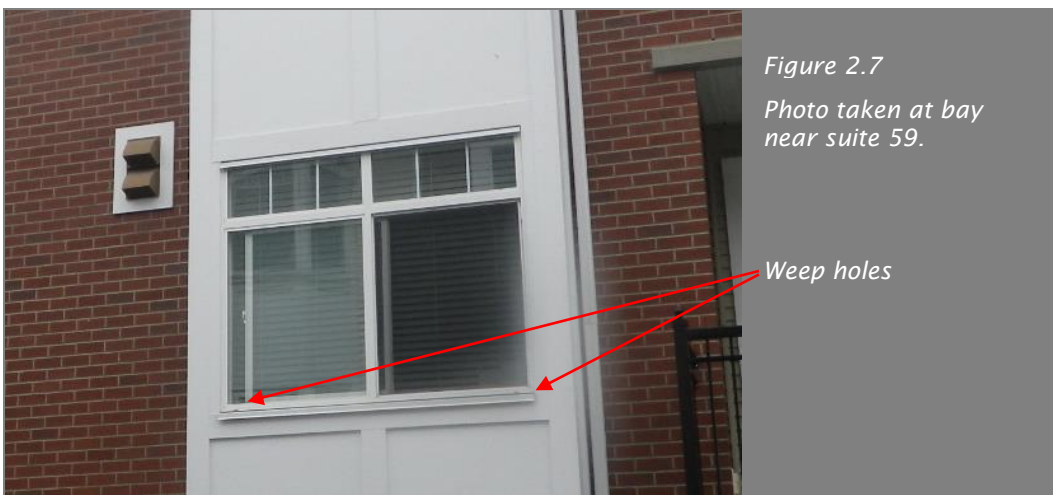
There are typically sill tracks installed at the interior below fixed glass type windows (Figure 2.8). Sill tracks are not typically installed below casement vents or at slider type

Figure 2.8
Photo of bay assembly
taken at interior of
suite 83, south
elevation.
IGU
Swiggle spacer (black)
Sill track

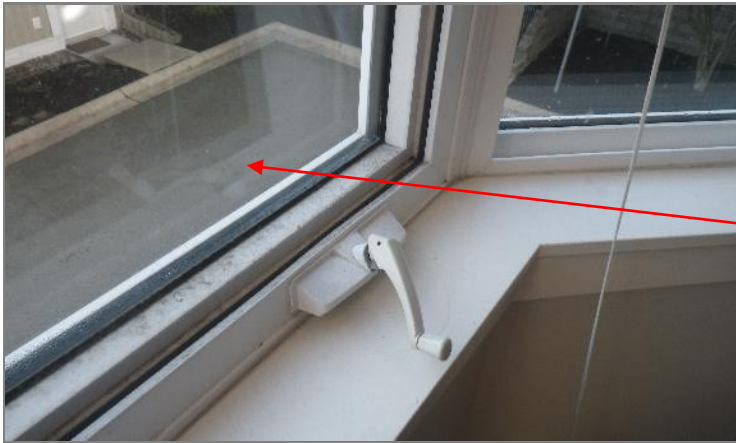
window assemblies (Figure 2.9). There is a secondary track installed at Window Type A above the fixed glass and slider vent (Figure 2.10). There do not appear to be drain holes installed in the sill track or secondary track.

Figure 2.9
Photo of bay window
assembly taken at
interior of suite 83,
south elevation.
Casement vent

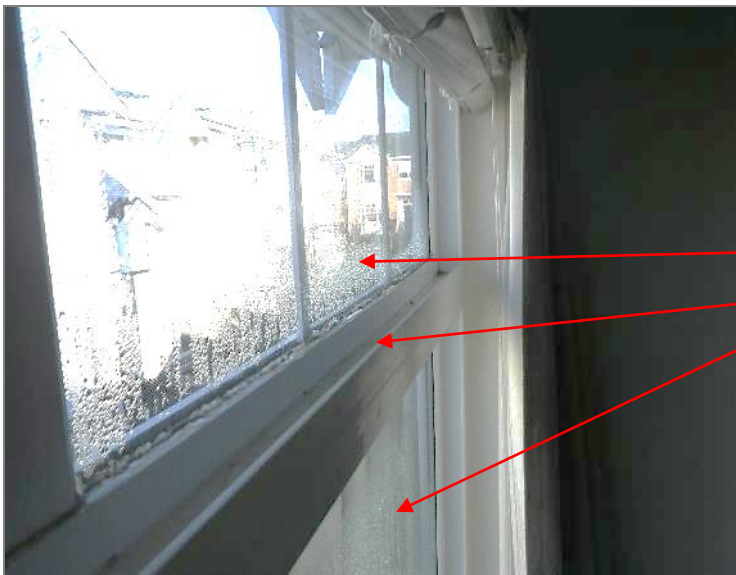
Figure 2.10
Photo of bay assembly
taken at interior of
suite 70.
IGU
Secondary track
IGU

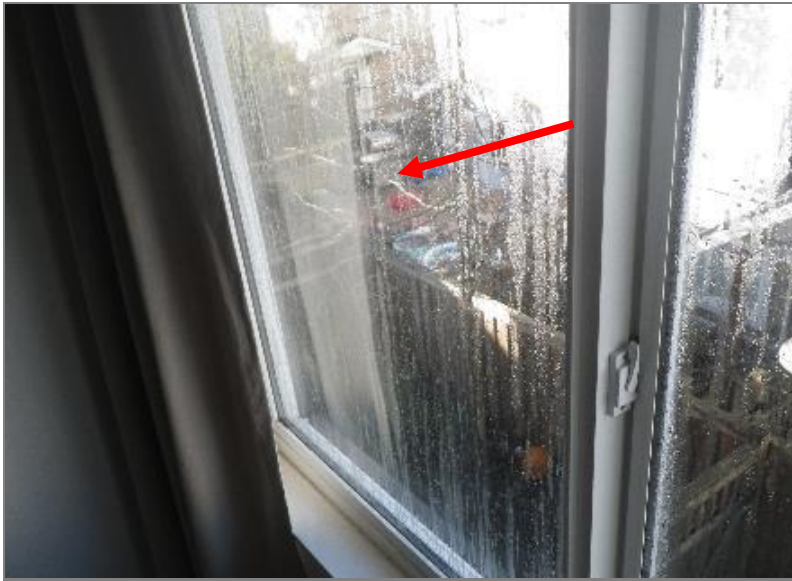
- About 1/3 of the windows reviewed from the interior had condensation at the interior pane of glass at the time of the review. Additionally, about 40% of the windows reviewed from the interior had some sort of mould on or around the window frame, consistent with the effects of condensation of interior humidity.

Figure 2.11
Condensation on the interior surface of glass. Photo taken at the bay at the master bedroom of suite 70.

- Obtain original window shop drawings.
- The Owners should distribute information regarding condensation reduction strategies to all residents. An HPO technical bulletin pamphlet appended to this report is a suitable handout.
- RDH recommends the Owners contact the original window manufacturer (assumed to be Tye Windows of Abbotsford, BC) to comment on the issues relating to operation of the windows, and propose a repair. Repairs to the windows may still be covered by a manufacturer warranty offered by Tye Windows. If minor adjustments to the hardware will not address the problem, more significant work involving the replacement of some of the window components may be required.

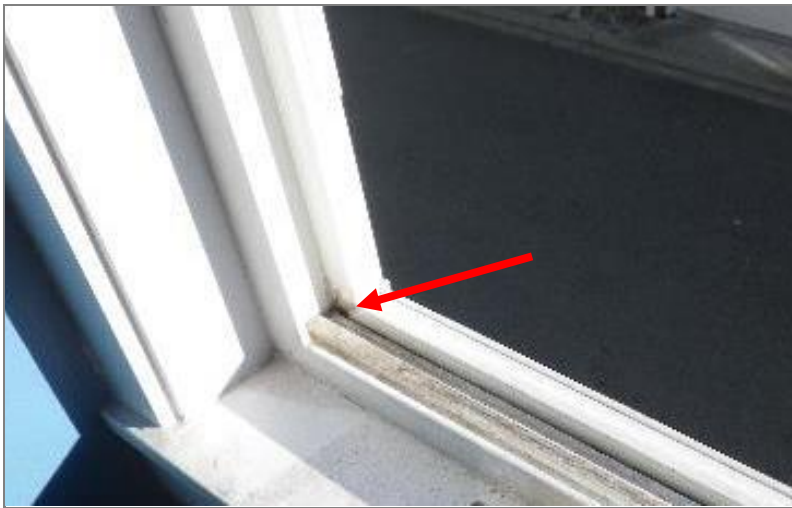
Figure 2.12
Staining & mould on the window frame within slider vent track at a bay. Photo taken at kitchen window at suite 70.

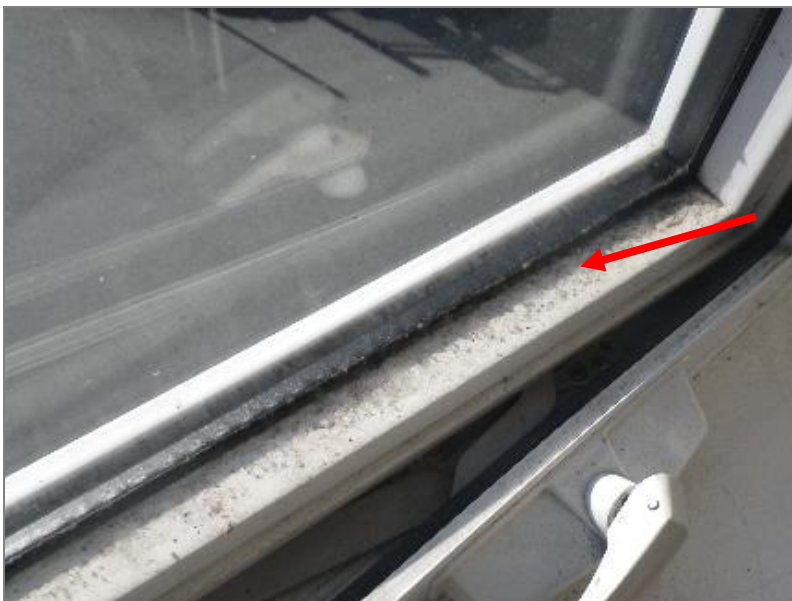
Figure 2.13
Staining & mould on the window frame of casement vent of bay window. Photo taken at master bedroom window of suite 31.

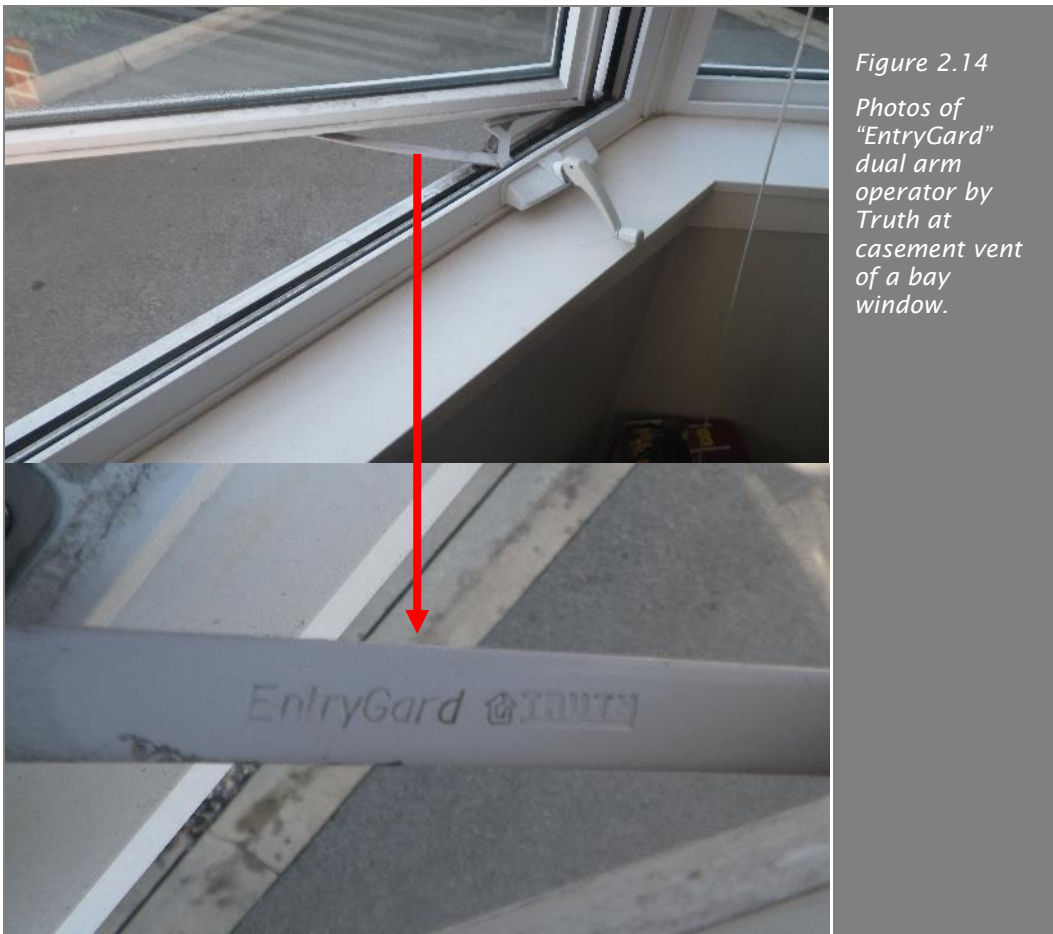
During our interior review of the windows, RDH noted a manufacturer stamp on the window hardware of a typical casement vent at a bay window: “EntryGard Truth” (Figure 2.14). This is assumed to be the EntryGard dual arm operator series by Truth Hardware.

It is important to note from the Truth Hardware technical documentation for the manufacturer’s recommendation regarding the sash weight for the operable vent of the window:

“Sash weight should be limited to 60lbs. to insure ease of operation for the lifetime of the window. When used on a sash weighing over 60 lb., operating torque will noticeably increase and operator life will be reduced.”

Without window shop drawings RDH cannot confirm thickness of glass used and other components used in construction of the window assembly. The thickness of glass used, other components used in construction of the window assembly, and the cumulative weight should be evaluated at a date when the window shop drawings are available.

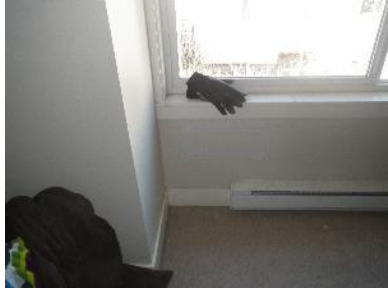
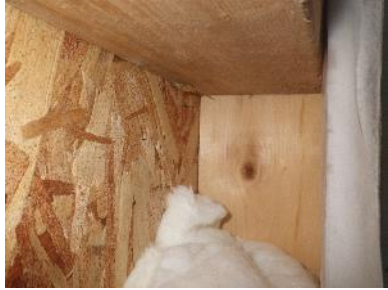
EXPLORATORY OPENING #1

sampling of suites. The exploratory openings made at suites 70, 83 and 31 did not reveal damage to the underlying wall sheathing or framing at their respective locations.

<i>Figure 2.16</i> <i>Suite #70, Third Floor, Master Bedroom</i> <i>West Elevation</i> <i>Below Window Jamb to Sill Interface</i>
Moisture Content: 8%

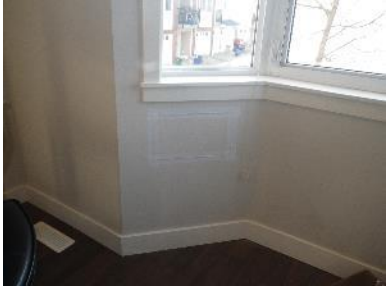
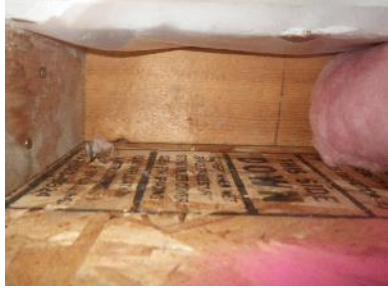
EXPLORATORY OPENING #2

<p>Figure 2.17 Suite #83, Second Floor, Kitchen South Elevation Below Window Jamb to Sill Interface</p>
Moisture Content: 10%		
Physical Observations: Sound

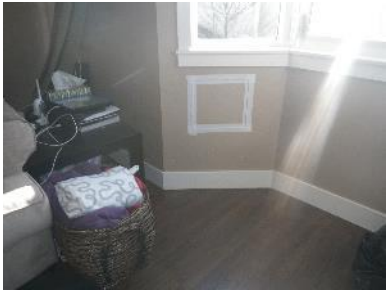
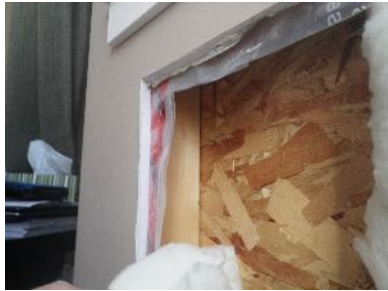
EXPLORATORY OPENING #3

<p>Figure 2.18 Suite #31, Second Floor, Living Room South Elevation Below Window Jamb to Sill Interface</p>
Moisture Content: 10%		
Physical Observations: Sound

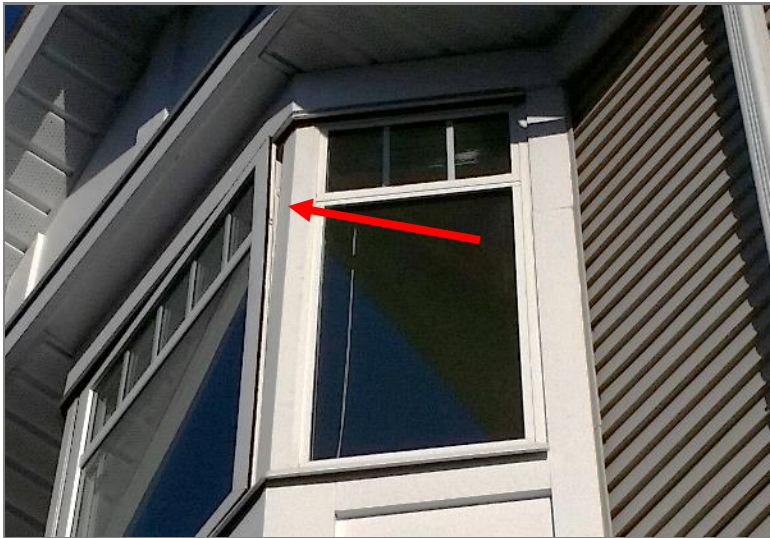
Figure 2.19

- Almost half of the casement vents of the bay windows reviewed from the drive aisles of the complex appeared to be visually out of plumb from the vinyl window frame to some extent. A horizontal gap between the top non-hinged side of the sash of the casement vent and the vinyl window frame were typically observed. As a result, the top of the operable vent and the window frame are not co-planar. The horizontal distance visible between the sash and the window frame typically varied from approximately 1/4" to 1-1/2" (Figure 2.19).

During our exterior review of bay windows, almost half of the casement vents of the bay windows appeared to be out of plumb from the window frame, and appeared not to be closed properly. In a situation where a casement vent does not close properly, it is unlikely that both the top and bottom points of a 2-point lock mechanism will engage. The horizontal gap noted between the top edge at the non-hinged side of the sash of the casement vents and the vinyl window frames is consistent with what we expect from only the bottom lock point engaging. As a result of only the bottom lock point engaging: the top lock is likely applying a force on the sash of the casement vents when the window is closed. The force applied at the top of the sash of the casement vents are likely exacerbating the problem of the visible horizontal gaps between sashes and the vinyl window frames.

The window manufacturer should review the issues relating to the operation of bay windows & bays and propose a solution. The windows may still be covered by a manufacturer warranty by Tyee Windows. The manufacturer may have a solution that involves minor adjustments to the window hardware. If minor adjustments to the window operator hardware are not suitable to fix the problem, more significant work involving replacement of some of the window components may be required.

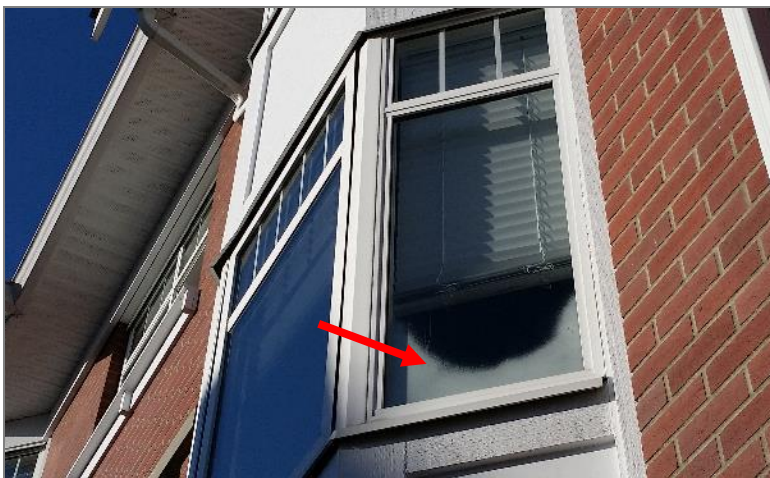
Figure 2.20

- 2 windows were noted with condensation at what appeared to be the interior pane of glass during the exterior review (Figure 2.20). It is important to note that the exterior review portion of the work was carried out in the afternoon. As a result of the time of the review, we would expect condensation related issues to be less prevalent than they would when compared with the early morning interior review.

Condensation at the interior pane of glass.

Additionally, condensation at the interior side of glazing was noted at several windows during the interior reviews of suites.

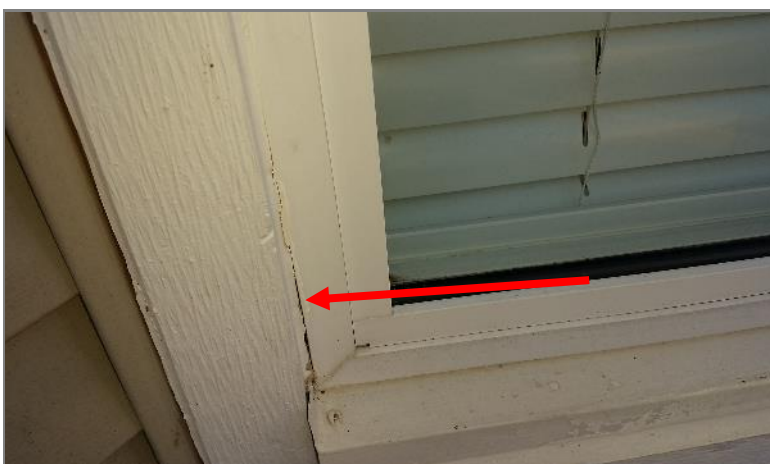
Figure 2.21

→ Cohesive sealant failure (cracking sealant) was noted at 5 of the windows observable from the drive aisles. It is important to note the width of perimeter sealant joints varied over the length of the joint. Varying sealant joints were noted at the perimeter sealant joint between the vinyl window frames and adjacent wall assembly.

Photo of failing sealant. The sealant joint at this window frame to perimeter trim interface varied in width from approximately 1/8" to 1/2"

RDH reviewed sealants at window perimeters during the exterior review. The sealant joint profiles at window frame to adjacent wall interfaces vary throughout the complex. Sealant joints are typically recommended to be a minimum of 3/8" to 1/2" wide, depending on the joint profile. The thinly applied sealant joints are more subject to excessive strain from expansion and contraction and are more likely to fail prematurely. Consequently, the sealants should be monitored for further signs of cohesive failure (cracking) or adhesive failure (sealant debonding from the substrate material). Sealant issues appeared to be localized to select windows at the time of the review. The threat of water ingress to the interior at the cracked sealants is fairly minimal. Condition of the sealants should be monitored as part of regular building maintenance for the complex.

Localized areas of cohesive sealant failure at window perimeter joints were noted. Exterior sealants should be monitored as part of the maintenance program for the complex.

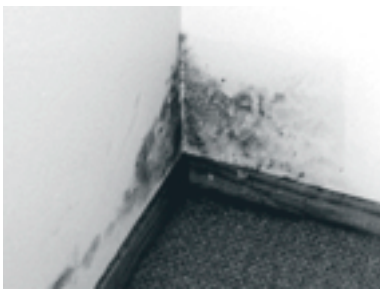
Condensation has led to mould problems on the drywall.

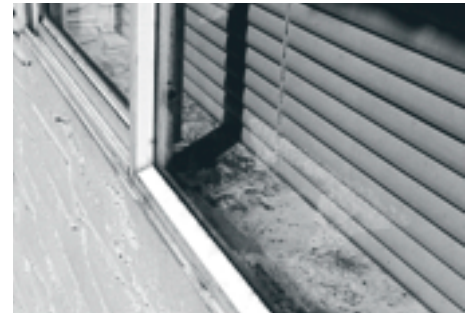
Evidence of problems resulting from condensation can be seen on the interior window sill.

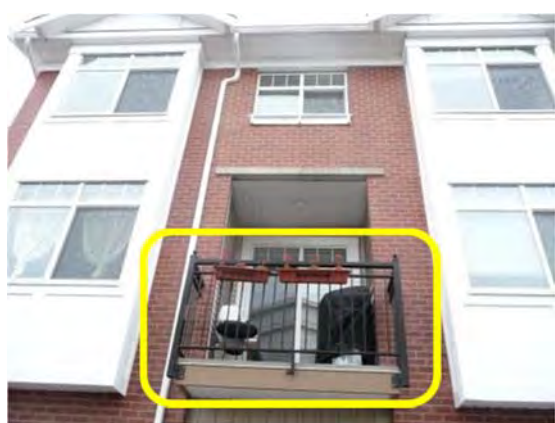
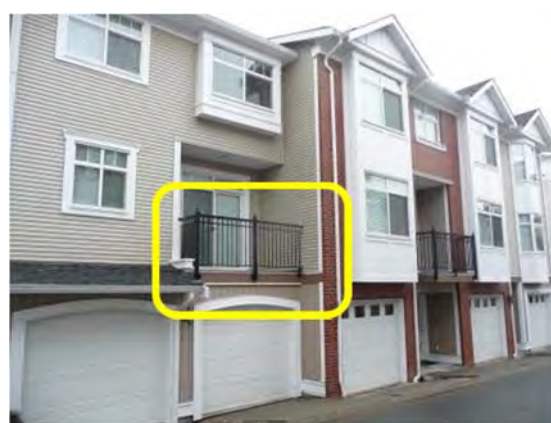
Year Installed	2007	Description: There are wood-framed balconies (left photo) and terraces (right photo). Terraces are similar to balconies, but are located over interior spaces. Both assemblies are constructed of wood-framed flooring that extends past the 2nd floor exterior walls. The wood flooring is protected with a single-ply vinyl sheet membrane. There are terraces at the rear side of the buildings located at the east side of the property. These terraces are concrete-framed, and are finished with a painted concrete finishing mortar.
Expected Life Span	10-20	
Observed Condition	8	
Repair or Replace	7

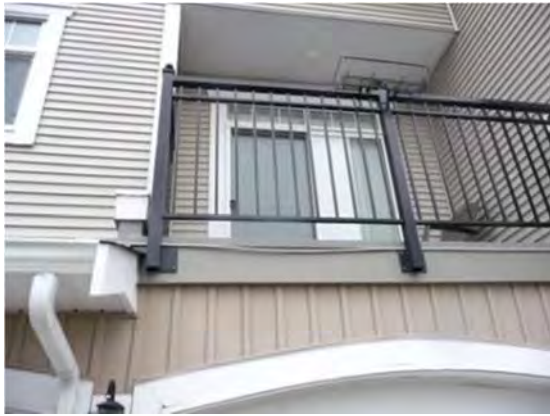
S 3 — Balcony & Terrace Guards

Year Installed	2007	Description: The balcony and terrace guards consist of prefinished aluminum picket-style assemblies, that are supported by aluminum posts secured to the front fascia. Adjacent terraces and balconies are separated with wood divider screens.
Expected Life Span	30-40	
Observed Condition	8	
Repair or Replace	22

Financial Review: We understand that all balcony and terrace guards are original to the construction of the buildings and that no major repairs have been completed.

Visual Review: We assume that all balcony and terrace guard assemblies are similar to the guards reviewed, at the amenity building, at the time of our visit.

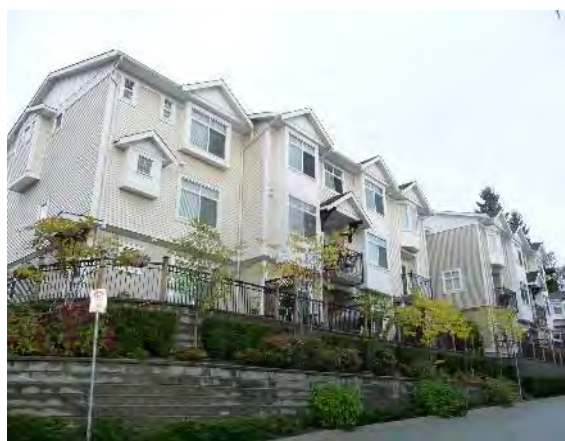
EE 2 — Exterior Cladding

Year Installed	2007	Description: The buildings are primarily clad in vinyl siding. Portions of the second and third floors are also clad in painted fiber cement board siding with painted wood battens. There are also areas of the exterior walls that are clad with masonry veneer. There is painted wood trim work around window and door perimeters, and painted wood fascia boards at all sloped gable roof ends.
Expected Life Span	30-35	
Observed Condition	5	
Repair or Replace	25

Financial Review: We understand that the cladding materials are part of the original construction. We are unaware of any significant repairs or replacements of this component.

Visual Review: We reviewed the exterior cladding from grade and the balconies of the amenity building. Where checked, the vinyl siding, fiber cement panels, wood battens, fascia and wood trim were generally free of visual damage.

For maintenance, we also recommend periodic, perhaps seasonal, cleaning of the cladding to reduce the amount of moss growth and dirt on the surfaces. The use of powerful pressure washers is not recommended as it can possible damage the materials. It is assumed that such maintenance will be included as a part of regular building maintenance that is funded from the annual operating budget.

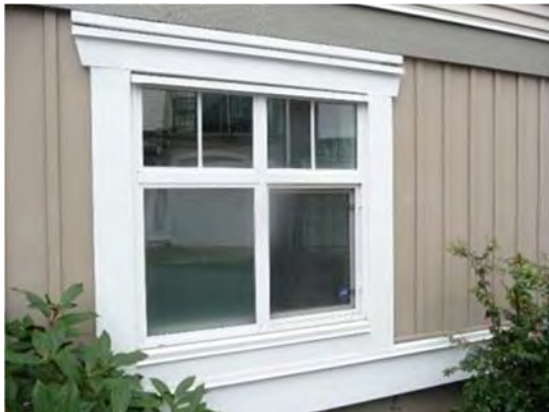
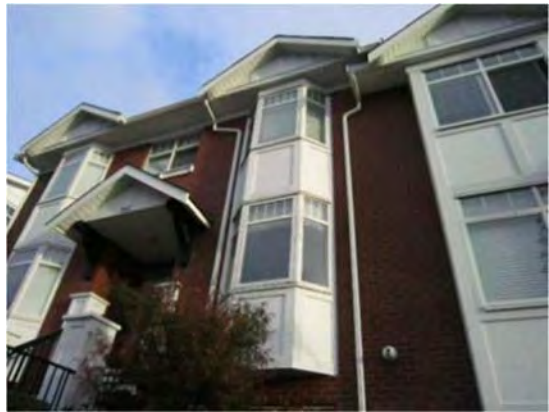
EE 3 — Windows & Sliding Doors		
Year Installed	2007	Description: The windows consist of double-glazed insulated glazing units (IGUs) in vinyl frames. There is an assortment of fixed, sliding and awning style window assemblies. Access to the balconies and terraces is provided by vinyl-framed sliding door assemblies with double-glazed sealed IGUs. Metal flashing is provided at the head and sills of the windows. Weep holes are provided at the base of the windows to allow for drainage.
Expected Life Span	25-35	
Observed Condition	5	
Repair or Replace	15/25

Financial Review: We understand that the windows and sliding doors are original to the construction of the property. According to the Strata documents, the Strata has repaired isolated damaged window assemblies, on an as needed basis, at costs less than the threshold of this Report.

Visual Review: Our visual review, from grade, revealed no noted fogging or condensation between the glazing units, which would indicate broken seals within the IGUs.

We have planned for the replacement of window and sliding door assemblies in 25 years, on a 30 year cycle. This is to coincide with the cladding replacement projects.

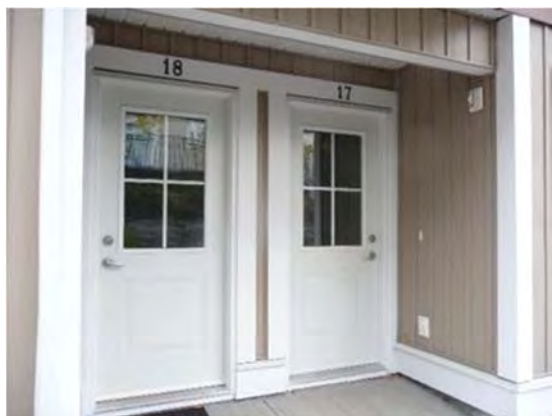
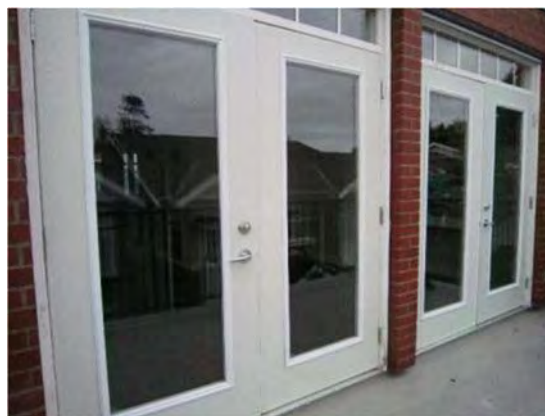
EE 4 — Exterior Doors		
Year Installed	2007	Description: The main entrance door assemblies consist of painted metal skinned wood doors in metal frames. The doors have window sections with sealed IGU panels. The balconies and patio areas at the amenity building are accessed by single swing patio doors with full height sealed IGUs. Exterior doors at the electrical rooms and to the basement of the amenity building are painted hollow metal doors in metal frames. Where checked, the exterior doors have dry-gasket weather-stripping and aluminum thresholds. The garages, located at the front of each unit, have single and double painted metal overhead sectional doors.
Expected Life Span	Various	
Observed Condition	5	
Repair or Replace	20/28

Financial Review: We understand that the exterior doors are original to the construction of the property. We are not aware of any major replacements or repairs to this component.

Visual Review: The exterior doors, including the garage overhead doors, are generally sheltered by the second and third floor framing of the buildings.

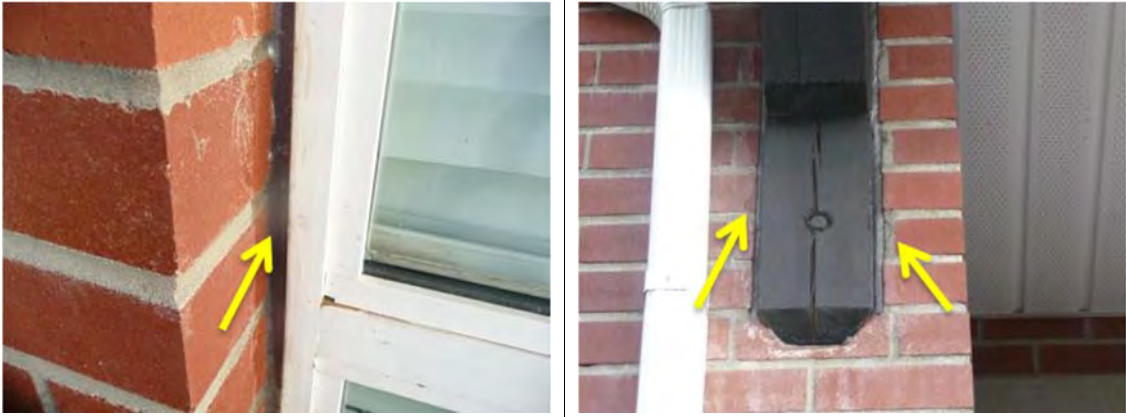
<p>Financial Review: According to the reviewed Strata documents, the caulking and painting of all wood trim, fascia and sealing of the masonry veneer was completed in 2012 by Remdal Painting & Restoration costing approximately \$150,000. We understand that a 5-year warranty from the contractor was also included in the above cost.</p>		
<p>Visual Review: In many locations, it appeared that a silicone based sealant may have been used to seal the majority of the exterior joints (left photo). Silicone based sealant is typically used for interior applications and is generally not recommended for use as an exterior sealant. Silicone based sealant tends to harden and become quite stiff, typically not allowing for movement between a sealed joint.</p> <p>We also identified several locations, around the wood knee brace perimeters, where the backer rod was visible and the sealant was completely missing (right photo, yellow arrows).</p>

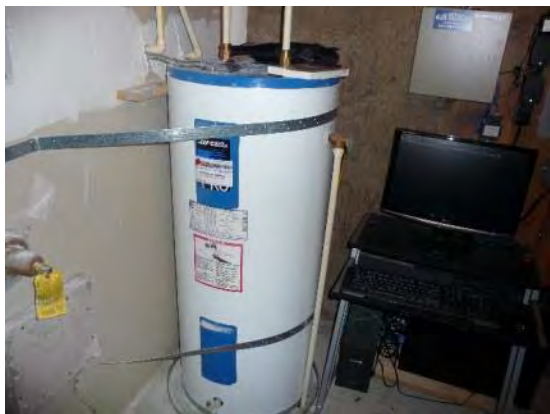
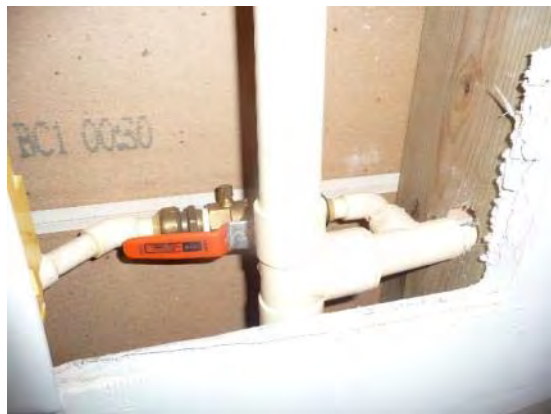
P 1 — Domestic Water Systems – Amenity Building

Year Installed	2007	Description: Domestic water enters the amenity building into the mechanical room that is located in the basement. Where viewed, the piping consisted of PEX. There is a 184 litre electric hot water heater tank, manufactured by John Wood, also located in the mechanical room.
Expected Life Span	Various	
Observed Condition	5	
Repair or Replace	19

Financial Review: We understand that all domestic water supply distribution piping and equipment within the amenity building is original to the construction of the property. We are unaware of any major repairs or replacements have taken place since.

Visual Review: Generally, we noted no significant physical damage or defects to the domestic hot water heater tank. Where checked, we did not observe any staining or damage to the interior finishes within the amenity building to indicate any current issues or leaks regarding the plumbing system.

A project has been budgeted for the replacement of the domestic water distribution piping within the amenity in 19 years, coinciding with the major renovation of the building interiors. The project has been planned to occur on a 30 year cycle. Without Plumbing Drawings we have estimated the length of piping and number of risers from the typical floor plan of the amenity building. We recommend the Strata engage a plumbing consultant prior to the replacement to assist with planning.

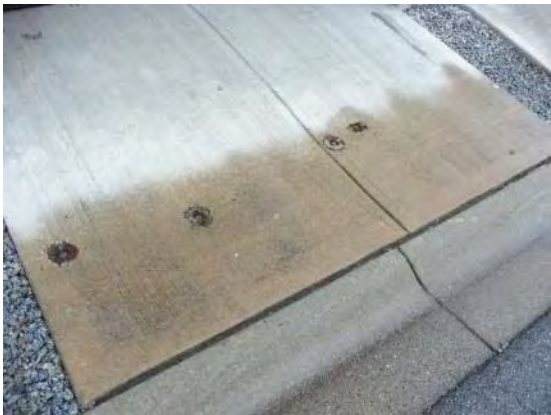
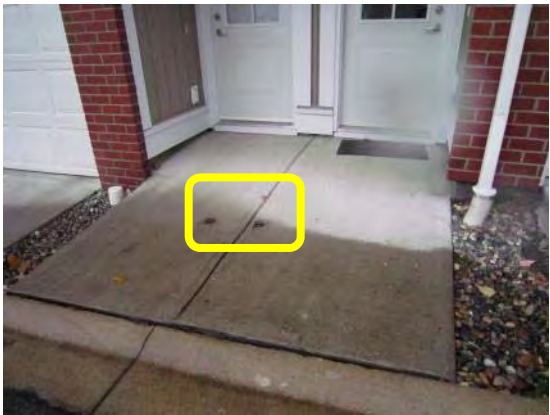
P 2 — Domestic Water System - General		
Year Installed	2007	Description: Domestic water is provided to the townhouse buildings via buried piping lines that are fed from the main municipal lines below the adjacent municipal street. Plumbing Drawings were not available for our review during the writing of this Report. Through our experience and on site observations, it is likely that a main domestic cold water line runs below the private roadway and branches off to each Strata Unit. Before entering the buildings, shut off valve chambers are provided at grade, and are located at each unit's driveway or at front entrance walkways. (photos below). Within each unit is a domestic hot water heater tank and domestic water distribution piping, which are assumed to be the sole responsibility of each owner.
Expected Life Span	50+	
Observed Condition	n/a	
Repair or Replace	n/a

<p>Financial Review: We understand that all domestic water supply distribution piping is original to the construction of the property and that no major repairs or replacements have taken place since.</p>

<p>Visual Review: Where checked, we observed no noticeable settlement or elevated shut-off valves, which may indicate an issue or possible break (detachment) of the buried service piping. We were unable to review majority of the buried services due to their concealment. We are unaware of any current issues regarding the domestic water supply systems or buried site services.</p>		
<p>Recommendations: While the buried piping may have a life expectancy that extends beyond the 30 year Report threshold, however it is quite possible that localized replacement and or repairs may be required. Allowances have been made for localized repairs to the buried piping, and are included with each asphalt repaving project. Refer to component S1 – Paving for further discussion.</p> <p>Distribution piping within individual units is assumed to be the responsibility of each Owner and has been excluded from this Report.</p>

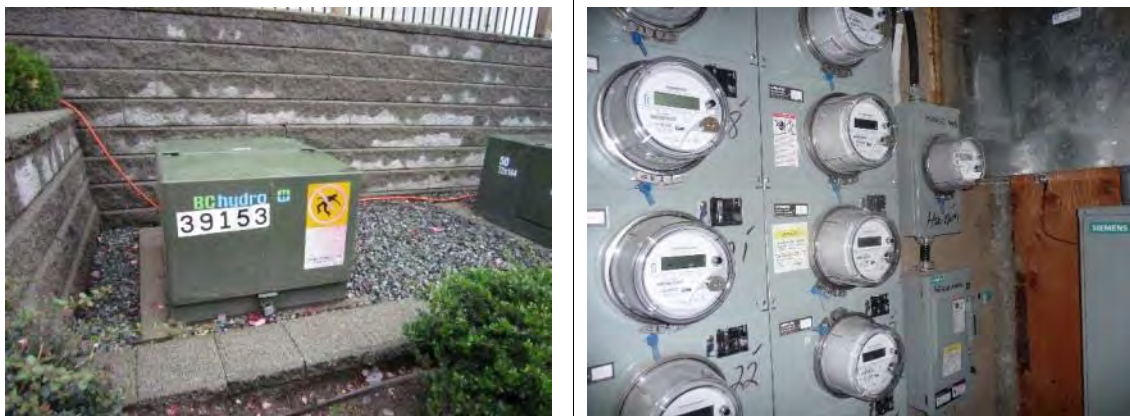
EL 1 — Electrical Systems (Building Distribution, Panels and Switches)		
Year Installed	2007	<p>Description: Electricity is supplied to the site via buried conduits that are fed from two pad-mounted transformers, located on the property. The transformers are marked and are assumed to be the property of B.C. Hydro. The transformers step the incoming service down to 120/240V. There are ten electrical closets throughout the site; one within the basement of the amenity building and nine that are attached to the ends of Buildings 3, 4, 7, 10, 11, 15, 20, 22 and 25. The electrical rooms distribute the service to attached units and the adjacent buildings.</p> <p>The electrical equipment in the amenity building has a meter center, service fourteen units, rated at 800A, 120/240V. There is a house panel rated at 600A, 120/240V and main switches rated at 600A, 120/240V in each electrical room.</p>
Expected Life Span	45+

Observed Condition	5	
Repair or Replace	22

<p>Financial Review: We understand that all electrical equipment and service lines are original to the construction of the property. We are unaware of any significant repairs or replacements that have taken place since.</p>		
<p>Visual Review: The electrical equipment, where checked, appeared to be functioning well with no visual defects.</p>		
<p>Recommendations: Electrical closets will typically last beyond 45 years. However, there is the possibility of failure due to material defects or poor installation. Animal infestation can also lead to damage to wiring.</p> <p>While we do not anticipate a full scale replacement of this component over the next 30 years, the plan allows for periodic upgrades occurring every 25 years. The plan allows for partial replacement of panels, switches and upgrades to electrical closets. The first instance is planned to occur in 2035.</p>

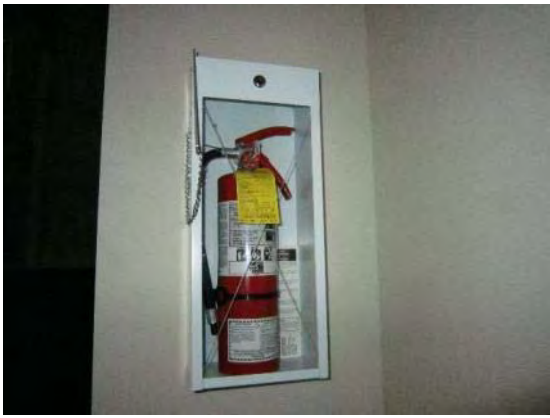
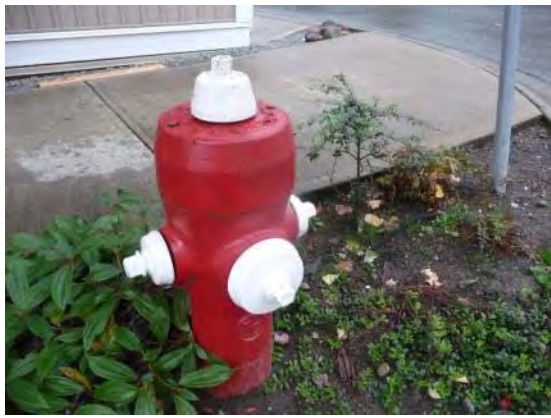
SS 2 — Suppression		
Year Installed	2007	Description: The site has a 4-inch buried main fire suppression line that runs below the main drive aisle that is fed from the municipal line below 196 Street. The line is assumed to enter the site at the south entrance of the property. The main line branches off to each individual unit.
Expected Life Span	30+	
Observed Condition	5	
Repair or Replace	19	<p>The amenity building is equipped with wall-mounted fire extinguishers.</p> <p>Building 4 is equipped with a sprinkler system. The sprinkler room is located at the north elevation of the building, where the wet sprinkler valve is located.</p> <p>There are three fire hydrants located on the property that are the responsibility of the Strata. The hydrants are serviced annually by Fraser Valley Fire Protection Ltd.</p>

<p>Financial Review: The suppression system is serviced by Fraser Valley Fire Protection Ltd. We are not aware of any significant issues regarding the system or equipment.</p>

<p>Visual Review: Our visual review revealed no noticeable damage to the suppression equipment, where checked.</p>		
<p>Recommendations: Eventually the fire hydrants and sprinkler system within Building 4 will require replacement, but are expected to surpass the 30 year term of this Report.</p> <p>Although full replacements are not expected to occur within the next 30 years, the plan allows periodic repairs including partial replacement of some suppression piping, should it be required, and replacement or major repair of the hydrants. The allowances are budgeted to occur every 20 years, with the first instance starting in 2032.</p>

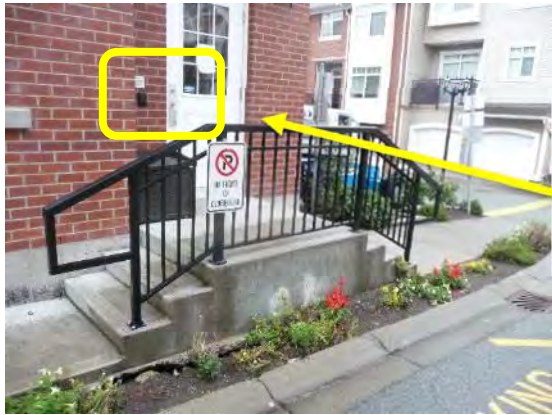
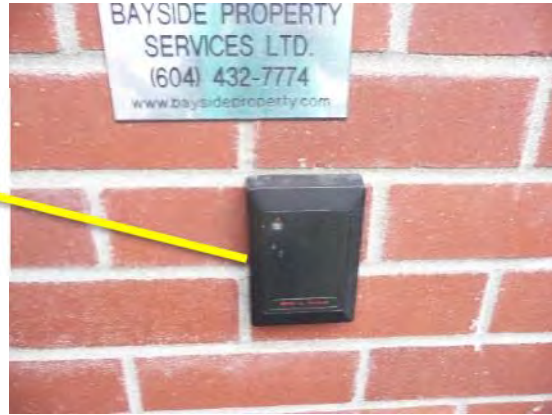
SS 3 — Amenity - Access Control & Security System

Year Installed	2013	Description: Access into the amenity building, and its various rooms, is granted with a fob access control system. There are about 5 fob scanners located throughout the building. The amenity building also has a security system with interior and exterior security cameras. The cameras are monitored onsite and the digital equipment is located in the electrical room in the basement.
Expected Life Span	15-20	
Observed Condition	1	
Repair or Replace	14

Visual Review: We are unaware of any major issues with the system. Because they were installed this year, and our visual review revealed no defects, we assumed that they were in good condition.

Recommendations: Over time new technologies are expected to emerge making older systems eventually obsolete, due to difficulty in finding replacement parts. As the systems installed at the amenity building are quite new, the plan allows for future upgrades to occur at the later part of their typical life expectancies.

The plan allows for the replacement of the amenity building security and access control systems at the end of their expected life term in 15 years.

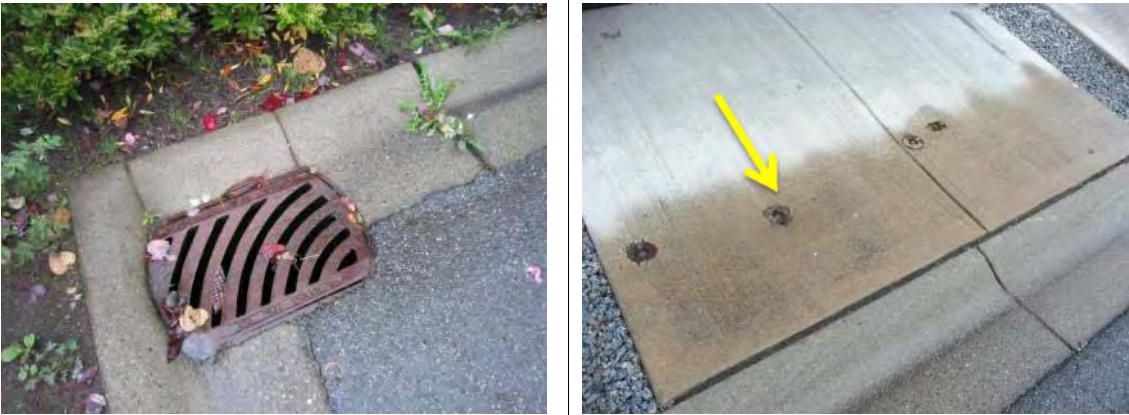
SRV 1 – Buried Site Services		
Year Installed	2007	Description: Site services including domestic water, incoming gas and sanitary and storm drainage systems are all located below grade. Concrete catch basins with steel grate covers are located throughout the site for drainage. The site has PVC sanitary and sewage piping lines that are connected to the buried municipal sewage line.
Expected Life Span	50+	
Observed Condition	5	
Repair or Replace	28

<p>Financial Review: We understand that all buried site service lines are original to the construction of the property. We are unaware of any major repairs or replacements that have taken place since.</p>		
<p>Visual Review: We were unable to review the buried lines at the time of our visit. The site was generally free of ponding water and appeared to have adequate drainage.</p>		
<p>Recommendations: We assume that the underground services and drainage have a remaining life that extends beyond the scope of this Report; therefore full replacements have not been considered. However, over time it is expected that repairs and localized replacement of sections of the buried piping will be required due to unplanned damage from occurrences such as natural settlement above and below the buried piping, soil erosion and seismic activity.</p> <p>We have included in the plan allowances for periodic repairs to buried site services to occur as part of the paving and landscaping repairs or replacements. Refer to component box Site 1 – Paving and Curbing for further discussion.</p>

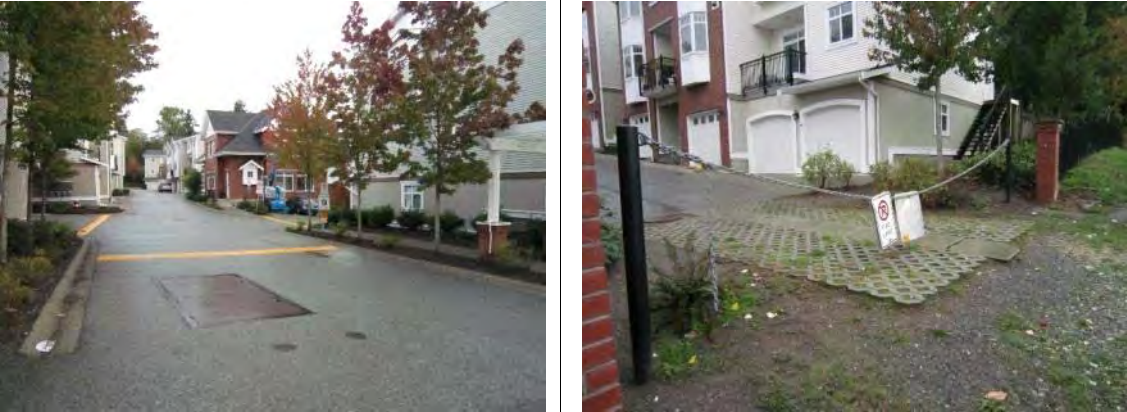
Site 1 — Paving & Curbing		
Year Installed	2007	Description: The site is accessed by a main curb cut that is located at the south side of the property, off of 66 Avenue. There is a main drive aisle that is primarily paved with asphalt. There is a fire lane entrance located at the northeast corner of the site, off of 196 Street, that is partially paved with precast concrete pavers (right photo). Visitor parking spaces consist of asphalt and some concrete paved areas. Cast-in-placed rolled-style concrete curbing outlines the perimeter of the main drive aisle. There are small concrete driveways at garage entrances. The driveways also extend to the unit entrances in many locations.
Expected Life Span	30-35	
Observed Condition	5	
Repair or Replace	28

Visual Review: We noted no major cracking or settlement at the time of our visit. Localized settlement was noted at some edges of the precast paver area along the curbing.		
Recommendations: The paved areas are susceptible to damage including cracking due to settlement and overloading, soil erosion and wear due to frequent traffic. An allowance for repaving all areas of the asphalt drive aisle has been included in the plan to occur in 28 years, on a 30 year cycle. This budget also allows for replacement of 10% of the cast-in-place concrete curbing each cycle. Localized re-setting and levelling of the pavers at the visitor parking areas is assumed to be minimal and to be funded by general maintenance and or landscaping funds.

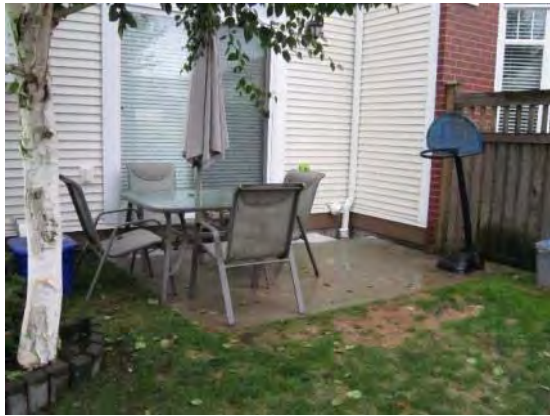
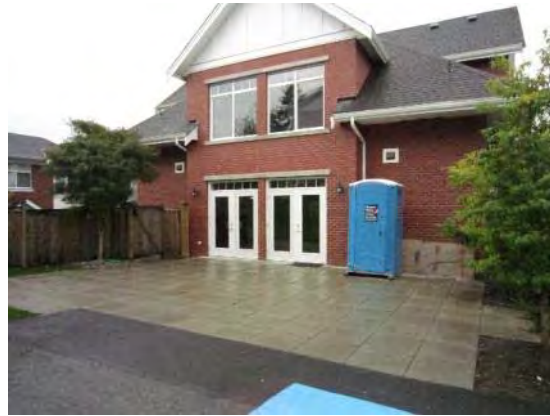
Site 2 – Concrete Staircases, Patios & Walkways

Year Installed	2007	Description: There are some cast-in-place concrete staircases located at entrances of units along 66 th Avenue and 196 th Street. There are also walkways, patios and outdoor areas that are constructed of cast-in-place concrete and concrete pavers.
Expected Life Span	25+	
Observed Condition	5	
Repair or Replace	20

Visual Review: There was generally no significant settlement of the walkways, where checked. Overall the staircases, patios and walkways appeared to be well maintained and in good condition.

Recommendations: Similar to the asphalt paved areas, concrete paved areas are susceptible to damage including cracking due to settlement and overloading, soil erosion and wear due to frequent traffic.

The plan allows for localized replacement of approximately 25% of the component to occur every 25 years, the first project has been planned in 2033. As the property is relatively newer, and if conditions change as it ages, future updates can be adjusted.

We assume that minor maintenance including localized repairs and/or replacements to settled and cracked areas will be addressed under the general landscaping budget.

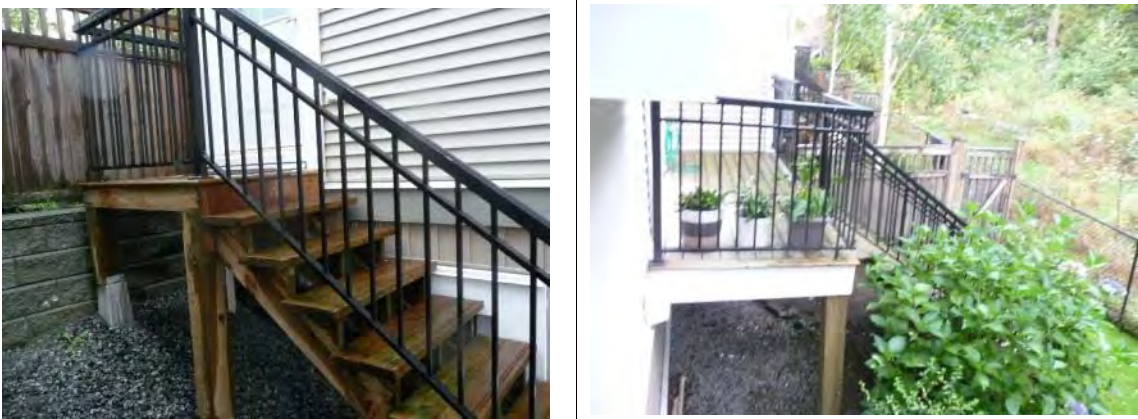
<p>Financial Review: We understand that the wood-framed decks are part of the original construction of the property.</p>		
<p>Visual Review: The decks are typically exposed to the elements. We did not note any significant settlement or cracking of the exposed wood framing components or of the concrete pier footings, where checked.</p> <p>We noted a few areas where landscaping was in close proximity to wood components. This may promote premature deterioration of the wood components over time and monitoring and maintenance of the vegetation should be devoted to ensure that proper clearance of the vegetation from the wood is kept.</p>

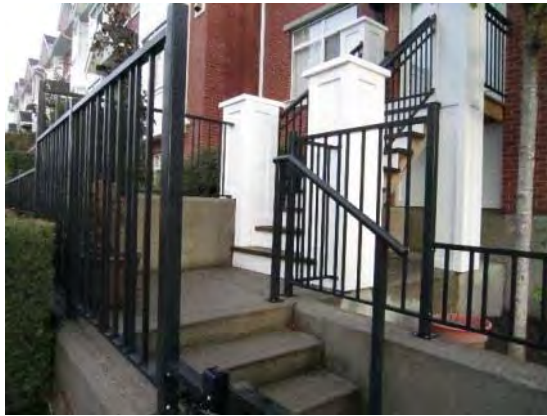
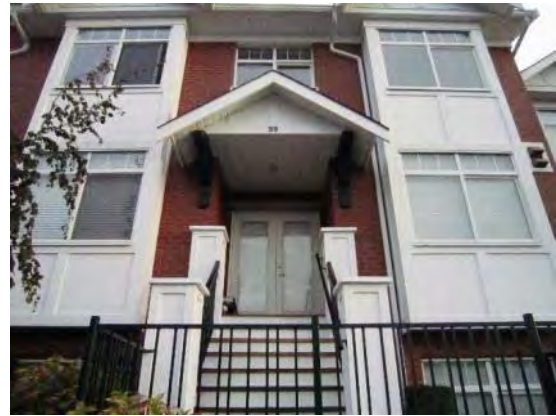
Site 4 – Site & Staircase Guards		
Year Installed	2007	Description: Guards and railings are installed along the top of the concrete retaining walls and at staircases throughout the site. The assemblies consist of prefinished aluminum picket-style guards that are supported by aluminum posts, which are anchored to the concrete retaining walls.
Expected Life Span	20-40	
Observed Condition	5	
Repair or Replace	12

Visual Review: We did not perform any physical testing regarding strength and code compliance of the guards. We assume that the necessary safety procedures including physical testing was performed after the construction and installation of the guards. We did not note any gaps greater than 4 inches, where checked.

Recommendations: Aluminum guards, when properly installed and maintained, have a typical lifespan of between 20-40 years.

While we do not expect a full replacement during the term of this report, we do anticipate periodic repair projects to sections. We have included in the budget a replacement of 20% of the aluminum site guards and railings in 12 years on a 20 year cycle.

We recommend that along with the annual inspection of the balcony and terrace assemblies the Strata also take note and monitor the condition of the guards.
