6322.002
Manhattan Skye
Window Review

REGARDING **Window Review**

As requested by The Owners, Strata Plan BCS2401 (Owners), RDH Building Science Inc. (RDH) is pleased to provide this report of a window review for the townhouse complex known as Manhattan Skye, located at 19551 66th Avenue, Surrey, BC.

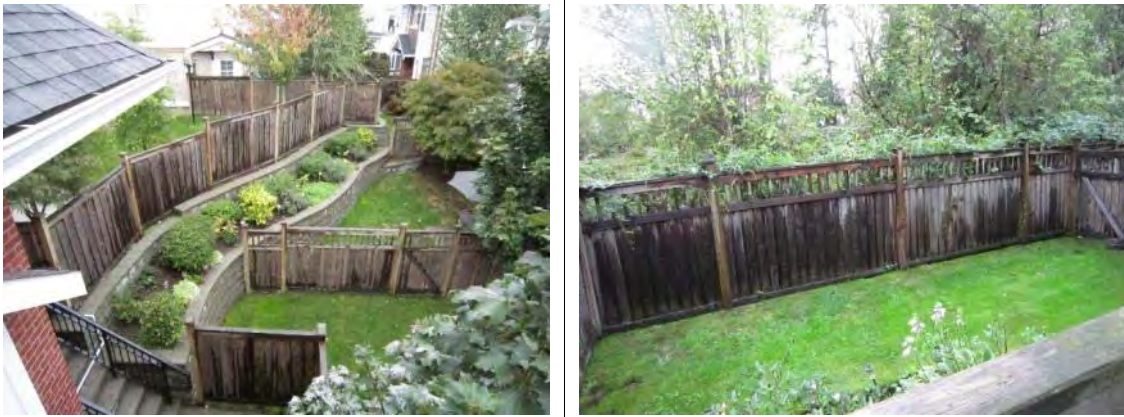
Site 5 — Fencing & Yard Dividers		
Year Installed	2007	Description: The property has various types of fencing. The west side of the property has pressure-treated wood, painted wood and galvanized chain-link fencing. Interior yard fencing consists of pressure-treated wood privacy fencing.
Expected Life Span	15-25	
Observed Condition	5	
Repair or Replace	15

<p>Financial Review: We understand that all fencing components are original to the construction of the site and that no major upgrades or replacements have occurred since.</p>		
<p>Visual Review: We noted no major deterioration along the wood fencing, where checked. The galvanized steel chain-link fencing was standing freely with no signs of tilting or leaning at the areas reviewed. The base of the fencing support posts were typically in direct contact with the ground.</p>		
<p>Recommendations: As the materials age and are exposed to the elements they will begin to deteriorate. Areas of concern are the base of the wood support posts, where the wood is in direct contact with the soil, and where metal hinges at gates and locks begin to rust due to prolonged exposure to the elements.</p> <p>The plan allows for a replacement project of fencing occurring in 15 years, on a 20 year cycle.</p> <p>For maintenance, we recommend periodic monitoring and maintenance including painting and treating the wood components and replacement of corroded metal hinges will assist in premature replacement.</p> <p>We assume that isolated repair and replacement of sections of fencing will be covered under regular maintenance and operation funds.</p>
