**Willowdale Court  
Plan No. VIS2934**

**Depreciation Report  
Effective: October 1, 2022  
Submitted: September 6, 2022**

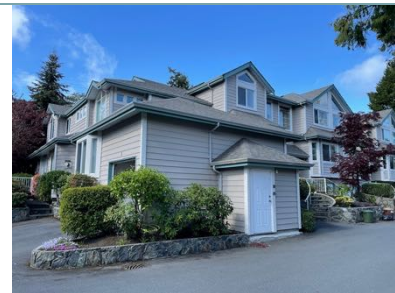
Cladding is the outer layer of the building envelope, with the highest exposure to environmental elements. It is intended to prevent the passage of air and water into the underlying assembly. Wood based systems require frequent painting to prevent water infiltration which can result in swelling, or other deformation of the materials.

Exterior coatings provide a shield between underlying materials, and the agents of degradation which can have a detrimental effect on those materials. Exterior coatings should be inspected on a regular basis with deficiencies corrected upon discovery between regular paint cycles. Special attention should be paid to south facing, or non-shaded areas.

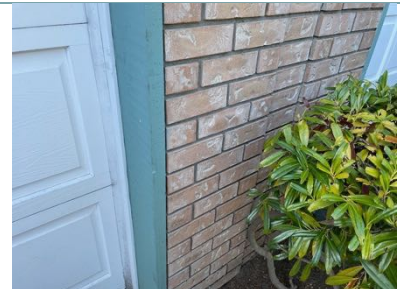
When installed as a facing material, masonry is described as a veneer.

Masonry is a porous material, and although they can become wet, they dry out easily. Preventing moisture from migrating in to the interior materials is generally accomplished through a weather barrier, or drainage cavity.

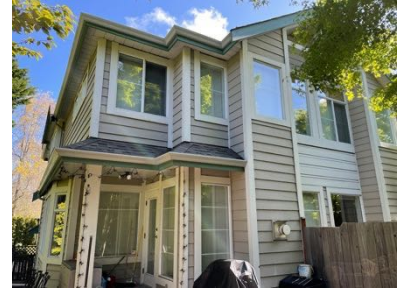
Dual-glazed windows are installed to provide light into the building, while preventing the passage of moisture or air. Sealed units also serve to reduce thermal losses by providing insulative qualities to the component.

Windows should be inspected regularly, and any deficiencies corrected upon discovery. Examples of defects include failure of sealed units, physical damage, caulking failure, poor operation and warping.

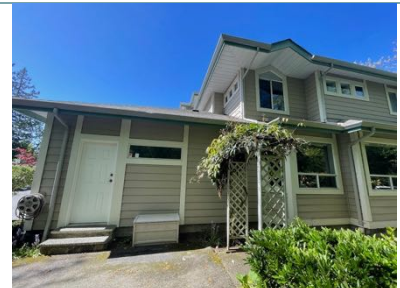
Exterior doors are typically insulated, and coated to protect underlying materials. The perimeter of the doors have a weather stripping to prevent the passage of air or water into the building.

Metal clad raised panel, and solid wood doors including a viewing lite provide access to the front and rear of units where installed. Adverse degradation was not present in samples observed.

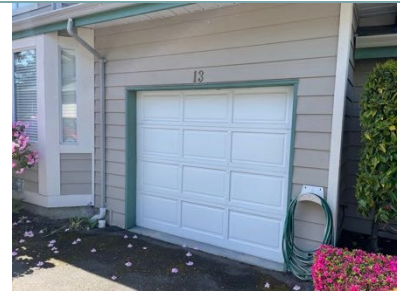
Overhead doors are constructed of hinged panels constructed of a variety of materials. Sectional overhead doors operate through manual or mechanical means.

No adverse degradation is apparent in samples observed. Reserve funds are not allocated for the operators, as they reside within the individual units.

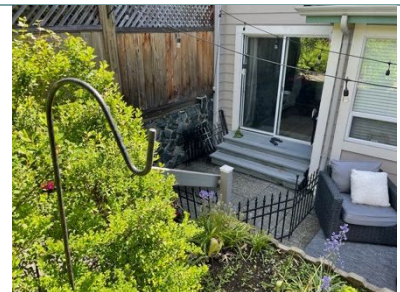
Each outside unit includes sliding patio door.

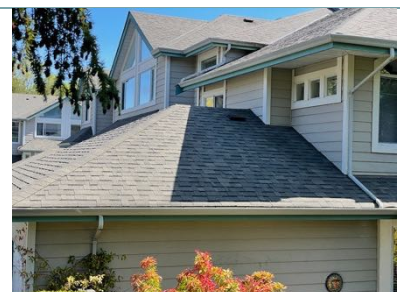
Composite shingles are installed to facilitate water movement away

from the building. Potential deterioration of asphalt shingled roofs includes granule loss, buckling or cracking, distortion, or missing materials. Blistering of the shingles can also occur caused by vaporization and expansion when the shingles are heated (e.g., poorly vented attic). Buckling of the shingles is another common form of deterioration caused by swelling and restraint of the shingle mat by the roofing nails.

Roofing should be inspected regularly to ensure the integrity of the building envelope is maintained. Deficiencies should be corrected upon discovery.

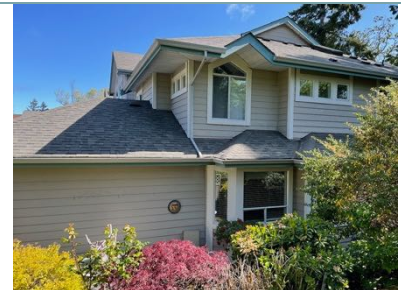
Gutters are part of the rainwater system downstream of the roof which provides the means by which rainwater may be collected and directed away from the building surface and footprint. They should be regularly inspected to ensure that they remain free of debris so they may function as intended.

Downspouts are part of the rainwater system downstream of the gutter which provides the means by which rainwater may be directed away from the building.

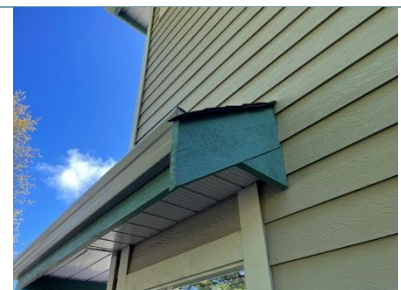
Soffit is installed on the underside of horizontal surfaces providing

protection to the underlying materials. Vented soffit provides airflow required to prevent condensation and moisture buildup within building cavities.

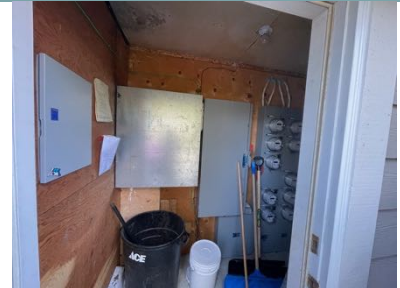
Electrical distribution includes two 600 amp service switches, and a 400 amp service housed in three maintenance areas. The main switches feed house subpanels, and individual unit meters.

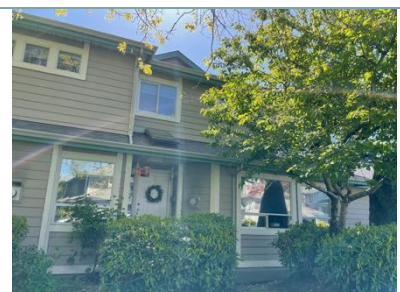
Exterior lights are installed at each pedestrian access point. It is observed that some individuals have installed alternative fixtures. Where original fixtures are present, average condition is observed.

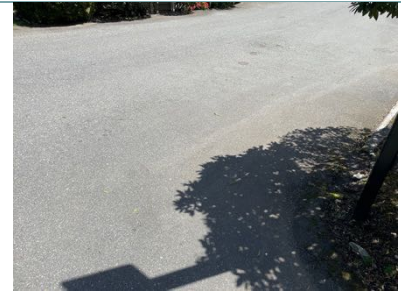
Asphalt pavement is subject to damage from substrate erosion; freeze thaw cycles, impacts, heat, chemicals (road salt) and wear and tear.

Regular maintenance of asphalt paving to fill large cracks, potholes or locations where standing water is present will help maximize the useful life of the component. If maintenance is not performed, the lot will likely not achieve the expected lifespan. Ongoing maintenance including crack filling and sealing should be undertaken on an annual basis to maximize the lifespan of the asphalt.

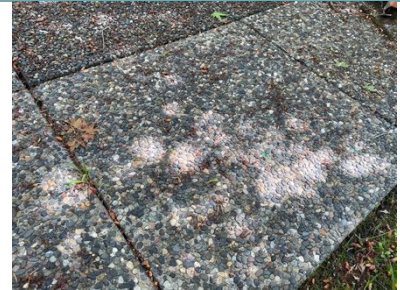
Concrete pavers are installed at front and rear access points.

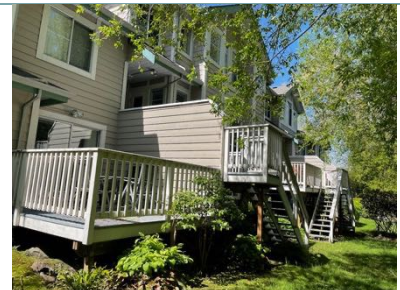
Wood decks are installed at the rear of building D. The decks appeared to be in average condition.

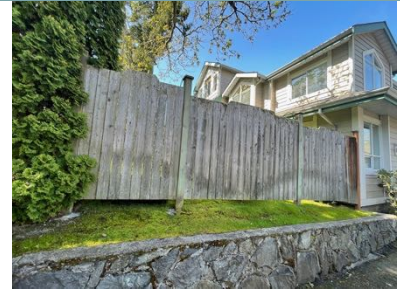
Wood fencing will degrade from exposure to outdoor elements such as water and sun. Moisture will cause the wood to expand and contract when it dries, potentially causing warping, cracking, and splitting. Should the wood stay wet for long periods it has the potential to develop rot. Ongoing maintenance and inspections should be undertaken to ensure the wood fences reach their maximum lifespan.

Some repairs were made to the fencing in 2014/16. Where observed the fence is in fair condition.

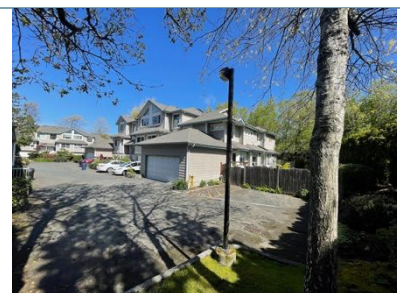
Illumination of parking areas is made up of pole mounted fixtures on metal standards founded on concrete piles.

No Adverse degradation is apparent in samples observed; as they were viewed in daylight hours, operation is assumed.
