**To: The Owners, Strata Plan EPS284  
c/o Mr. Roger Maftechuk  
Firm Management Corp  
#200-1931 Mt. Newton Cross Road  
Saanichton BC V8M 2A9**

**Site Visit: April 13, 2018  
Submitted: July 16, 2018 by  
RDH Building Science Inc.  
3795 Carey Road #500  
Victoria BC V8Z 6T8**

# 1 Introduction

## 2 Pacific Walk

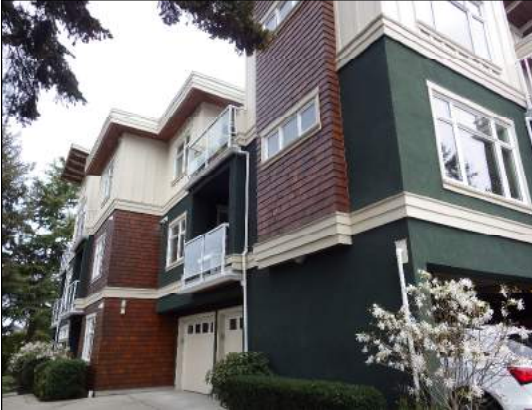
<p><i>Figure 2.1 Representative elevation photograph of Pacific Walk</i></p>	Date of first occupancy (approximate)	2010
	Gross floor area (ft <sup>2</sup> )	17,900
	Stories above grade	3 plus roof deck
	Total number of strata lots	12

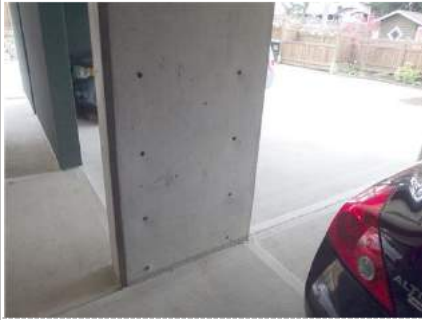
### Struct 01 - CIP Concrete Foundation

#### Location

Building foundation.

Service Life:	75
Installed Year:	2010
Chronological Age:	8
Effective Age:	8
Next Renewal Year:	2085

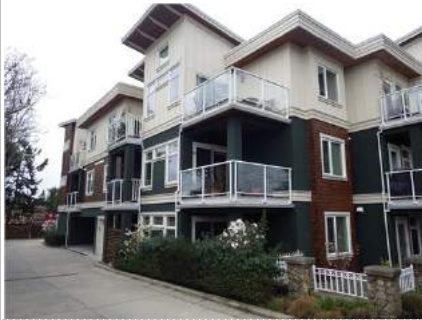
### Struct 02 - Wood Frame Structure

#### Location

Building superstructure.

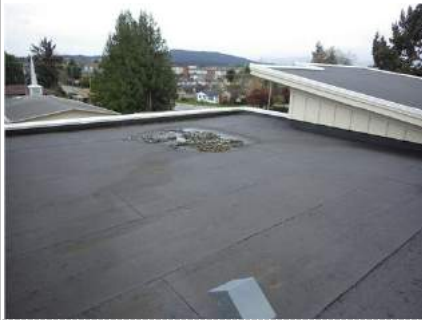
#### Encl 01 - Exposed SBS Membrane Roof and Deck

Main sloped and low-sloped roofs.

- Encl 01 Exposed SBS Roof Membrane and Deck - Commission a roof assessment and implement maintenance as recommended.
- Encl 06 Stucco Clad Wall - Drained - Re-paint stucco surface as required.

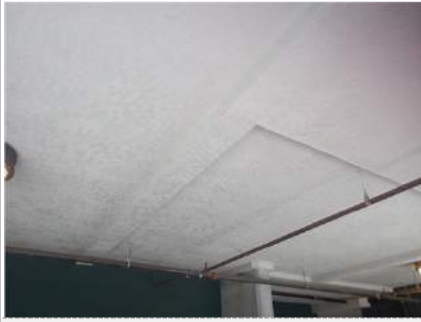
### Encl 03 - Stucco Clad Soffit

#### Location

Above parking areas.

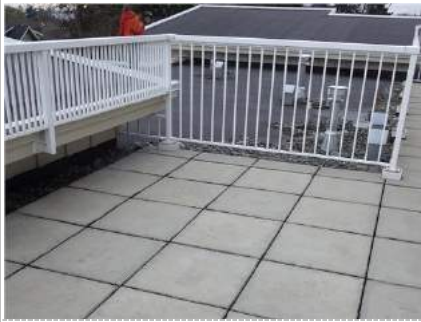
#### Encl 04 - Aluminum Guardrail

#### Location

Roof deck perimeter and portions of some balconies.

Service Life:	30
Installed Year:	2010
Chronological Age:	8
Effective Age:	8
Next Renewal Year:	2040

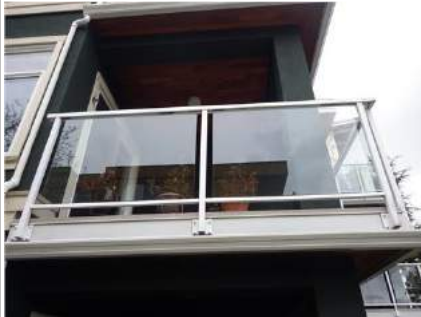
#### Encl 05 - Glazed Aluminum Guardrail

#### Location

Balcony perimeters.

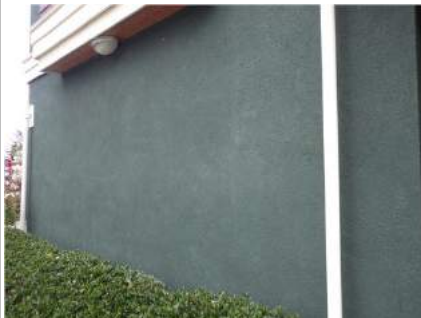
#### Encl 06 - Stucco Clad Wall - Drained

Primary exterior wall cladding.

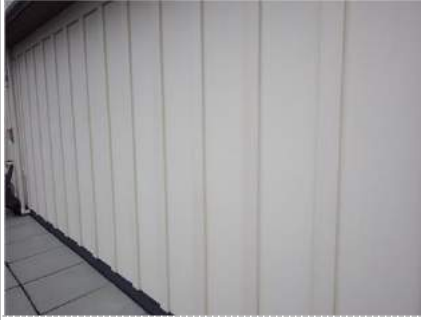
### Encl 07 - Fiber Cement Wall - Drained

Secondary exterior wall cladding.

- Encl 07 Fiber Cement Wall - Drained - Repaint fiber cement cladding.
- Encl 09 Wood Trim - Prepare and re-coat (6-year cycle). Anticipate the need to locally repair and touch up paint wood trim, as required (2-year cycle).

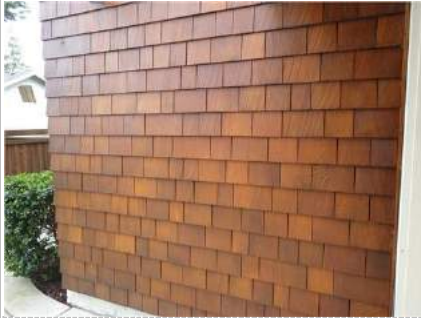
### Encl 08 - Wood Shingle Wall - Drained

#### Location

Tertiary exterior wall cladding.

Service Life: 30  
 Installed Year: 2010  
 Chronological Age: 8  
 Effective Age: 8  
 Next Renewal Year: 2040

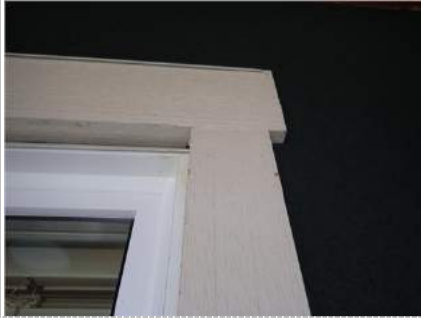
### Encl 09 - Wood Trim

Roof fascias, bands at each level, and around windows and doors.

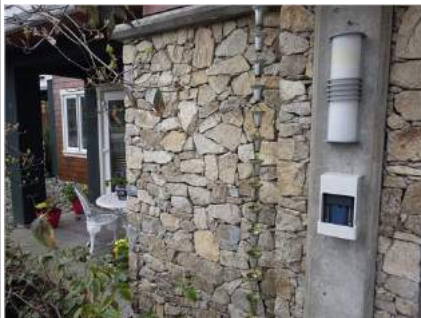
### Encl 10 - Cultured Stone Wall - Drained

#### Location

At the front entrance.

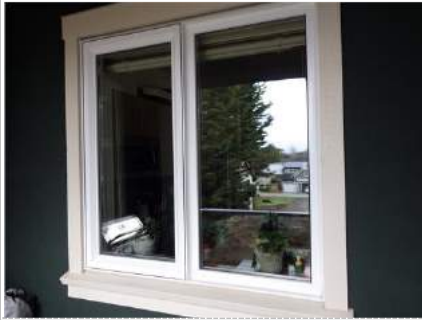
#### Encl 11 - Vinyl Framed Window

**Location**

All elevations and all levels of the building.

- Anticipate the replacement of insulated glazing units (IGUs) with condensation or misting between panes of glass (two-year cycle). Some affected assets include:

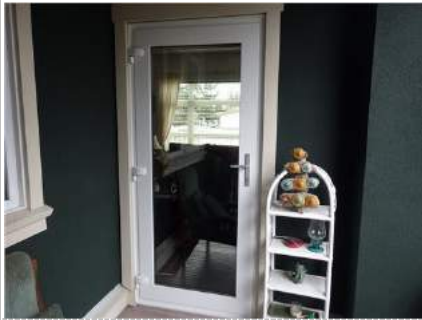
#### Encl 12 - Vinyl Frame Glazed Swing Door

**Location**

At select balconies and patios.

Service Life:	25
Installed Year:	2010
Chronological Age:	8
Effective Age:	8
Next Renewal Year:	2035

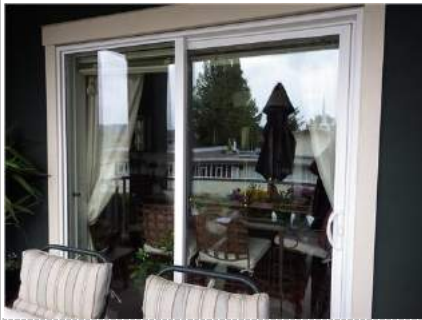
#### Encl 13 - Vinyl Framed Sliding Glass Door

**Location**

At select balconies and patios.

Service Life:	30
Installed Year:	2010
Chronological Age:	8
Effective Age:	8
Next Renewal Year:	2040

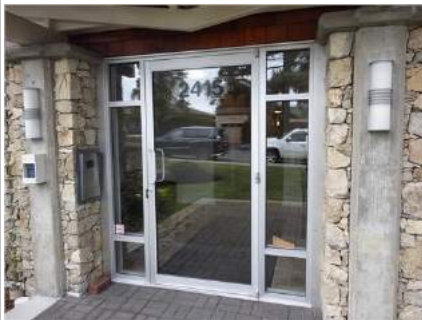
#### Encl 14 - Aluminum Frame Lobby Door

**Location**

Lobby entrance door.

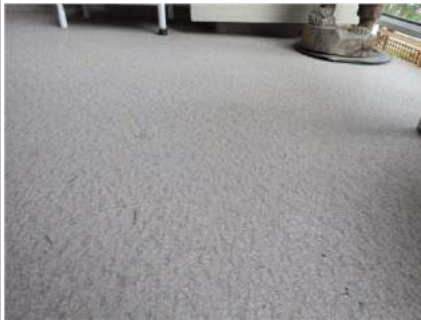
### Encl 16 - Exposed Vinyl Balcony Membrane

Balconies.

- Encl 16 Exposed Vinyl Balcony Membrane – Replace vinyl balcony membrane and associated components.

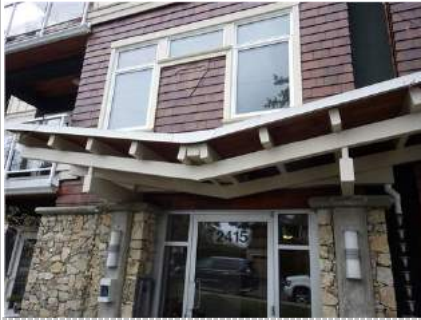
### Encl 17 - Metal Canopy

TABLE 3.2 OBSERVATIONS BY SYSTEM	
SYSTEM	OBSERVATION
Building Enclosure	→ Some crazing and degranulation of the low slope roof membrane was observed
	→ Superficial corrosion of the exposed metal frame beneath the main entrance canopy was observed
Site work	→ Staining was observed on sections of wood fencing

Above the front entrance.

- Encl 17 Metal Canopy
- Encl 20 General & Inspections - Perform 10-year extended warranty review in sufficient time prior to expiration of warranty period for certain portions of the work. Prepare list of any deficiencies for correction.

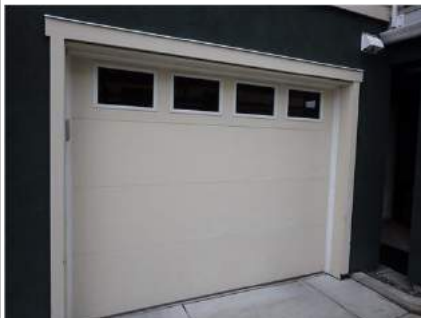
### Encl 18 - Sectional Overhead Door

#### Location

Garages for strata lots 1, 2, and 12.

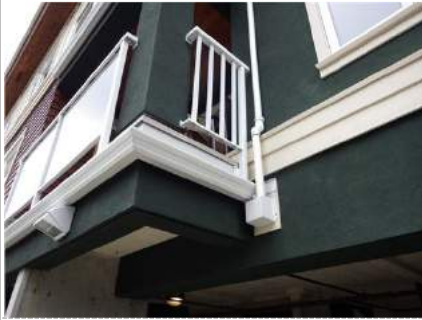
#### Encl 19 - Aluminum Gutter & Rainwater Leader

##### Location

Balcony perimeters.

Service Life:	20
Installed Year:	2010
Chronological Age:	8
Effective Age:	8
Next Renewal Year:	2030

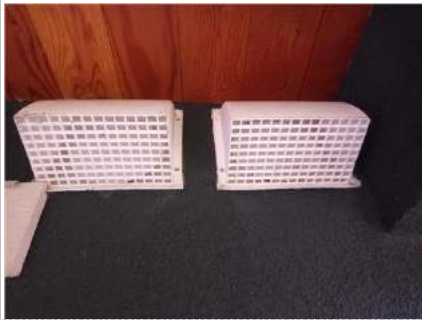
#### Encl 20 - General & Inspections

##### Location

Throughout the site.

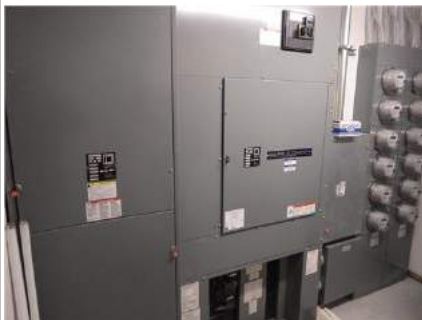
#### Elec 01 - Electrical Distribution

Electrical room.

- Elec 01 Electrical Distribution Conduct infrared scanning to verify that terminations are sound and operating temperatures of all conducting parts are within allowable limits. Correct any conditions contributing to overheating if it occurs (5-year cycle).

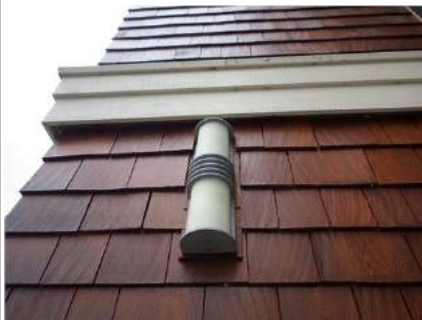
#### Elec 02 - Exterior Light Fixtures

##### Location

At balconies, patios, building entrances, soft landscaping, and in the parking area.

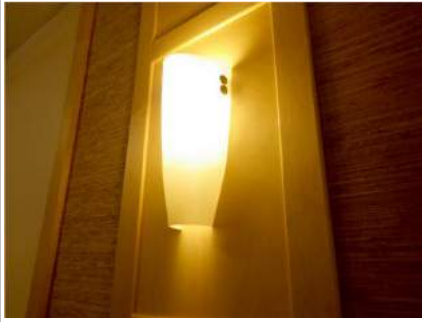
### Elec 03 - Interior Light Fixtures

**Location**

All common areas throughout the building.

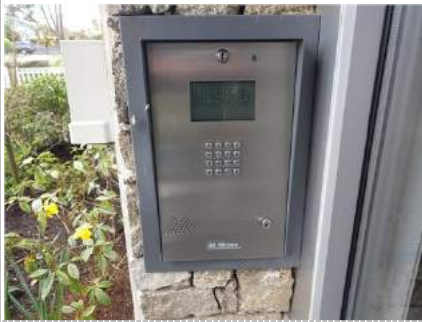
#### Elec 04 - Enterphone System

**Location**

Front entrance.

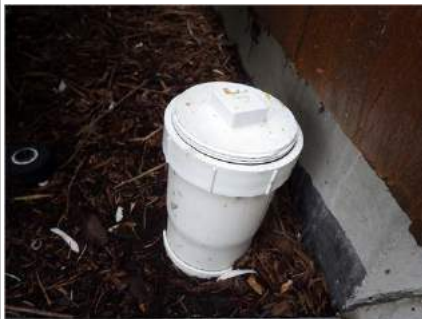
##### Mech 01 - Drainage - Perimeter and Foundation

**Location**

Perimeter of building.

Service Life: 40  
 Installed Year: 2010  
 Chronological Age: 8  
 Effective Age: 8  
 Next Renewal Year: 2050

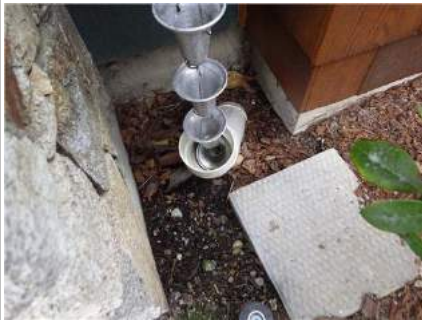
##### Mech 02 - Drainage - Storm - Exterior System

**Location**

Perimeter of building.

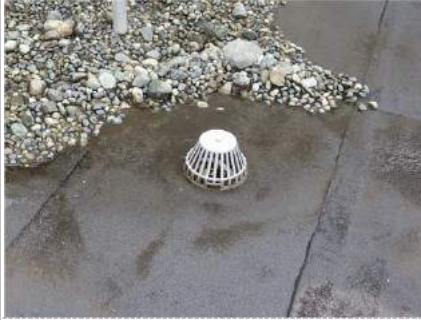
### Mech 03 - Drainage - Storm - Internal

**Location**

Throughout the building.

Service Life: 40  
 Installed Year: 2010  
 Chronological Age: 8  
 Effective Age: 8  
 Next Renewal Year: 2050

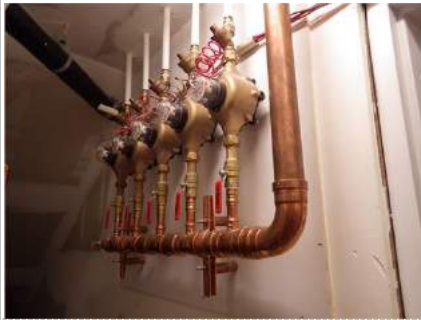
### Mech 04 - Piping - Domestic Water Distribution

**Location**

Connected to fixtures throughout the building.

Service Life: 35  
 Installed Year: 2010  
 Chronological Age: 8  
 Effective Age: 8  
 Next Renewal Year: 2045

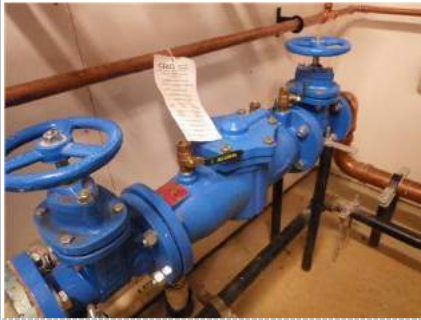
### Mech 05 - Valves - Cross Connection & Backflow Prevention

**Location**

Mechanical room.

Service Life: 20  
 Installed Year: 2010  
 Chronological Age: 8  
 Effective Age: 8  
 Next Renewal Year: 2030

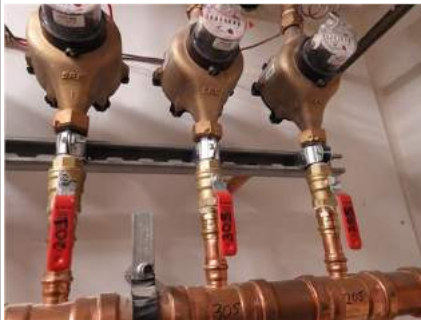
### Mech 06 - Valves - Plumbing Flow Control and Directional

**Location**

Mechanical room.

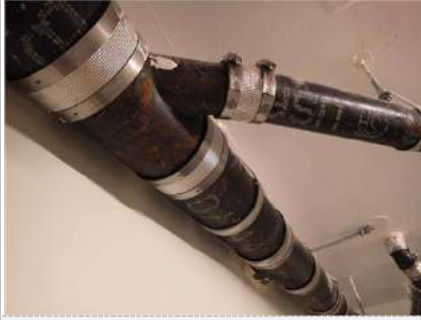
### Mech 07 - Drainage - Sanitary

#### Location

Connected to waste fixtures throughout the building.

- Jetflush or auger the following drainage assets and insert video cameras into the main lines to conduct pipe inspection (completed on a 5-year cycle):
  - Mech 11 - Drainage - Storm - Perimeter & Foundation
  - Mech 10 - Drainage - Storm - Exterior System
  - Mech 08 - Drainage - Storm - Internal
  - Mech 07 - Drainage - Sanitary

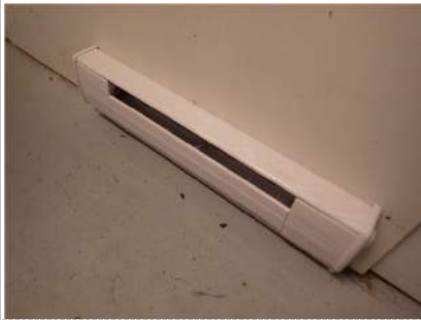
### Mech 08 - Baseboard - Electric

#### Location

Stairwells and service rooms.

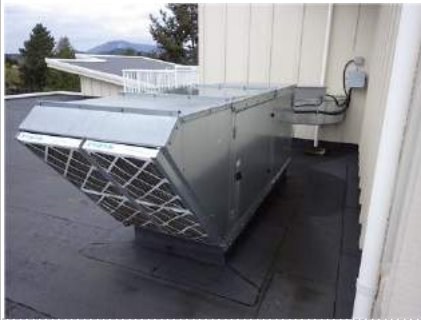
### Mech 09 - Air Handler - Make Up Air Unit

#### Location

Rooftop.

Service Life:	20
Installed Year:	2010
Chronological Age:	8
Effective Age:	8
Next Renewal Year:	2030

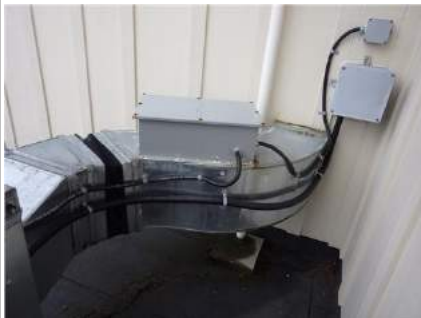
### Mech 10 - Coil - Electric - Duct Heater

#### Location

Rooftop, downstream of make up air unit.

- Mech 10 Coil – Electric – Duct Heater – Replacement of electric duct heater.

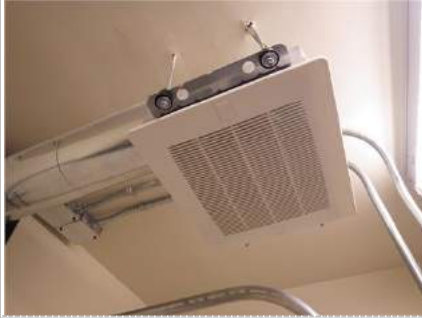
### Mech 11 - Exhaust Fan - Small Service

#### Location

In the bicycle and elevator machine room.

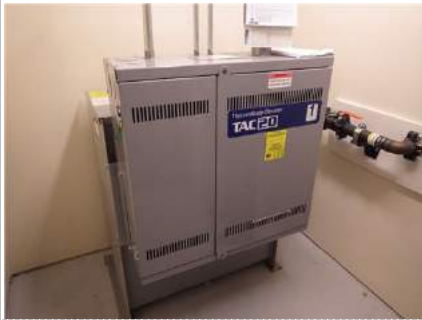
### Elev 01 - Hydraulic Elevator

#### Location

Elevator machine room.

Service Life:	25
Installed Year:	2010
Chronological Age:	8
Effective Age:	8
Next Renewal Year:	2035

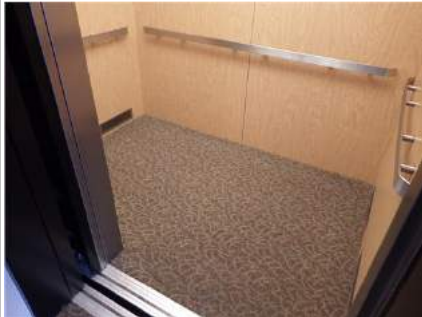
### Elev 02 - Elevator Cabs & Hoistway

#### Location

Elevator shaft.

- Elev 02 Elevator Cabs and Hoistway – Replace elevator interior finishes, and the operating and signal fixtures, including cab phones.

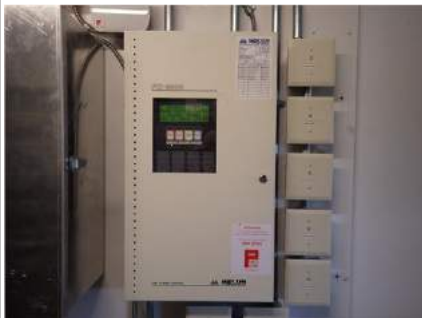
### Fire 01 - Fire Alarm Panel - Addressable

#### Location

Electrical room and front entrance.

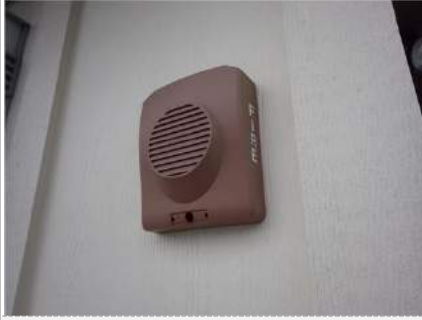
### Fire 02 - Fire Detection & Alarm

#### Location

Throughout the building.

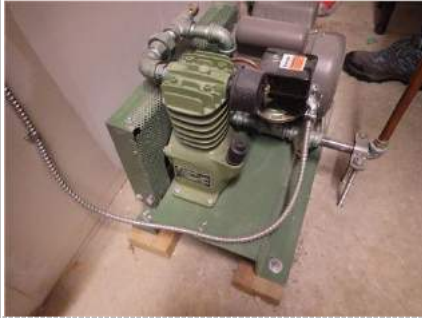
### Fire 03 - Dry Sprinkler Compressor

Mechanical room.

- Fire 03 Dry Sprinkler Compressor – Replace fire sprinkler compressor.

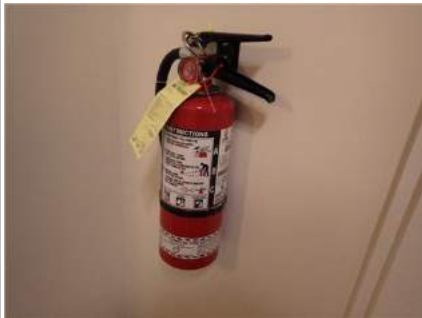
### Fire 04 - Portable Fire Extinguisher

#### Location

Throughout the building.

Service Life:	24
Installed Year:	2010
Chronological Age:	8
Effective Age:	8
Next Renewal Year:	2034

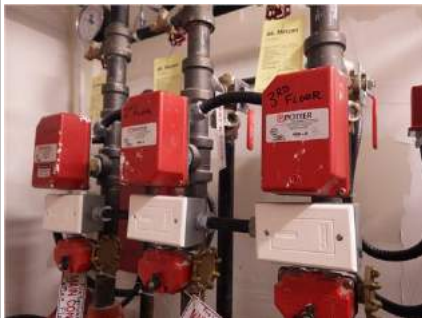
### Fire 05 - Sprinkler & Standpipe - Wet

#### Location

Throughout the building.

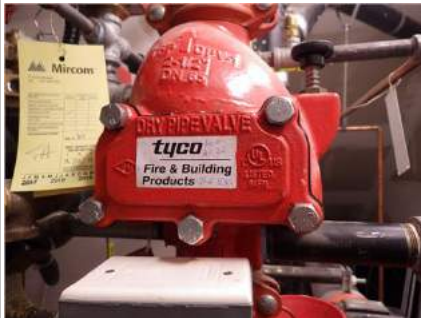
### Fire 07 - Sprinkler Valve Assembly - Dry

#### Location

Mechanical room.

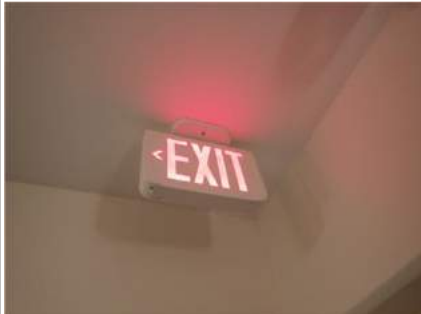
### Fire 08 - Emergency Egress Equipment

#### Location

Throughout the building.

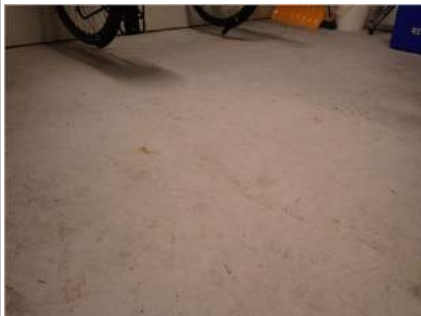
### Finish 01 - Painted Concrete Flooring

#### Location

Service rooms.

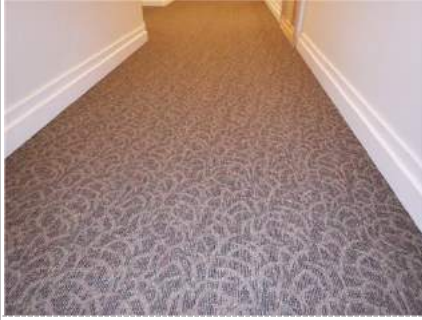
### Finish 02 - Sheet Carpet

Common hallways and stairwells.

Service Life: 10  
 Installed Year: 2010  
 Chronological Age: 8  
 Effective Age: 8  
 Next Renewal Year: 2020

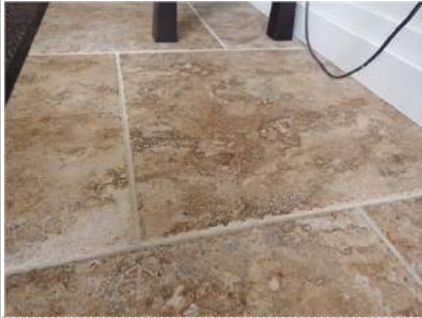
### Finish 03 - Floor Tile

Front entrance lobby.

Service Life: 25  
 Installed Year: 2010  
 Chronological Age: 8  
 Effective Age: 8  
 Next Renewal Year: 2035

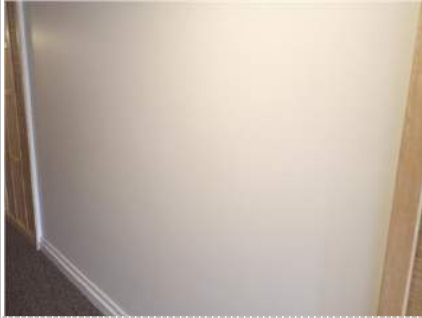
### Finish 04 - Paint

Common hallways and stairwells.

Service Life: 10  
 Installed Year: 2010  
 Chronological Age: 8  
 Effective Age: 8  
 Next Renewal Year: 2020

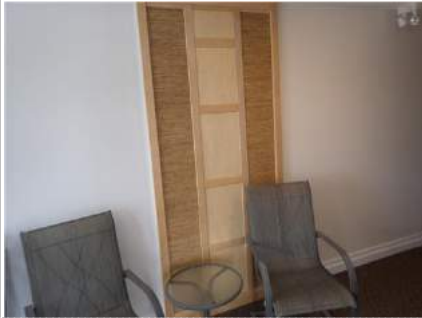
### Finish 05 - Wood Paneling

Common hallways.

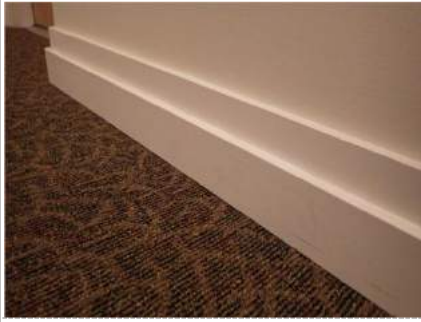
### Finish 06 - Baseboard, Molding and Casing

Common areas throughout the building.

Service Life: 40  
Installed Year: 2010  
Chronological Age: 8  
Effective Age: 8  
Next Renewal Year: 2050

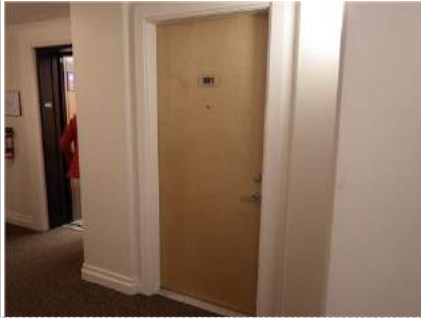
### Finish 07 - Interior Swing Door - General

Unit entry, service room, and stairwells.

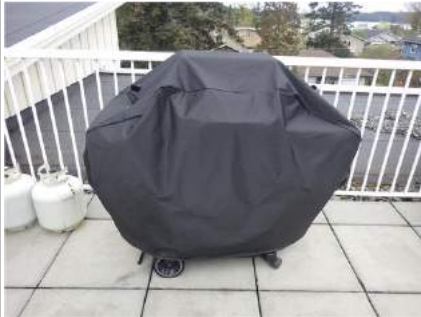
### Amen 01 - Outdoor Barbecue

Roof deck.

Service Life: 10  
Installed Year: 2017  
Chronological Age: 1  
Effective Age: 1  
Next Renewal Year: 2027

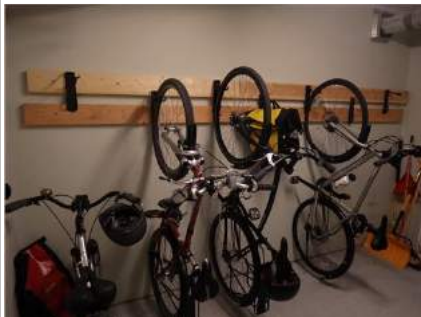
### Amen 02 - Bicycle Rack

Bicycle room.

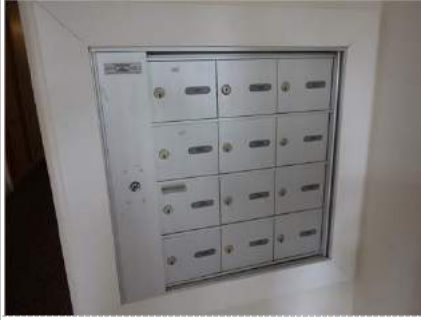
### Amen 03 - Central Mailboxes

Front entrance lobby.

Service Life: 30  
 Installed Year: 2010  
 Chronological Age: 8  
 Effective Age: 8  
 Next Renewal Year: 2040

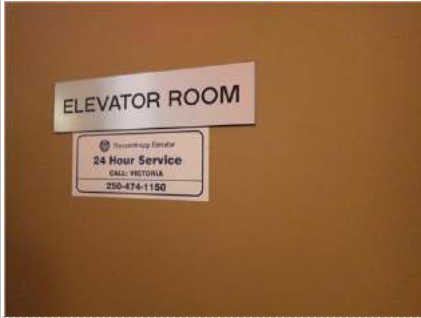
### Amen 04 - Public Signage

Throughout common areas.

Service Life: 25  
 Installed Year: 2010  
 Chronological Age: 8  
 Effective Age: 8  
 Next Renewal Year: 2035

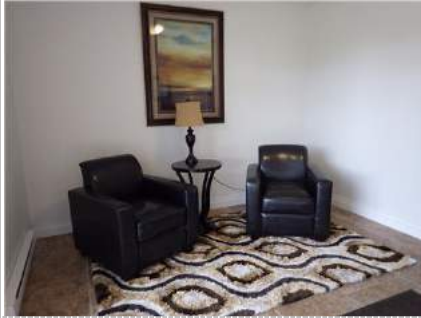
### Amen 05 - Furniture and accessories

Front entrance lobby.

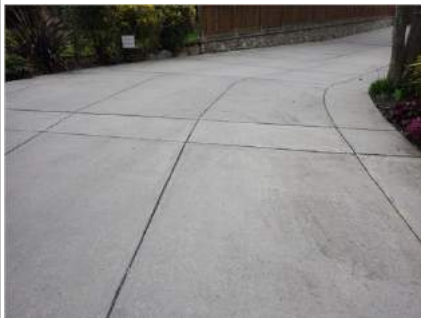
#### Site 01 - Concrete Paving Driveway

Driveway and parking areas.

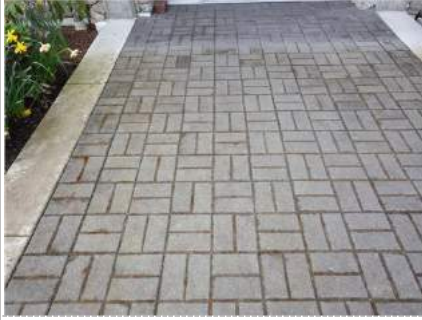
### Site 02 - Interlocking Unit Paving Driveway/Walkway

Front entrance walkway.

Service Life: 40  
 Installed Year: 2010  
 Chronological Age: 8  
 Effective Age: 8  
 Next Renewal Year: 2050

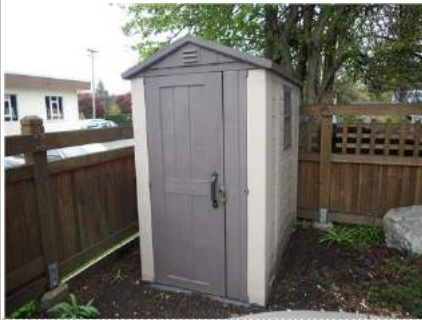
### Site 03 - Maintenance Shed

Southwest corner of property.

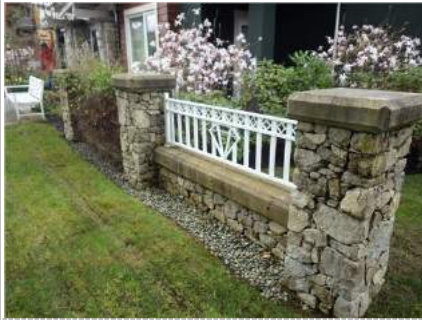
### Site 04 - Concrete and Stone Fence Wall

Front landscaping area.

- Anticipate localized repairs to portions of the following assets:
  - Site 04 Concrete and Stone Fence Wall
  - Site 05 Concrete and Stone Retaining Wall
- Site 06 Outdoor Furniture and Accessories – replacement of outdoor furniture, as required.

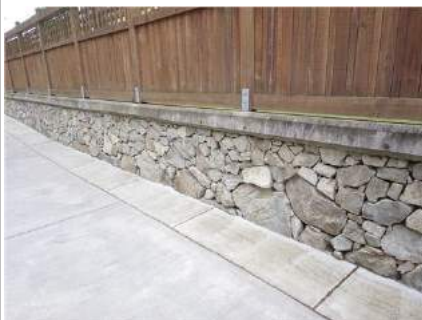
### Site 05 - Concrete and Stone Retaining Wall

East property line.

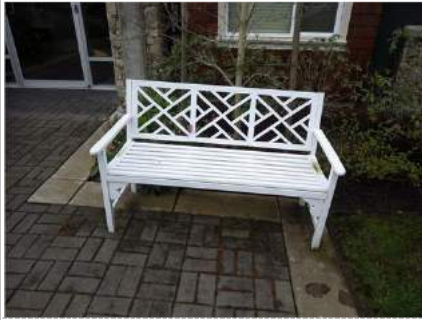
### Site 06 - Outdoor Furniture and Accessories

Throughout the site.

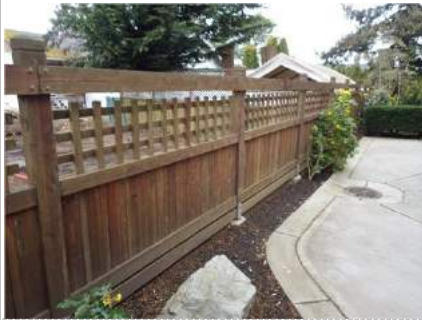
### Site 07 - Wood Fencing

Site perimeter.

- Site 07 Wood Fencing – Prepare and re-coat/repaint wood fencing (six-year cycle).
- Review underground drainage piping by video camera for condition and performance. Powerflush to clear and remove any buildup of debris. Affected assets (completed on a 5-year cycle):
  - Site 11 - Underground Drainage Services – Storm
  - Site 12 - Underground Sewer Services – Sewer

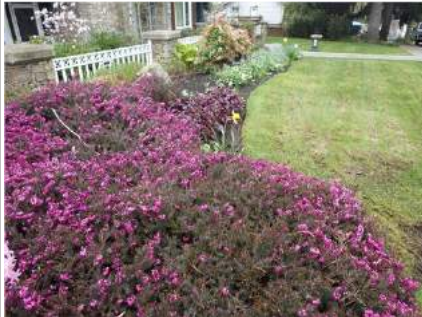
#### Site 08 - Soft Landscaping

Throughout the site.

Service Life: 15  
 Installed Year: 2010  
 Chronological Age: 8  
 Effective Age: 8  
 Next Renewal Year: 2025

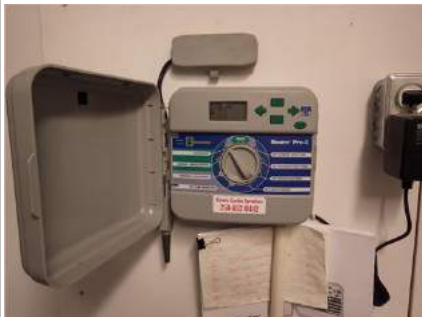
#### Site 09 - Irrigation System

Throughout the common landscaped areas of the site.

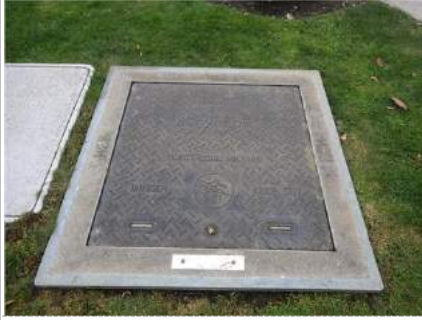
### Site 10 - Electrical Site Services

From property line to the electrical room.

Service Life: 50  
 Installed Year: 2010  
 Chronological Age: 8  
 Effective Age: 8  
 Next Renewal Year: 2060

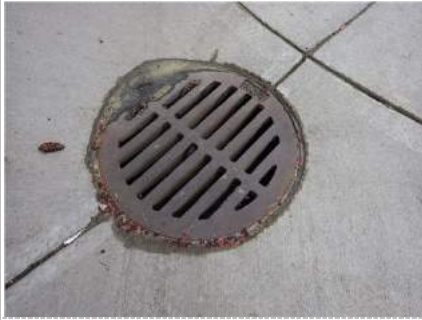
### Site 11 - Underground Drainage Services - Storm

Concealed asset; connection to municipal main and throughout parking areas.

Service Life: 80  
 Installed Year: 2010  
 Chronological Age: 8  
 Effective Age: 8  
 Next Renewal Year: 2090

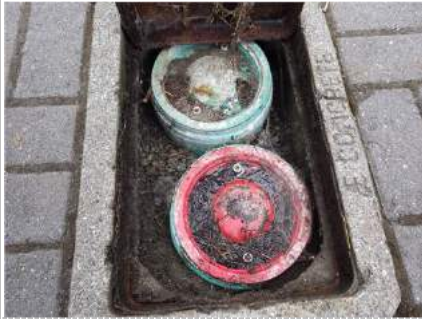
### Site 12 - Underground Sewer Services - Sewer

Concealed asset; from building to municipal main.

Service Life: 80  
 Installed Year: 2010  
 Chronological Age: 8  
 Effective Age: 8  
 Next Renewal Year: 2090

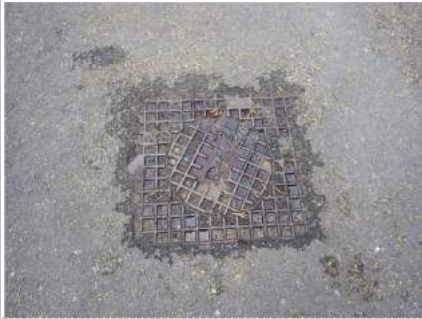
### Site 13 - Underground Water Services with PVC/Copper and Ductile Piping

Concealed asset; from building to municipal main.
