To: The Owners, Strata Plan VIS6613  
c/o Ms. Heather Zayonc,  
Property Manager  
Firm Management Corp  
#200-1931 Mt. Newton Cross Road  
Saanichton BC V8M 2A9

Site Visit: June 24, 2019  
Report Submitted: December 13, 2019 by  
RDH Building Science Inc.  
602 - 740 Hillside Avenue  
Victoria BC V8T 1Z4

# 1 Introduction

RDH Building Science Inc. (RDH) was retained by The Owners, Strata Plan VIS6613 (the Owners) to prepare a Depreciation Report Update (the Report) for the complex known as The Aspen at Lakeside, which is located at 101 & 201 Nursery Hill Drive, Victoria, BC. The Report considers the common property and limited common property components (the Assets) that the Strata Corporation is responsible to maintain, repair, and replace.

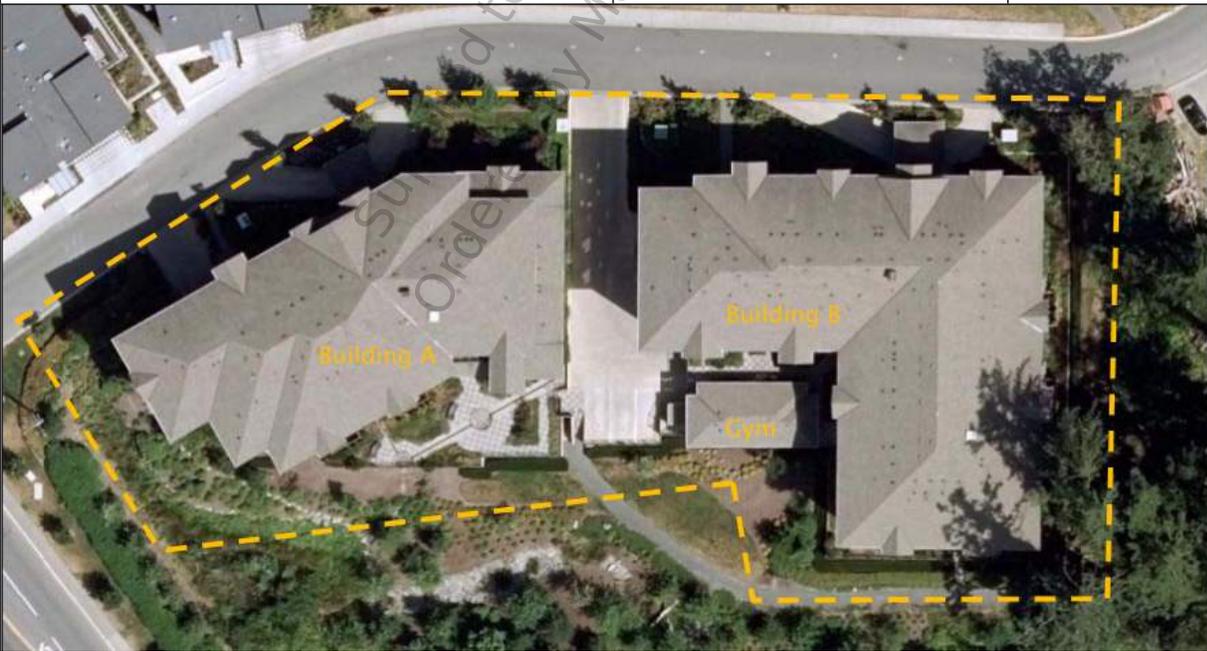
*Figure 2.1 Elevation photograph of The Aspen at Lakeside*

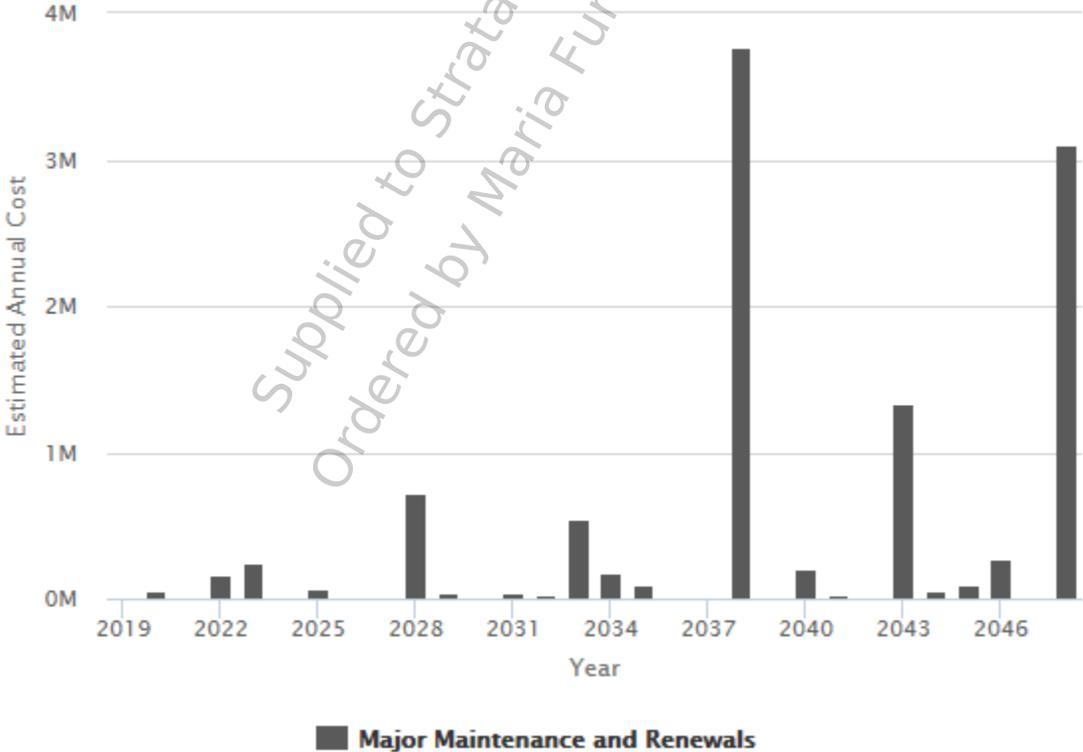
Figure 5.1 Strategic Forecast (30 Years), showing the approximate timing and value of some key capital expenditures.

Each bar on the graph represents a collection of different major maintenance and renewals activities, each with different values.

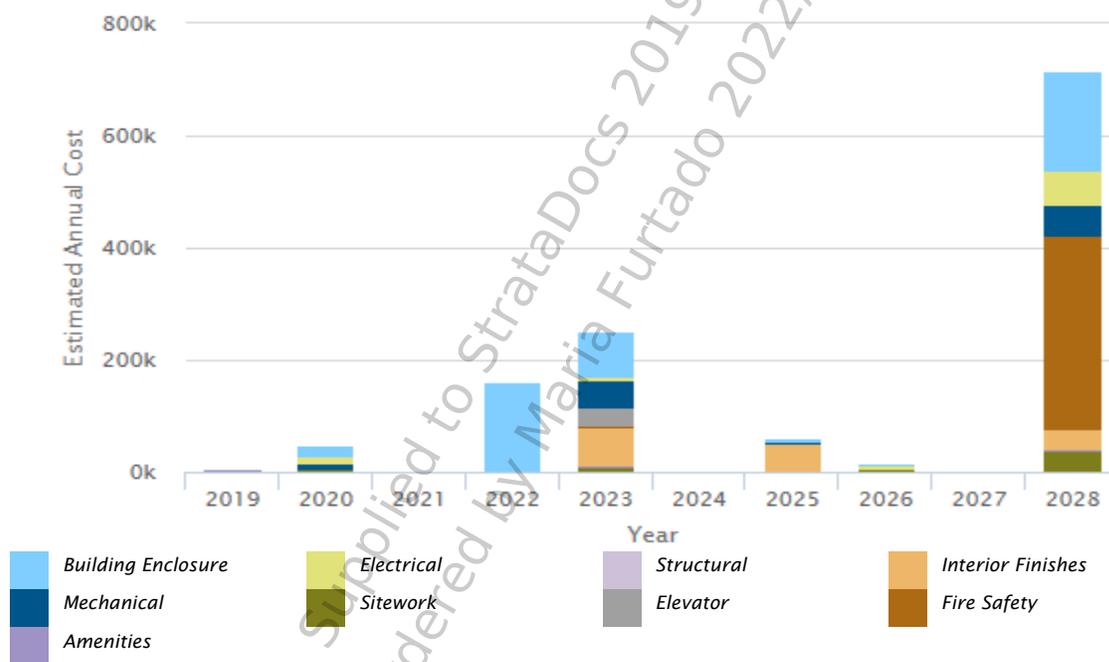
The bars indicate the years in which an event (or bundle of events) is most likely to occur as well as the total magnitude of major maintenance and renewal costs for that year and the costs broken down by system. The costs associated to correct any warranty defects are not included. The soft costs associated with project implementation, such as site access, design, and contract administration, are not included.

Figure 5.2 Tactical Forecast (10 years), showing the approximate timing and value of some key capital expenditures.

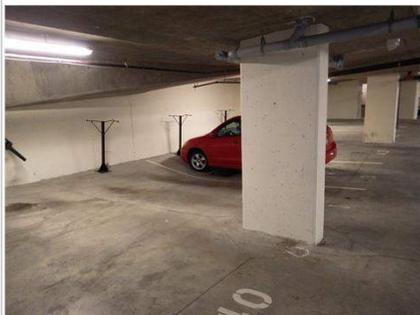
##### Struct 01 - Concrete Foundation & Parkade Structure

Foundation and parkade.

Cast-in-place concrete building foundation and underground parking structure.

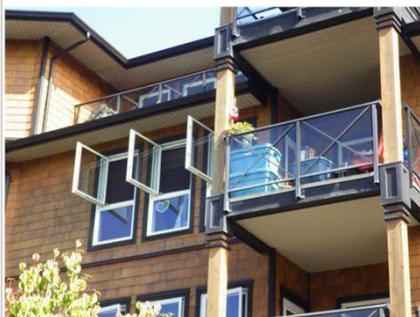
##### Struct 02 - Wood Frame Structure

Superstructure.

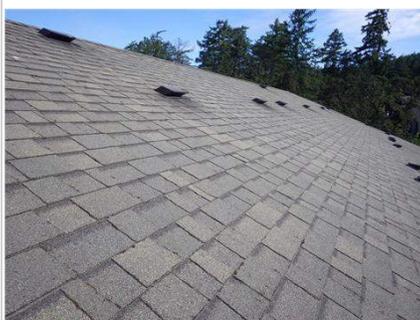
##### Encl 01 - Laminated Asphalt Shingle Roof

All sloped roofs.

- Encl 01 - Replacement of roof vents.

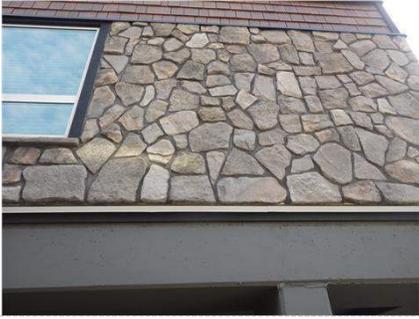
### Encl 06 - Cultured Stone Wall - Drained

Secondary building cladding.

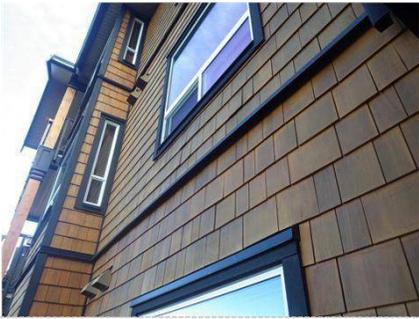
### Encl 07 - Wood Shingle Wall - Drained

Primary building cladding.

- Encl 07 - Re-stain/repaint wood shingle and associated wood trim.
- Encl 14 - Replace vinyl balcony membrane and associated components.
- Encl 17 - Perform a maintenance review of all enclosure systems.

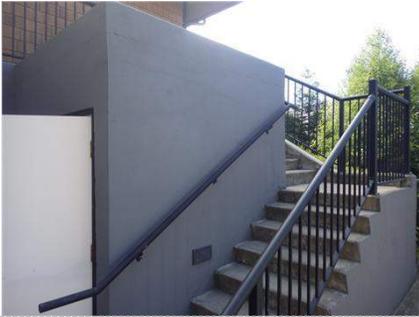
### Encl 08 - Concrete Wall

Foundation walls.

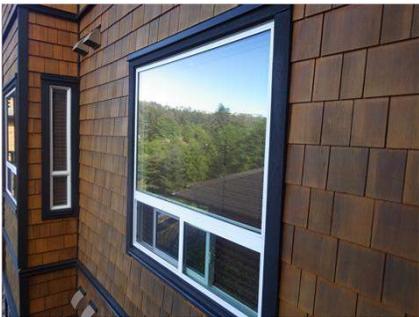
### Encl 09 - Vinyl Framed Window

All elevations and all levels of the buildings.

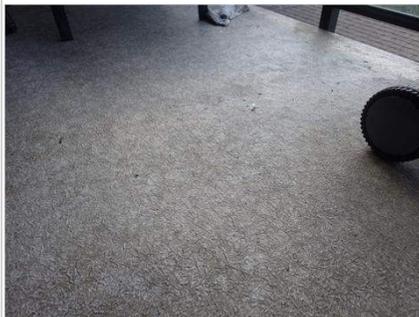
#### Encl 14 - Exposed Vinyl Balcony Membrane

Balconies.

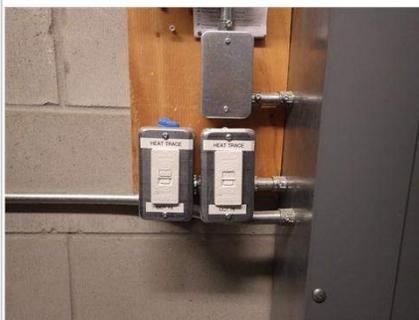
##### Mech 02 - Heat Tracing - Freeze Protection

Throughout the parking garages.

- Mech 02 - Replacement of components of electric heat tracing cable

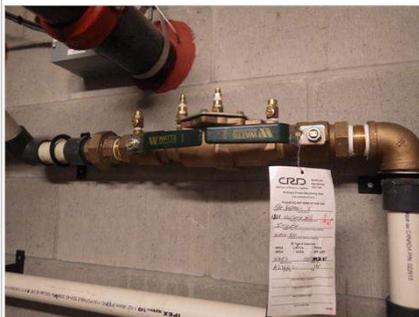
##### Mech 04 - Valves - Cross Connection & Backflow Prevention

Mechanical rooms.

- Mech 04 - Cyclical replacement of cross connection & back flow prevention valves.
- Mech 05 - Cyclical replacement of valves.

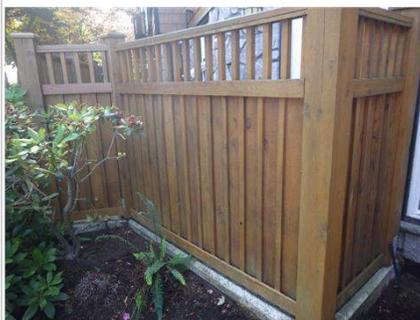
##### Site 02 - Wood Fencing

At ground level units.

- Site 02 - Replace wood perimeter fencing.
- Site 03 - Prepare and re-coat exterior metal railings.

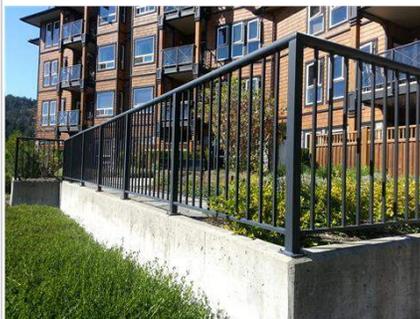
##### Site 03 - Exterior Metal Railings

Perimeter of site walkways, stairs, and on top of parkade and various retaining walls.
