February 11, 2022

**Re: Tantalus Resort Lodge – 4200 Whistler Way, Whistler  
Garage, Roof, and Siding Evaluation - DRAFT**

Sense's Project No. 22vR006A

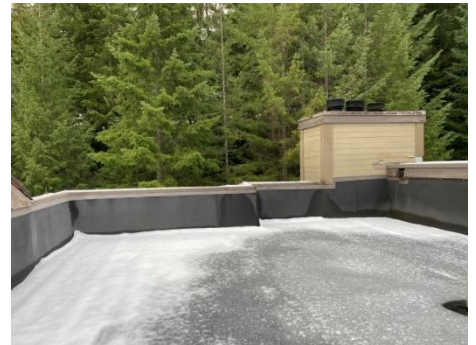
Photo 2: Fifth floor roof.

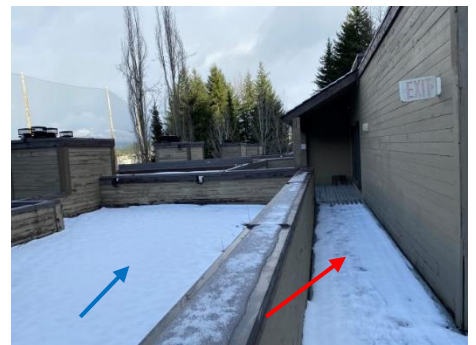
Photo 3: Roof deck (red arrow) and adjacent flat fourth floor flat roof (blue arrow).

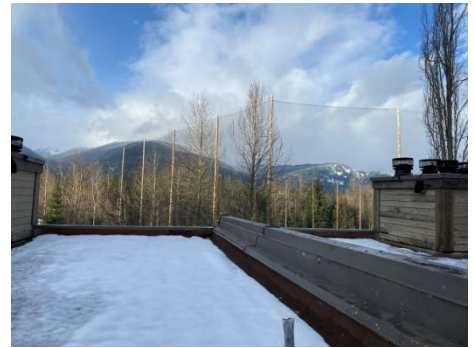
*Photo 4: Fourth floor roof.*
