# Your Inspection Report

403 Durie St  
Toronto, ON M6S 3G5

**INSPECTION DATE:**  
Monday, August 24, 2026

RE: Report No. 98938, v.2  
403 Durie St  
Toronto, ON  
M6S 3G5

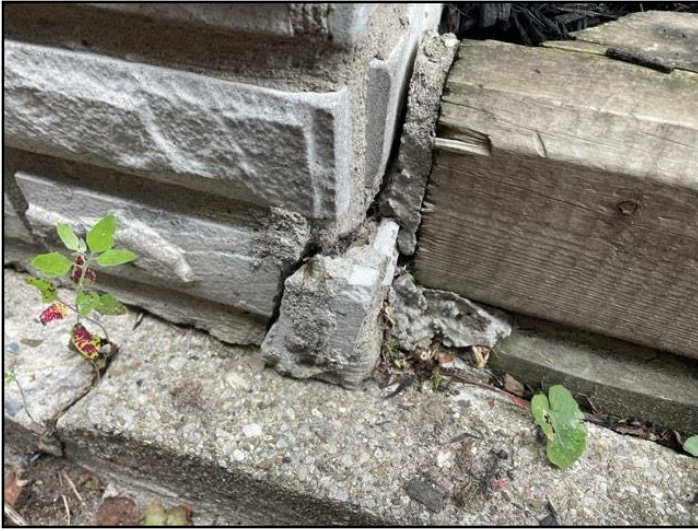
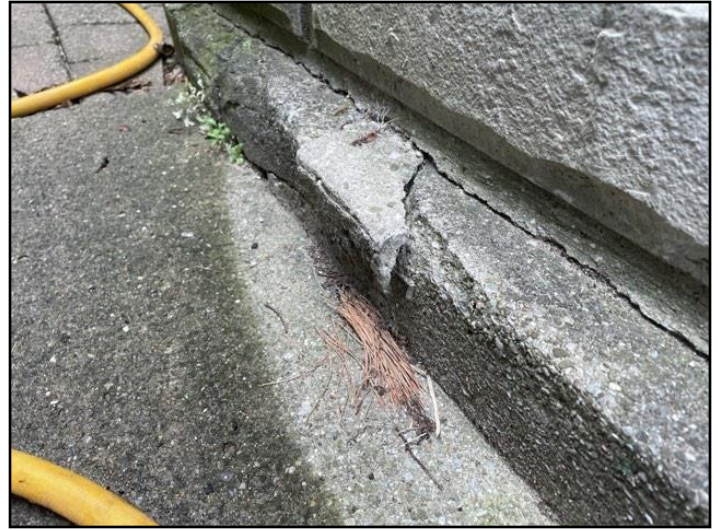
Cracked

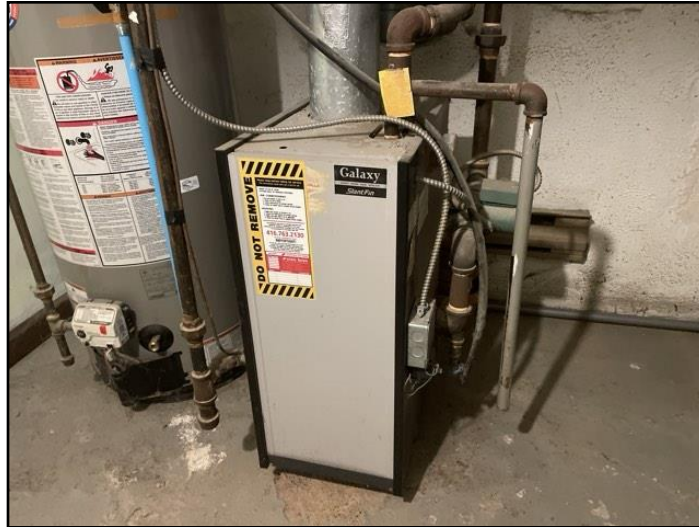
Boiler

**Condition:** • Near end of life expectancy.

Although the boiler is close to the end of its life, continue to use and maintain the unit until it fails. Be prepared to replace the boiler at any time.

**Task:** Replace

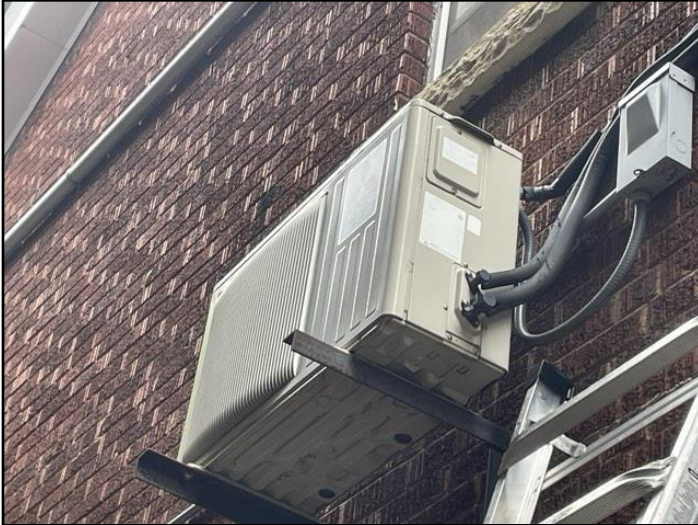
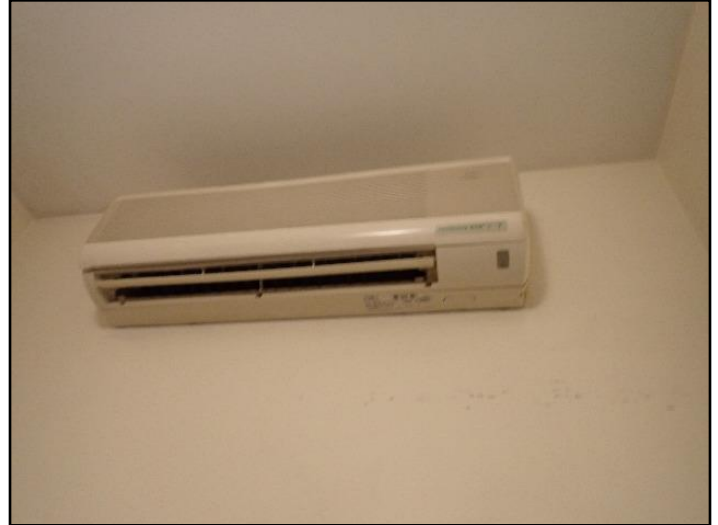
Outdoor unit

**Condition:** • Air conditioner near the end of typical life expectancy

Although the heat pump system is close to the end of its life, continue to use and maintain the unit until it fails. Be prepared to replace at any time.

**Task:** Replace

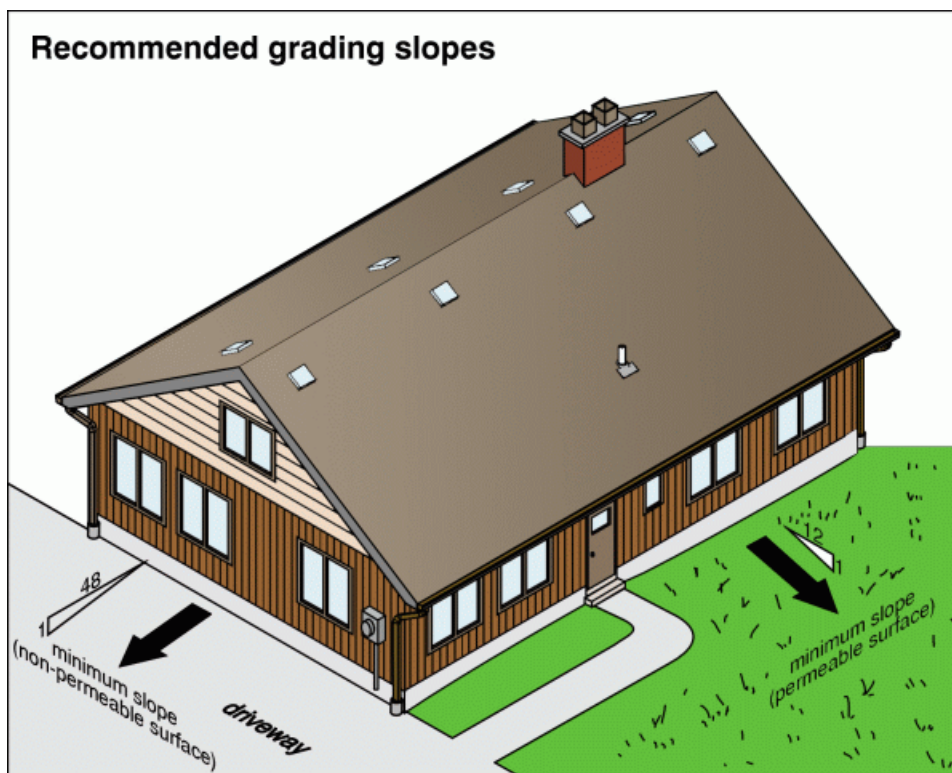
Elevated moisture readings (High)
