# Your Inspection Report

220 Medland St  
Toronto, ON M6P 2N7

**INSPECTION DATE:**  
Thursday, August 20, 2026

RE: Report No. 98891, v.2  
220 Medland St  
Toronto, ON  
M6P 2N7

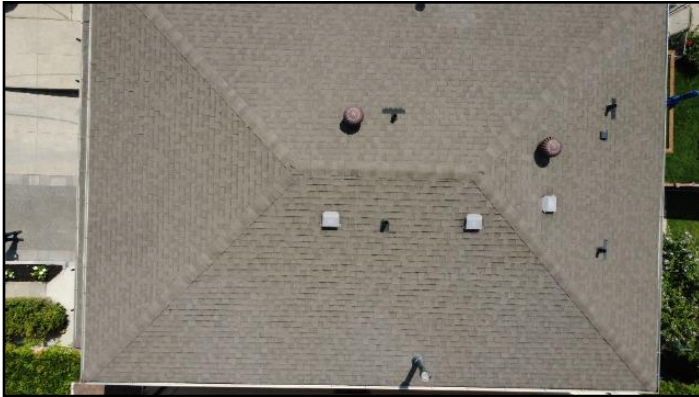
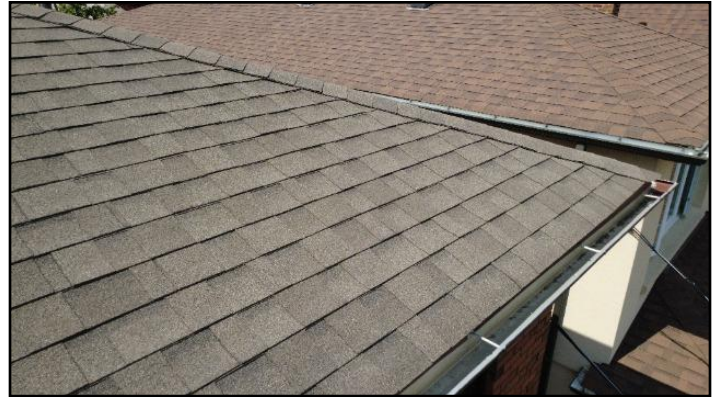
Asphalt shingles

**Condition:** • The roof shingles are in good overall condition.

Annual inspections are recommended (on any roof) to take care of any roof damage and/or regular maintenance items (flashings/caulking).

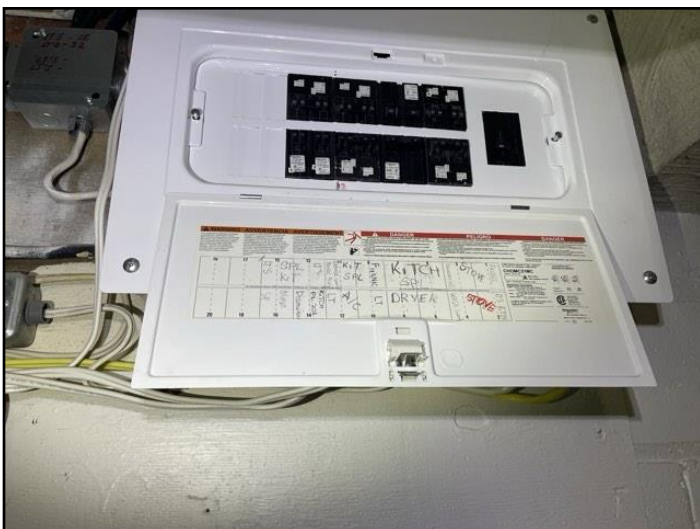
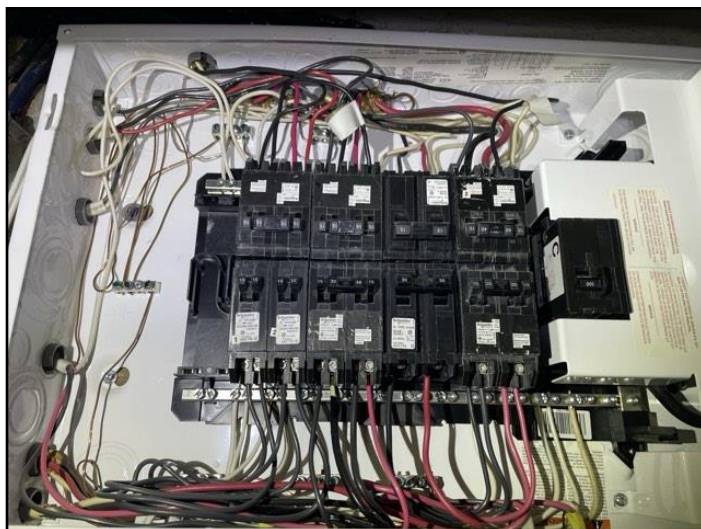
Breakers - garage

**Distribution wire (conductor) material and type:** • [Copper - non-metallic sheathed](#) • [Copper - metallic sheathed](#) • Aluminum - non-metallic sheathed

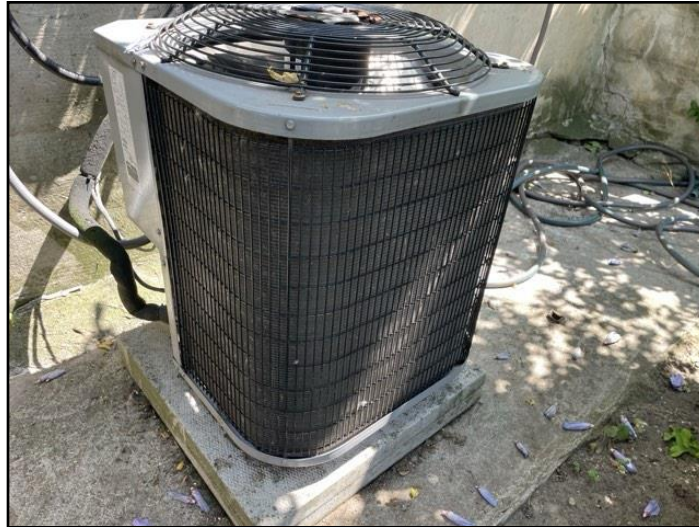
*Air cooled*

**Condition:** • Air conditioner near the end of typical life expectancy

Although the air conditioning system is close to the end of its life, continue to use and maintain the unit until it fails. Be prepared to replace at any time.

**Task:** Replace

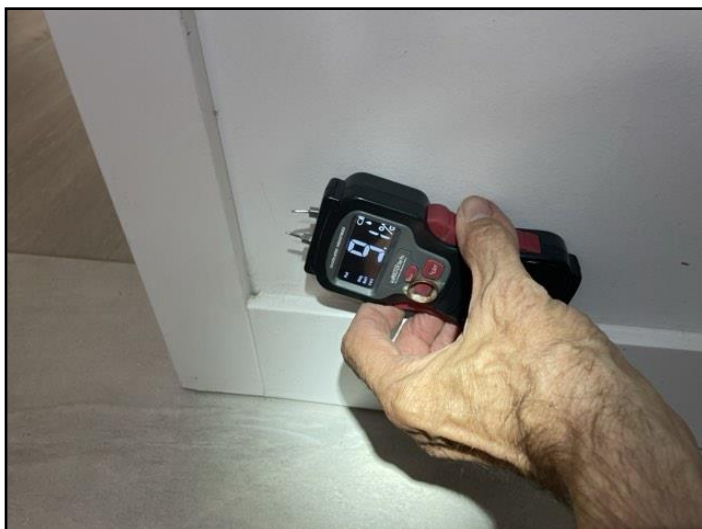
Interior Wall (Reference)

**Condition:** • Typical reading noted with meter during inspection.

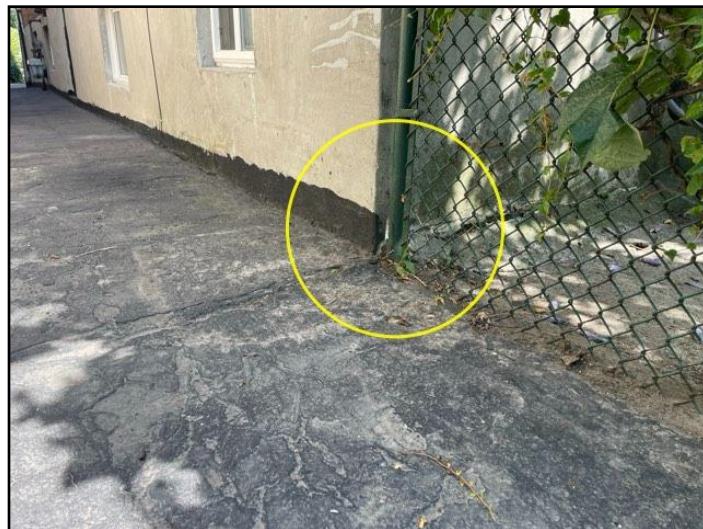
*Exterior View*

**Condition:** • Evidence of moisture noted

*Evidence of moisture noted*

**Task:** Ensure gutters and downspouts are working properly and exterior grade slopes down away from the home. Monitor the area for evidence of moisture, particularly in the spring when snow melts or after heavy or persistent rains.
