Inch By Inch Inspections Home Inspection Report

1681 Medallion Court, Mississauga, Ontario

Date of Inspection: 5/11/2023 Time: 2:00pm

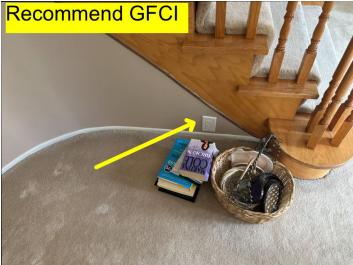
• ()Electrical is in good order at time of inspection unless noted. Random electrical outlets were tested through the home during the inspection. Good at time of inspection. Consult a qualified contractor as needed.

as noted
