## Home Inspection Report

2847 Wyndeatt Avenue  
Victoria, BC V9A 2L7

Date of Inspection: 06/17/2020

Inspection No. 1013-2-417

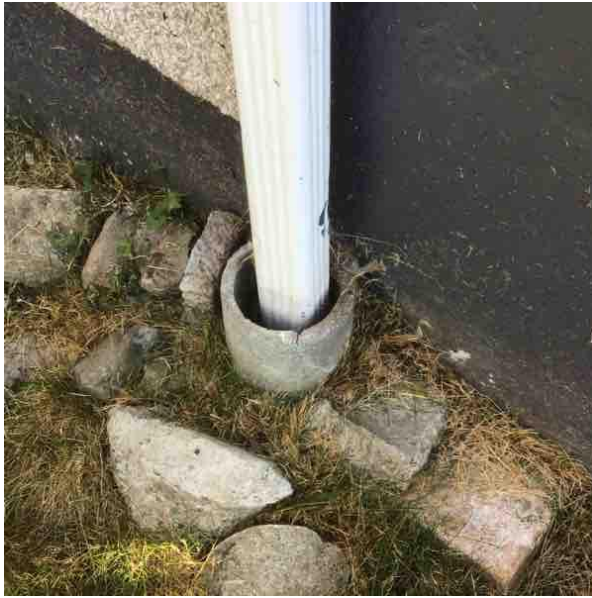
4.5.1 Due to the age, we advise you obtain a history of perimeter drain pipe service from the seller. If the system has not been serviced or updated recently, we advise you do so to help ensure the drains are free draining. This will help prevent unwanted foundation settlement and seepage into lower areas. We are unable to inspect foundation walls below grade and underground pipes.

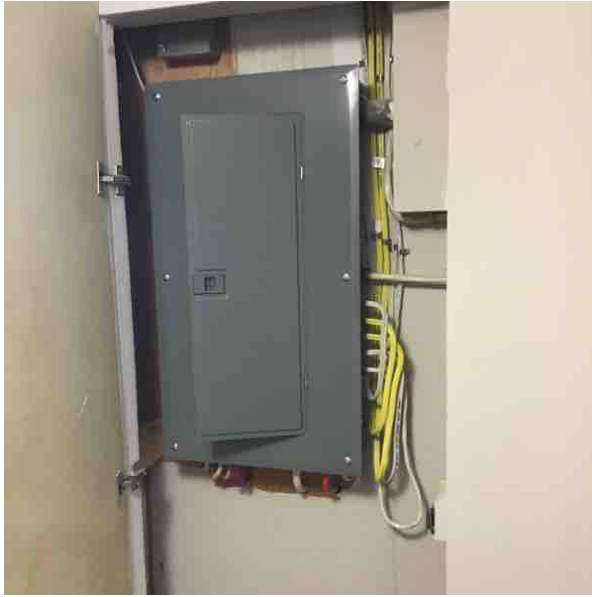
8.2.1 The electrical system appears to be updated since original construction, this is a nice feature. Obtain permits and inspection records from seller.

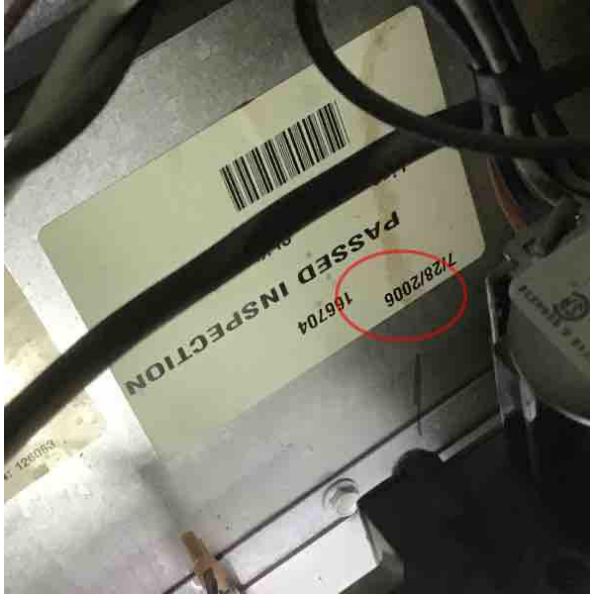
9.1.1 The heating system in the home has been updated since original construction, this is a nice upgrade feature. Copies of installation information should be obtained from the seller.

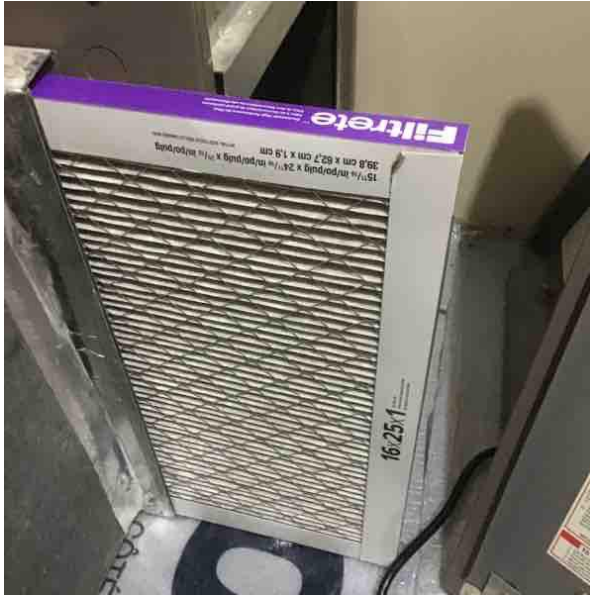
9.6.1 Clean, change and maintain filter system regularly to help system efficiency unit lifespan and indoor air quality.

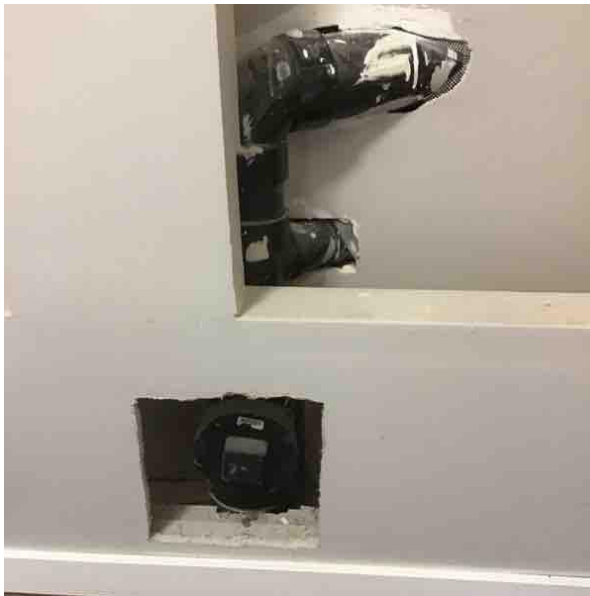
10.2.1 Inspected updated plumbing components , this is a nice feature. We recommend contacting the vendor for documentation and permits.

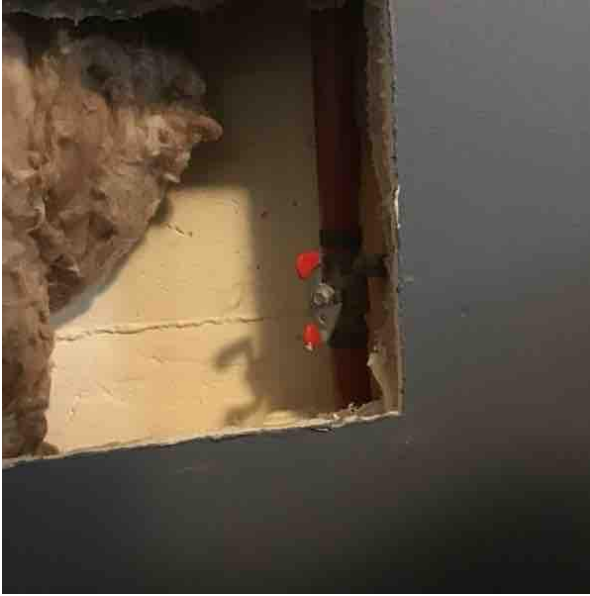
10.3.1 Location: Basement family room.

☉ Water main is plastic pipe.

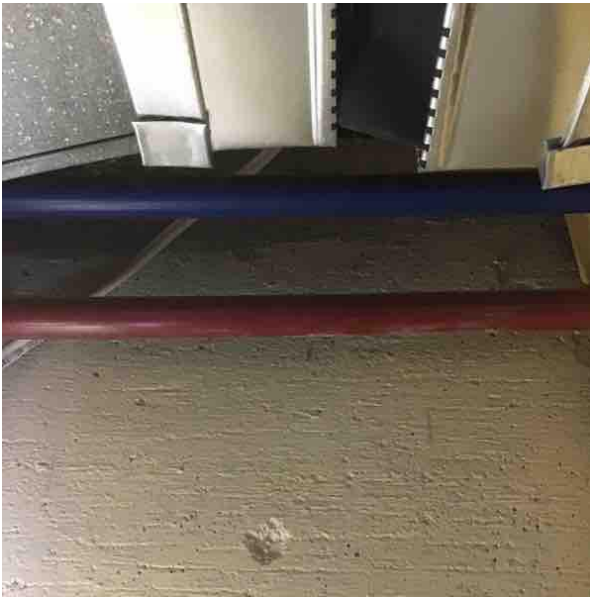
10.4.1 The visible distribution piping is plastic.
